**The Bahamas
Maritime Authority**

NOVA BRETAGNE

**Report of the investigation into the
Accidental release of lifeboat during a drill**

14th November 2009

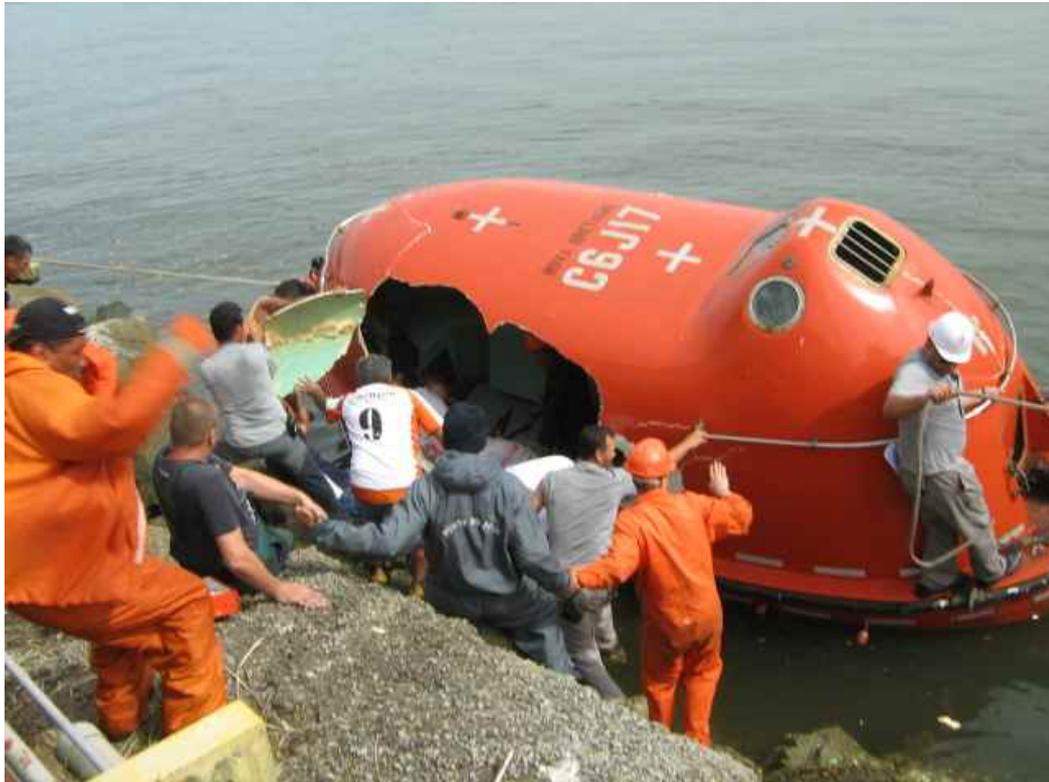
Photo 1: Ship's crew move quickly to recover the damaged boat to the shore after the accident and to rescue the injured boat's crew.

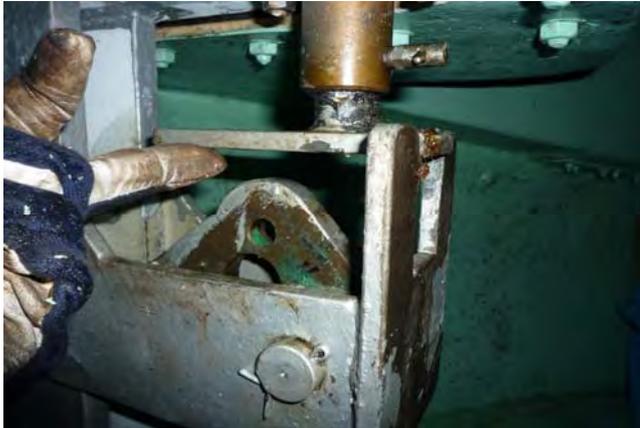
Photo 2 and 3: Under-deck cam plate.

The under-deck Cam Plate indicating a position in which the release of the hook was possible (not necessarily the position in which the failure occurred but held in this position for clarity of subject area)

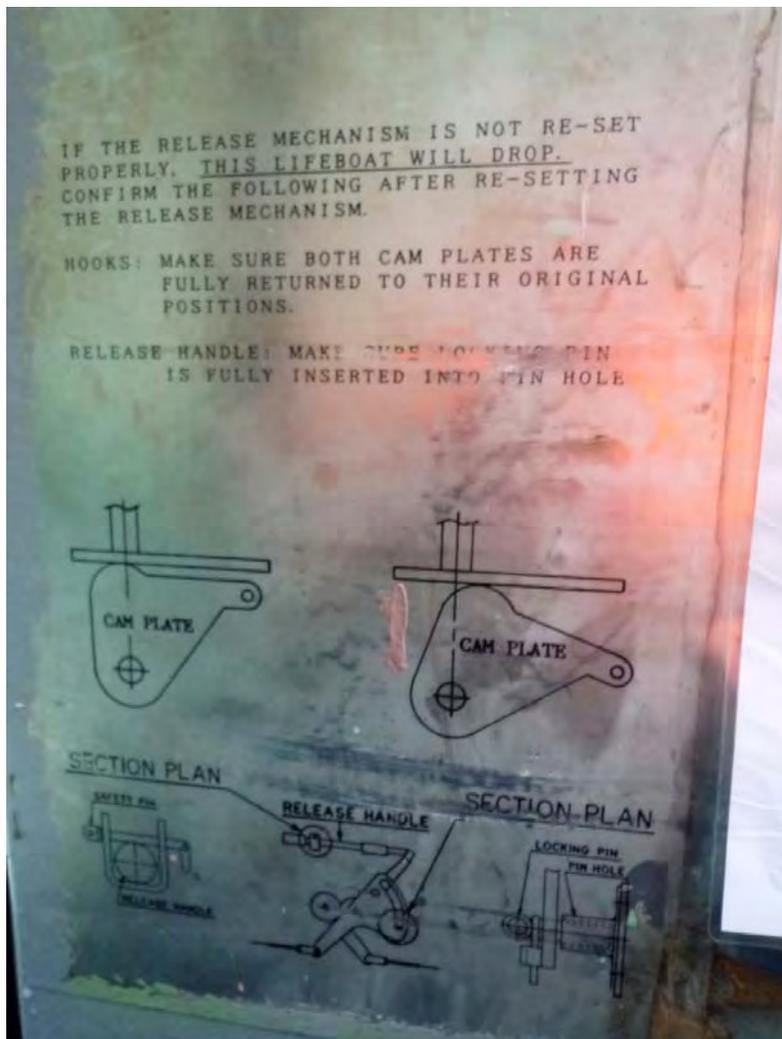
Above:
The instruction plate close to the helmsman's feet, indicating correct and incorrect settings for the under-deck cam plate

- 4.45** The instruction plate (Photo 3) relating to the Cam Plate ④ setting is an engraved plaque. It does not have any highlighting features, it should have. Similarly the Cam Plate (Photo 10) is a neutral colour. It could be painted in a highly contrasting colour so as to emphasise its importance.
- 4.46** The decision to disconnect the boats from the falls is entirely within the requirements of SOLAS but, ignoring the competence of the crew and their natural instinct for self-preservation, there is very little to prevent the users doing so inadvertently.

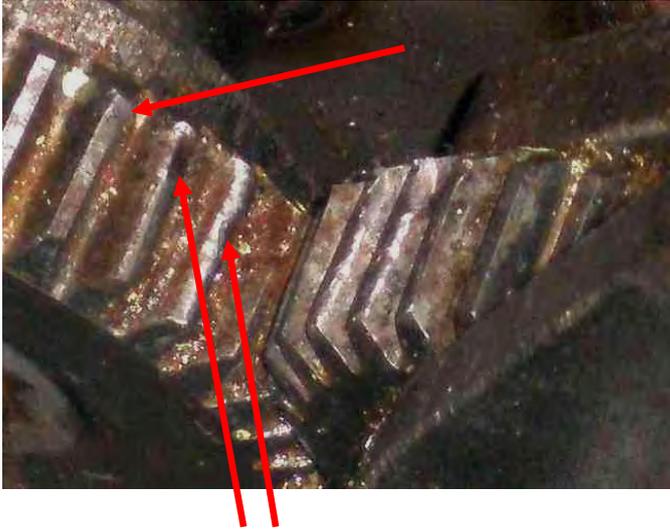
Photo 4 and 5: Release mechanism activation point.

- 4.5 Investigation revealed that the release lever mechanism at the activation point used by the helmsman was damaged although it was still operable. Interlocking teeth of the two meshing gear wheels were damaged. These in turn operate the cranks that are connected through the turnbuckles to the flexible cables operating the under-deck cams.

Gear teeth showing damaged interlocking surfaces; Some but not all signs of damage arrowed.

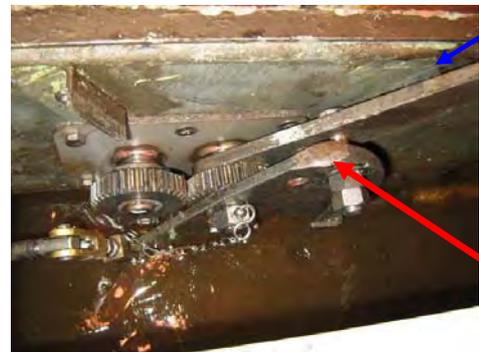
The assembly as a whole seen from above and slightly outboard to starboard; Evidence of abuse hammering: arrowed red and backplate joint of flattened lever stop: arrowed blue.

- 4.6 Further damage to the release lever mechanism was also evident. The crank nearest the operator, labelled “gear” in the manufacturer’s diagram (Figure 1 below), was damaged, showing signs of being hammered in the past. This would suggest that the system could have been locked up at some time due possibly to misalignment of the damaged gear teeth and excessive force was used to free the mechanism. Impacts from the same force may have been responsible for damage to the gear teeth originally.

- 4.9** The stop referred to above is not fully visible in Photo 5 but it's joint with the back plate is. It is positioned behind the lever, between it and the back plate in a folded flat state. This means that the lever pictured is not in the correct position – it is too far forward – suggesting that the whole linkage is out of adjustment. This in turn allows for a final position of the Cam Plate intended to lock the hook could be out of the horizontal. (see also 4.5 above and 4.11 below).

- 4.34** The abuse damage found on the gears and crank of the after release gear, added to the damaged stop plate strongly suggests that the mechanism has not been fully understood by crews in the past. The significance of the release lever being out of position and other linkages similarly has apparently been missed.

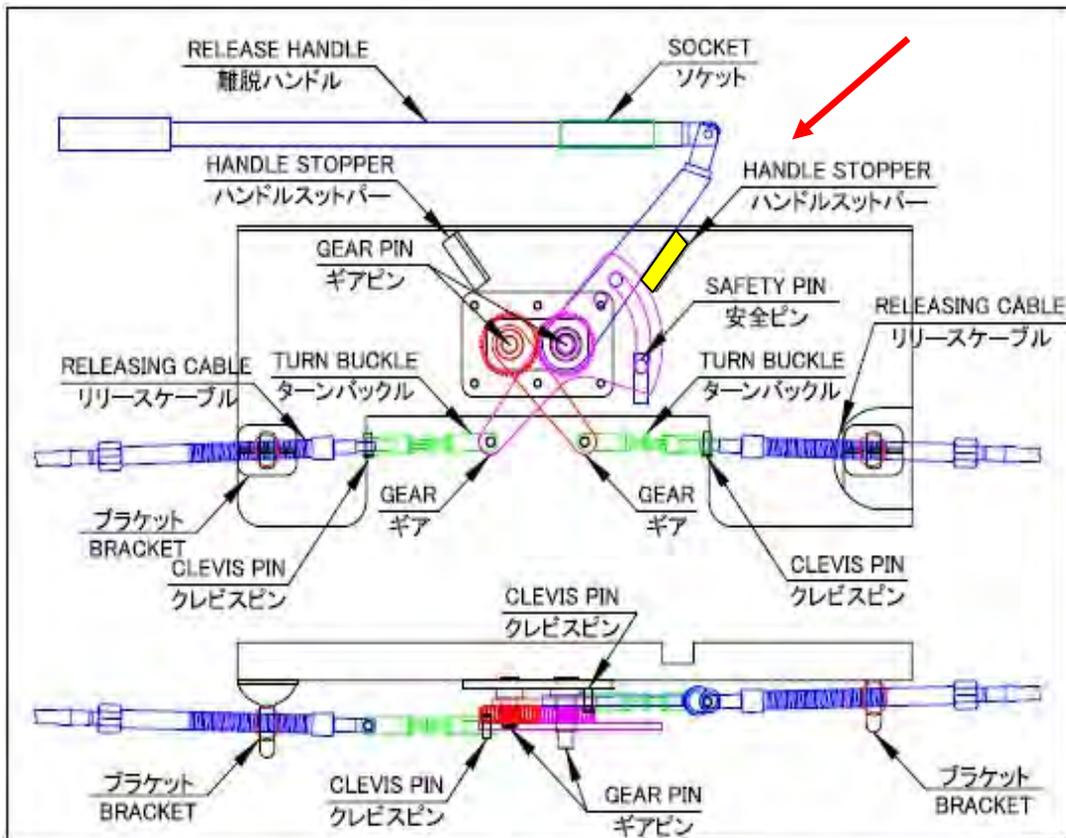
Figure 1: Release handle mechanism. Diagram from SHIGI Manual

- 4.8 A stop, labelled “handle stopper” in figure 1 (below arrowed in red and highlighted in yellow), designed to prevent the handle being set too far forward during a re-setting operation, was found to be bent almost flat as a result of excessive force being applied to the handle in the re-setting position (the one illustrated). This would result in removal of a defined stop position for the lever. If, as would appear to be a possibility, this was the case and/or the turnbuckles connecting the cables to the two operating cranks were wrongly adjusted, the final position of the under-deck cam - known in manufacturer’s drawings as the Cam Plate - would be proportionately affected.

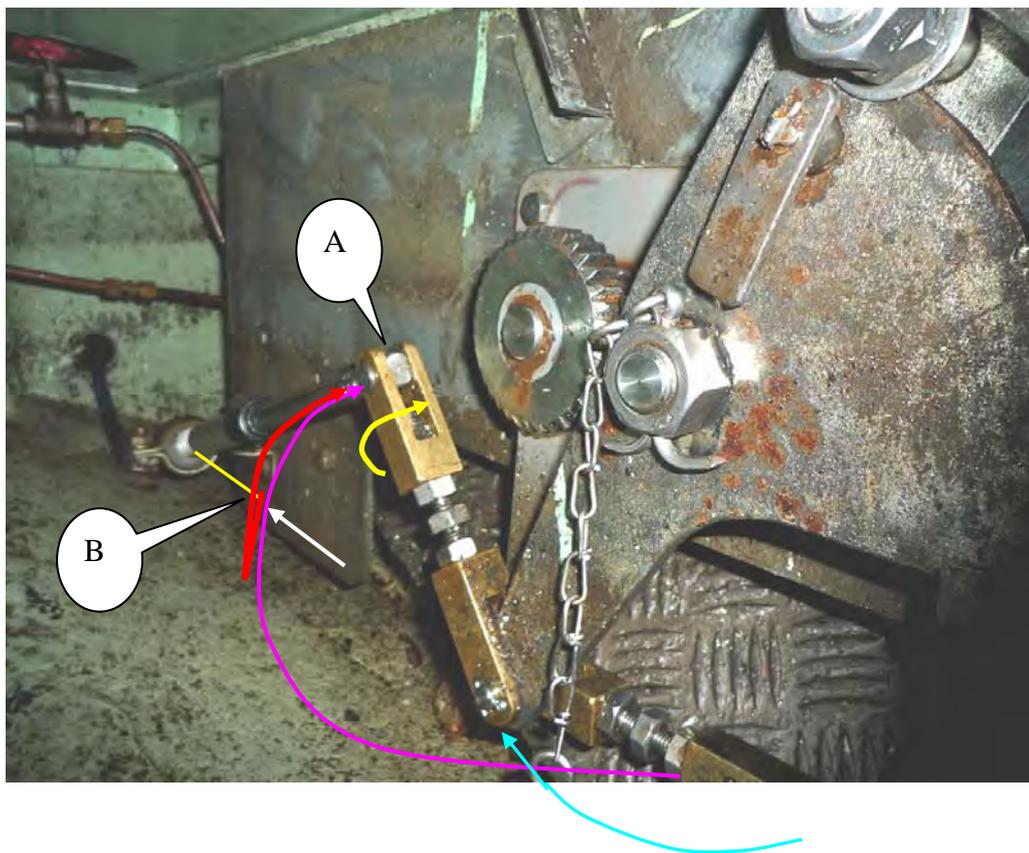
Photo 6: Release handle mechanism displaced from correct re-set position as found possible at repair yard. Note orientation of outer clevis (upper centre of picture).

- 4.14** Displacement of the after outer clevis is possible as in Photo 6 through the conical path shown in magenta. Because the locking nut on the turnbuckle is inadequate to resist the resulting torsional forces the rotation indicated by the yellow arrow in Photo 6 is possible. The Release Lever, in being pushed forward to the re-set position causes the crank to which it is attached to describe the arc shown in turquoise (light blue) in the vertical longitudinal plane. The crank arc is constrained to the longitudinal plane by its rotation about the pinion of the Gear Pin (see Figure 1), which is fixed in the athwartships or lateral plane. The cable end to which the outer clevis is attached however is free to rotate over a limited field of movement by the ball joint bracket by which it is constrained (left of picture in distance of Photo 6). The correct path for the cable/clevis joint is shown by the yellow line and white arrow.

- 4.17** In the event of resistance of movement of the under-deck cam plate, the conical displacement shown by the magenta line in Photo 6 is possible as soon as the clevis rotates under the asymmetric rotational forces acting upon it in the event of a resetting movement. The additional articulation of the linkage caused thus will result in little or no movement of the under-deck cam plate at the far end, i.e. the after or forward hook, all of the displacement having been taken by the articulation of the outer clevis. This in turn leaves the hook susceptible to opening as the tail of the hook is not fully secured in the correct closed position.

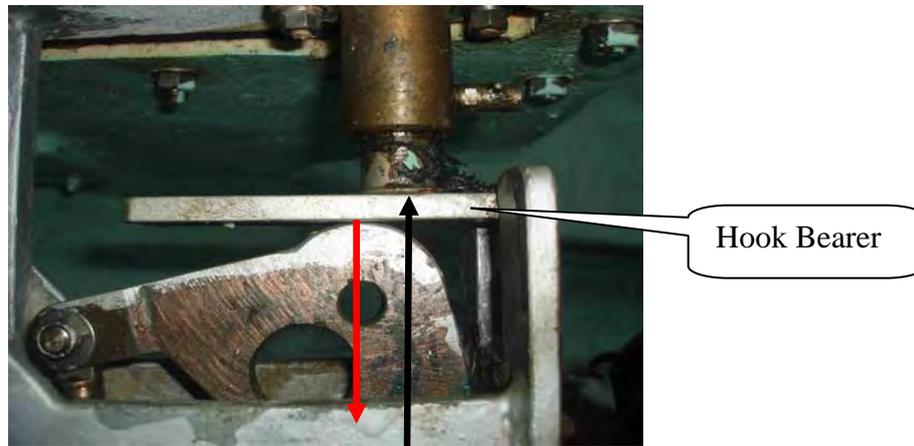
Photo 7: Under-deck Cam Plate in incorrectly re-set position.

In this position the tangential contact of the Cam Plate with the Hook Bearer will not be aligned vertically above the fulcrum point and the combination of the down thrust due to the pressure from the hook (red arrow) and the upward reaction through the Cam Plate fulcrum (black arrow) will result in an opening couple. See also Figure 2.

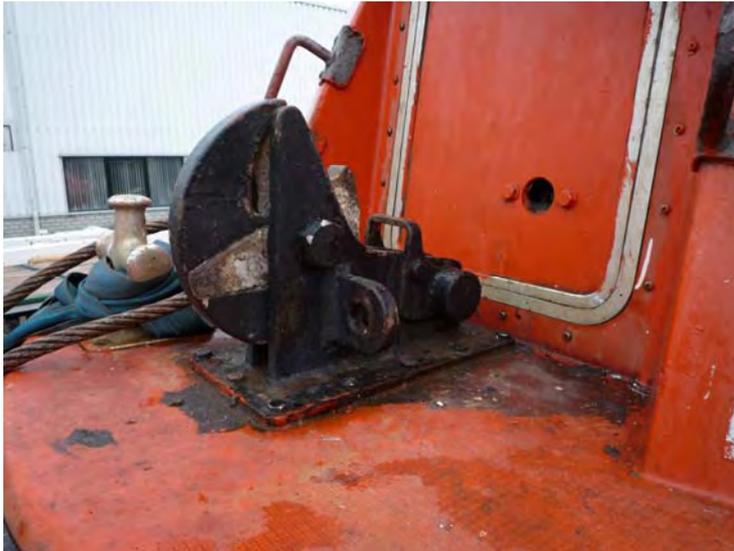
- 4.21** It is noted that there are some minor differences between the hook fitted to the boat (Photo 8) and the one depicted in the manufacturer's drawing (Figure 2). The side plates do not have the extended horn with hanging-off points formed by the shackling hole - Figure 2 - (30). They are however provided with lugs on either side (starboard lug visible in photo). These lugs have significance in the use of FPDs discussed below.

Photo 8: Hook as fitted. Note lug on side of side plate. There is another on the opposite side.

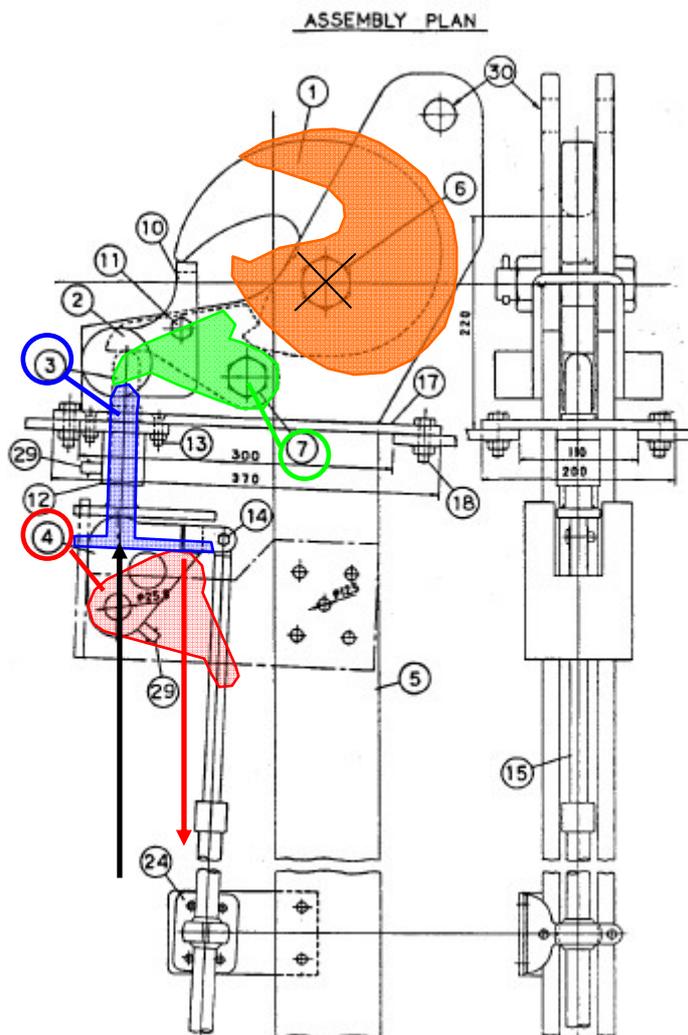
- 4.22** The Cam Plate ④ depicted in the drawings does not include the hole at the centre of curvature of the bearing surface interfacing with the Hook Bearer ③. In the subject boat this hole existed and can be seen in the photographs. It could be significant if a pin type FPD were introduced to the design (see Recommendations)

Figure 2:
Hook Assembly showing mode of operation. Note in closed position Cam Plate ④ is tangentially in contact with Hook Bearer ③ in position vertically above fulcrum of Cam Plate thus locking mechanism. In any other position an opening couple is possible under load, indicated by Red arrow, representing downward force acting in conjunction with the black arrow representing the lifting force exerted by the suspension link acting through from the hook ①

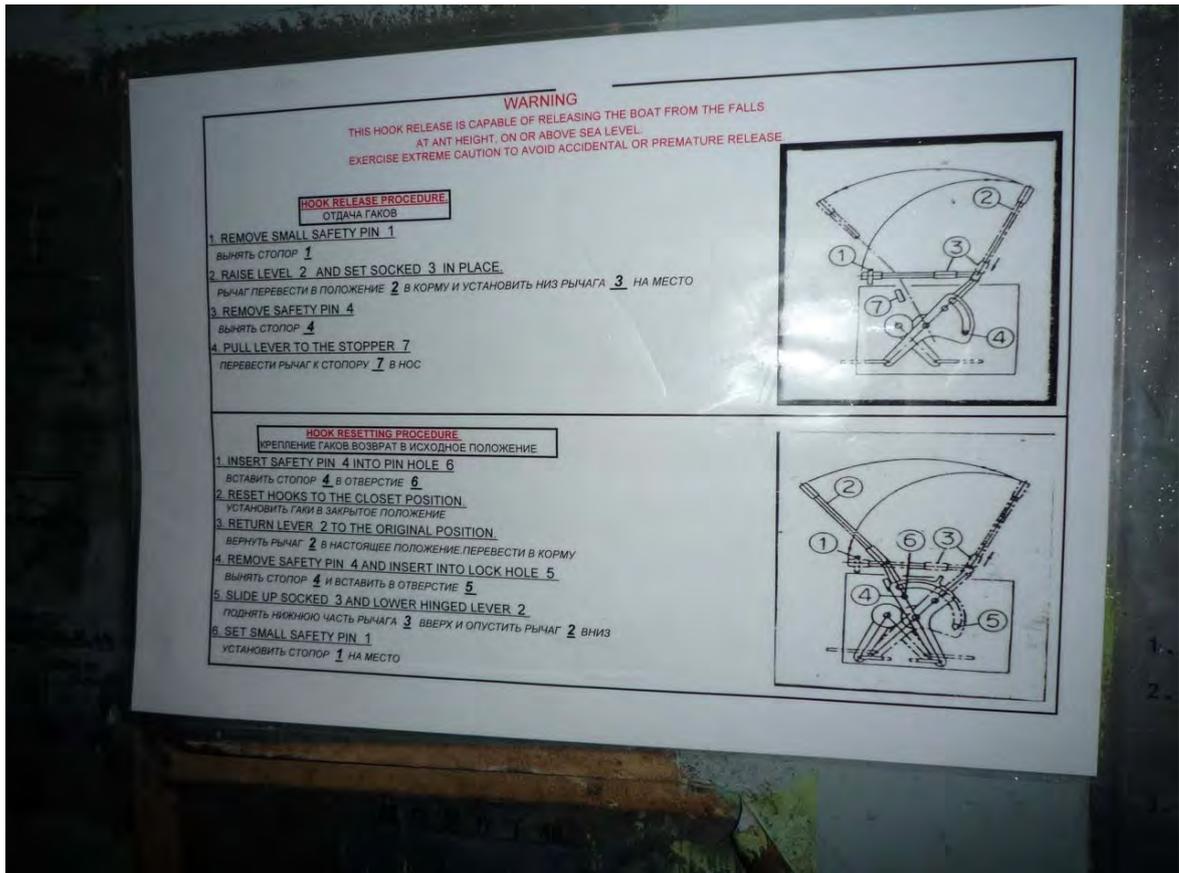
Photo 9: Instructions for Operation of the release mechanism and hook resetting procedure.

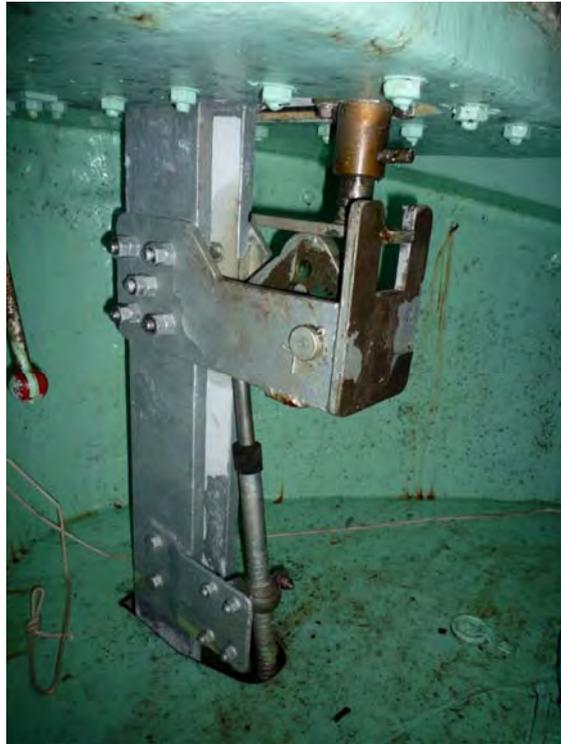
Cam Plate in the horizontal position are locked shut. Unfortunately, if the Cam Plate is not correctly positioned it provides a lever that is able to transmit forces into the system of linkages (cables, turnbuckles and levers) between that position and the control. If any part of that system allows sufficient play the hook may reach a position whereby it releases. There is no locking arrangement to ensure the Cam Plate is held in the correct position. There could be. (see recommendations)

Photo 10: Underdeck Cam Plate visible for status check. Note this is incorrectly set.

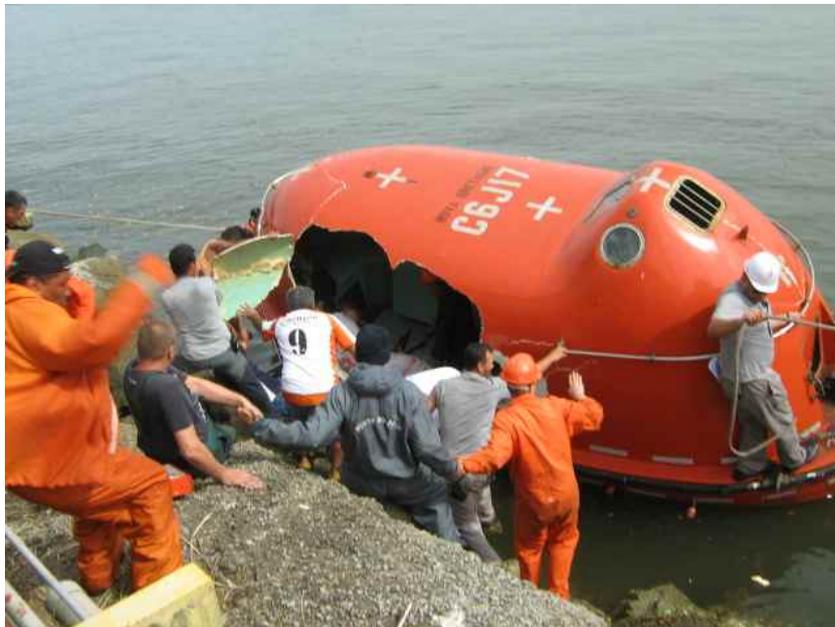
Photo 11: Lifeboat immediately after the accident. Note in relation to 4.45 above, the positions of the viewing apertures available to the helmsman and directions in which they face.

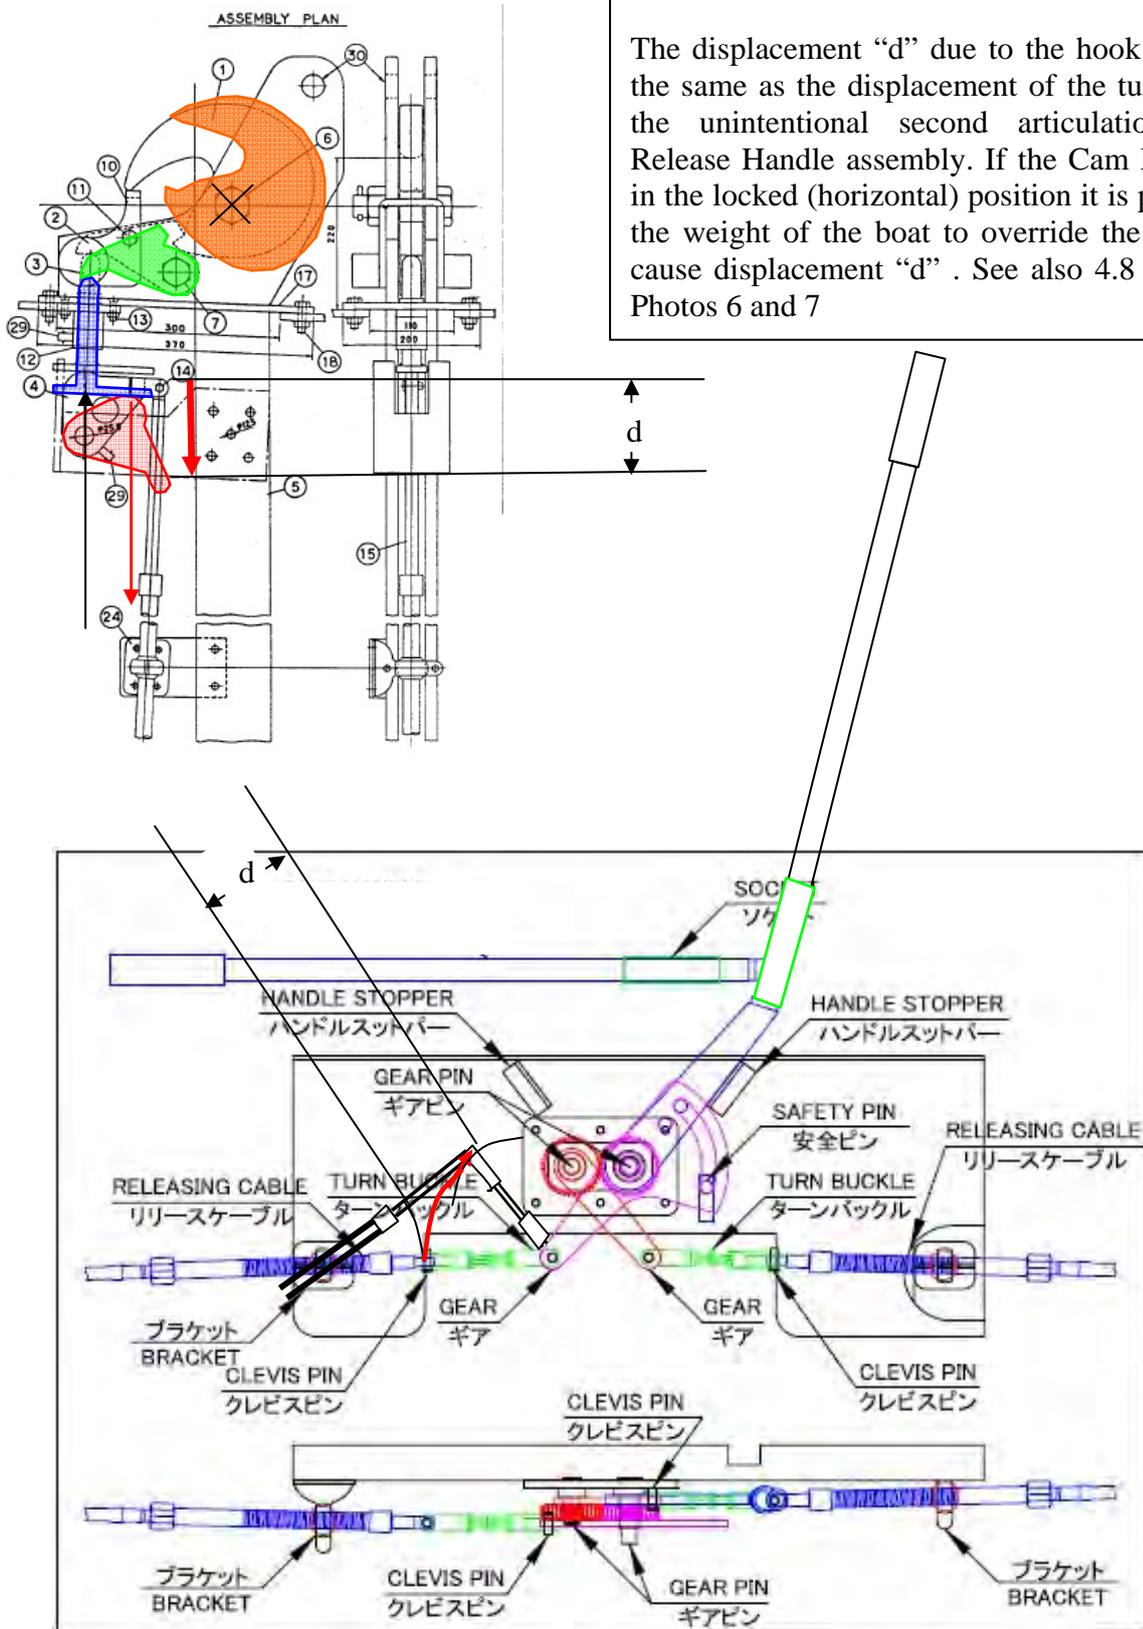
The displacement “d” due to the hook opening is the same as the displacement of the turnbuckle at the unintentional second articulation of the Release Handle assembly. If the Cam Plate is not in the locked (horizontal) position it is possible for the weight of the boat to override the levers and cause displacement “d”. See also 4.8 – 4.21 and Photos 6 and 7

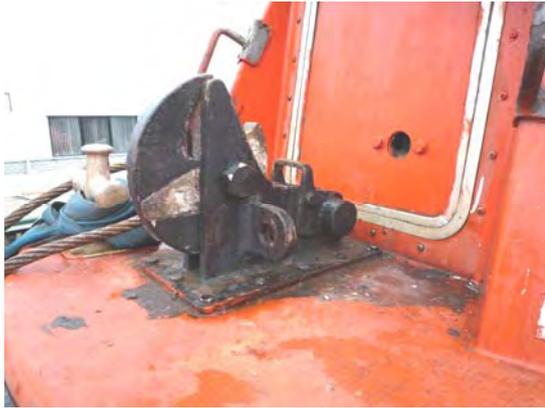
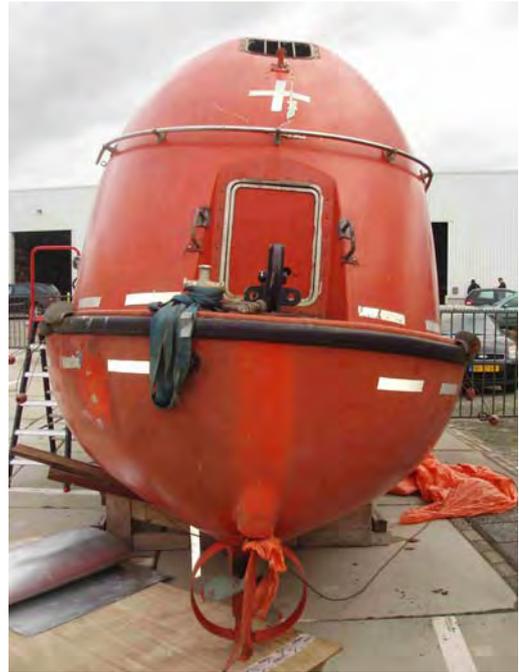
Above and Right: After hook arrangement on the SHIGI boat showing side lugs that are suitable points of attachment for FPD Slings.as in the arrangement below.

Note the close proximity to the access hatch, making this arrangement even more suitable as an immediate modification.

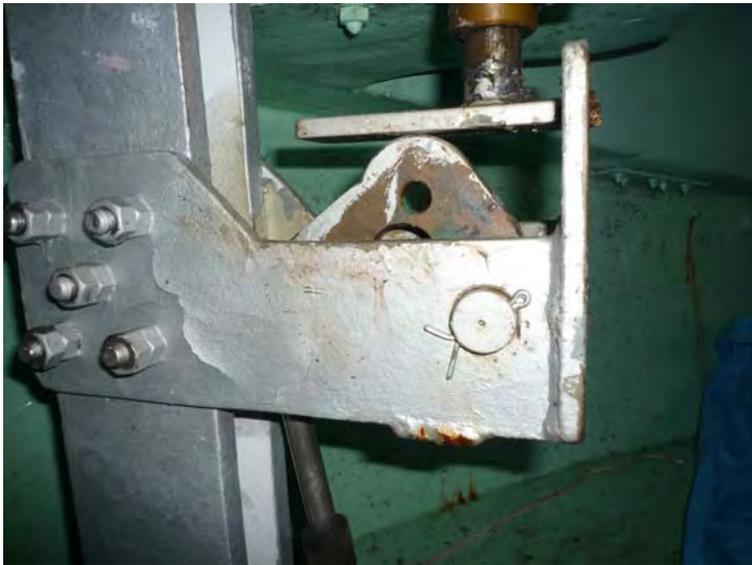
Left: The existing arrangement in the Shigi boat and

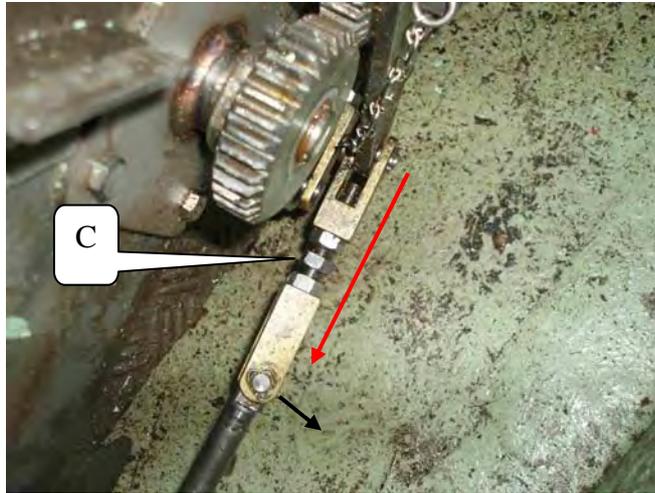
- 4.37** The single point of failure evident at each of the hooks is further compounded by another at the turnbuckle which has a single inadequate locking arrangement. The arrangement is evidently unable to prevent inappropriate rotation and additional articulation in the linkages.(see 4.15, 4.16 and Appendix III)

In the photo above the turnbuckle adjuster has been correctly adjusted with the two clevis pins at right angles to each other. In the photo the reset lever has begun its travel towards the re-set position and it can be seen that the clevis serving the after cable connection (bottom of picture) has already begun rotating out of the right angle aspect to its partner. The locking nut on the adjuster (C) is unable to resist the torsional stress caused when the cable end is displaced outboard (arrowed black) during the compression movement (arrowed red). The locking nut amounts to a single point of failure.
