TECHNICAL ALERT No. 14-04

Jiangsu Jiaoyan Marine Equipment Company Freefall Lifeboats and Launching Appliances

Unintentional release of the freefall lifeboat from the bulk carrier *Aquarosa*

ATSB Transport Safety Report
Marine Occurrence Investigation
307-MO-2014-002
Preliminary – 31 March 2014

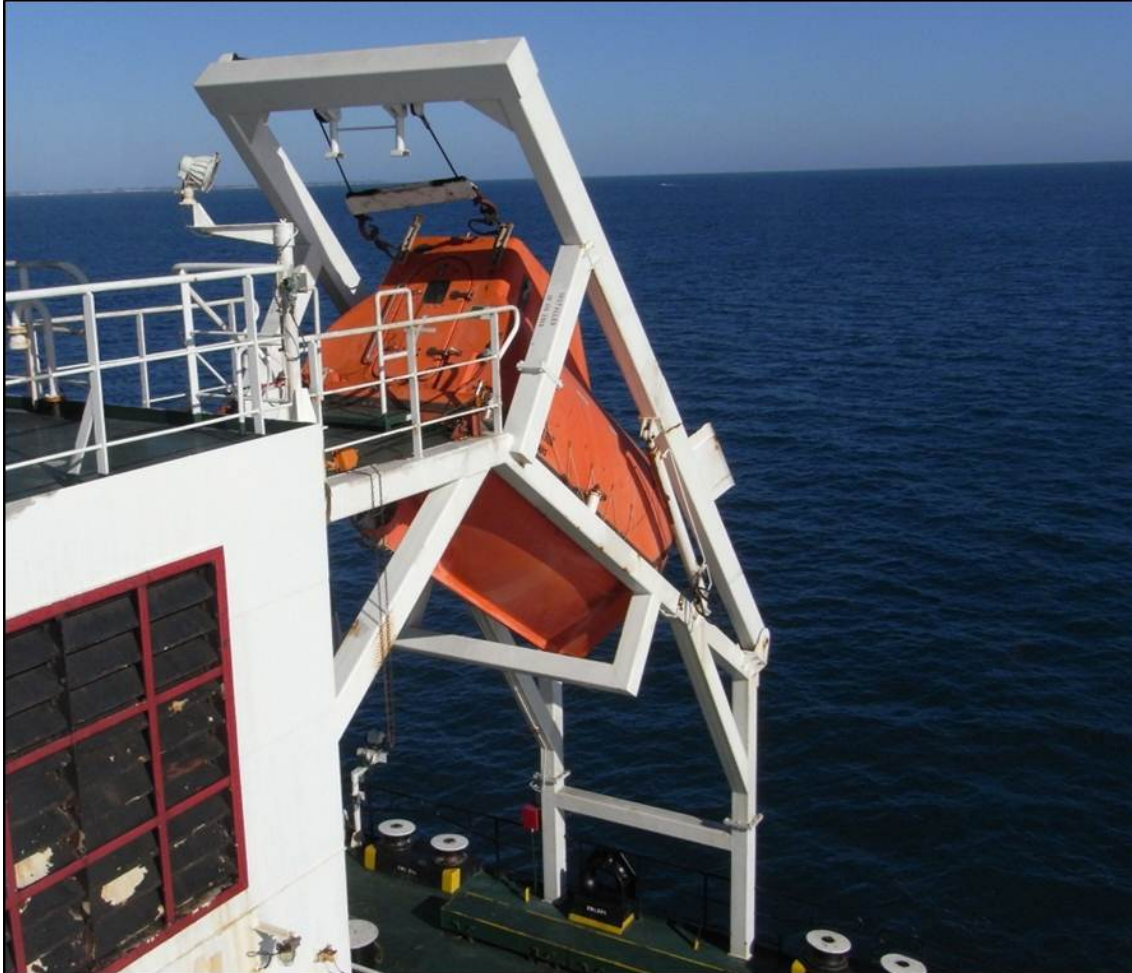
Figure 2: *Aquarosa's* freefall lifeboat

At about 1100,² the third engineer and the supernumerary chief engineer went to the freefall lifeboat (Figure 2). They verified that the simulation wires securing the boat to the ship were fitted and then removed the hook release lock pin which was attached by a lanyard to the entry door and entered the lifeboat. Once inside, they carried out a general inspection of the lifeboat's machinery and equipment. When the checks were completed, they left the boat.

move down the launching rails. Knowing that the boat had been released and that he was unable to make the exit, he took a seat and attempted to fit the seatbelt. As the lifeboat moved down the launching rails, the simulation wires parted and the boat launched from the stern of the ship.³

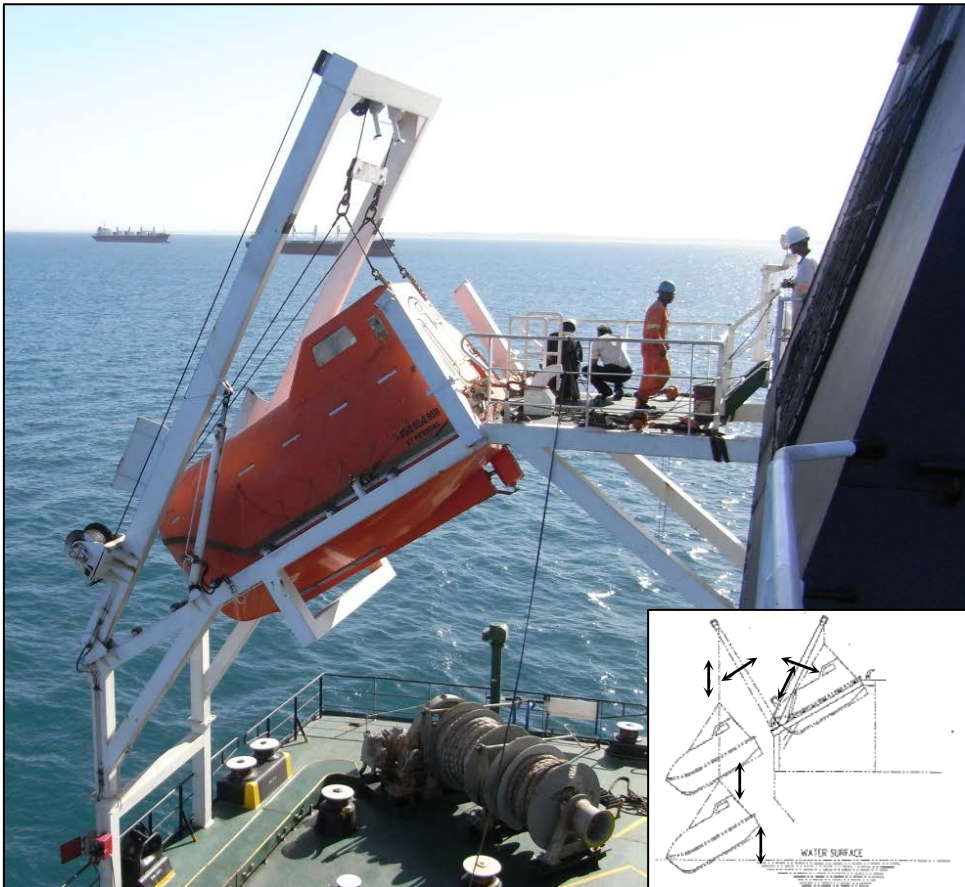
Figure 3: *Aquarosa's* freefall lifeboat arrangement with appliance operating action (inset)

The lifeboat was housed in a Jiangsu Jiaoyan Marine Equipment Company JYF55 type launching appliance (Figure 3) which included provision for controlled lifting and lowering of the lifeboat into and out of the launching frame. This system included a davit and winch with a maximum hoist load of 42 kN⁶ and maximum working load of 55 kN.

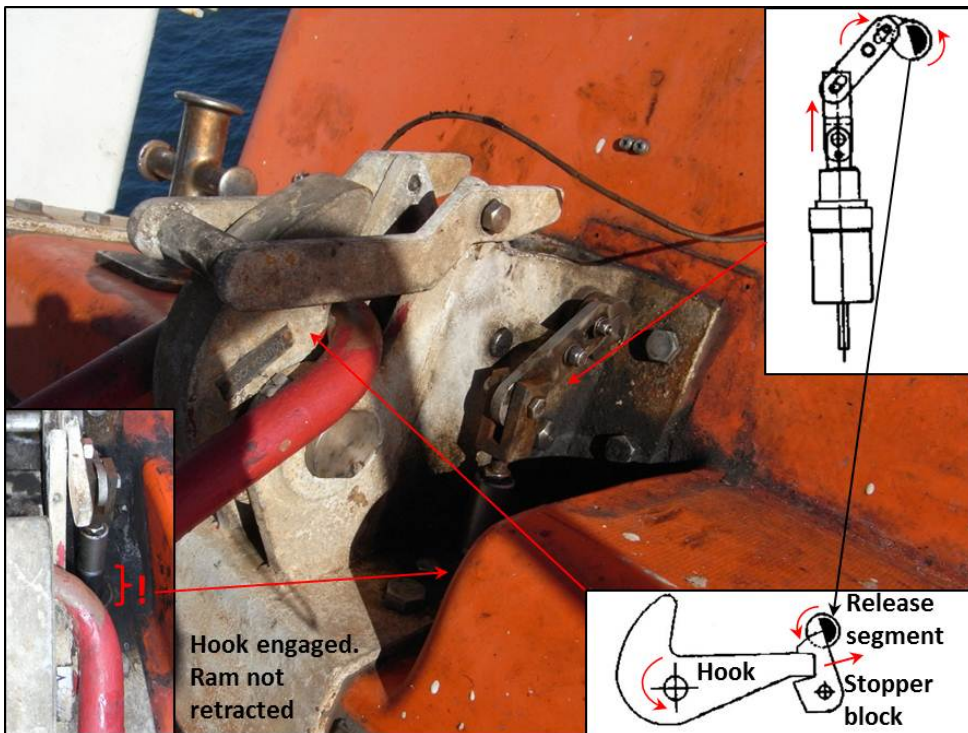
Figure 4: Freefall lifeboat release hook

Under normal (ready for use) conditions, the freefall lifeboat was positioned in the launching arrangement with its side rails sitting on rollers fitted in the ramp section of the launching frame. The lifeboat was attached to the ship solely through ring links connected to a fixed hook on the ship and the release hook on the lifeboat (Figure 4).

A security pin was fitted into the lifeboat release hook to prevent the hook from opening and the unintentional release of the boat. This pin was attached by a lanyard to the entrance door of the lifeboat and arranged such that the pin had to be removed from the hook before the door could be opened and the lifeboat entered.

Inspection of the lifeboat, its release mechanism and analysis of the available evidence showed that the actuating cylinder ram did not always retract fully into the cylinder without some external force being applied. Furthermore, it was found that the hook stopper block (Figures 4 and 5) could be repositioned sufficiently to engage the hook and prevent it opening without the actuating cylinder ram being fully retracted. In such cases, with the hook reset, the hydraulic pump recirculation valve could be closed trapping the system in this position.

In such circumstances, the release hook could be activated with a reduced number of operations of the hydraulic pump because the actuating cylinder ram had less distance to travel before it released the stopper block and the hook.

It is likely that this is what happened when the lifeboat release system was reset following the tests in Singapore. Then, on 1 March, the second engineer only had to operate the pump handle three or four times for the actuating cylinder ram to move far enough to release the stopper block and the hook.

On board *Aquarosa*, a safety pin that can be placed into the release hook when entering the boat for inspections and maintenance has been made up. Tool box meetings are now required before entry into the lifeboat to carry out maintenance and procedures which list the checks that are to be made prior to any lifeboat maintenance being carried out have been implemented. Further, the master's permission is now required before the lifeboat release system hand pumps are operated. Warning signs have been placed at the pump locations stating this requirement.

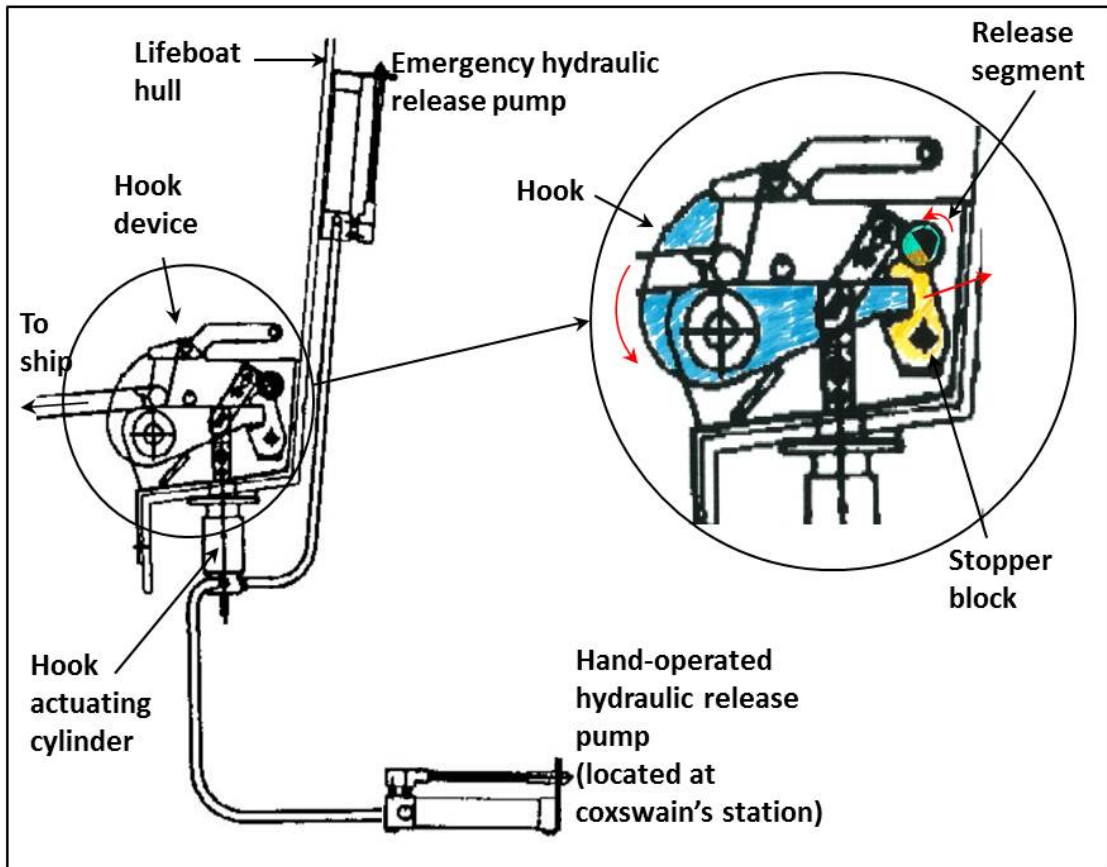
Figure 5: Freefall lifeboat hook release system

The lifeboat was fitted with a Jiangsu Jiaoyan Marine Equipment Company model JX-4 hook device and release mechanism (Figures 4 and 5). The system comprised the release hook mechanism located at the stern of the lifeboat, the hook hydraulic actuating cylinder and two hand operated pumps, one adjacent to the coxswain's position and an emergency pump to be used in case the coxswain's pump failed. A short section of ring links connected the release hook to a fixed strong point on the ship's structure.

To release the boat normally, the hydraulic pump handle needed to be operated 10-12 times (according to the operating manual) to extend the actuating cylinder ram which, through a series of linkages, released the hook stopper block. The hook was then free to rotate and release the ring link connecting the lifeboat to the ship. The pump also had a small valve on its body which when opened allowed the oil to circulate back to the oil reservoir without pressurising the discharge line. This valve had to be closed for the system to actuate the hook. The valve was, therefore, normally left in the closed position ready for use.

After the hook was released, it had to be reset before the lifeboat could again be secured in place. To do this, the hydraulic oil which had been pumped into the hook actuating cylinder had to be returned to the oil reservoir. This was achieved by opening the recirculating valve, positioning the ring link in the hook and then engaging the tail of the hook in the stopper block. The release segment could then be rotated into position by retracting the actuating cylinder ram, to lock the stopper block in place.

Once the hook was reset, the hydraulic pump recirculating valve had to be closed. This locked the oil in the system and the links in position. An indicator on the side of the hook provided a visual confirmation that the hook was in the correct position.

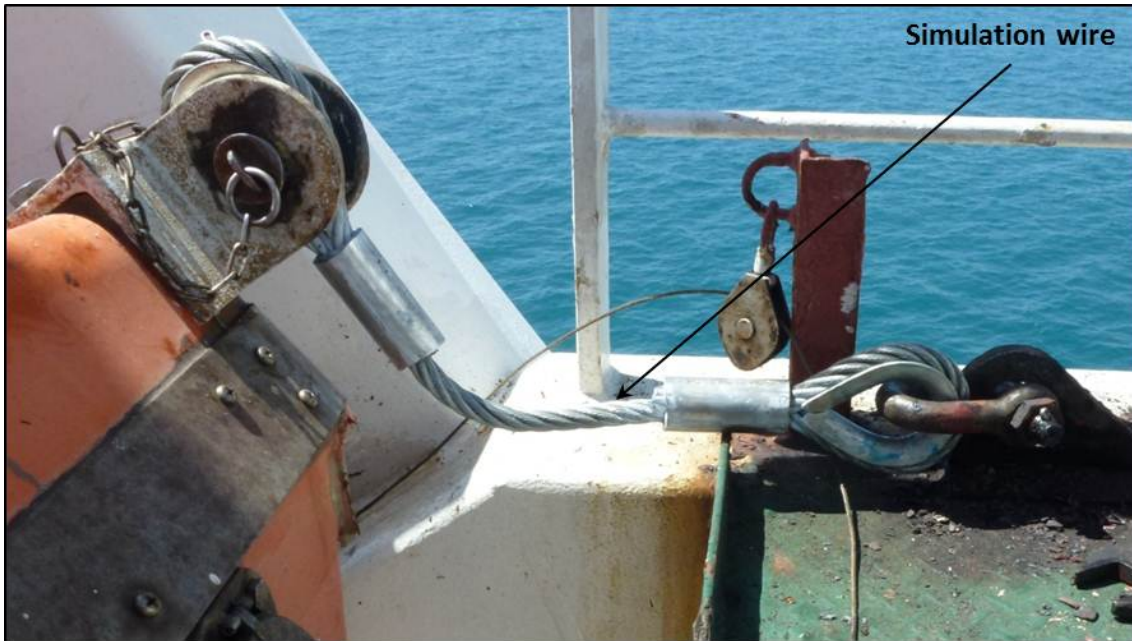
Figure 6: Aft lashing arrangement showing one of the two simulation wires

- 2.3. During the routine maintenance the lifeboat was fitted with the manufacturer's approved launch simulation wires, these wires failed to restrain the lifeboat when the lifeboat was unintentionally launched resulting in the lifeboat being launched to the water with a crewmember inside.

Initial analysis also indicates that the two simulation wires, which were designed to hold the lifeboat when the hook was released during a simulated release, failed at a load significantly below their rated safe working load.

In addition to the release hook attachment, the lifeboat was also fitted with an aft lashing unit which consisted of securing points on the port and starboard quarters. A wire rope could then be attached to these points and secured to eye plates that were welded into the lifeboat launching frame deck (Figure 6).

With the lifeboat secured to the ship via the release hook and links, the aft lashing unit wire ropes (known as simulation wires) were slack. This arrangement was designed so that the operation of

the release hook could be tested without launching the lifeboat over the stern of the ship. With the simulation wires attached, the hook could be tripped and the lifeboat would move about 150 mm down the launch ramp, at which point, the slack in the simulation wires would be taken up and the boat would be stopped. The lifeboat could then be repositioned and the hook reset.

- 2.4. The Bahamas Maritime Authority recommends that owners with Freefall Lifeboats and Launching Appliances Manufactured by Jiangsu Jiaoyang Marine Equipment Company assess the condition of their Lifeboats and launching appliances in light of the preliminary findings of the accident report and associated lessons learned.
- 2.5. The BMA further recommends that all owners with freefall lifeboats installed on their ships review their training and operating procedures to ensure that:
- All crew members are aware of the need to ensure that hydraulic hook release rams are fully retracted after the system has been operated;
 - Safety procedures are reviewed to reduce the risk to personnel if an inadvertent lifeboat release occurs.
