TECHNICAL ALERT No. 14-03

GME EPIRB's- EPIRB Self-Test Defect.

EPIRB PRECAUTIONARY SAFETY ALERT

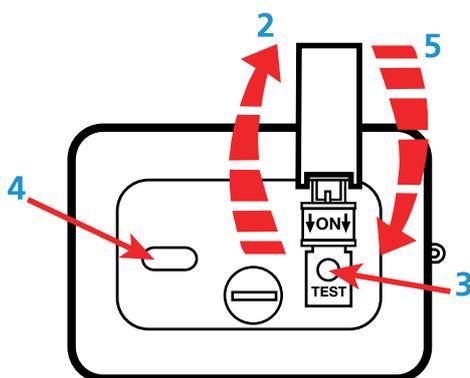
Subsequent testing and investigation in the company's Sydney engineering laboratory, identified a microprocessor malfunction that effectively shuts the beacon down, hence the self test failure.

Owners of all GME EPIRBs are required to undertake an immediate test of their beacon using the following procedure:

1. Remove the beacon from the bracket. Keep the antenna well clear of metallic objects during testing.
2. Lift the cover marked 'LIFT'.
3. Briefly press then release the yellow 'TEST' button.
4. The unit will give a double beep and flash of the strobe light to show it is functioning correctly.
5. Close the switch cover and press firmly into place until it clicks.
6. Return the beacon into the bracket.
