SAFETY ALERT No. 17-07

Master Link Failure CH330.P.320, HA-32 PL Pear Links

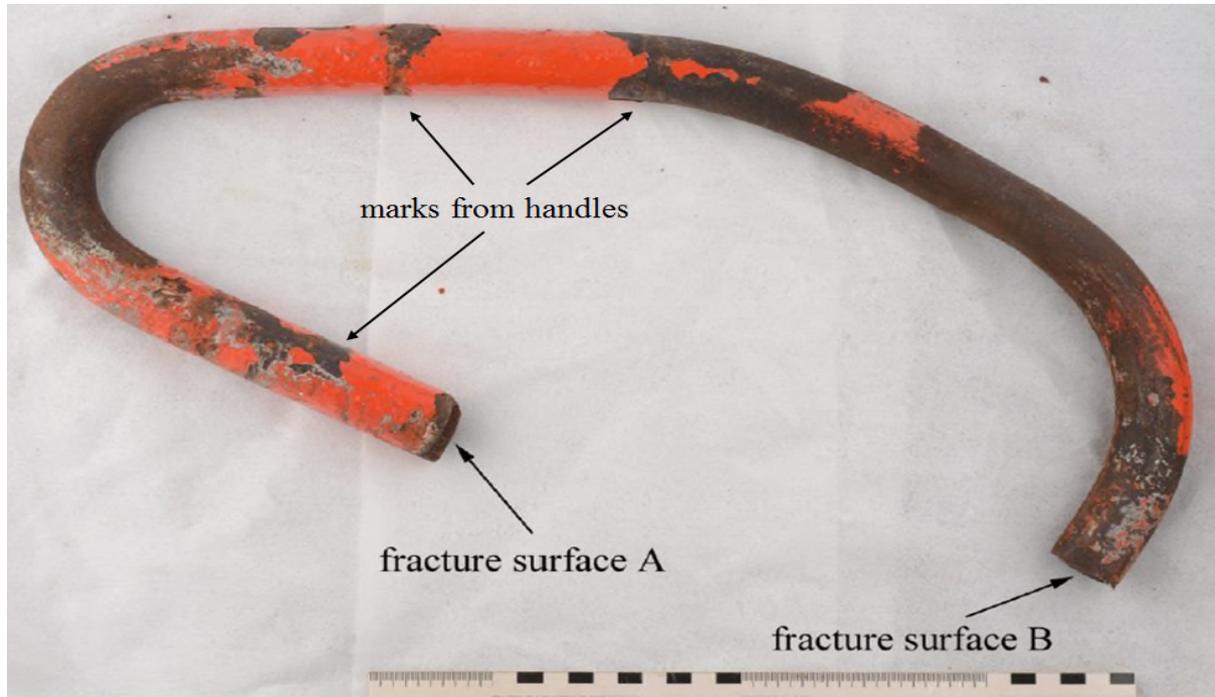
- 2.1 A tender boat onboard a cruise ship registered in the Commonwealth of the Bahamas suddenly fell from its stowed position into the water. The immediate cause was a catastrophic failure of the link that connects the fall block to the release gear/hook ([see figure 1](#)). No persons were injured; however the tender boat itself was a total loss.
- 2.2 An immediate internal investigation was commenced by the Owners who also instructed the vessel's Classification Society to conduct material examination to determine the failure mechanism of the master link. The conclusions drawn from the investigation are detailed below.

Figure 1: Fractured master link with handles removed

- 3.1 The **failed** connecting link material composition was not in accordance with the supplied certificate. The break load tests conducted on the intact link which is most likely to be from the same batch based on chemical analysis proved that the break load was below what was described on the **original** certificate **in 2009** and below that of the minimum required by the LSA Code (Chapter VI, 6.1.1.6). The certificate and LSA Code both specify a minimum safety factor of 6:1; the actual measured safety factor was between 4.1:1 and 4.6:1 at the time of testing.

- 3.2 The master link suffered a fatigue fracture. The initiation of this is most likely attributed to the location of the stainless steel handle which was attached to the straight part of the link **in vicinity of the fracture**. The mechanism is believed to be either corrosion fatigue (galvanic corrosion) or fatigue initiated from a minor indent at the surface.

- 5.1 It is recommended that the above information is taken into consideration and the condition of master links be verified by a competent authority to ensure the structural integrity is not compromised. [SSI UK Ltd. recommends replacement of lifting links every 5 years.](#)

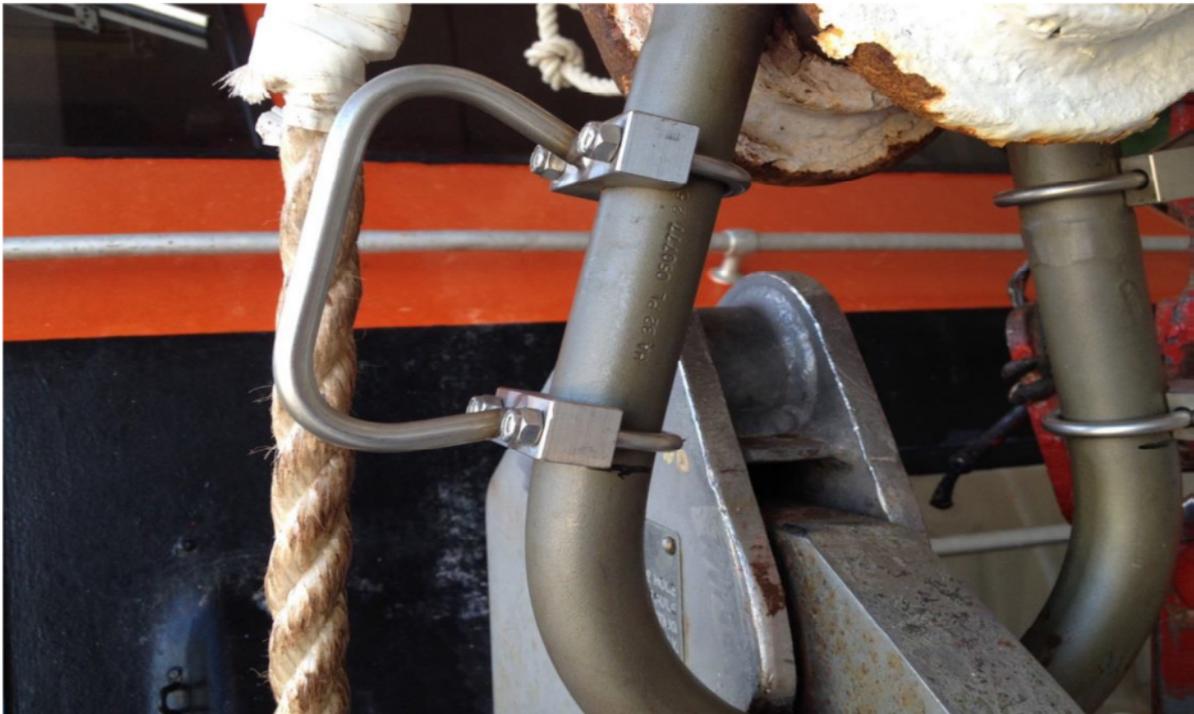
Figure 2: Master link in service with bolted on stainless steel handles

- 3.3 The material used was high tensile strength steel, with increased notch sensitivity. The link was fitted with bolted on stainless steel handles (as per original design and delivery) which serve as an originator of notches into the link, if subjected to outside force or if tightened too hard these can cause potential galvanic corrosion **generated by exposure to the marine environment**, due to material difference compared to the links themselves.

- 3.4 The addition of these stainless steel handles obstructs complete visual inspection of the links.
