SAFETY ALERT No. 18-06

Free Fall Lifeboat Incident During Drill

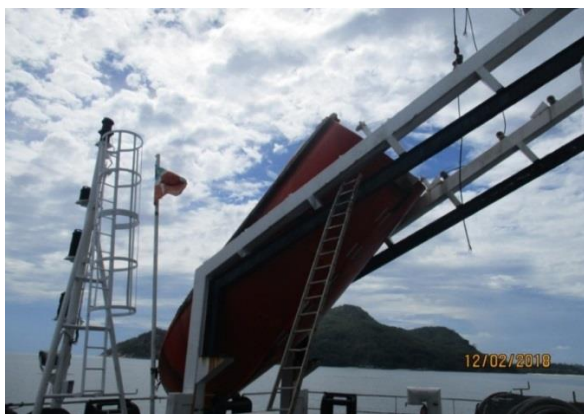
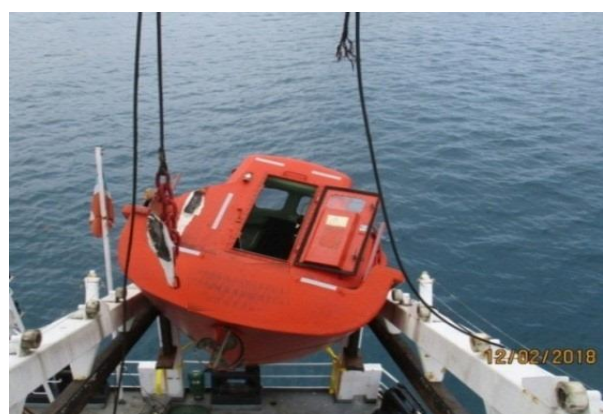
- 2.1. The vessel was carrying out the abandon ship drill and was simulating the launching of Free Falling Lifeboat (FFLB), at Port Victoria. The Chief Officer boarded the FFLB and was responsible to launch the FFLB from inside.
- 2.2. As the hook was released from helmsman position, the starboard side wire sling got parted and the weight of the boat caused subsequent breaking of the port wire slings. The FFLB, slid down rapidly and stopped on the aft fairlead, damaging the bow bottom section and starboard side forward of the boat.
- 2.3. Chief Officer who was inside the lifeboat, experienced a minor injury on his left leg.

- 4.1. It is recommended to review the maintenance and inspection program of the Lifesaving appliances (LSA) and associated equipment to ensure visual inspection to be completed before conducting any safety drill.
- 4.2. Ensure that the officers responsible for inspection of the LSA and associated equipment are familiar with the signs of wear and report the same.
- 4.3. Ensure that LSA and associated equipment certificates and maintenance history are available onboard at all times.

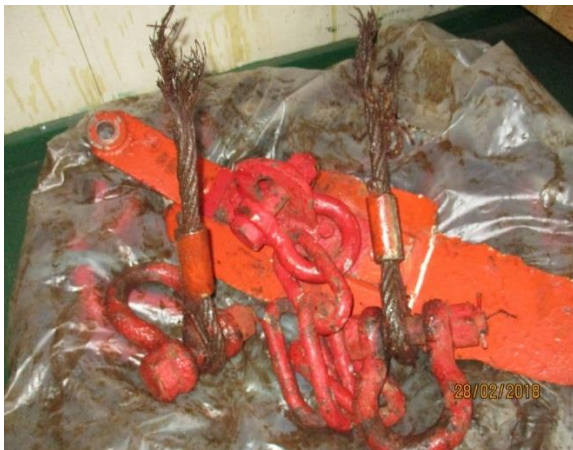
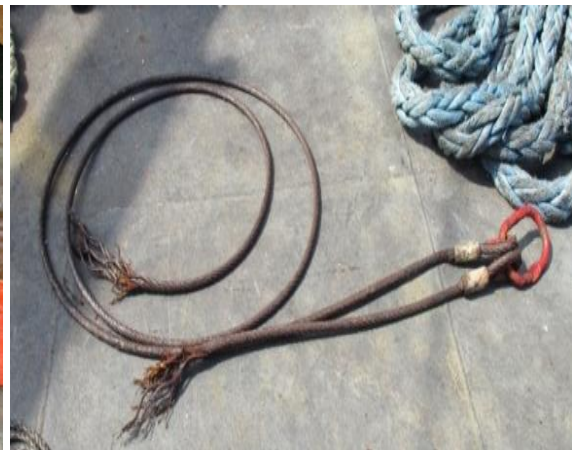
3.1. Corrosion of wire slings due to lack of proper maintenance.

3.2. The visual inspection and wire sling suspension test was conducted in a laboratory.

- 3.2.1. The visual test concluded that the sling wire had significant corrosion and there were protruding single wires from the broken strands at the place of bending on the thimble.
 - 3.2.2. The wire sling suspension test concluded that the maximum suspension strength of the sling was 51.6 KN. As per the report from the laboratory the wire sling of similar dimension should have rope breaking load of 219.29 KN.
- 3.3. The replacement of the wire sling was not conducted in the required period.
