## SAFETY ALERT No. 19-03

### Hand Injury While Attempting to Secure Crane's Auxiliary Block

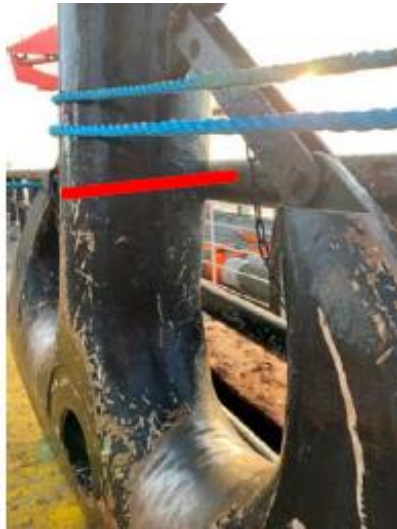
**Figure 2: Close up of auxiliary block with the intended position of rope indicated with the red line**

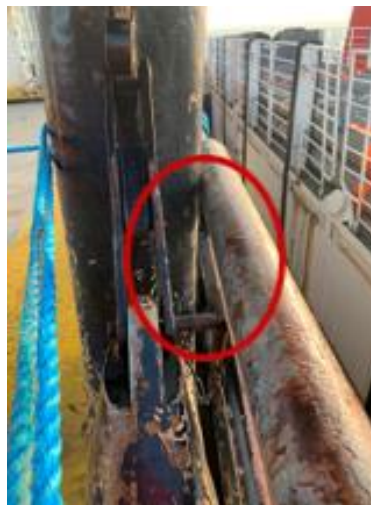
**Figure 3: Location of the area where the Rigger's hand was trapped**

- 3.1. The planning for the work activity was inappropriate. The Rigger attempted to secure the auxiliary block before a clear signal was given by the Banksman as the auxiliary block was not sufficiently stabilised.
- 3.2. The hazards and risks associated with the work activity involving securing of the auxiliary block were not identified appropriately. The Rigger placed his hand between the auxiliary block and handrail, without realizing the risk involved.
- 3.3. The Banksman did not stop or call back the Rigger when he approached the auxiliary block prior to a clear signal.

- 4.1. It is recommended to conduct an effective risk assessment and implement appropriate control measures to mitigate the risks before commencing any high-risk work activity.
- 4.2. The work activity should be planned and discussed with all team members to ensure that all team members have a clear understanding of the roles and responsibilities.
