**KAREN DANIELSEN**  
**Collision with the Great Belt West Bridge**  
**3 March 2005**

The joint Bahamas Maritime Authorities & Danish  
Division for Investigation of Maritime Accidents report

**The casualty report was issued on 17 August 2005.**

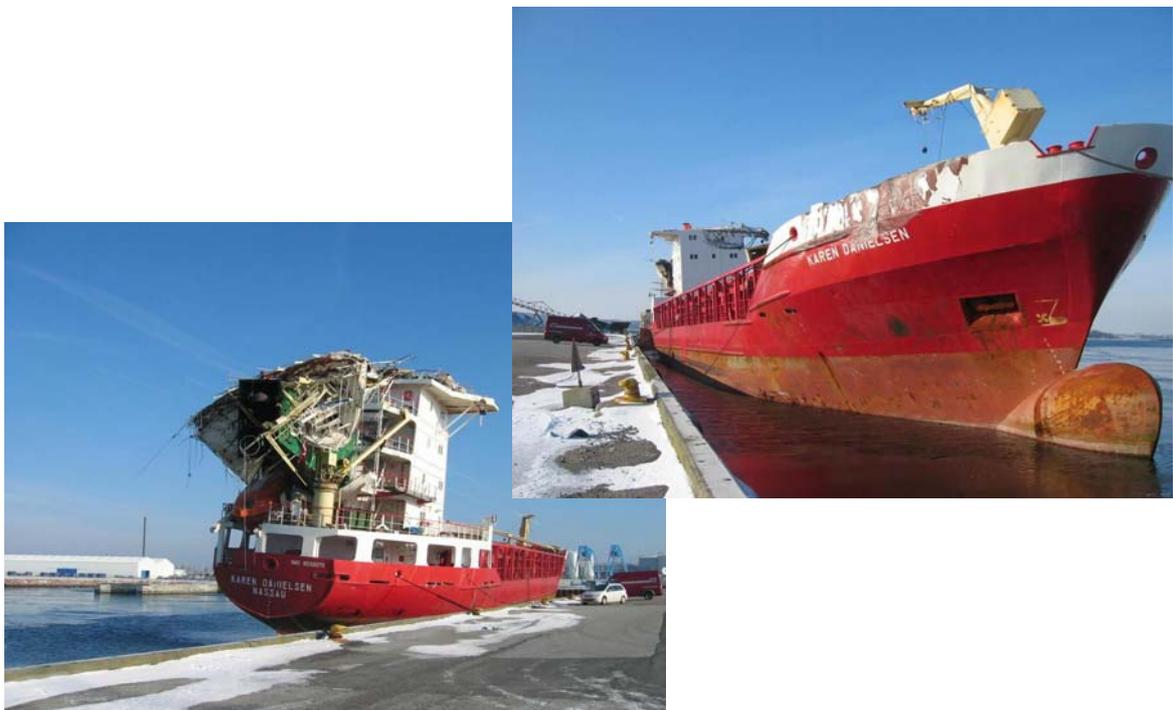
The ship hit the West Bridge at a speed of 11.5 knots, on a course of 005° and collided with the bridge span between pillars No 52 and 53.

On its way under the West Bridge motorway span, the ship's fore mast was torn from the deck and bent aft, the starboard bow hit a glancing blow against pillar No. 52 and was damaged as a result. Then the bridge span brought down the ship's forward crane which broke off at its attachment flange and landed across the hatchway on deck. The aft crane was also torn off at its attachment flange and lost overboard into the sea and finally when the wheelhouse hit, it was cut off at deck level and pressed astern to finally rest on top of the funnel. The funnel was torn off at its attachment to the deck and laid horizontally aft, with the wheelhouse on top of it. The ship was wedged firmly under the motorway bridge span and brought to a stop against the railway bridge span, which is slightly lower than the motorway. The ship's engines were still at full ahead upon impact.

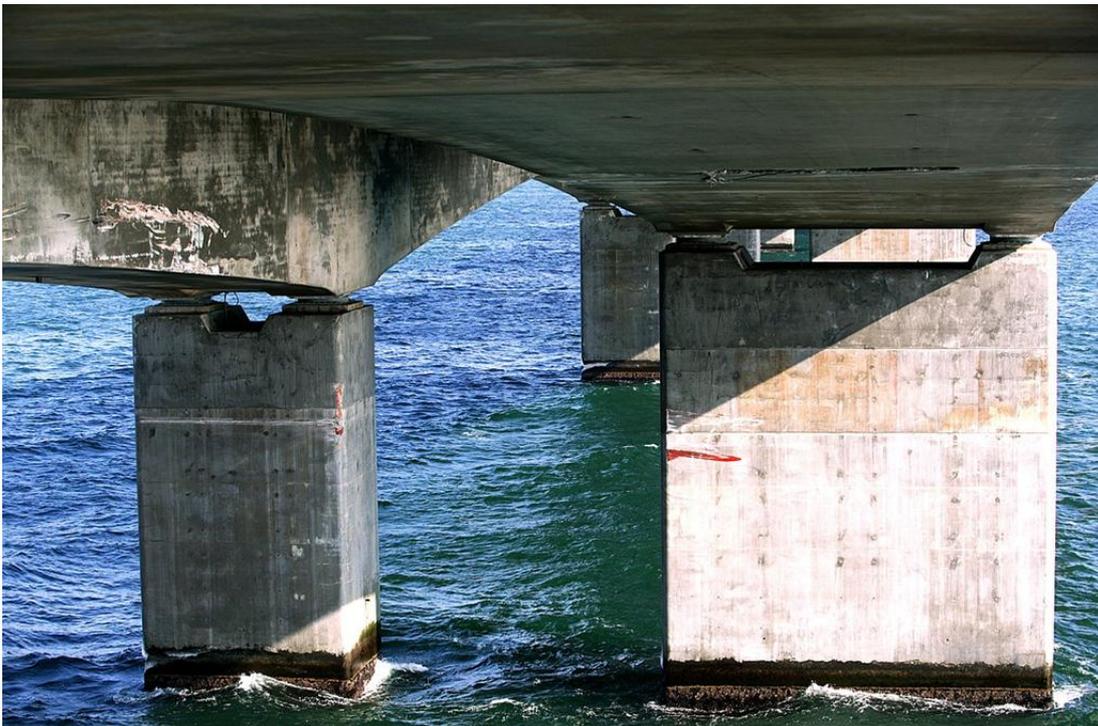
The ship's starboard bow hit the concrete bridge pillars which supports the motorway and rail bridges (Pillar No 52). The ship's superstructures made a hole in the concrete girder below the motorway bridge.

*Great Belt West Bridge pillar No 52, with motorway section on the right and rail section on the left.*

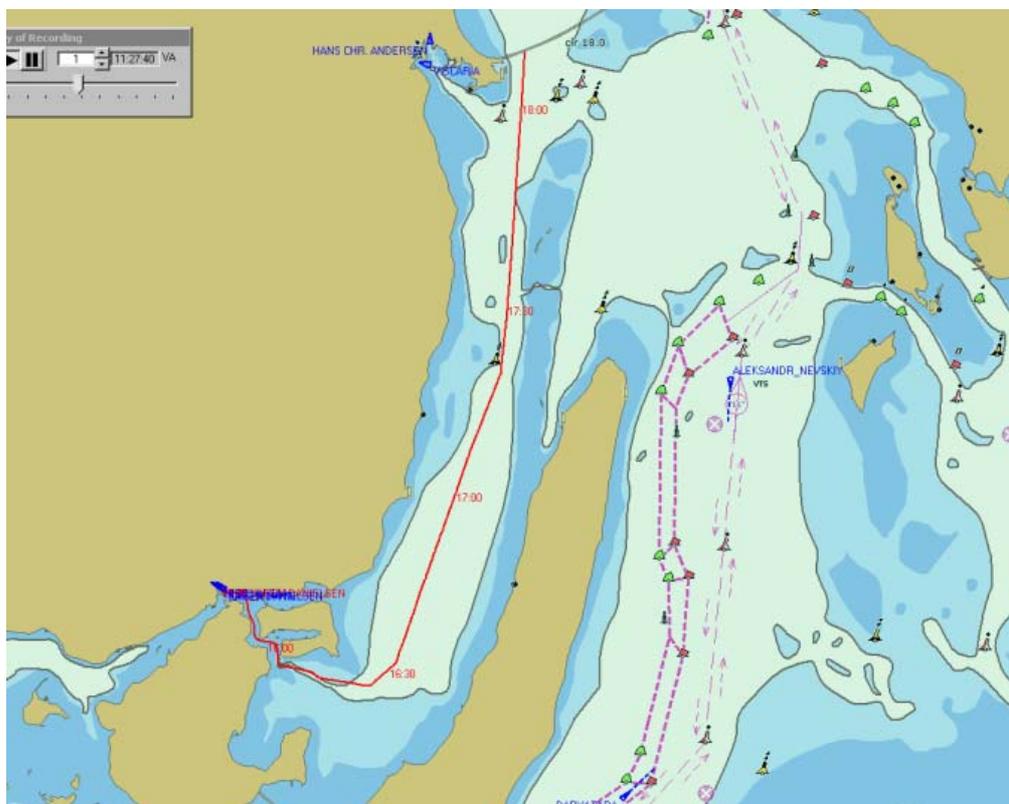
*Extract of the AIS plot from the Royal Danish Administration of Navigation and Hydrography's display system. Times shown on the plot is UTC (Local time – 1 hr)*

The AIS information shows that KAREN DANIELSEN from 18.20 hours and until the vessel collided with the bridge maintained the same course and speed of 005° and 11.5 knots respectively.

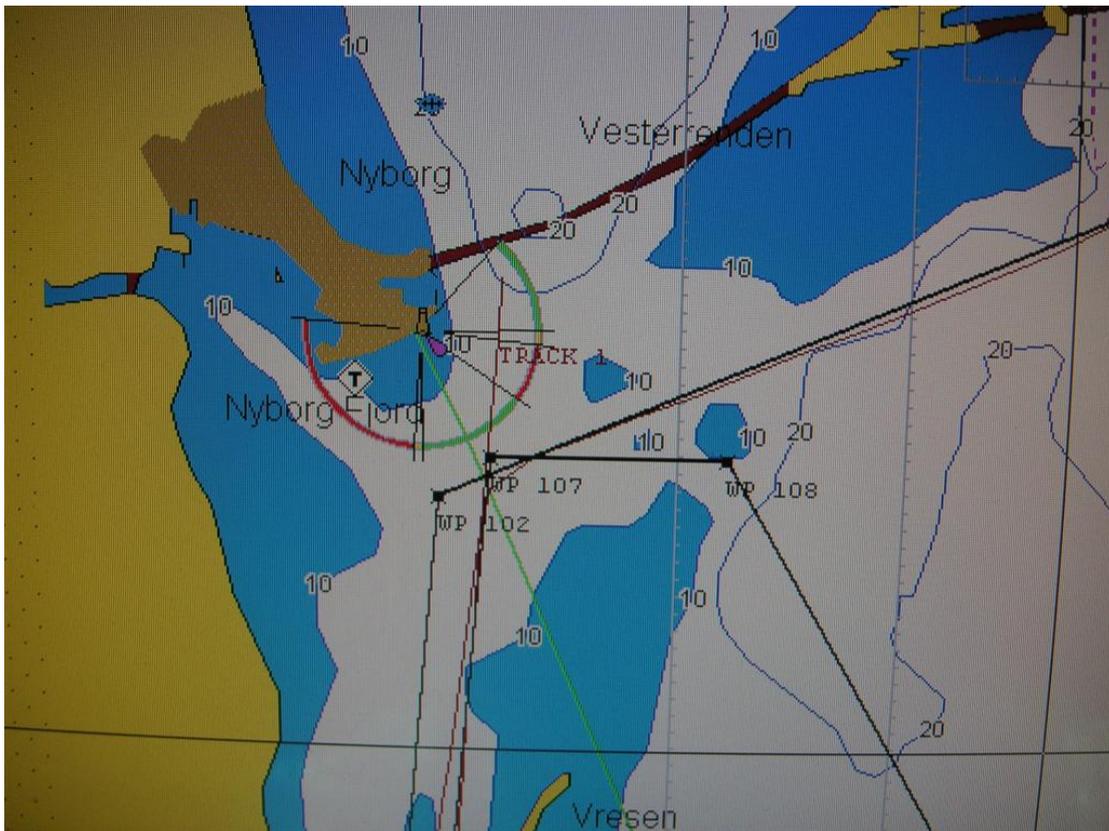
*The photos show the area south of the Great Belt Bridge. The red line "TRACK 1" shows the ships actual track before the accident. The track is historical information stored in the system. The track stops shortly before the bridge (0,22 nm) due to the periodic updating of the system.*

*The inbound passage plan through the Great belt to Svendborg is also shown, via WP 102. The outbound passage plan from Svendborg is via WP 107 and WP 108.*
