**The Bahamas
Maritime Authority**

Norbe VIII

**Report of the marine safety investigation into a
boiler explosion leading to three fatalities on a
drill ship on 09 June 2017**

Date of Issue: 18 March 2020
Bahamas Maritime Authority
120 Old Broad Street
LONDON
EC2N 1AR
United Kingdom

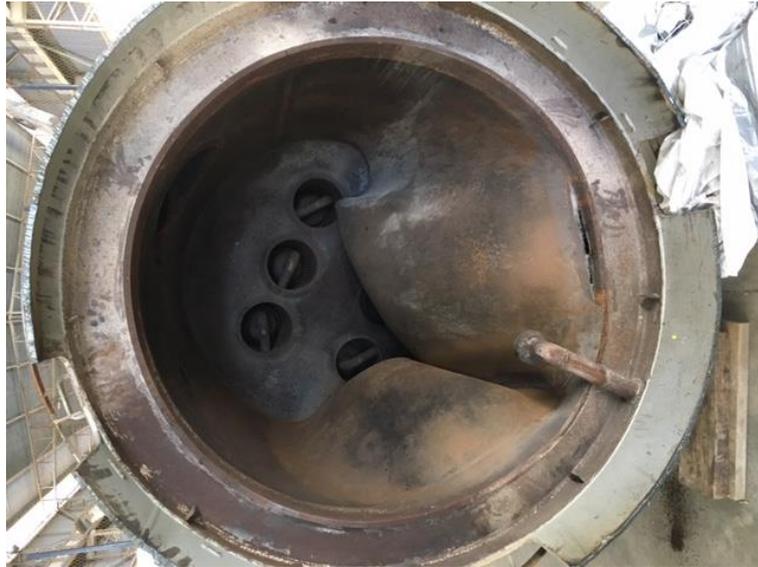
Figure 3: Deformation of internal wall

The simulations showed that water chamber pressure of approximately 30 bar was required to cause the observed deformation of the internal wall. Flashback in the furnace was considered unlikely to increase the waterside pressure to this level.

Finite element analysis suggested that the maximum stress in the boiler due to over-pressurisation would occur at the interface between the upper combustion chamber and riser pipes with buckling occurring opposite the firehole, in line with the observed damage. The model suggested structural failure at a pressure of 34.5 bar, in line with DNV GL's simulations.

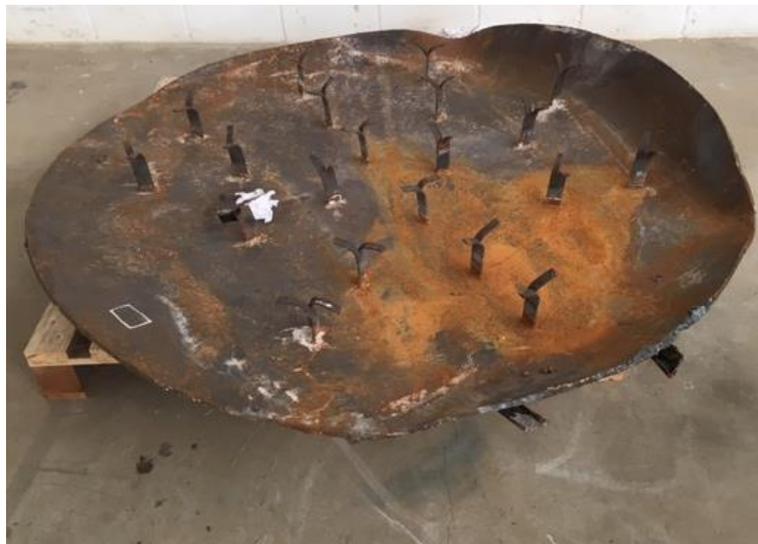
Figure 4: Furnace bottom plate (insulation removed)

The simulations also showed that after the failure of the internal wall, water entering the furnace would be vaporised and create pressure in the furnace until the furnace bottom and / or fire hole ruptured. The damage to the furnace bottom indicated this ruptured at approximately 15 bar which would also be enough to eject the burner unit with the force seen.

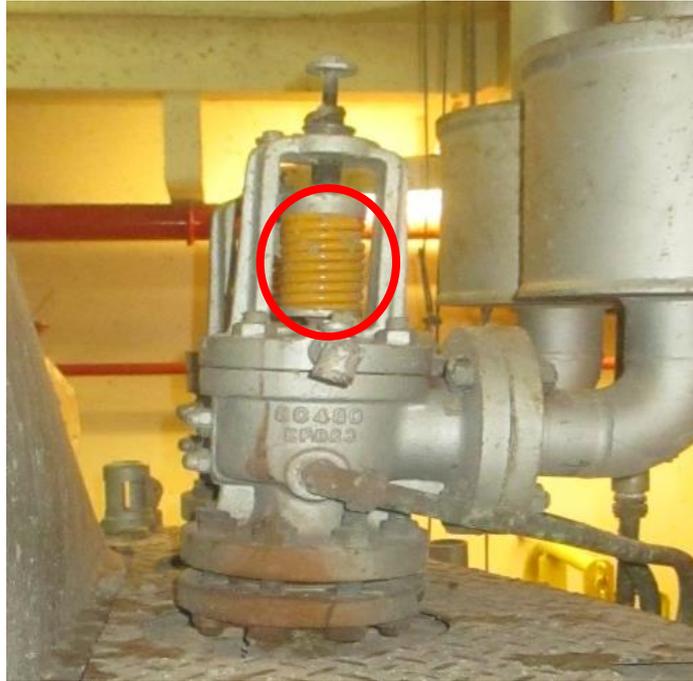
Post-incident scene investigation identified that the manual activation mechanism had been removed from the pressure safety valves on boiler #1. In addition, the pressure safety valves no longer had their anti-tamper seals⁴ in place and were wound significantly tighter than those observed on boiler #2.

Figure 5: Pressure safety valves – boiler #1 – note compression of spring, ringed in red

Inspection of the valves from both boilers found corrosion and foreign material deposits inside the valves. It was confirmed that both valves from boiler #1 had been adjusted so that their springs were fully compressed.

Pressure testing identified that, in this condition, the valves would partially open⁵ at a pressure of around 24 bar but would not fully open, even when subjected to test bench pressures in excess of 35 bar.

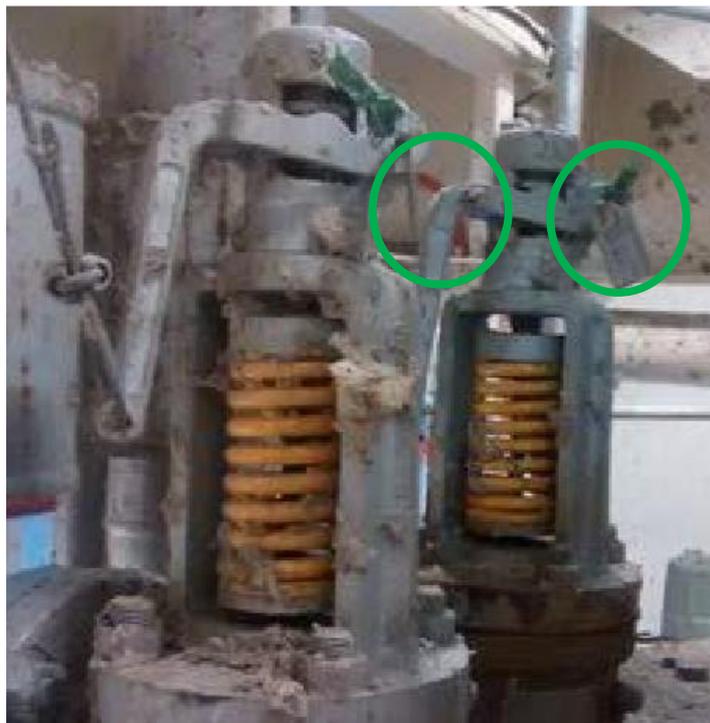
Figure 6: Pressure safety valves – boiler #2, seals ringed in green
(source: Brazilian Navy)

Tests on the pressure safety valves of boiler #2 yielded similar results.

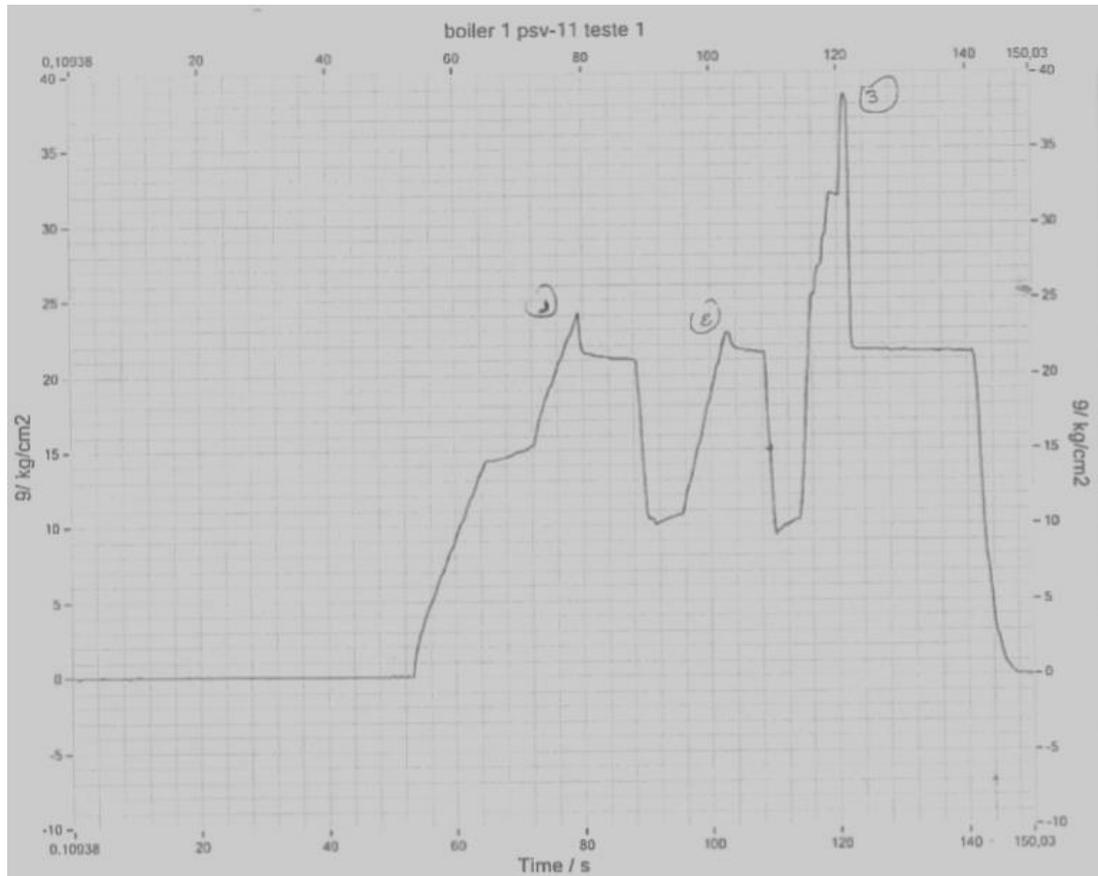
Figure 7: Example pressure test – boiler #1, pressure safety valve 1, as found condition

When adjusted to a set pressure of 9 bar, boiler #1's pressure safety valves partially opened at set pressure but could not be made to fully open, even at a pressure in excess of 35 bar.

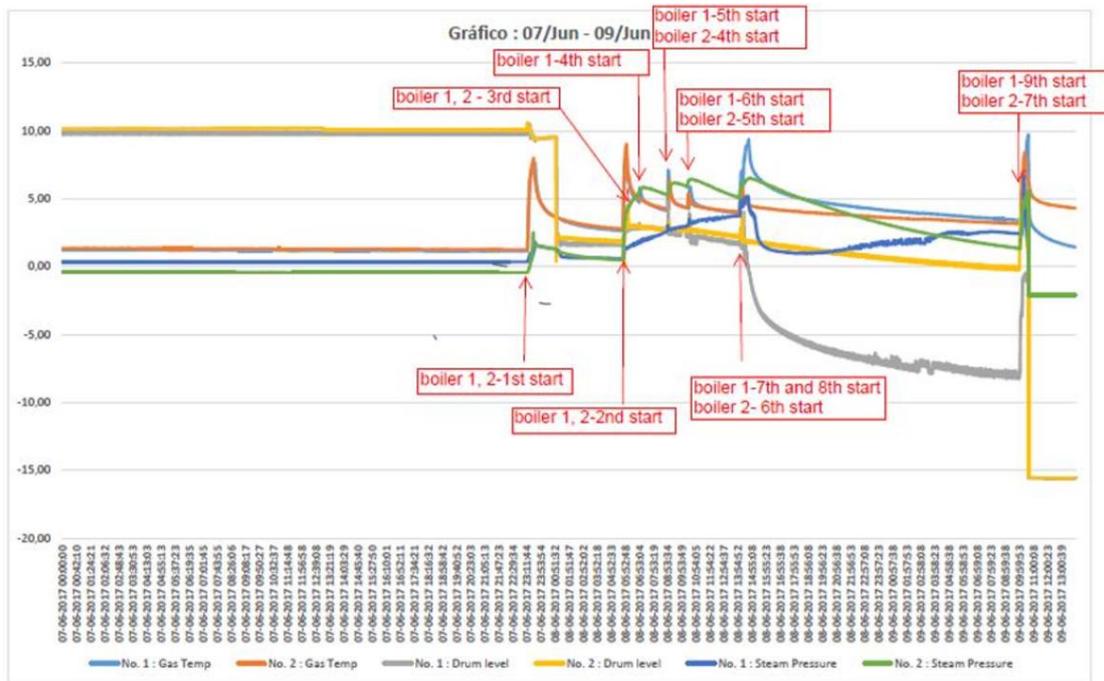
The engine room monitoring system included pressure monitoring of the auxiliary boilers. According to the history extracted from the system, boiler #1 was started eight times in the 36 hours prior to the incident, with measured steam pressure (figure 8, green line) never reaching the boiler’s design operating pressure.

Figure 8: Boiler level, pressure and temperature records 07-09 June 2017

The pressure trace over this period is similar to those seen in test bench conditions, where the pressure safety valves partially opened.

Post-incident scene investigation identified that the feed to the pressure sensor was restricted by the partial closure of the system’s isolation valves. Additionally, testing of both boilers’ pressure sensors by Shimmer Inspection found that the instruments were not operating as required⁶.
