**The Bahamas  
Maritime Authority**

**Cathinka Spirit v Zhe Ling Yu Yun  
60007**

**Report on the collision between the LPG/chemical tanker  
Cathinka Spirit and the fish transportation vessel Zhe Ling  
Yu Yun 60007 on 24 December 2019**

Date of Issue: 11 September 2020  
Bahamas Maritime Authority  
120 Old Broad Street  
LONDON  
EC2N 1AR  
United Kingdom

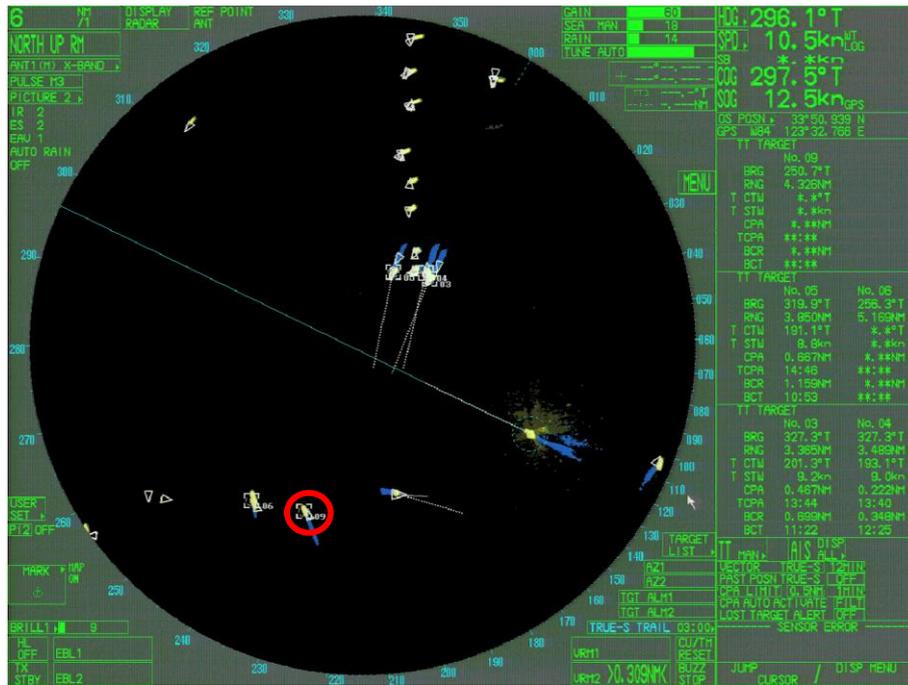
Having cleared the dense fishing fleets at around 23:00, Cathinka Spirit's lookout identified Zhe Ling Yu at approximately 23:19 and reported it as a "fishing vessel<sup>2</sup>". The OOW acquired it as an ARPA target on the X-band radar two minutes later. The Master of the Zhe Ling Yu reports he sighted the Cathinka Spirit at around 23:30.

Figure 3: Cathinka Spirit X-band radar, 23:21. Zhe Ling Yu (target 09) is circled in red.

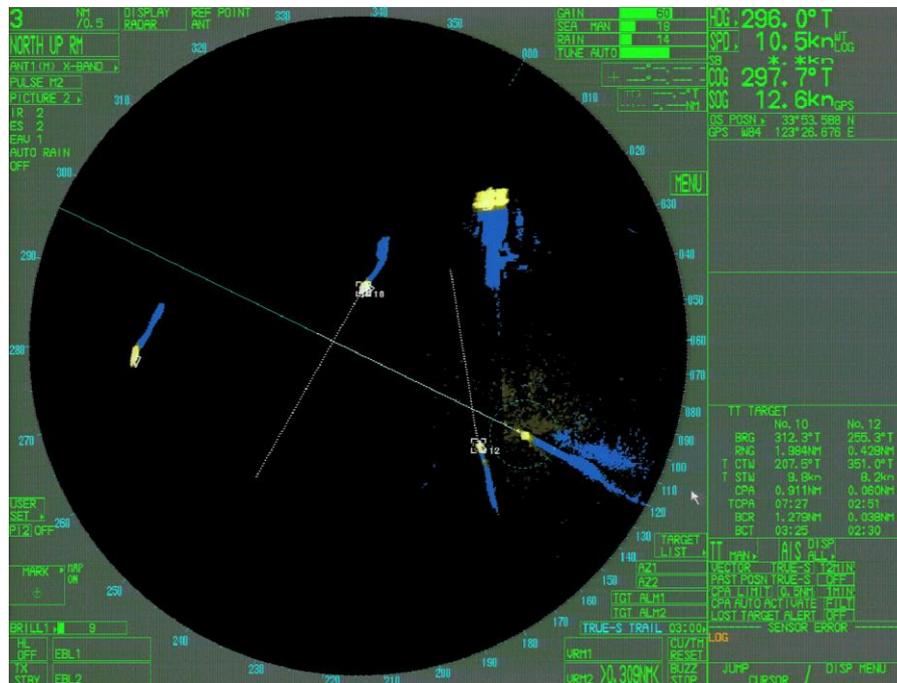
Approximately three minutes before CPA, Cathinka Spirit attempted to attract the attention of Zhe Ling Yu using an Aldis lamp but the two vessels, on a steady bearing and closing range, maintained their course and speed until they were less than 0.5NM apart.

Figure 4: Cathinka Spirit X-band radar, 23:48. Zhe Ling Yu (target 12).  
Note: VRM is set to 0.309NM

At this point, Cathinka Spirit’s OOW took control of manual steering and altered course to port using 15° port helm. At about the same time, Zhe Ling Yu made a bold

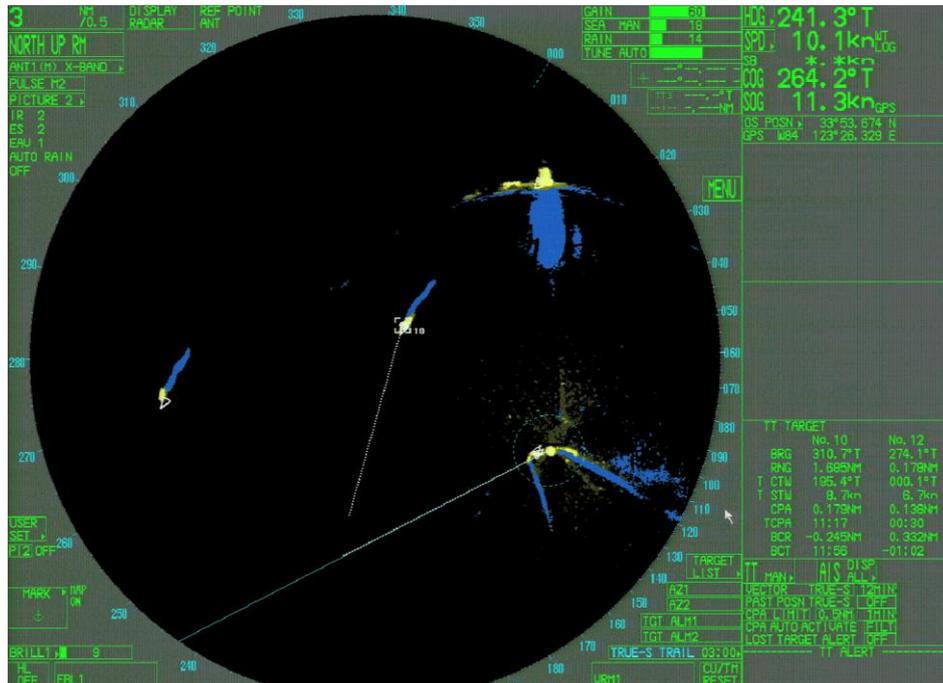
Figure 5: Cathinka Spirit X-band radar, moments before impact

The vessels collided with a closing speed of approximately 15 knots, Cathinka Spirit’s bow impacting Zhe Ling Yu on the port side, just forward of midships with a 45° angle of blow.

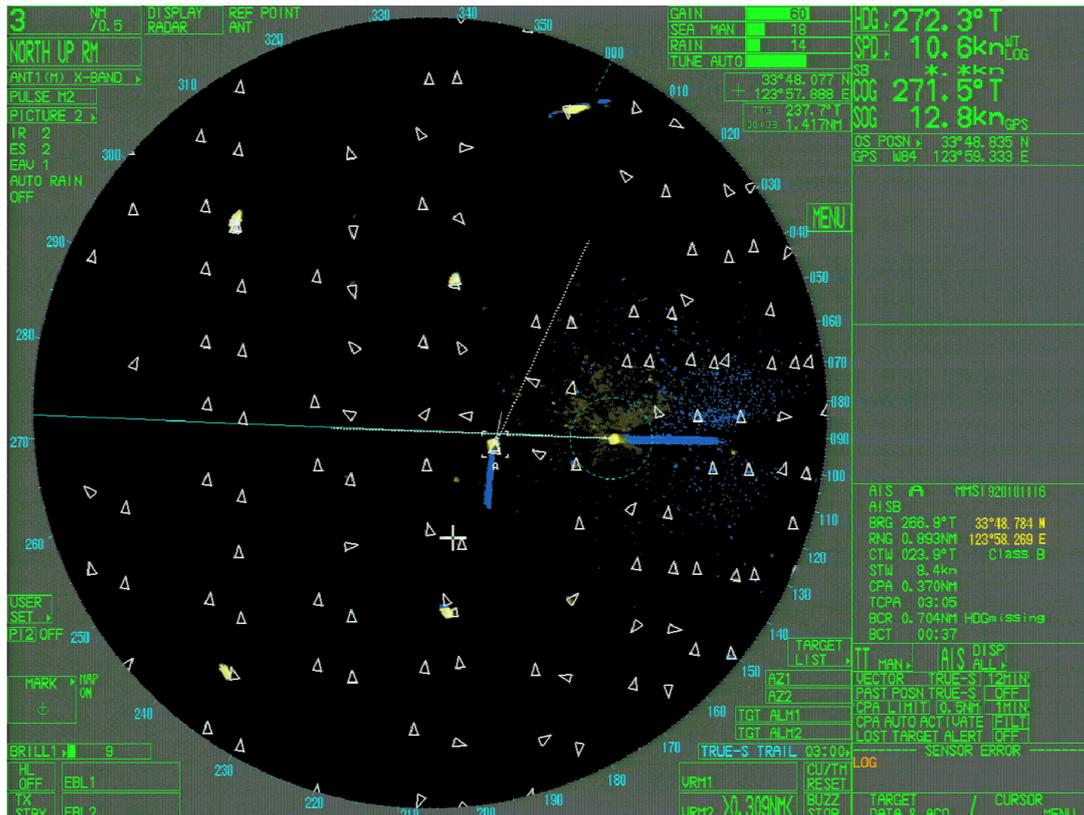
Figure 8: Cathinka Spirit radar, 21:33

During this period, there were four violations of the “ocean going vessels” 1.0NM CPA limit and 61 violations of the 0.5NM “fishing vessel” CPA limit. The vessel’s speed was not adjusted at any time.

Close quarters navigation through these fishing fleets with the Master on the bridge may have normalised the Cathinka Spirit’s OOW to non-compliance with the minimum CPA limits documented in the SMS and MSO and increased his threshold for acceptable collision risk.

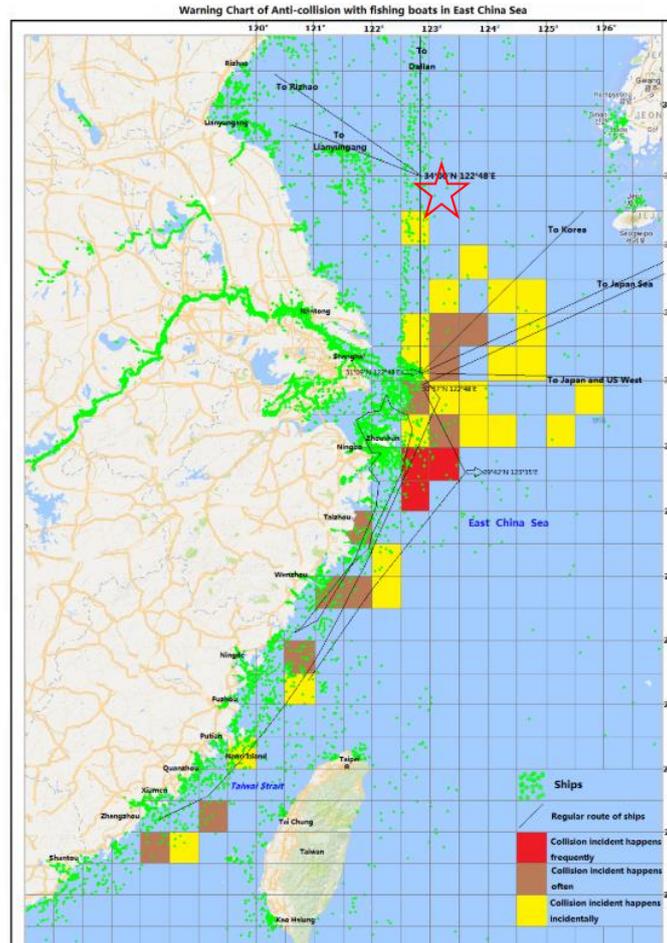
There have been multiple similar incidents in the region, many leading to loss of life. A study, conducted by Huatai Insurance Agency and Consultant Service Ltd and published by Gard<sup>5</sup>, identified that there were 268 incidents involving fishing vessels in Chinese waters, resulting in 562 deaths in the period 2006 - 2011.

Figure 8: Collision density. Location of the collision marked “★”
