**The Bahamas
Maritime Authority**

**M.v. Baltic Ace
IMO Number 9386213
Official Number 8001370**

**Report of the investigation into the loss of m.v Baltic
Ace following a collision with m.v Corvus J at the
North Hinder Junction Precautionary Area on the 5th
December 2012**

Date of Issue: 27th May 2016
Bahamas Maritime Authority
120 Old Broad Street
LONDON
EC2N 1AR
United Kingdom

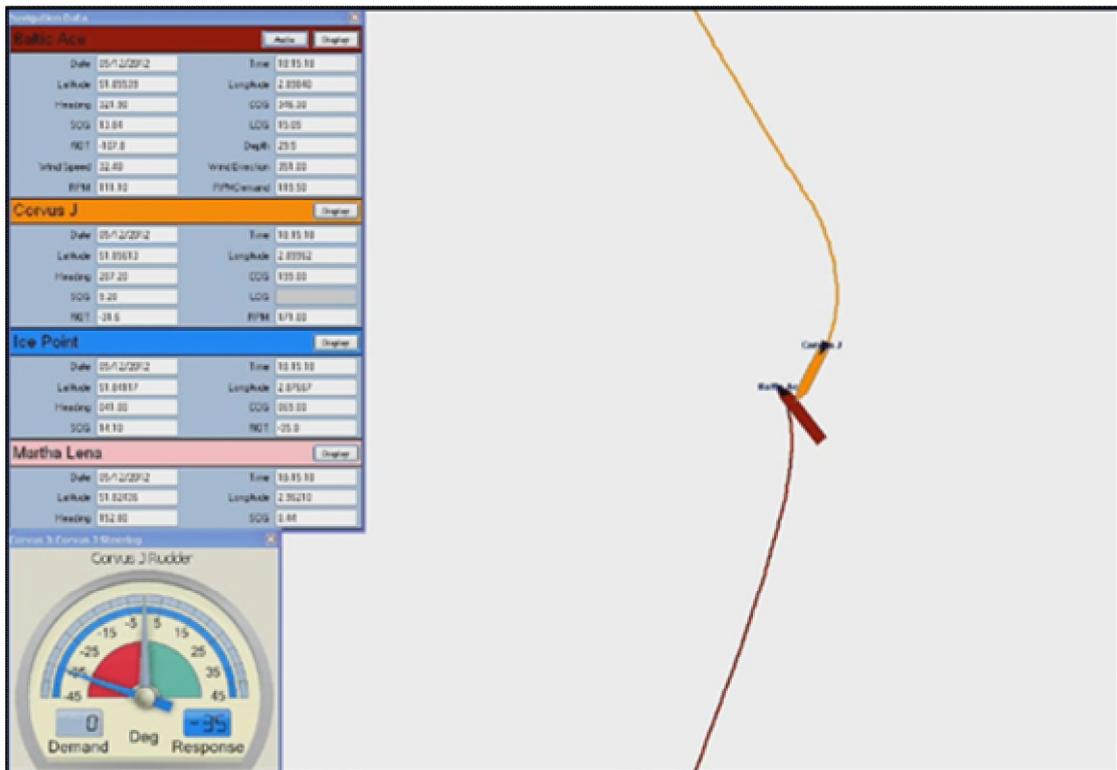
- 3.6.1 At 18:15:17 the Corvus J collided with the starboard side of the Baltic Ace in vicinity of frame 165. On impact the Baltic Ace was traveling at a speed of 15.1kts on a heading of 322°, the Corvus J was traveling at a speed of 9.2kts on a heading of 207°. The Corvus J rotated clockwise as it travelled along the starboard side of the Baltic Ace penetrating the side shell plating with the bulbous bow and bow structure.

Figure 14: Point of collision at 18:15:17

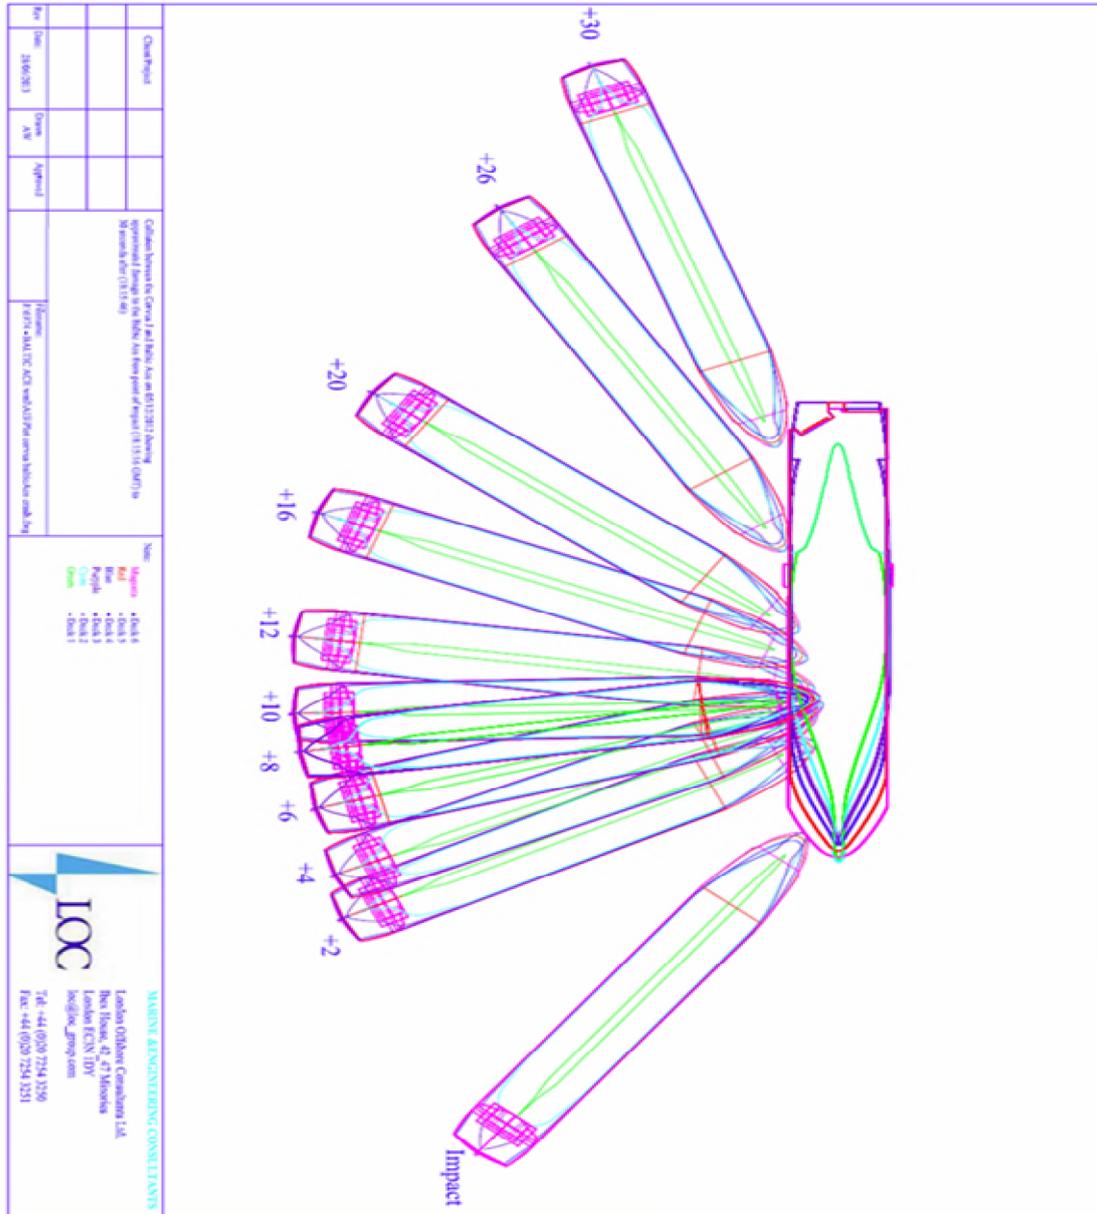
Figure 20: Damage assessment from impact (18:15:16) to 30 seconds after (18:15:46)²⁰

4.6.3 Immediately after the two vessels had separated from one another, an analysis of the VDR audio recordings on board the Baltic Ace indicate falling hardware and breaking glass, a sound that is synonymous with a large angle of inclination. Witness testimonies indicate that the vessel took on an immediate trim by the head after impact and began listing to starboard soon after. Analysis of the dimensions of both vessels supports this conclusion by providing an estimation of the position of penetration as seen in figure 20 above.

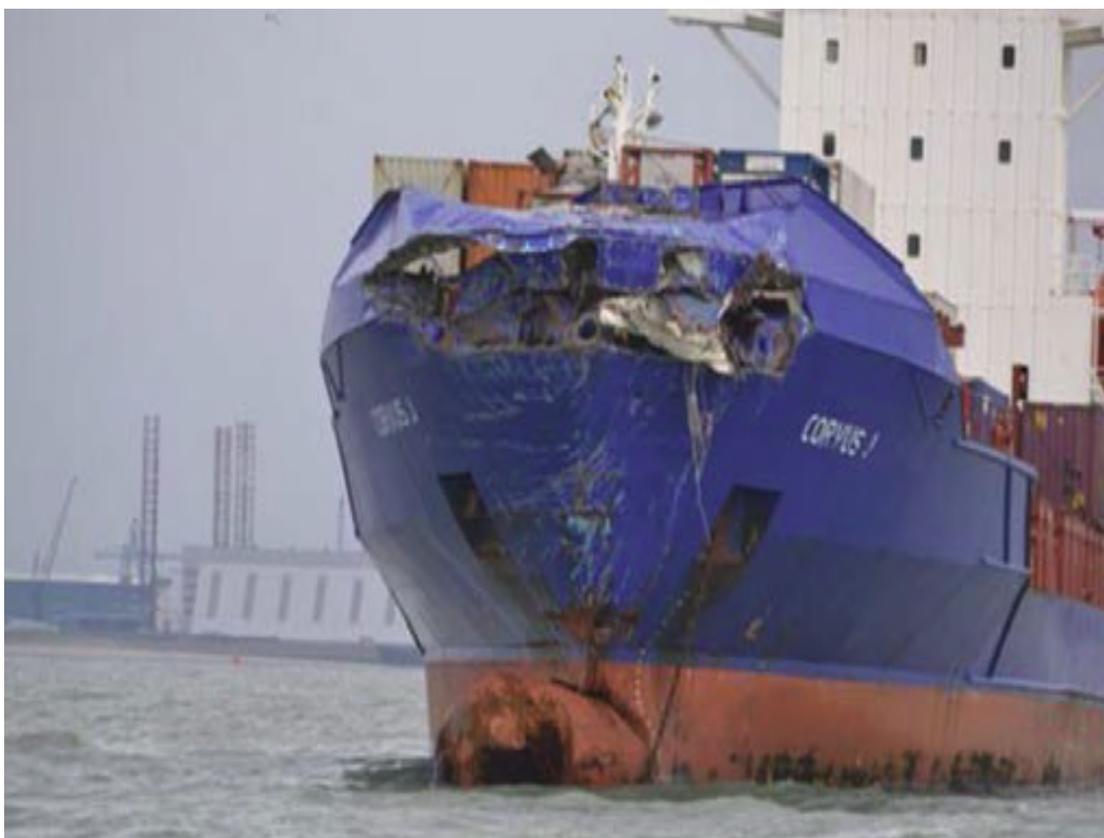
- 4.6.5 The extent of damage sustained to the bow of the Corvus J (as seen in figures 21, 22 and 23) highlight the extent of the penetration to the side shell plating of the Baltic Ace. The perimeter of the Baltic Ace cargo hold is surrounded by ballast wing tanks and void spaces extending inwards from 1.3m and 2.6m respectively. Following visual analysis it can be determined that the surrounding spaces were fully penetrated resulting in immediate ingress of water to the cargo deck spaces.

- 4.6.6 Although the Corvus J sustained severe structural damage as a result of the collision, the watertight integrity of the vessel was not compromised. The vessel was therefore able to remain on scene to assist with the search and rescue operation.

Figure 21: Bow damage to Corvus J post collision

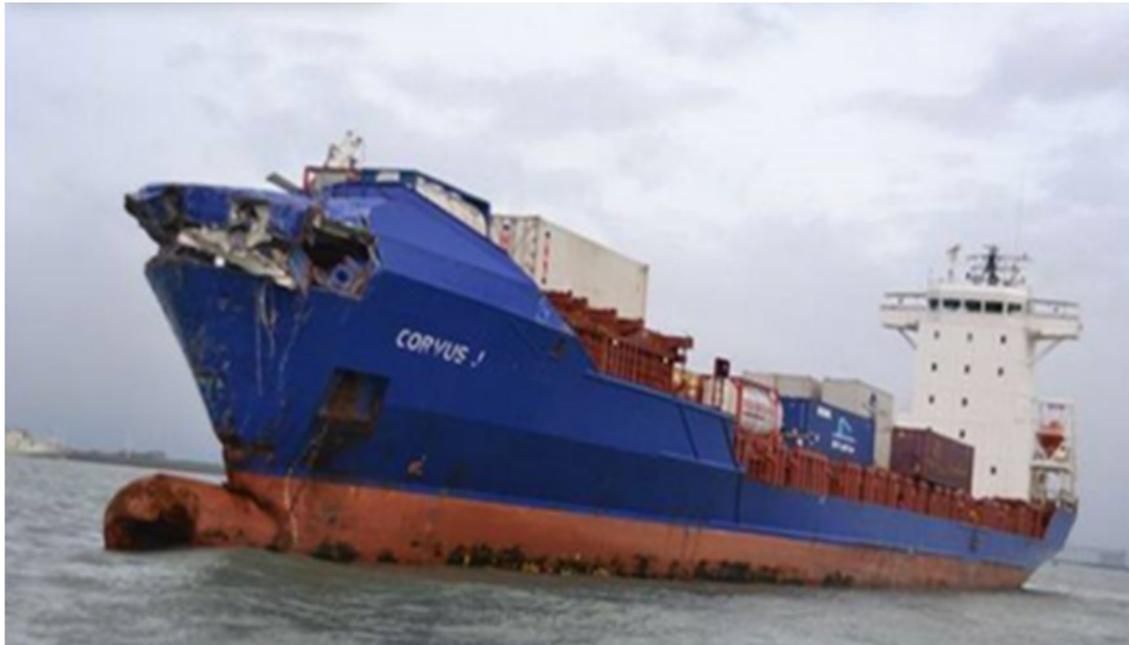
Figure 22: Port bow view of Corvus J post collision

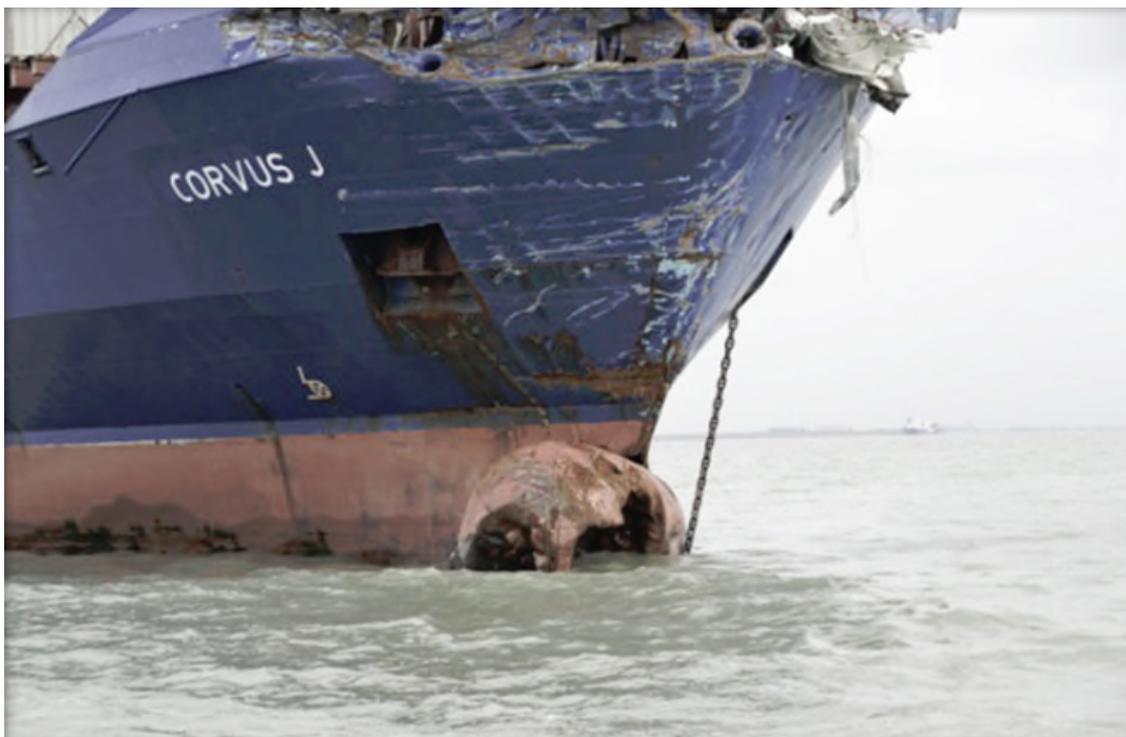
Figure 23: Bow damage to Corvus J post collision

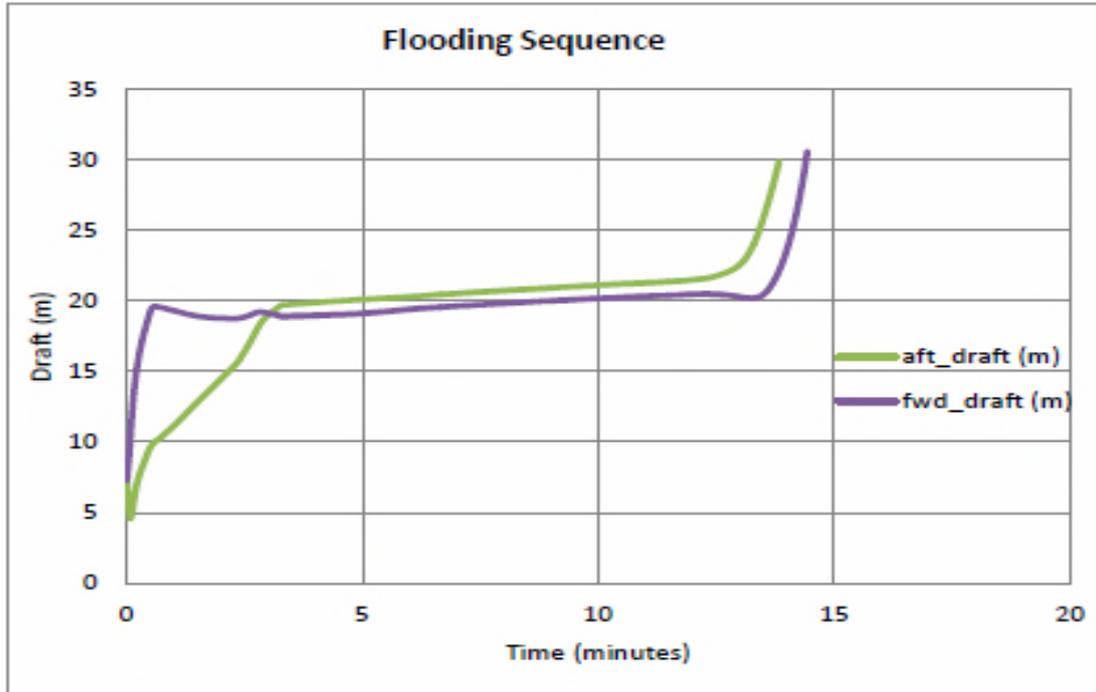
- 4.6.7 During the analysis, draught, heel and trim were measured against time from the point of impact. The results are provided within figures 24, 25 and 26 respectively.
- 4.6.8 Based on the damage plots it is clear that the vessel suffered a large tear on its starboard side opening up decks 2 to 7 almost instantly. The stability shows that the ingress of water caused a rapid increase in draught from 7m to

approximately 20m, 3 minutes after impact. The draught of the vessel then remained stable with a slow increase until 13 minutes after impact, at which point draught increased rapidly. All three data plots (figures 24, 25 and 26) remain consistent and demonstrate the severity of the damage by the speed with which the vessel lost all buoyancy.

Figure 24: Analysis of Draught plot over time from the moment of impact commencing at 18:15:16 (0+) using GHS

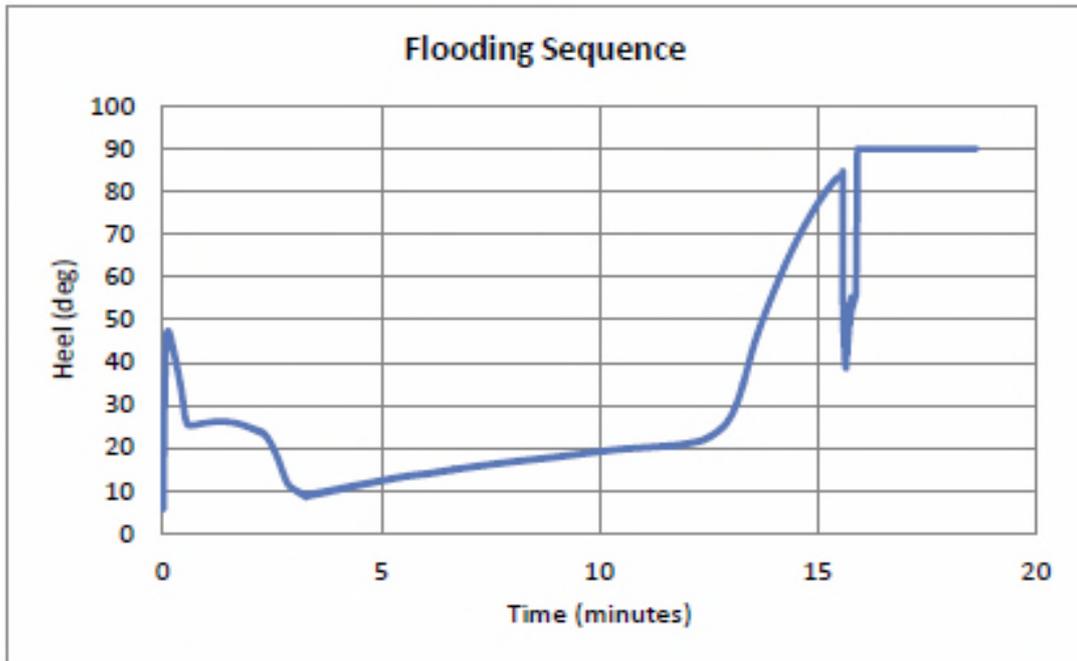
4.6.9 The results provided below show that the vessel quickly took on a 50° list which reduced to 25° and then stabilised. The list then reduced to approximately 8°, 3 minutes after impact. The list then slowly increased until it reached 20° approximately 13 minutes after impact. After that the list rapidly increases until it reached 80°, 15 minutes after impact the vessel sinks below the water and comes to rest on the seabed on its starboard side.

Figure 25: Analysis of Heel plot over time from the moment of impact commencing at 18:15:16 (0+) using GHS

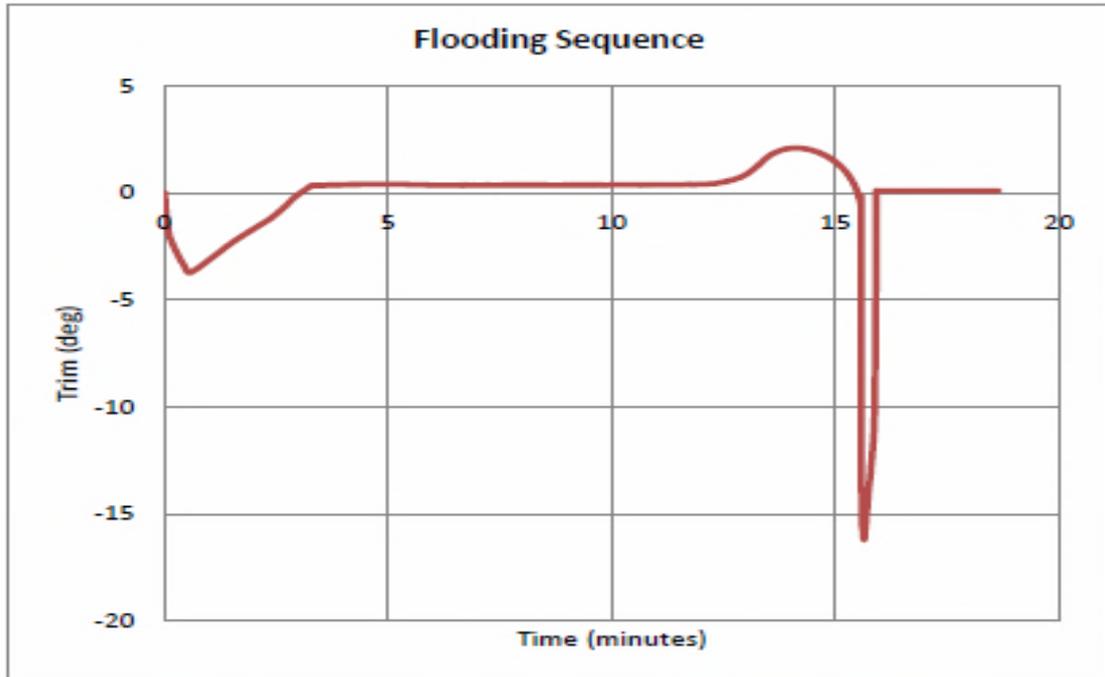
4.6.10 The poor weather conditions that prevailed on the evening of the 05th December coupled with the extent of the damage that was sustained during the collision, the ingress of water into the cargo deck spaces would have occurred rapidly, to such an extent that the Baltic Ace capsized in approximately 15 minutes. The free surface effect²¹ would cause significant dynamic forces to act against the righting moment, and a detrimental effect to the vessel's residual stability reducing and potentially eliminating the positive GM that existed prior to the collision.

Figure 26: Analysis of Trim plot over time from the moment of impact commencing at 18:15:16 (0+) using GHS

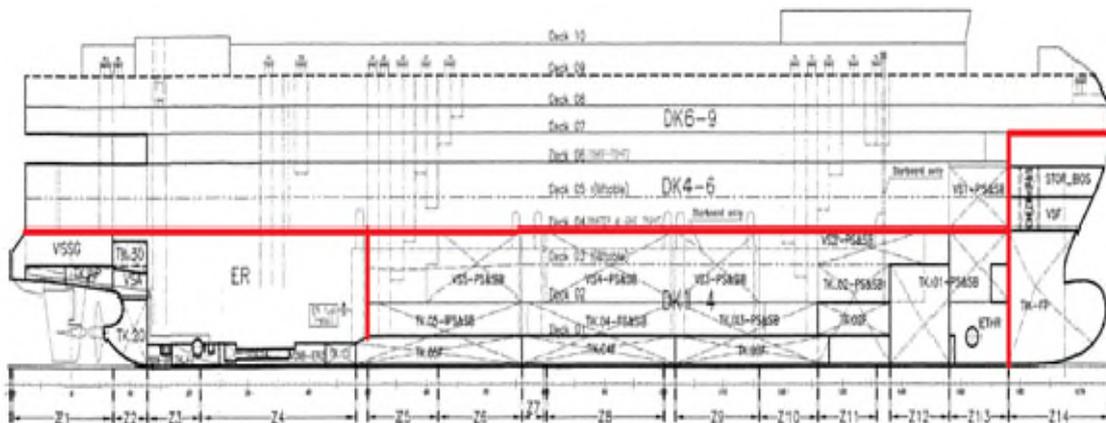
4.6.11 The structural arrangement of the vessel consists primarily of two subdivisions within the internal structure. A transverse subdivision exists between the engine room (forward engine room bulkhead) and that of decks 1 through 4. This is the singular transverse subdivision separating two significant compartments within the structural arrangement. A subdivision exists longitudinally along deck 4 which is the load line deck that separates the lower hold from the upper hold and has no transverse subdivision. Figure 27 shows the transverse and longitudinal subdivision represented in red. Although the vessel has a low extent of subdivision, it did comply fully to Regulation 4 of Chapter II of SOLAS in regard to subdivision and stability.

Figure 27: Damage Control Plan indicating watertight structural subdivision (in red)

- 4.6.12 Although the vessel complies fully with SOLAS, the reliance placed on the watertight subdivision being maintained is critical to the vessel’s reserve buoyancy and watertight integrity due to the presence of only one horizontal and transverse subdivision. The damage stability booklet indicates that the vessel should survive the complete flooding of the lower hold or flooding of the lower hold and the engine room providing deck 4 and above the watertight subdivision is not breached. In the event that the watertight subdivision becomes compromised a significant reduction in the amount of reserve buoyancy will be exhibited. When this occurs the watertight subdivision becomes partly or fully submerged below the final damage waterline.

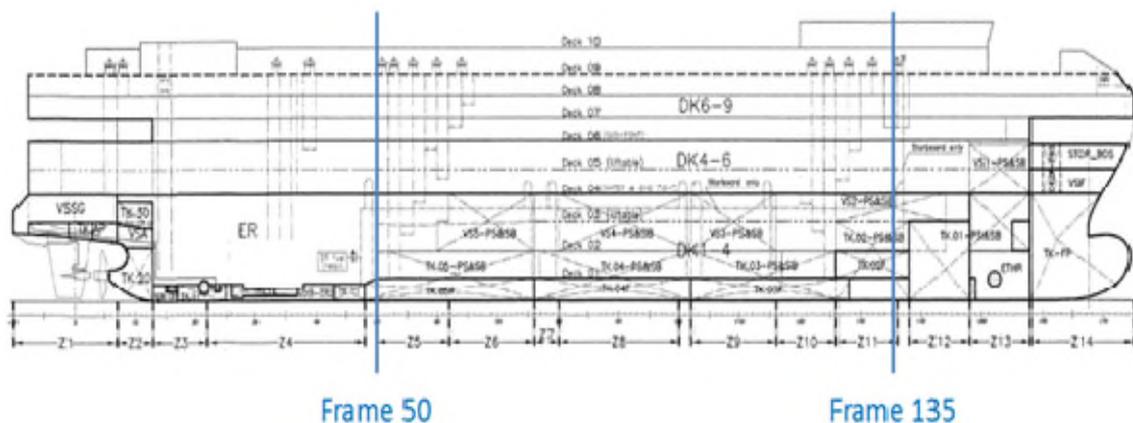
- 4.6.14 It has been determined from the evidence provided via GHS analysis, the vessel capsized due to the significant and rapid ingress of water between deck 2 and deck 6. Given the depth of penetration based on photographic evidence of the bow of the Corvus J it is unlikely that the loss of stability causing the initial heel could have been avoided given the compromised watertight integrity of the vessel above and below the longitudinal watertight subdivision between frame 135 and frame 50.

Figure 28: Frame location on Damage Control Plan

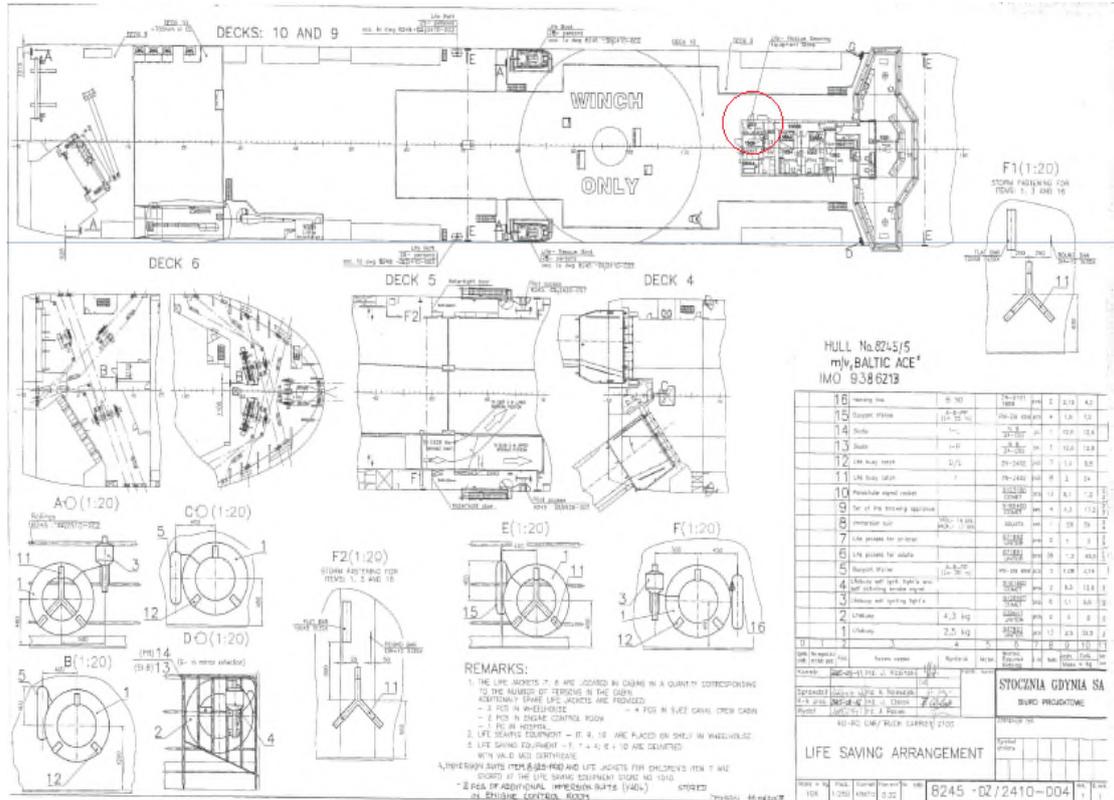
- 4.7.7 Only two crew were wearing immersion suits upon recovery, it was determined later that both crew members had gathered their immersion suits in the early stages of abandonment as they were in the region of the immersion suit storage locker having come from the bridge. The majority of the crew however were unable to climb up to deck 10 from deck 9 due to the angle of list that was adopted so quickly and therefore did not have access to immersion suits prior to abandoning the vessel. The effectiveness of an

Figure 29: Baltic Ace lifesaving arrangement plan – Immersion suits stored within Life Saving Equipment Store on Deck 10 (circled)

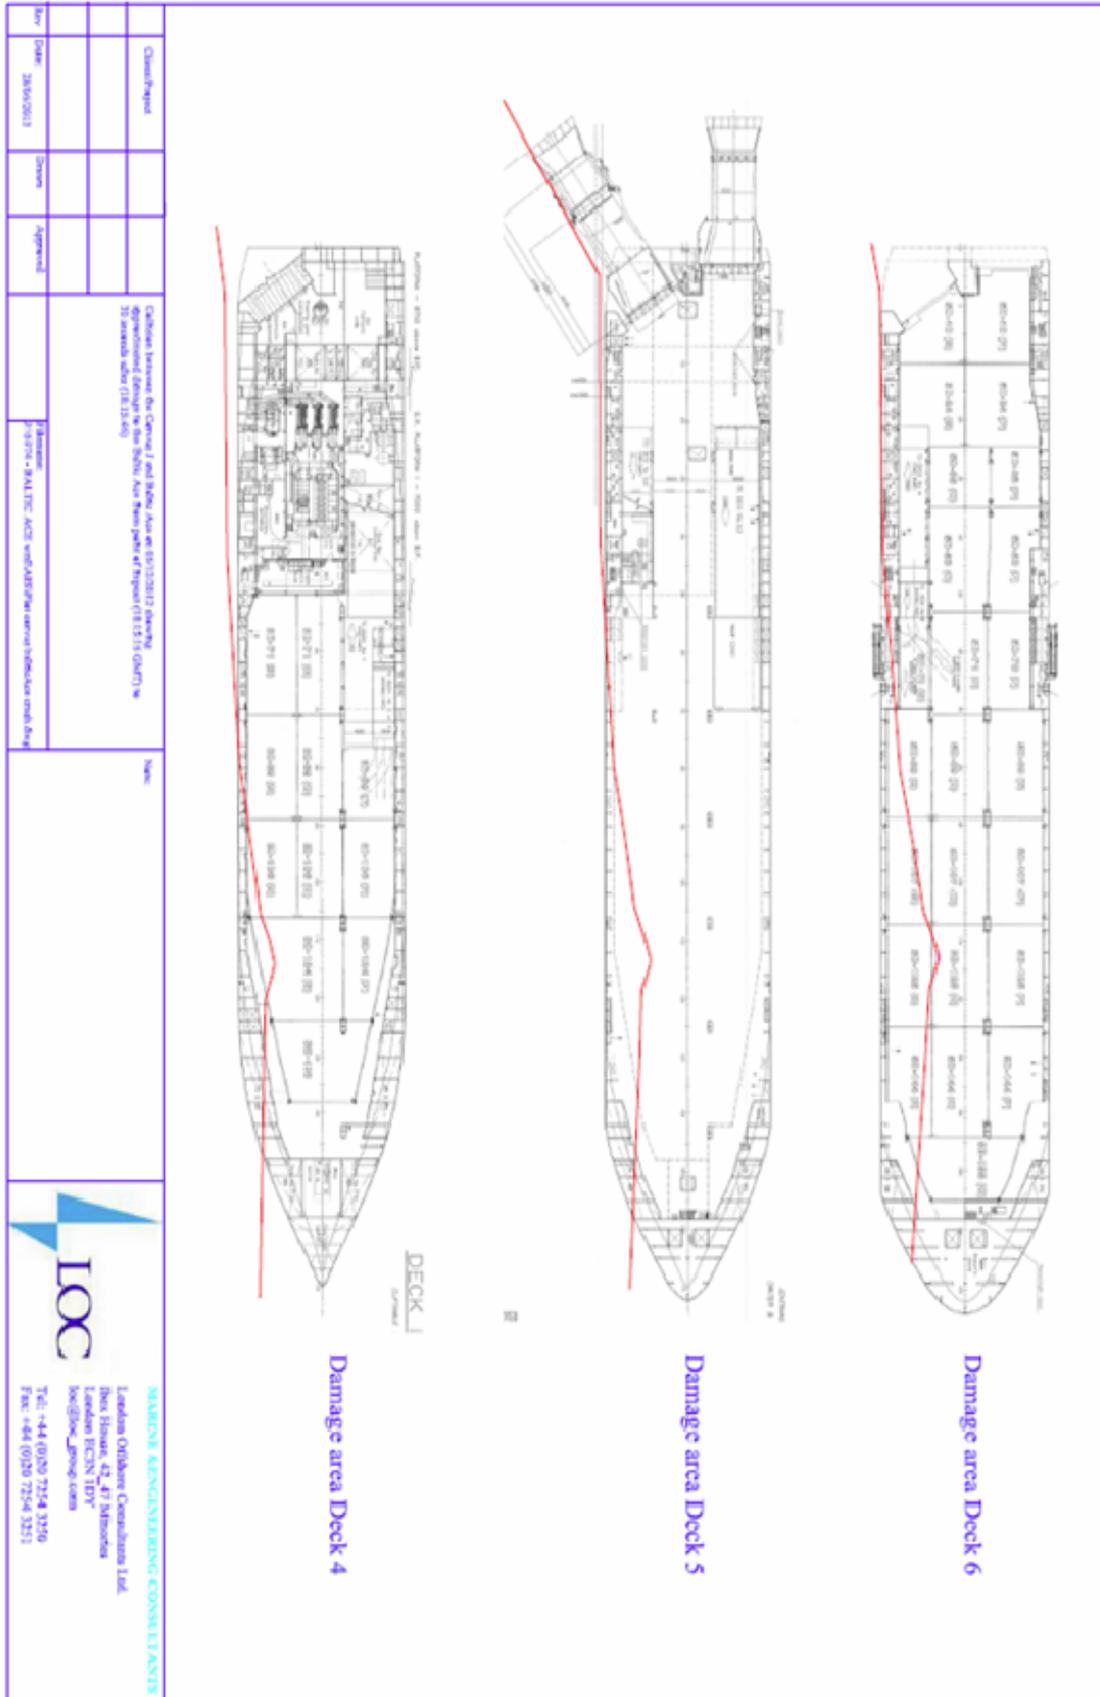
- 4.6.4 Appendix II shows the damage sustained on the starboard side of the Baltic Ace was likely to be below the waterline, decks 02 and 03 and above the waterline on all decks up to and including deck 06.

Figure 35: Baltic Ace Damage Plot (decks 4, 5 & 6)
