CELTIC WARRIOR

**Report of the investigation into
the collision between
CELTIC WARRIOR and
ANNEGRET
on
07 December 1997**

Report Reference : 2278

Date of Issue : 17 January 2000

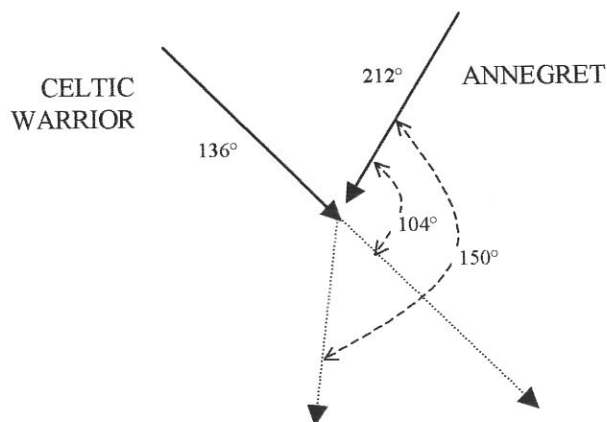
- 4.4.8. The angle of blow, considered as the angle of approach of ANNEGRET at the final moments before contact with CELTIC WARRIOR was at least 104° on the port bow of the latter but, according to the recollections of the CELTIC WARRIOR officer of the watch, was up to 150° (60° abaft her beam.) Considering that CELTIC WARRIOR had commenced an alteration to starboard the most likely final angle of blow at the point of first contact was between 120° and 150° . The following diagram, not to scale, represents those courses and the possible angles of blow.

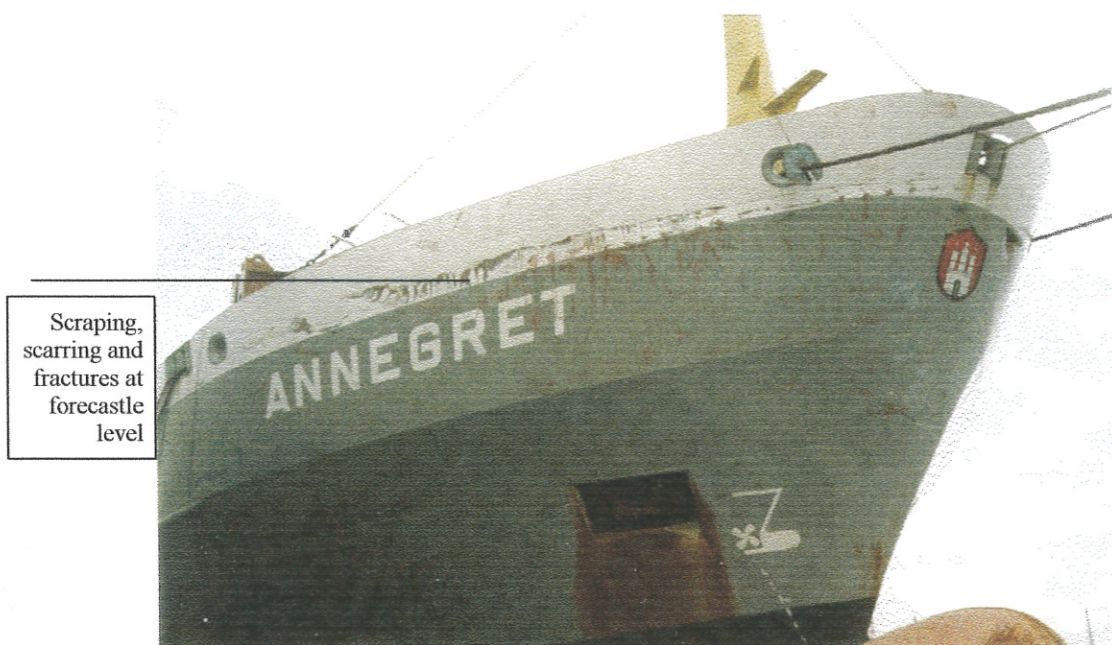
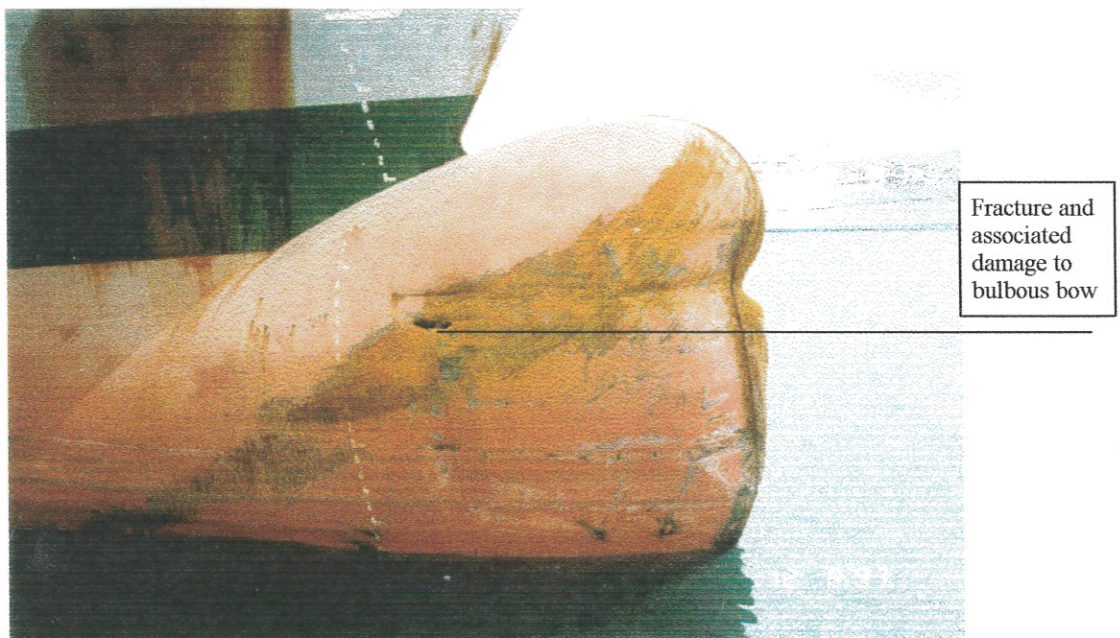
- 3.5. The damage to ANNEGRET, noted after her arrival at Piraeus, was confined to:
- heavy setting in of the bow and forecastle structure with a sharp indentation near to the 6.3 metre draft mark, immediately to starboard of the bulbous bow running aft,
 - fracture of the bulbous bow plating
 - fracture of the forecastle plating immediately below the forecastle deck, 1½ metres to the port side from the centre line of the vessel and
 - various minor scratches, mainly to the starboard side bulwarks.
- 3.6. An unknown number of the deck stowed containers from CELTIC WARRIOR broke adrift to become a hazard to navigation. Many of these containers were washed ashore on the coasts of nearby islands. Some light pollution, assumed to be Diesel Oil, was observed but was seen to evaporate and dissipate over a comparatively short space of time.

- 4.5. Immediately after the contact both vessels remained locked onto one another for about three or four minutes before separating. The bow of ANNEGRET then bumped down the port side of CELTIC WARRIOR. This implies that the astern propeller pitch ordered by the ANNEGRET officer of the watch began to take effect before the similar order of the CELTIC WARRIOR Chief Mate on his vessel.
- 4.6. The damage to ANNEGRET was limited to fractures, scarring and indentations to her bulbous bow and her starboard bow/forecastle plating. The reported hole in the side shell of CELTIC WARRIOR was most probably caused by the damaged starboard side of the bulbous bow of ANNEGRET.

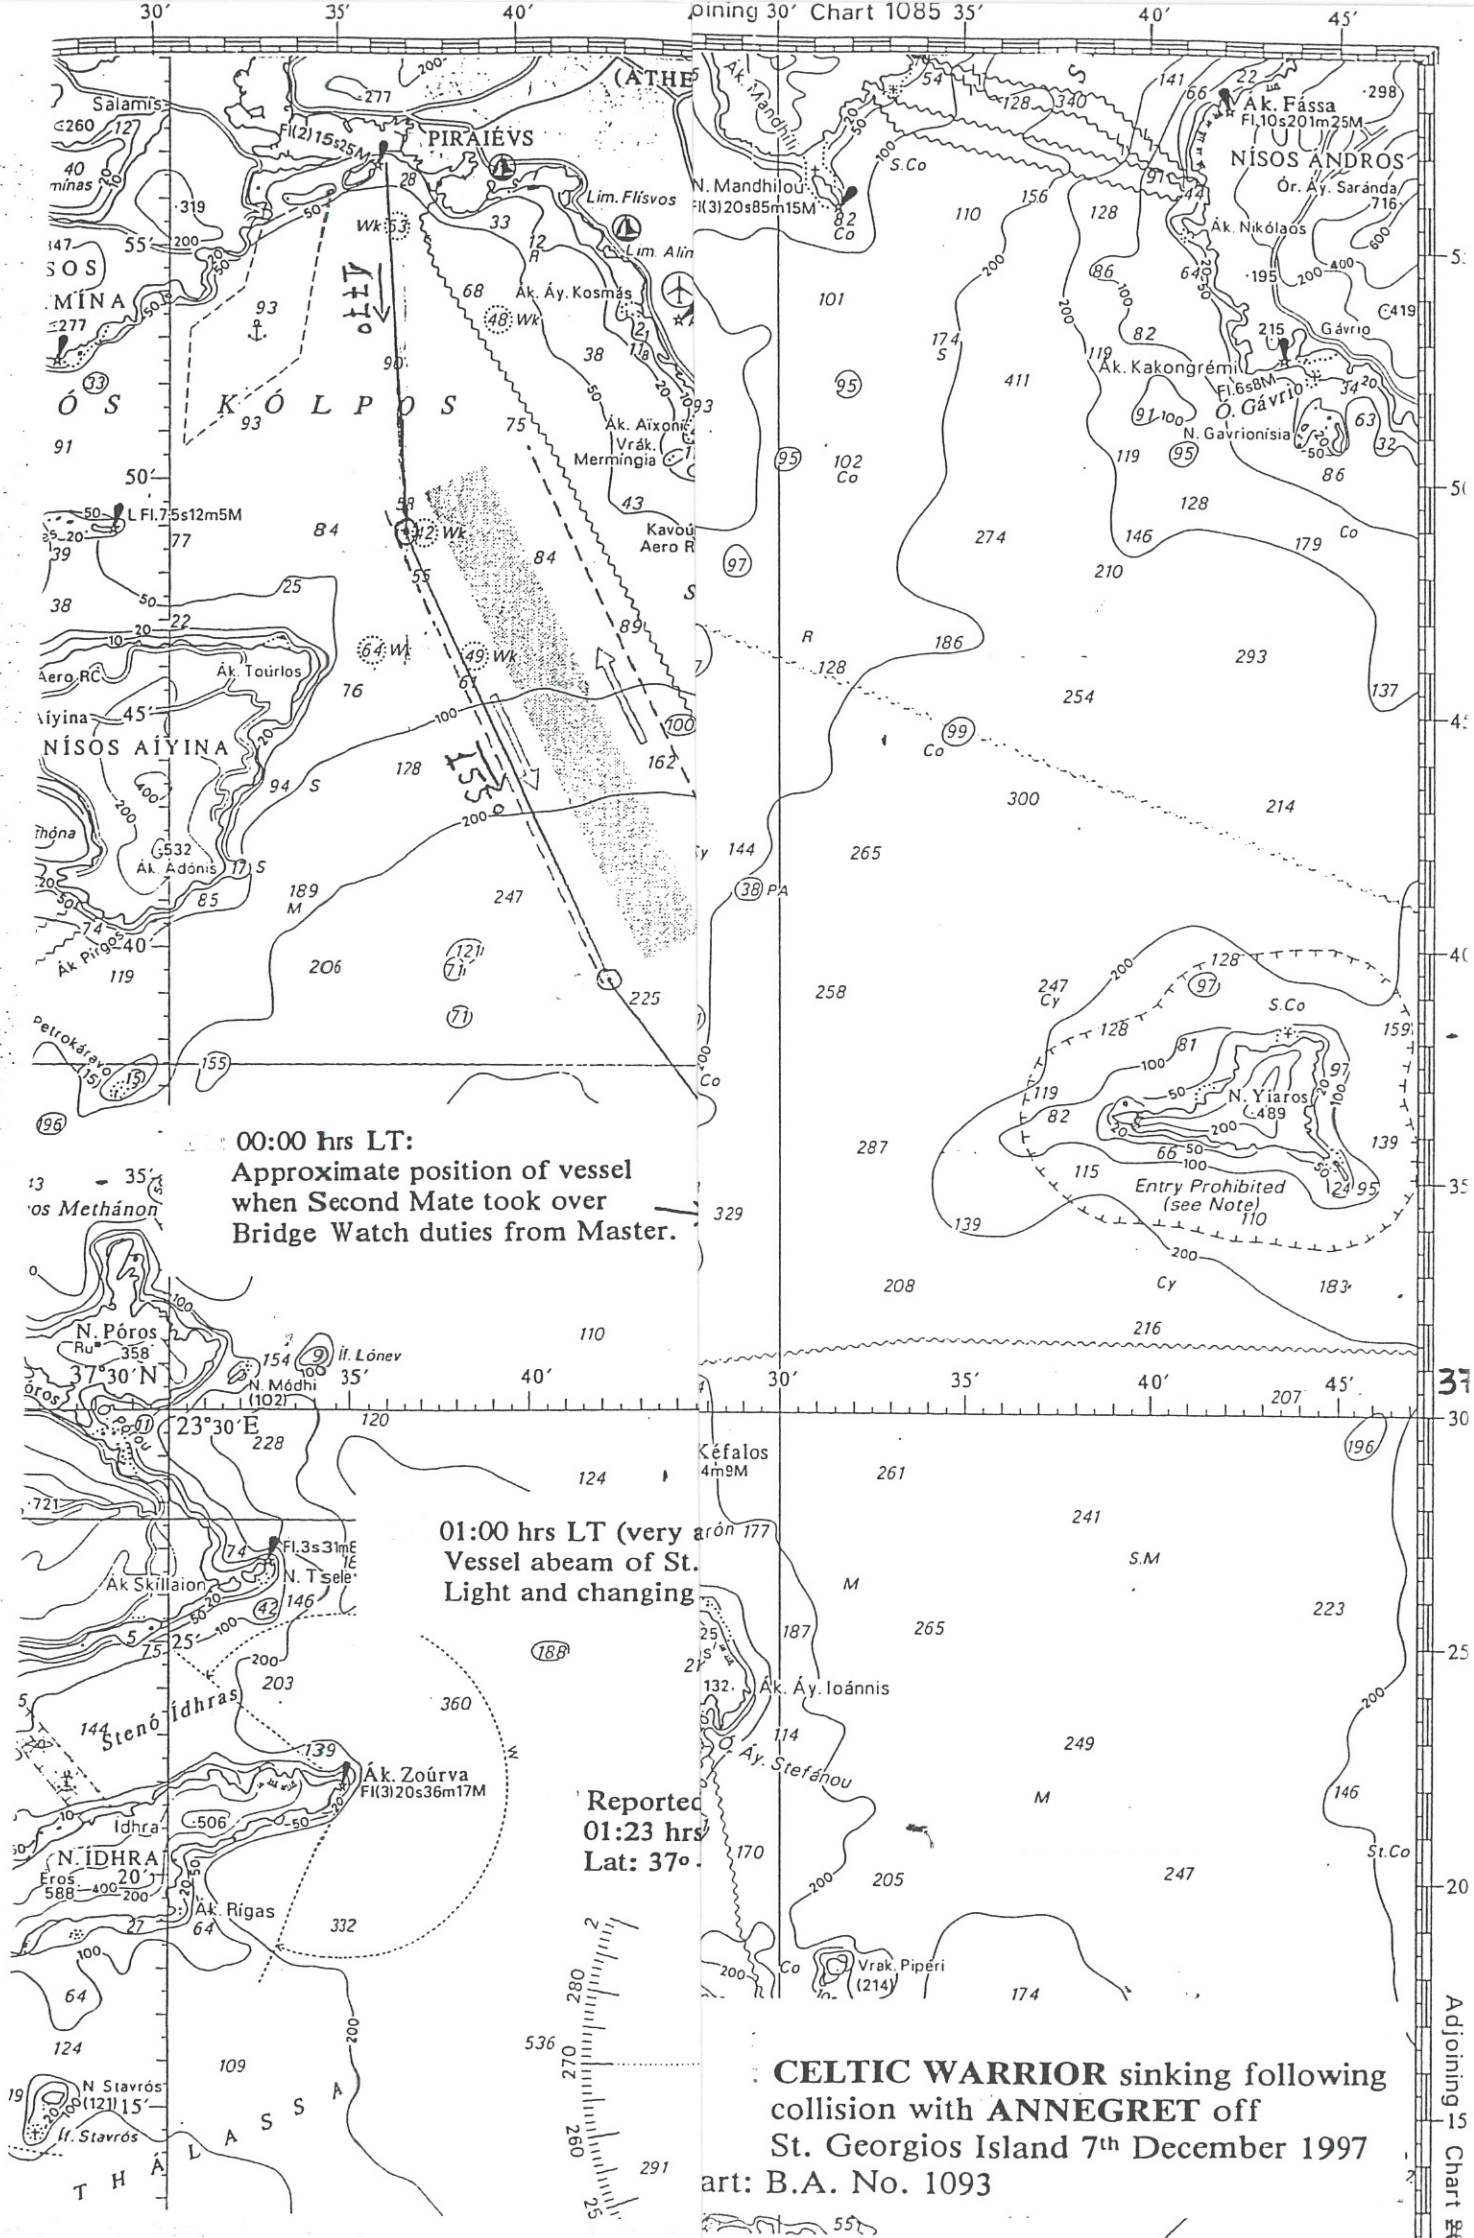
Extract of Chart B.A. 1093 showing the tracks and positions of the two vessels.

- 4.4.6. The intended tracks of the vessels and the balance of the evidence indicates that both vessels maintained their plotted course lines and sea speeds up to a time just seconds before the collision when CELTIC WARRIOR made a starboard helm order and ANNEGRET placed her propeller pitch from ahead to astern. Neither action, alone or as a joint effort was sufficient to avoid the collision.
