**The Bahamas  
Maritime Authority**

**Report of the investigation into  
the contact between the  
High Speed Craft  
HD1**

**And the moored High Speed Craft  
CONDOR EXPRESS**

**During berthing operations  
at St Helier, Jersey on  
28<sup>th</sup> July 2007**

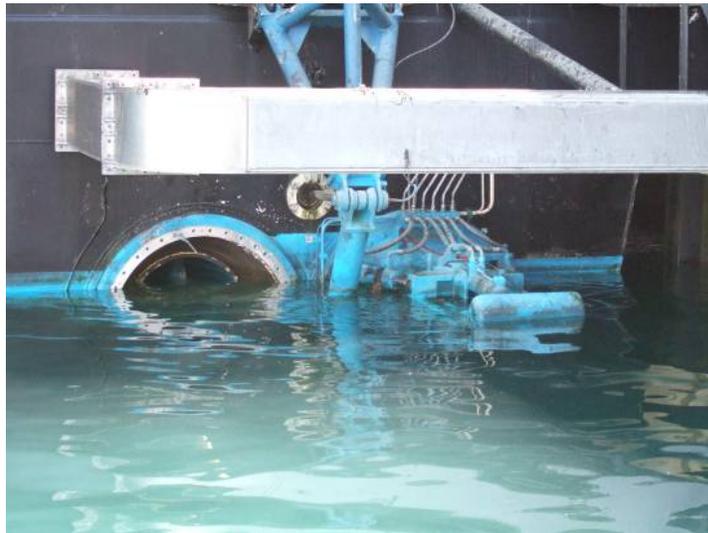
- 3.2.3 The vessel had one significant mechanical deficiency which had been correctly reported by the Managers to the BMA and was known about by the master, crew, pilot and the harbour authority. The inner starboard engine and water jet had been decommissioned following a failure in the water jet pump during an earlier voyage. Consequences of this deficiency are discussed further in this report.

The starboard remaining nozzle, the inner unit having been removed.

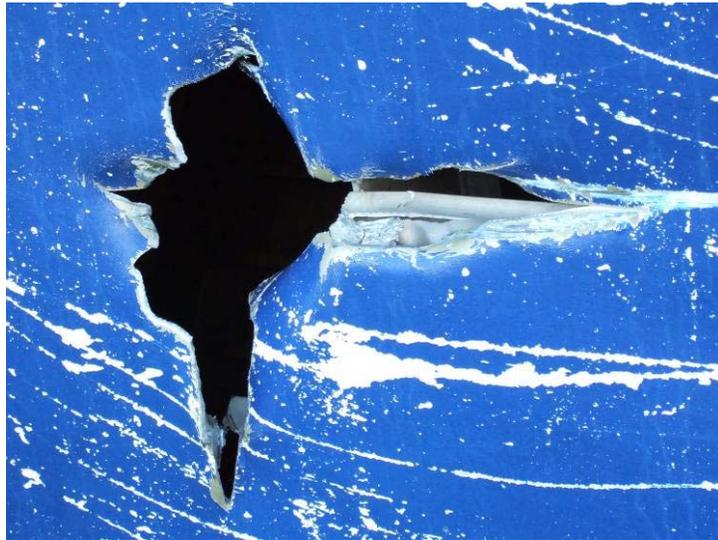
**Left:**  
HD1 initial penetration and exit  
gouge in an astern direction.

3.6.1 After the initial contact and penetration HD1 continued to move ahead. This forward movement did not initially clear the bow of the CONDOR EXPRESS. The HD1 port side shell traversed across the sharp wave piercing structure around the bow of CONDOR EXPRESS which caused further damage to the HD1 shell plating, breaching three compartments.

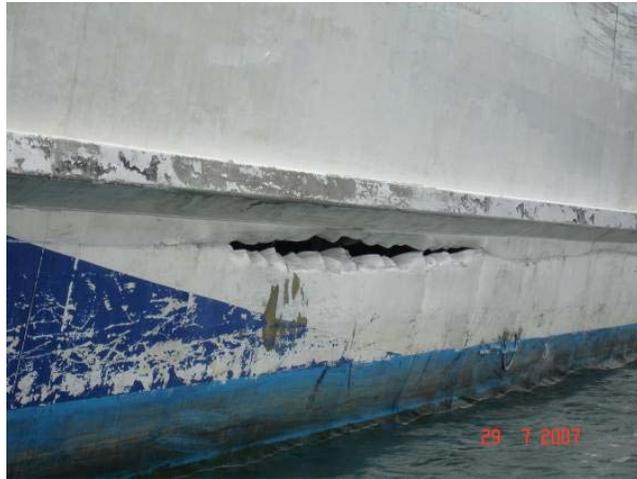
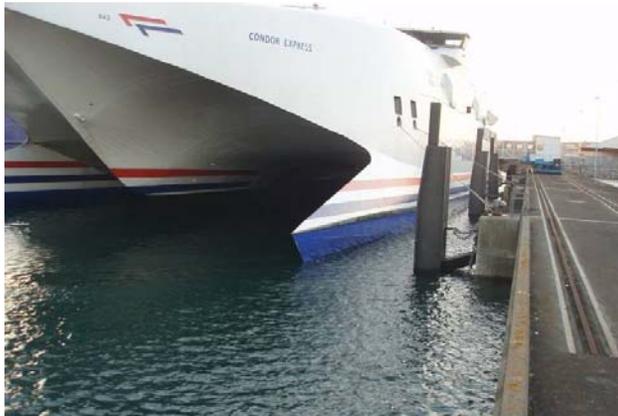
**Right:**  
Secondary incisions and damage to the Hull of HD1

- 3.7.3** The vessel was inspected once alongside Victoria Quay and repairs put in hand. The extent of the damage was a diamond shaped incision in No. 2 port void space in way of frame 43 and a number of incisions and indentations along a line from just abaft the initial impact position crossing the after end of No. 2 Port void and passing across No. 3 and 4 port voids. The position of the impact in No. 3 void space was coincident with the line of the cables supplying the bilge pump and the signal lines from the bilge alarm for that space. Whilst they were displaced the cables were not damaged.

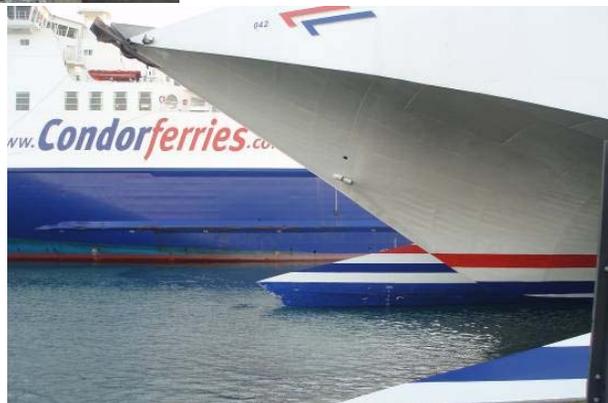
- 1.8.** CONDOR EXPRESS sustained superficial damage to the starboard bow that, after inspection was deemed not to affect the seaworthiness of the vessel and there was no influx of water.

**Right:**  
CONDOR EXPRESS starboard wave piercing bow upon which the HD1 landed.

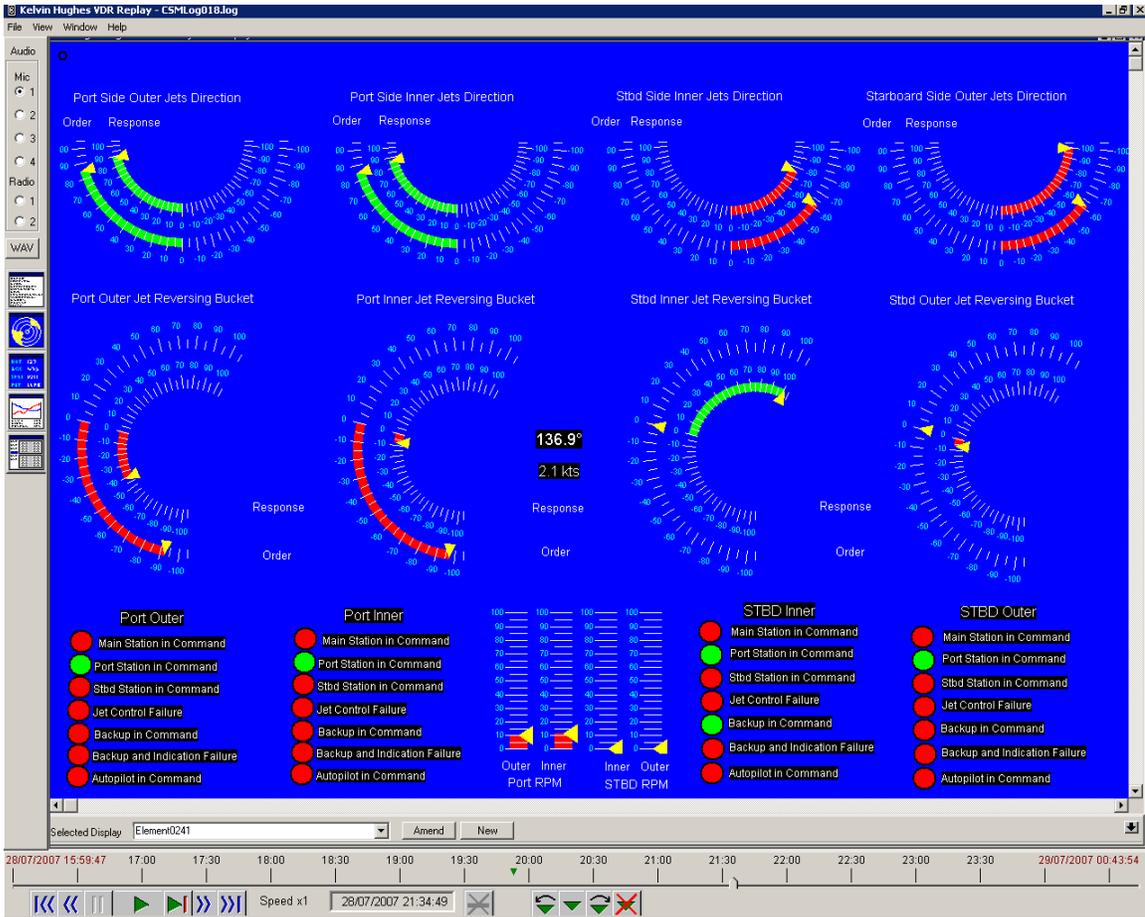
At 22:34:49 the master is on the controls at the after position. The pilot has advised him that the bow is “paying off”, which has confused him and he is still indicating his irritation. He appears to have become distracted as the port engine is astern and starboard is neither ahead nor astern, when it needs to be astern to provide the principal input for stern way. The port engine, will be applying a turning moment to port which is evident in the heading swinging to port and being advised by the pilot, and the chief mate..

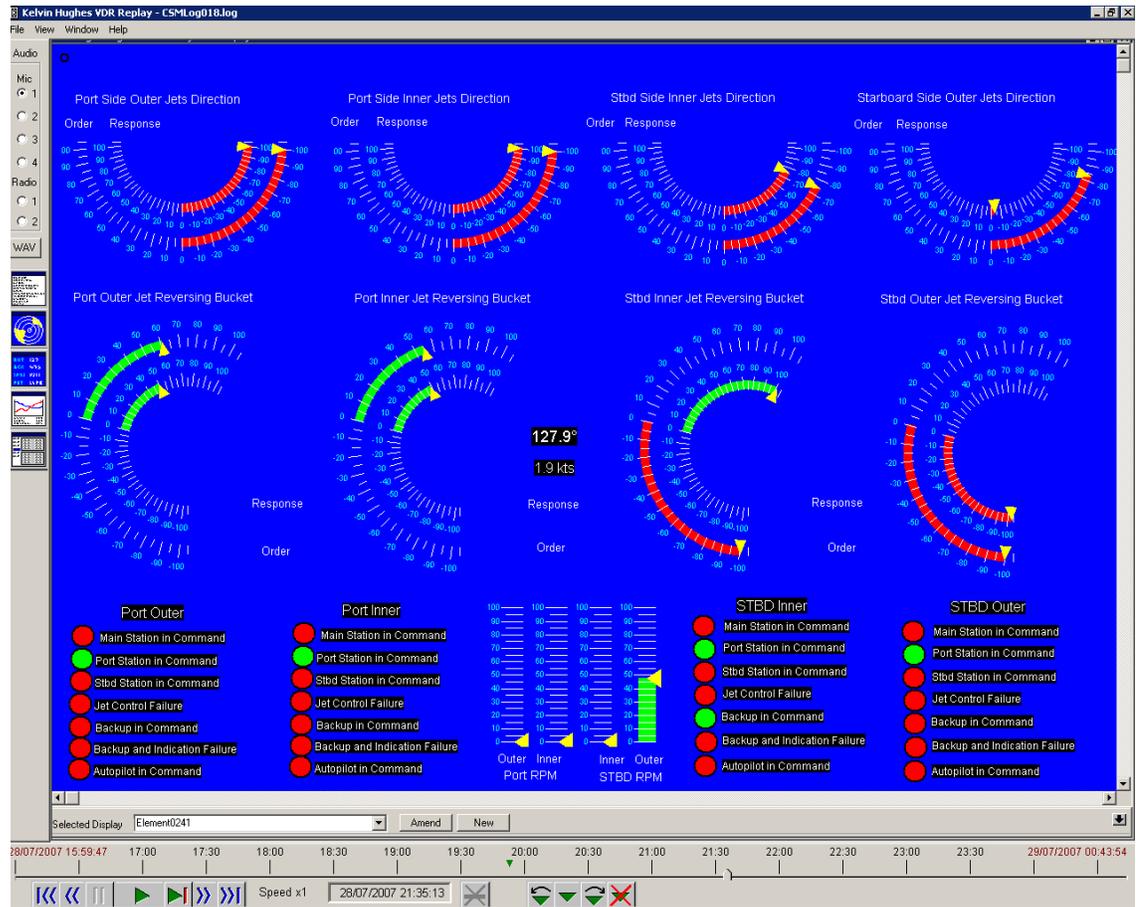
22:35:13

The master, still in the after control position has now altered the engine controls so that the port engines are now responding to an ahead demand with nozzles toed out. This is necessary to counteract the swing to port still being identified by the chief mate and at one point the chief engineer. The heading has now come round to 127.9°, a change of 9 degrees in 24 seconds (0.38 °/s).

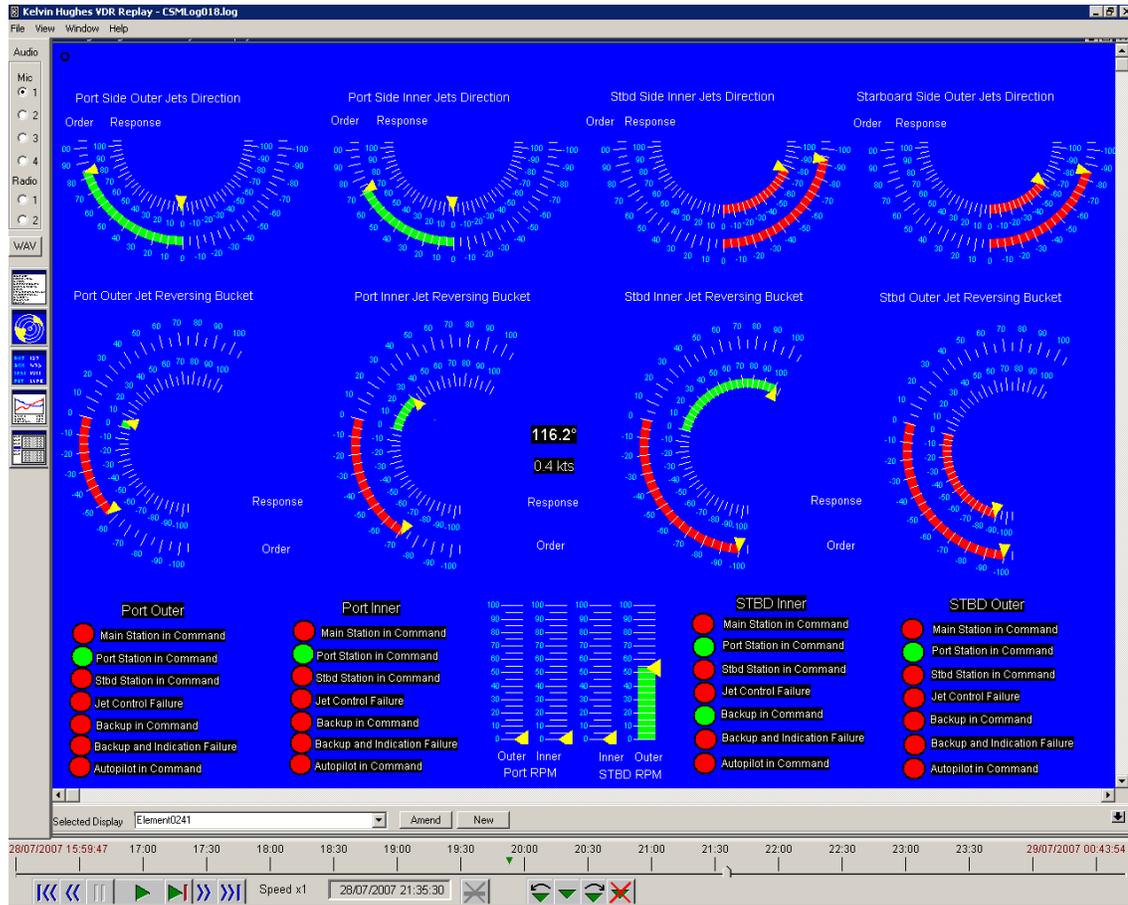
22:35:30

The master is becoming apparently more confused. The port engines have now been returned to an astern position thus fuelling the swing to port. The port nozzles are being altered to a toed in configuration but that lag at this point means that the thrust is amidships.

The heading is now 116.2°. a change of 11 degrees in 17 seconds (0.64 °/s)

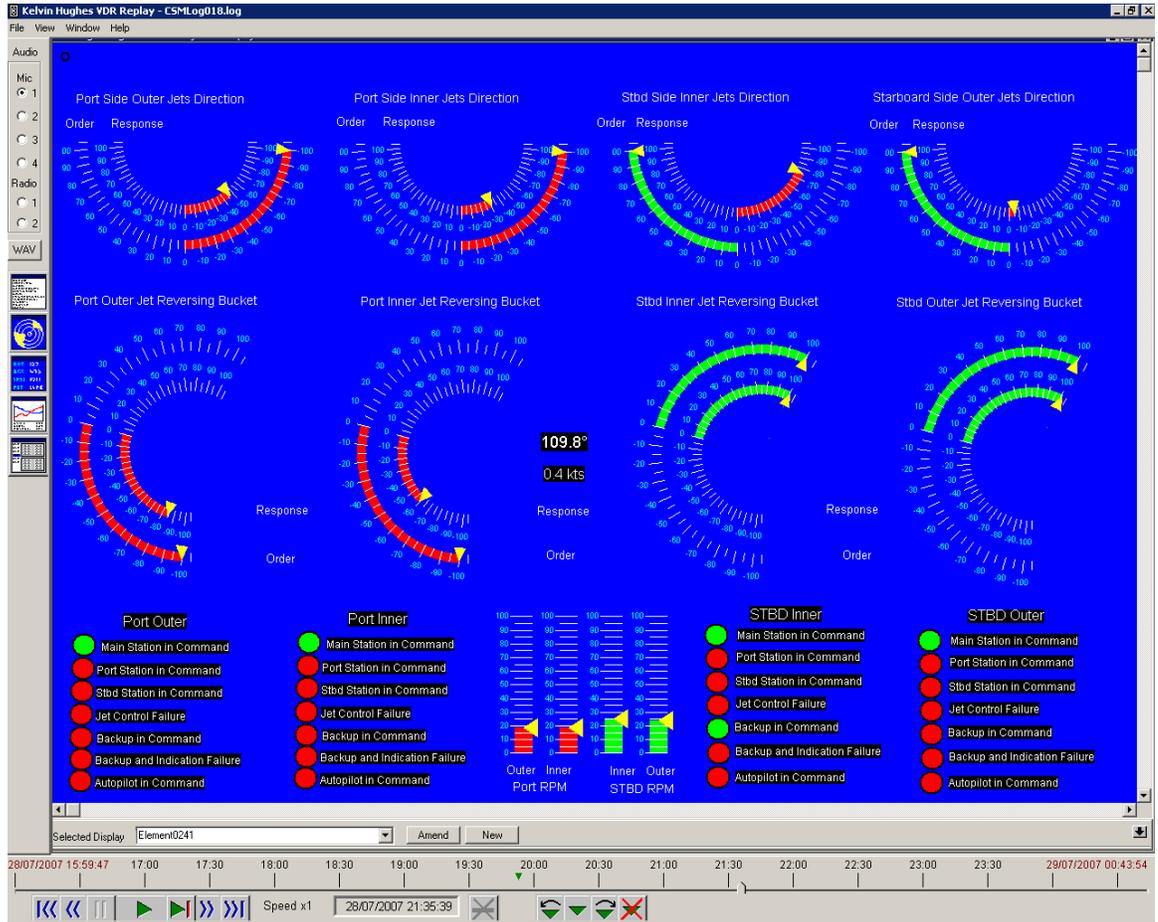
22:35:39

The master has now just transferred control to the forward position where the chief mate has forcefully suggested he should take control. The swing to port has increased and is distinctly visible on the CCTV footage from the port. The heading is now 109.8°, a change of 6.4 degrees in 9 seconds (0.7 °/s)

The engines are contributing a sizeable turning moment to port now.

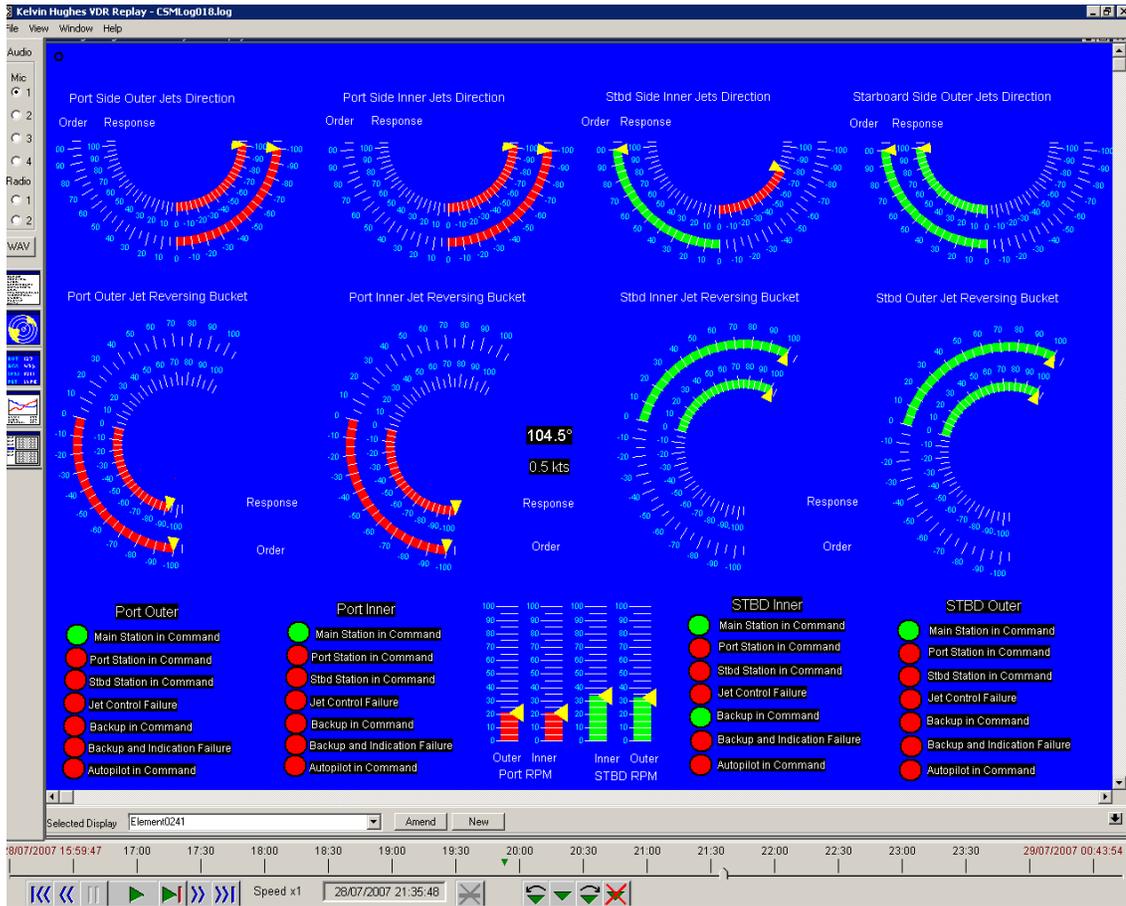
22:35:48

The control now appears to have been transferred to the chief mate at the forward position but engines remain applying significant power astern on the port side and ahead on the starboard, which is continuing to apply a significant turning moment to port.

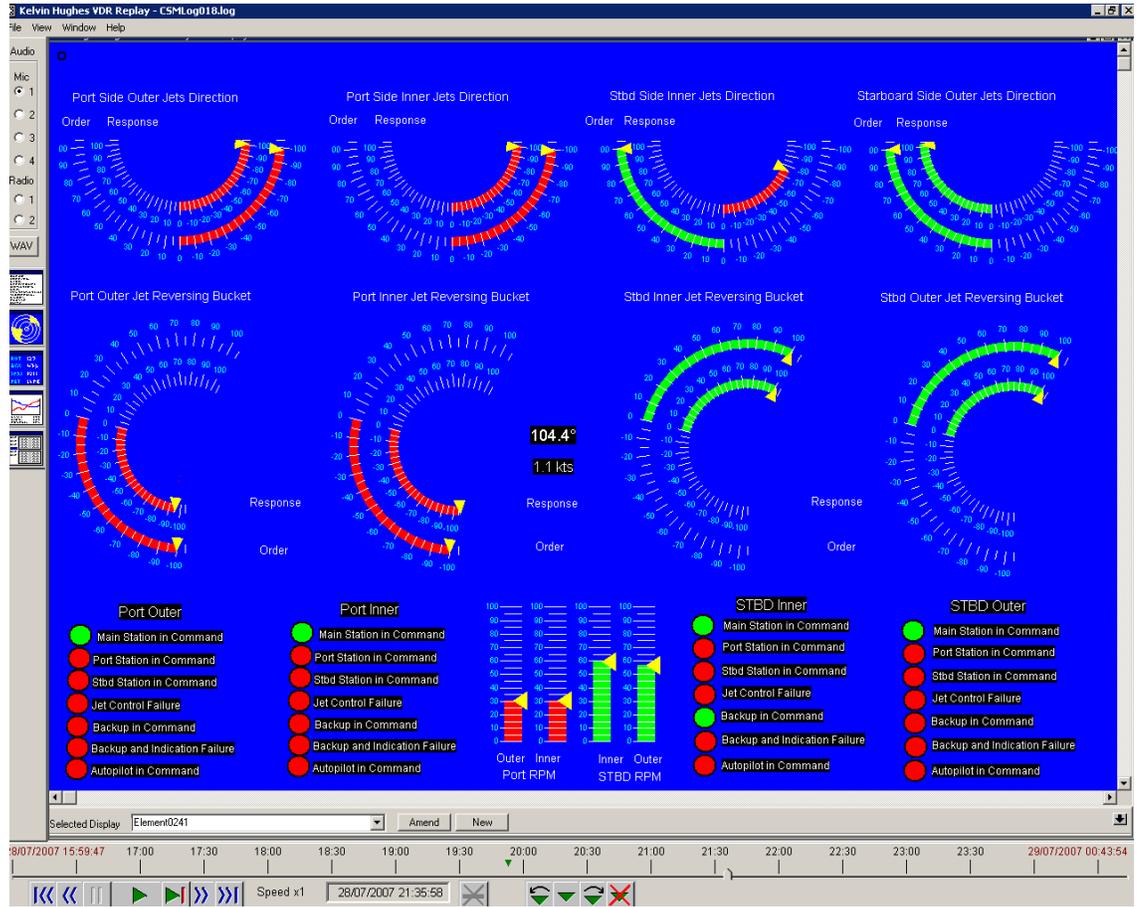
23:35:58

The deck has just reported 1m (distance from the CONDOR) and the chief mate – who it is presumed is on the controls and has resigned himself to the fact that “we’re going to hit”. The master can be heard in the vicinity of the control position, stating “you kept full astern?”, having presumably recognised that the engines are completely the reverse of where they need to be. i.e. full astern on port and full ahead on starboard. The plume of water from the starboard jet can be clearly seen on the CCTV footage at this point as it impinges on the quay wall.

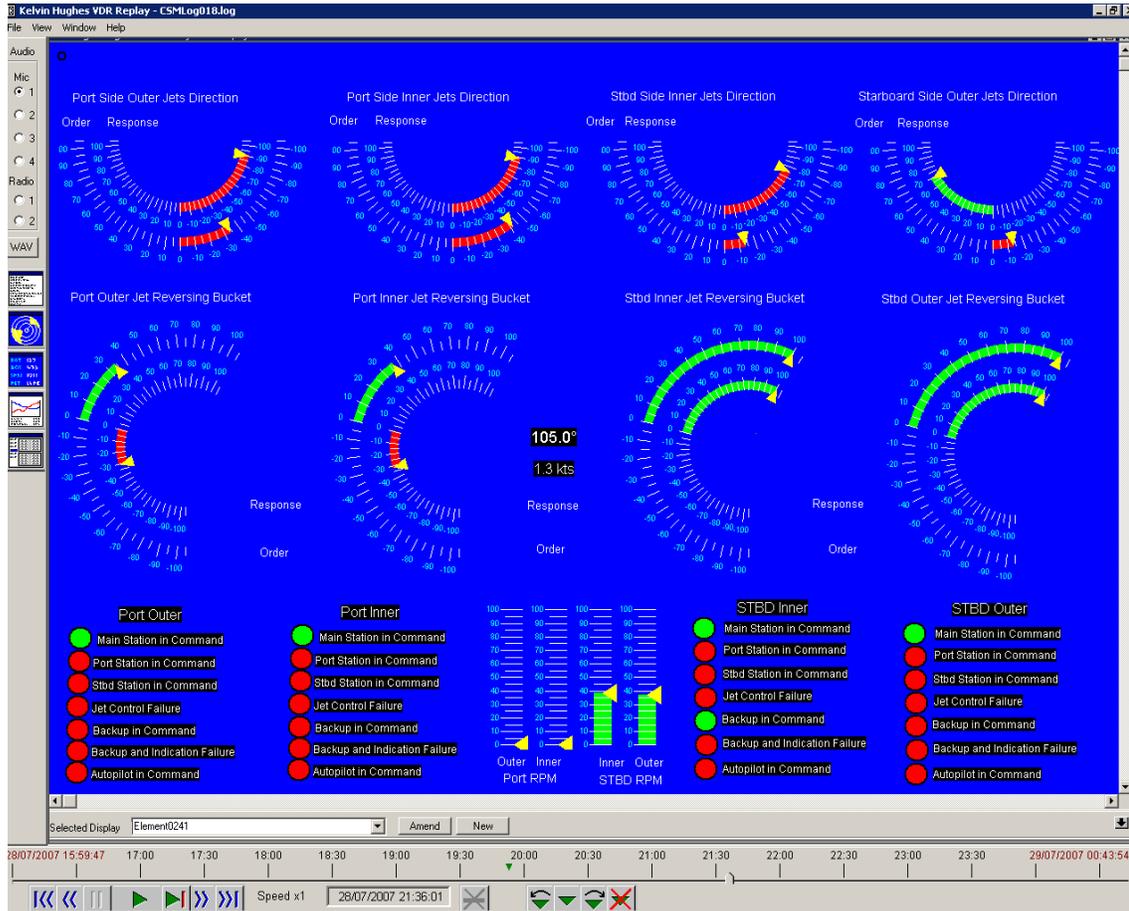
22:36:01

The chief mate— who it is assumed has control – has responded to the master’s question about the full astern and has immediately demanded full ahead on the port engines. Unfortunately this is too late. The impact is imminent and the starboard engine is still thrusting ahead forcefully. The heading has now ceased to alter, suggesting that impact has just occurred. The fact that the engines continued ahead after this impact is a reason for the continuing impacts along the hull over four compartments,
