THE BAHAMAS MARITIME AUTHORITY

“ICEVINHA”

**Report of the investigation into
the Collision between “ICEVINHA” and a towed barge
on
on 22 August 1995**

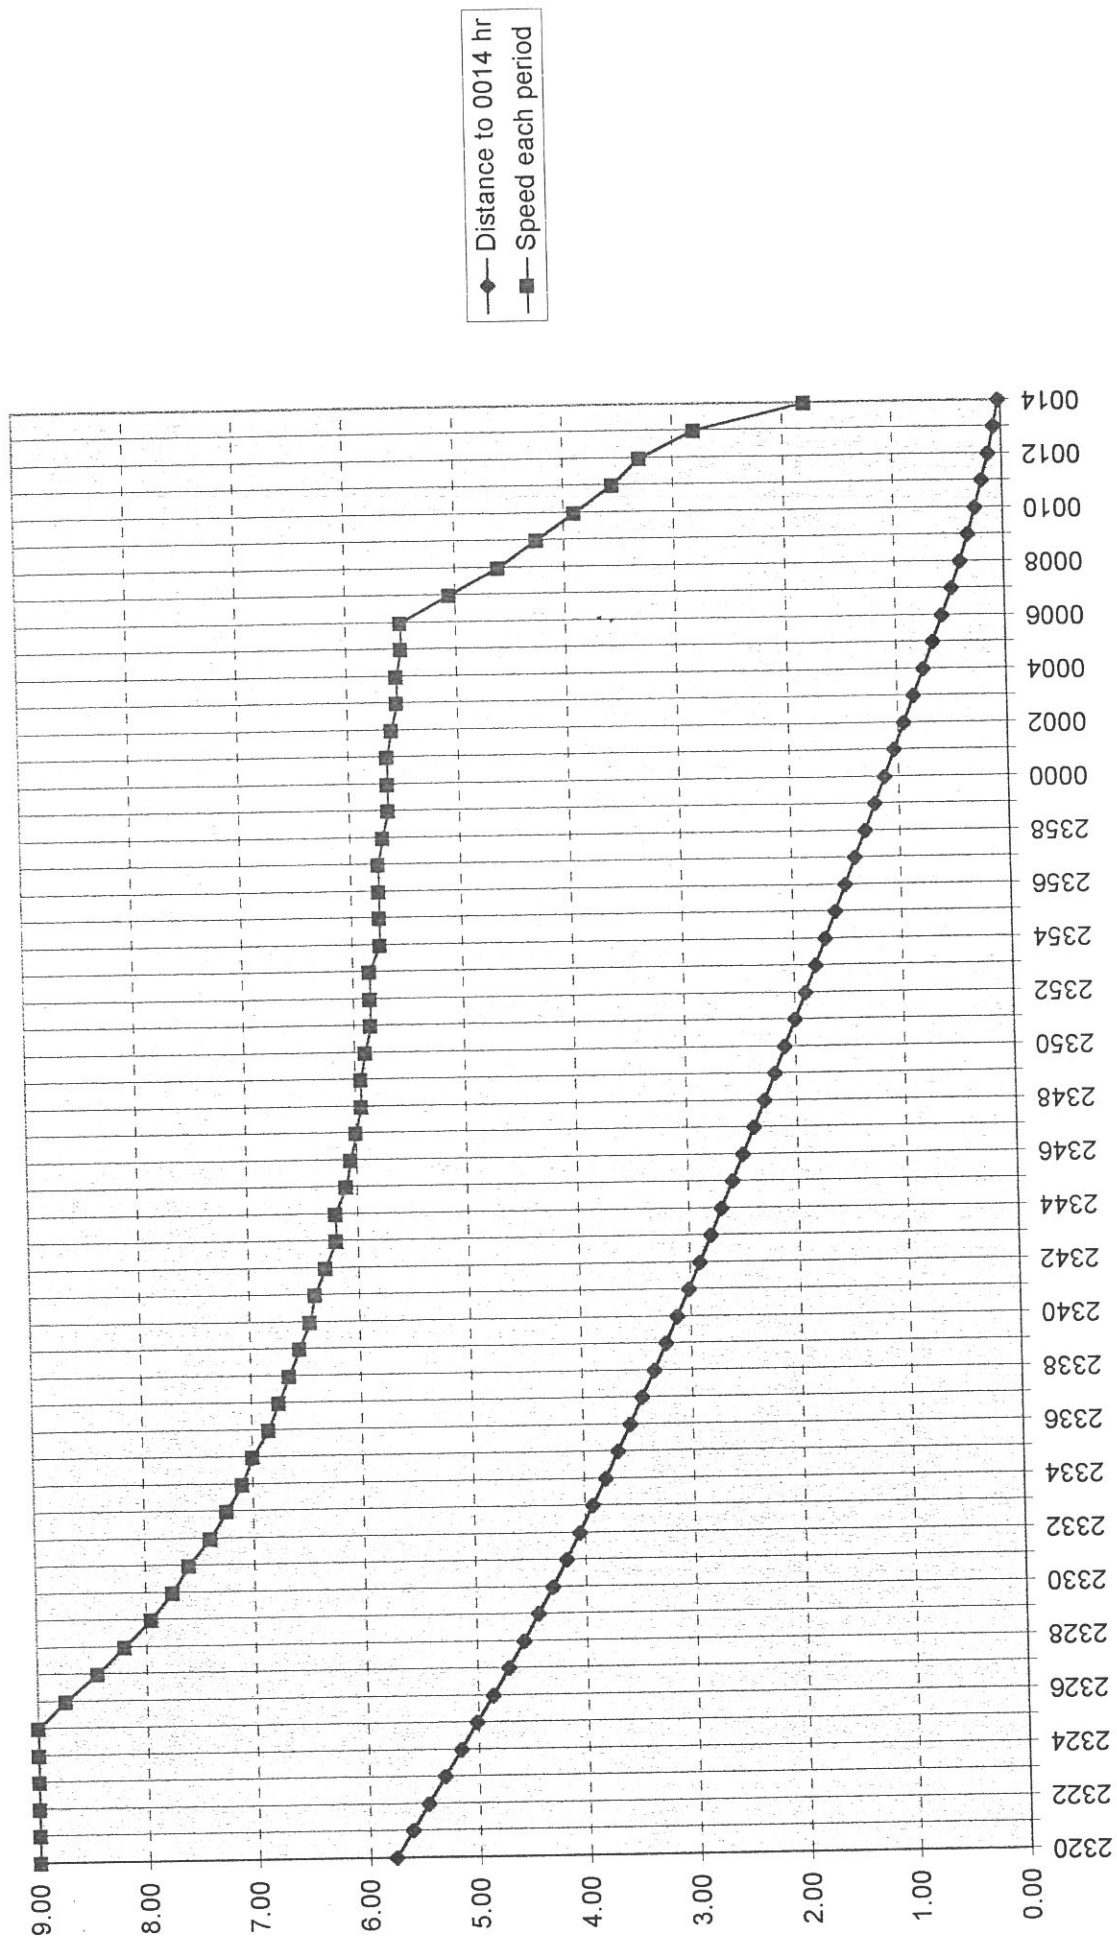
"ICEVINHA"
Speed of Vessel and Distance Steamed while Slowing Down

- 4.1.2. We estimate, based upon the speeds and engine movements given in evidence, that the distance travelled by “ICEVINHA” between 2320 hours and the collision at 0014 hours was about 5.8 miles which places the vessel, when on a course of 330° to have been just outside the northbound safety fairway which leads to the LOOP at 2320 hours.
