# **“ROYAL PACIFIC”**

## **Report of the investigation into the collision with the trawler “Teh Fu No. 51”, the subsequent flooding and sinking of “ROYAL PACIFIC”**

**on  
23 August 1992**

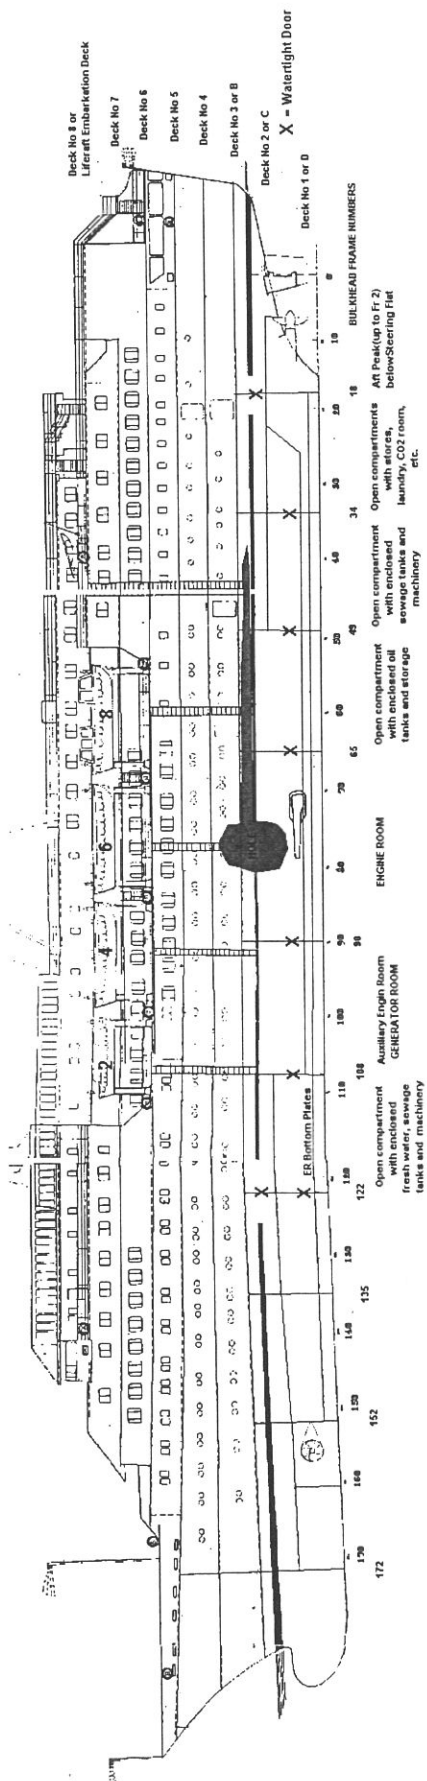
**Top:** Initial contact -Centred at about Frame No. 78, No. 6 lifeboat (Ref: Chief Officer (Deck))

- 4.6.4 Damaged plating was identified immediately above and at the water line in a direction aft from the initial contact point. The plating was bent inwards leaving a gap, into which sea water entered. The Chief Officer (Deck) stated that the gap was about 60 cms wide in way of frame No. 50 and 10 cms wide at frame No. 38. He did not consider that the damage extended aft of frame No. 34.

- 4.6.6 The attached elevations of the port side of "ROYAL PACIFIC" indicate two possible areas of damage. The upper diagram is as described by the Chief Officer (Deck) and would imply that the primary area of initial contact and flooding was the Engine room. The Engineer on watch clearly states that he saw no obvious major hull damage in the engine room. The other evidence that the compartment immediately aft of the engine room flooded so quickly that water pressure was seen ALL AROUND the newly closed "steel cover" to the watertight door No. 5 at frame No. 65, implies that the major area of initial damage was that compartment. There was further evidence that the engine room did flood quite quickly up to deck plate level. We thereby infer that there was some form of direct hull failure in the engine room shell plating which allowed some direct flooding into that compartment.

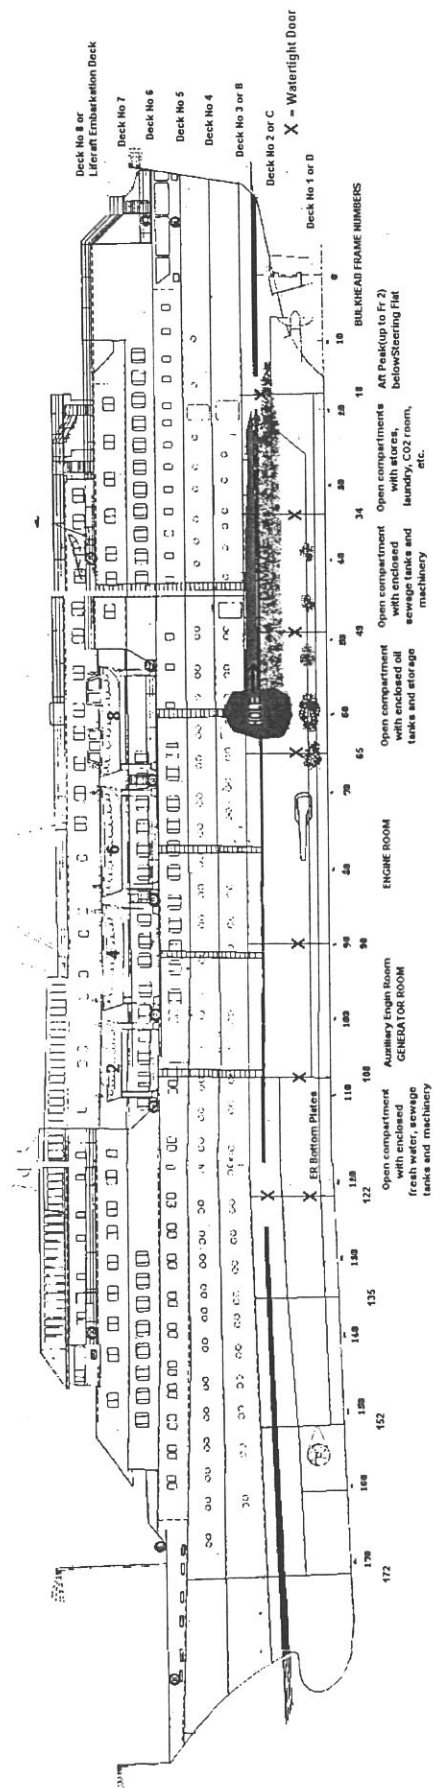
**Bottom:** Initial contact - Centred at about Frame No. 60, No. 8 lifeboat (Ref: Engineer on duty)

- 4.6.5 If, in his natural confusion, he mistook No. 6 lifeboat davits for No. 8 the damage would have extended further aft to the area of frame No. 20 or even No. 15.

Similar capacities may be obtained by omitting the engine room but adding the remaining aft compartments to simulate the effects of the damage initially centred at frame No. 60, below No. 8 lifeboat.
