**M.V SEABOURN ENCORE  
IMO NUMBER: 9731171  
OFFICIAL NUMBER: 7000860**

**Report of the marine safety investigation into a collision  
with a bulk cement carrier on 12 February 2017 at  
Timaru, New Zealand**

Marine inquiry MO-2017-204

Breakaway from wharf and collision with bulk  
cement carrier at Timaru

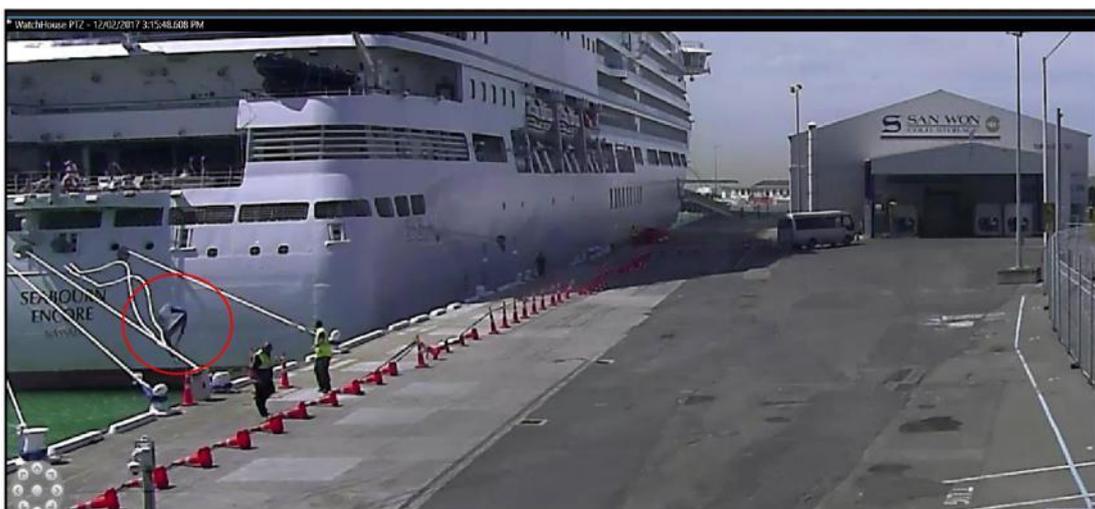
Figure 2  
Failure of bollard 26 with two mooring lines attached

- 3.1.16. Seconds later a shore mooring bollard holding a forward spring failed, rendering the mooring line ineffective. This was followed seconds later by the failure of an aft shore mooring bollard holding two stern lines (see Figure 2). Both lines became ineffective. Seconds later the bollard holding the second forward spring failed, rendering that line also ineffective.

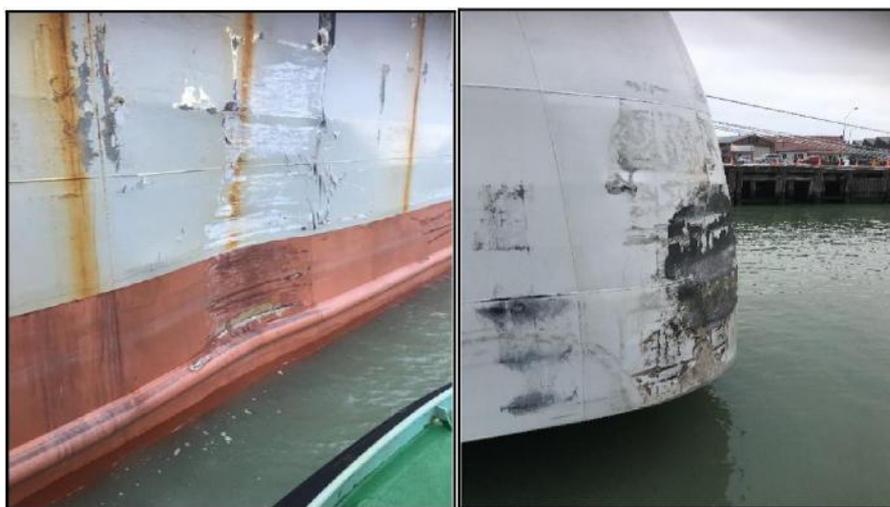
Figure 4  
Damage sustained by the *Milburn Carrier II* (left) and the *Seabourn Encore* (right)

- 3.3.1. A classification society<sup>11</sup> survey by Registro Italiano Navale was carried out on board the *Seaborn Encore* in Melbourne, Australia on 3 March 2017. The survey found that the damage consisted of a side shell indentation on the port side between frames -11 and -13 inside the marina store. The damage extended 2-2.5 m above the waterline and was approximately 1.8 m in length and 1.6 m in height. The maximum indentation was 600 millimetres (mm). An approved temporary repair was carried out using four steel brackets connecting two side shell longitudinal frames and the indented hull plating.

- 3.3.2. The *Milburn Carrier II* suffered damage to the shell plating in way of the number three top wing saltwater ballast tank. The hull was penetrated and saltwater ballast was emptying into the harbour from below the waterline. The tank was pumped dry and the damage to the shell plating rose above the waterline (see Figure 4).

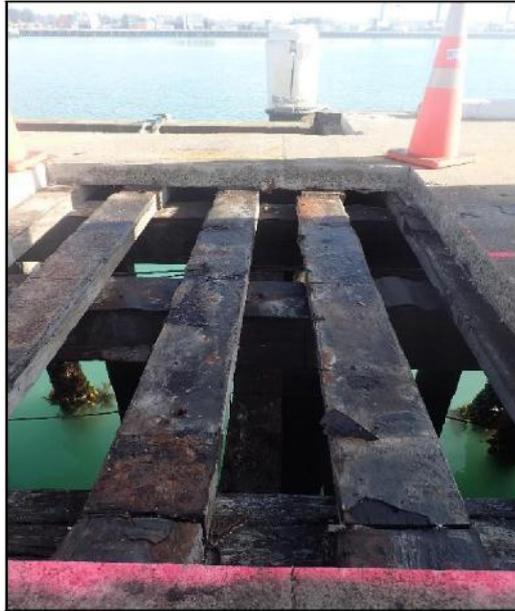
**Figure 7**  
**Number One Wharf – ‘hit and miss’ decking under concrete**

- 3.7. Number One Wharf**
- 3.7.1. Number One Wharf was constructed in 1878 and there had been a number of modifications, additions and repairs carried out since. With a length of 380 m and a width of 10 m, the wharf had been constructed using hardwood timber piles, timber beams and stringers, and more recently a 100 mm thick concrete deck had been laid over the wooden ‘hit and miss<sup>16</sup>’ deck (see Figure 7).

3.7.4. The inspection found decay in many of the stringers and beams and identified that considerable restorative work was required as a high or urgent priority. Some areas of the wharf were not to be used until restorative work was completed. The report identified a methodology with which replacement or maintenance interventions could be undertaken and made several recommendations that included:

- broken piles are replaced or repaired
- excessive decayed beams and stringers are replaced or repaired
- an inspection regime is adopted and implemented to monitor further decay across all members
- a structured management plan to end of life is progressively developed and implemented to manage residual risk and maintenance requirements
- PrimePort Timaru and Opus discuss access/inspection process for the seaward stringer, row A piles and end of beams over row A piles for future maintenance management.

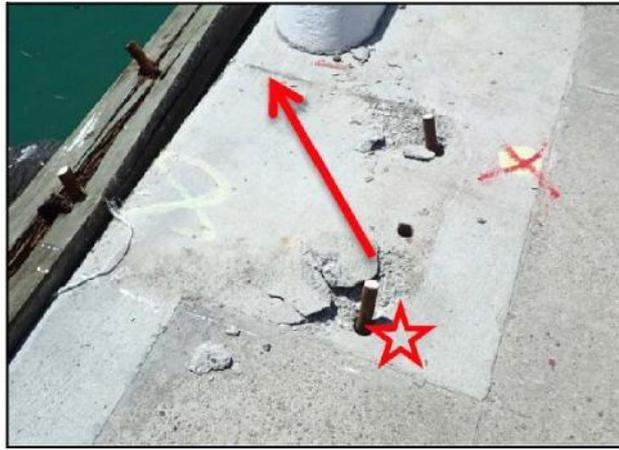
**Figure 9**  
Bollard 26 after the failure, showing the direction of mooring lines to the ship

4.2.8. About five minutes after bollard 26 failed, all the remaining stern lines parted or slipped off damaged shore bollards, with the exception of one of the stern lines that was surging on a set of mooring bitts. As the stern started to drift off the berth, additional load came onto the two aft spring lines and within one minute one of the spring lines had parted and the second had slipped off a bollard that had failed. The stern was now free to drift across the harbour towards Number Two Wharf.

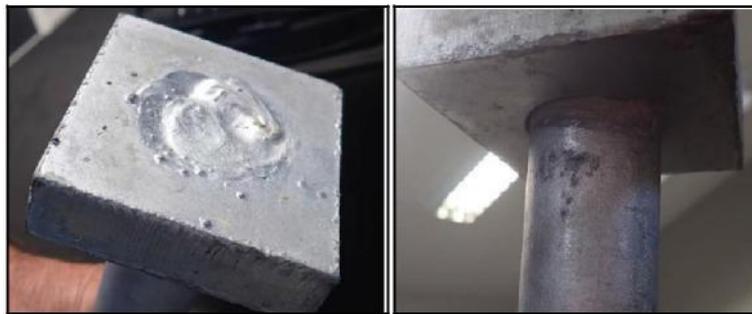
**Figure 10**  
The top (left) and bottom (right) welded bolt head plates, same design used to secure bollard 26

4.3.11. The metallurgical analysis confirmed that there was no significant loss of section due to corrosion, but that the shearing had occurred at the weld material, which had a total area of about half the cross-sectional area of the bolt shank. The welded head had therefore become the weakest point in the securing arrangement (Figure 10).

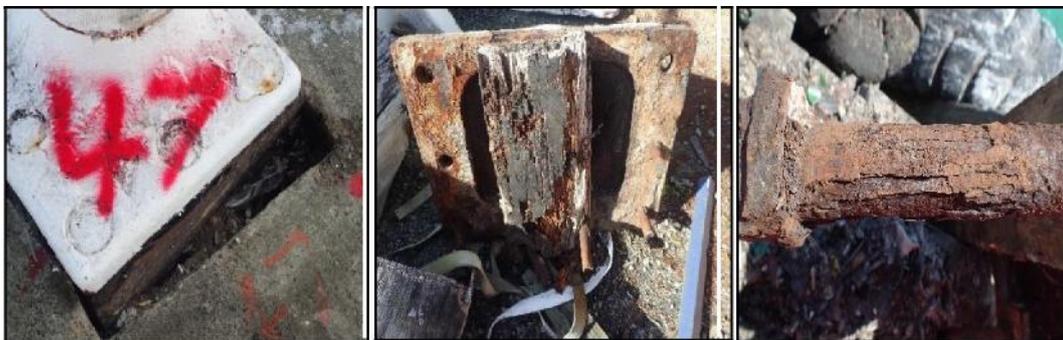
**Figure 11**  
Decaying timber and corroded bolts supporting bollards 47 (left) and 46 (centre and right)

4.3.15. Another factor was that some bollards were secured through decaying timber at the face of the wharf (Figure 11), which was the weakest point in the securing arrangement. The load on the mooring ropes was transferred to the bollard securing bolts that passed through the supporting timber structure. The timber was unable to withstand the loads being applied and gave way, causing the bollards to fail.

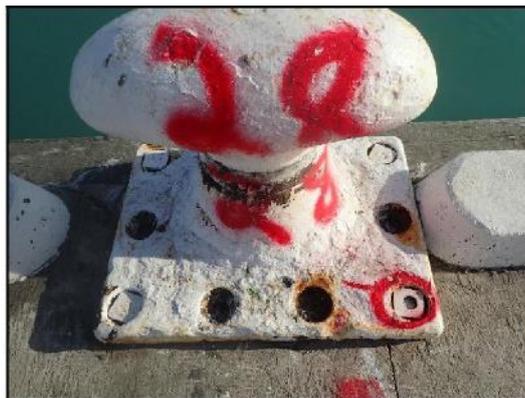
Figure 12  
Underutilisation of the bollard securing arrangement

4.3.16. Another factor was the inconsistency in how bollards were secured. There were a number of different bollard designs and securing methods in use. No bollard contained the maximum possible number of securing bolts and the bolt head design for securing them was inconsistent (Figure 12). As a consequence, the bollards were not secured in a way consistent to achieve their designed safe working load, making it virtually impossible to establish a known safe working load for each.
