**The Bahamas
Maritime Authority**

M.v. Solent Star

**Report of the marine safety investigation into a
fatality on a Refrigerated Cargo vessel on 1 May 2018**

Date of Issue: 06 March 2019
Bahamas Maritime Authority
120 Old Broad Street
LONDON
EC2N 1AR
United Kingdom

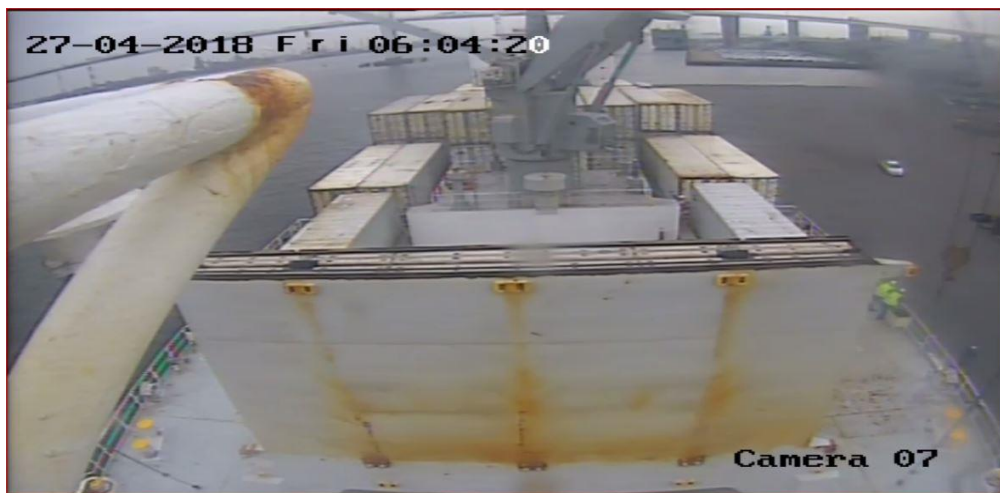
Figure 3: Position of crane after the motor was burnt

- 4.1 On 27 April 2018, at 1320 hours while the vessel was in Nagoya conducting discharging operations, the main pump motor of crane no. 1 was burnt due to short circuiting.
- 4.2 The crane was at an angle of 45-degrees to port when the motor failed. (refer to figure 3)

- 5.2.1 The motor of the main pump of the crane no. 1 was burnt out due to a short circuit which occurred while discharging hold no. 1 at the port of Nagoya on 27 April 2018 at 1320 hours.

- 5.2.2 The crane was at a 45-degree angle to port at the time the motor failed (refer to figure 3).
- 5.2.3 The crane was rotated manually to move the jib above the seagoing stowage position. The hydraulic oil was then released from the luffing rams and the jib descended under its own weight into the jib support, where the jib is located when the vessel is at sea. Subsequently the jib was secured. At the time of the incident, the crew were attempting to lift the jib from its seagoing stowage position.

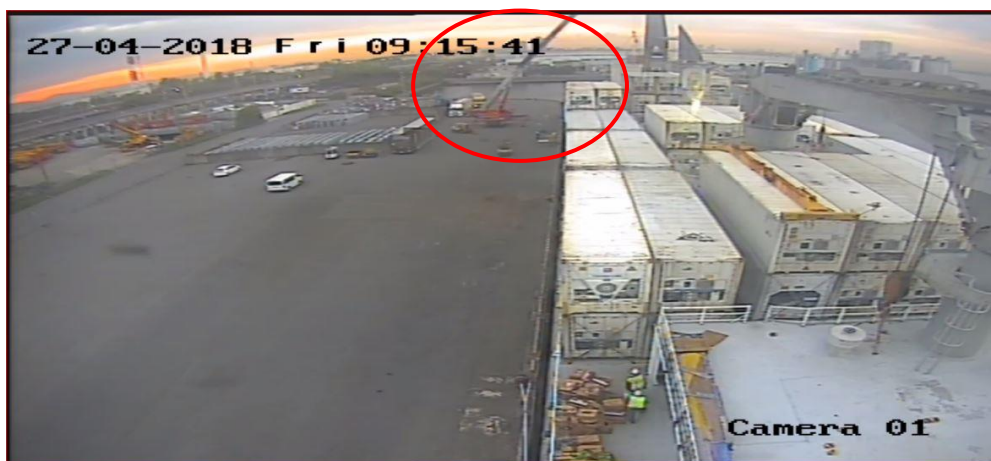
Figure 4: Shore crane used for cargo operation

- 4.2 The loading operation was completed using the shore crane, as there was no spare motor available onboard to replace the faulty motor of crane no. 1.

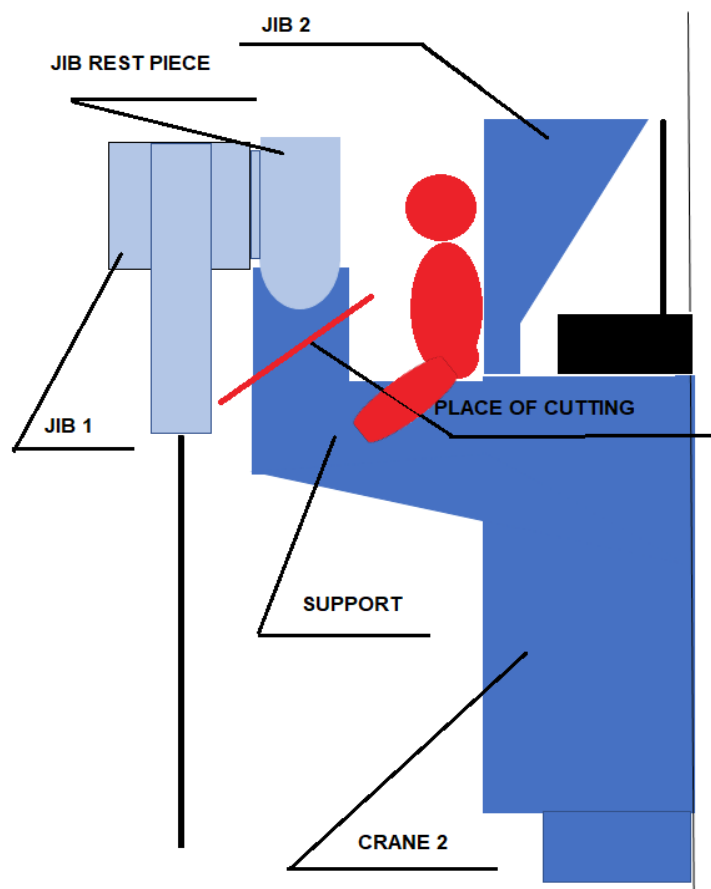
Figure 5: Location of the fitter

- 4.8 To move the crane no. 1 jib, the Master authorised to cut the jib support plate of crane no. 1. The side to cut was chosen towards the intended direction of the crane to be moved. Subsequently, the Fitter was tasked to cut the jib support plate of crane no. 1 by gas cutting the plate diagonally. The Bosun was tasked to operate the crane no. 2 and was inside the crane cabin, while the AB was assisting the Fitter on the crane platform.

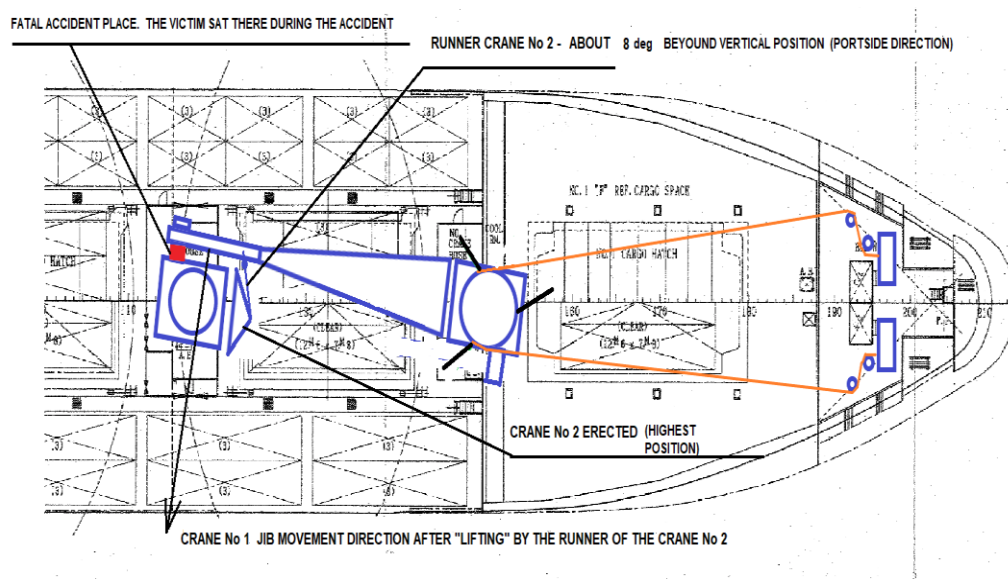
Figure 6: Illustration of the cranes position and Fitter's location

- 4.15 At 1712 hours the Chief Officer instructed the Bosun to not do anything with the crane.
- 4.16 At 1717 hours shortly after the gas cutting operation was complete, the Chief Officer instructed the Bosun to operate¹ the crane. The Bosun hoisted the crane no. 2.

- 4.17 The hoisting of the crane developed some movement and since the jib support plate had already been cut, the jib moved off the jib support and the Fitter was

struck by crane no. 1 between the two structures of crane no. 1 and crane no. 2. The impact led to Fitter's instantaneous death.

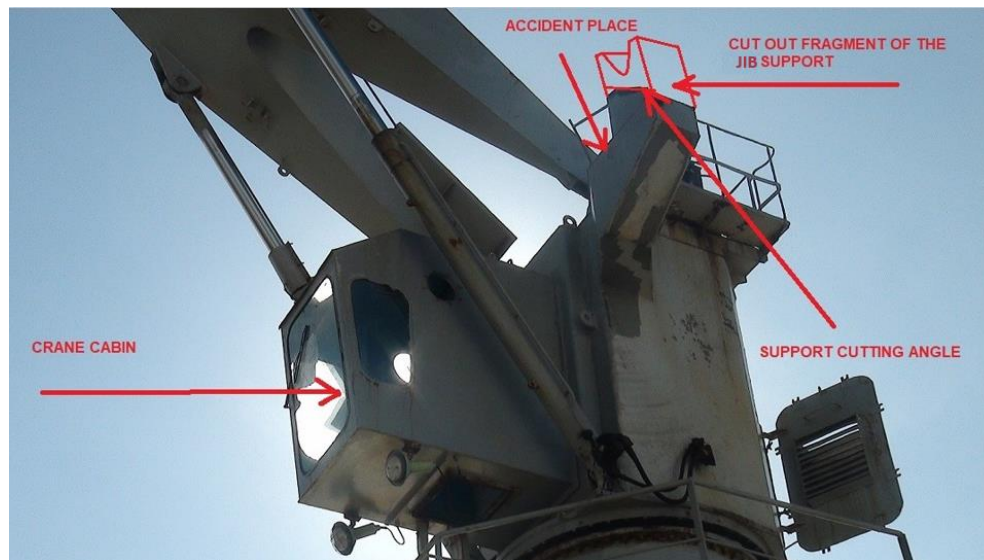
Figure 5: Illustration of the crane cabin and accident place

- 5.4.7 The permit to work for work aloft/over the side and hot work was completed before the work activity was initiated. However, no hazards were identified specific to the work activity which involved a combination of identifiable hazards relating to the Fitter working in between the two structures of crane no. 1 and crane no. 2.

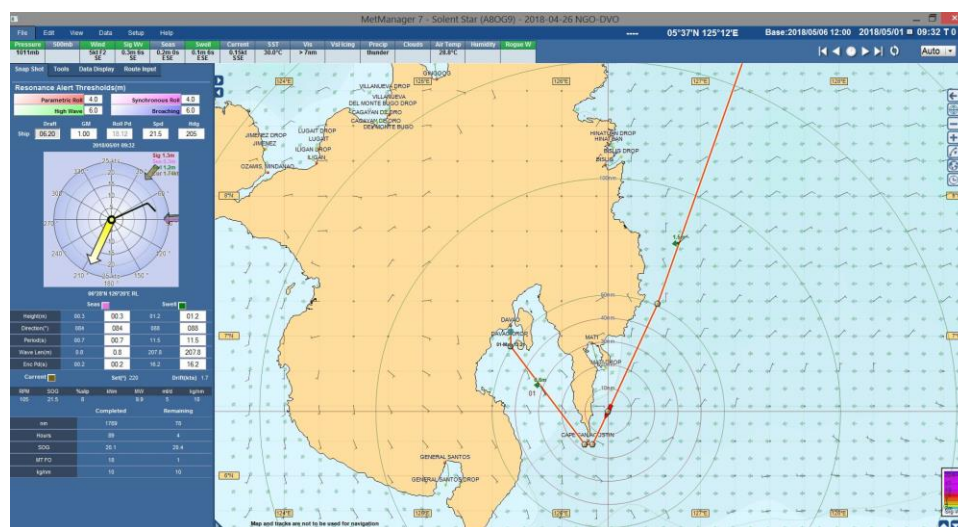
Figure 7: Weather report screenshot

5.6.1 The weather was calm at the time of the incident. Therefore, the weather or any other unexpected movement of the ship was not a contributory cause of the incident.
