M.v. Skandi Pacific

**Report on the marine safety investigation into a
fatality aboard an offshore supply vessel on
14 July 2015**

M.v. Skandi Pacific – Marine Safety Investigation Report

Date of Issue: 12 December 2018
Bahamas Maritime Authority
120 Old Broad Street
LONDON
EC2N 1AR
United Kingdom

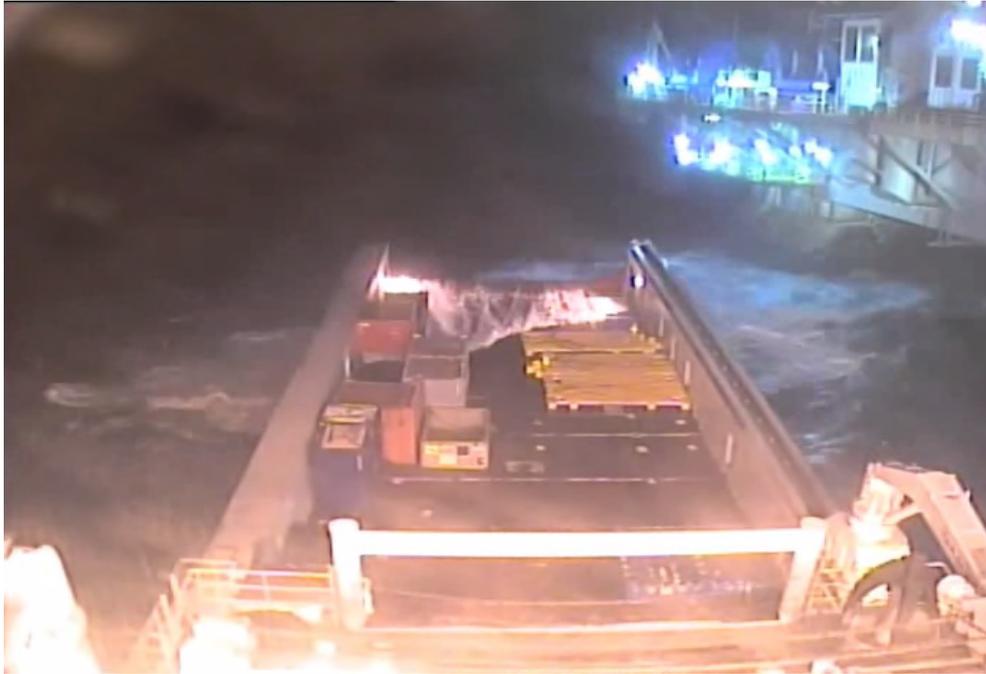
- 4.13 At 0140 back loading of containers from Atwood Osprey commenced but as the operation continued, the weather deteriorated with the occasional water shipped on deck due to heavy swells. At 0400 the recorded sea state was 5 (wave height 2.5 – 4m or rough seas) and by 0502 the vessel pooped⁵ heavily as increasingly larger waves shipped over the aft deck.

Figure 4: CCTV image of deck at 0502 hours

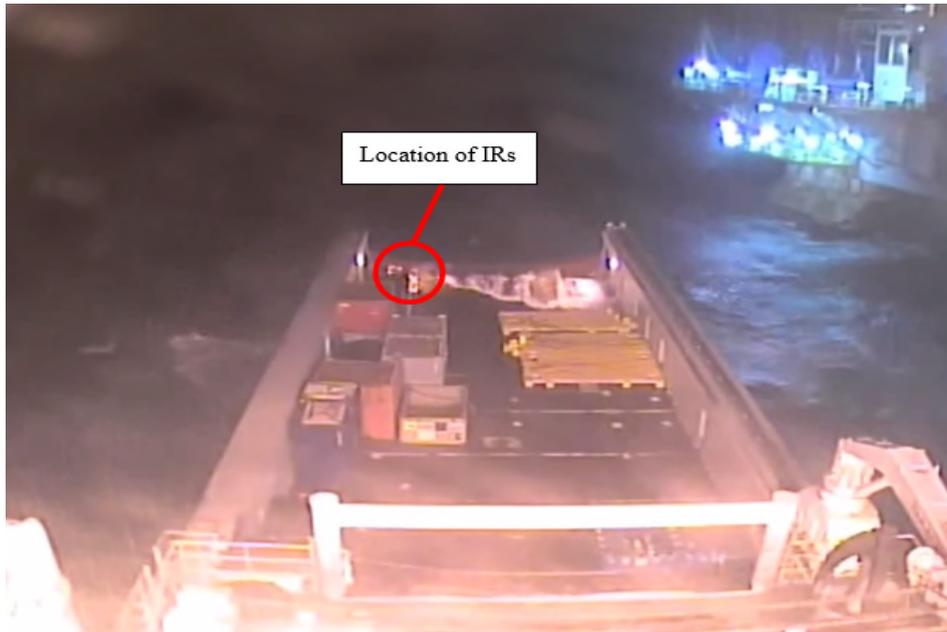
- 4.17 Both Integrated Ratings secured cargo on the port side using chains running from the stern crash barrier rail, around the cargo platforms and tightening it with the port tugger winch⁷. This initial task was complete at 0511 while water continued to ship on deck. They then moved to the starboard side at 0512 to lash the cargo stow which consisted of open top, mini and sea containers. Shortly after a wave shipped over the transom from aft of the vessel at 0519 (See Figure 5).

Figure 5: CCTV image of the deck at 0519 hours and IR's location

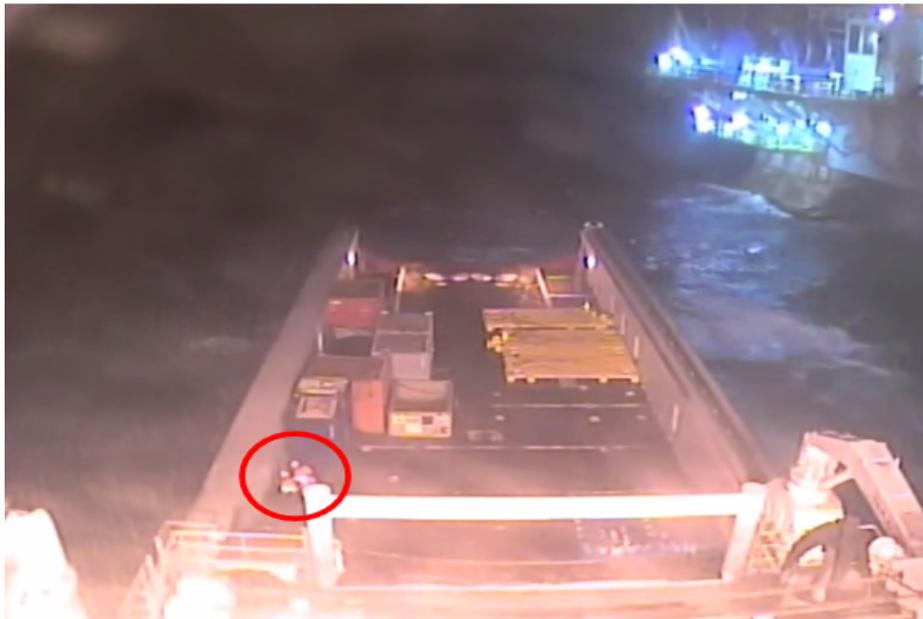
- 4.18 After securing backloads on the starboard side at around 0520 the two Integrated Ratings noticed that the fastening arrangement of the 2 mini-containers located on the starboard side forward were “loose” and decided to use a smaller secondary chain shackled to the primary chain to create a locking point around the 2 mini-containers.

Figure 6: CCTV image of deck at 0520 hours: Both IRs are near mini containers

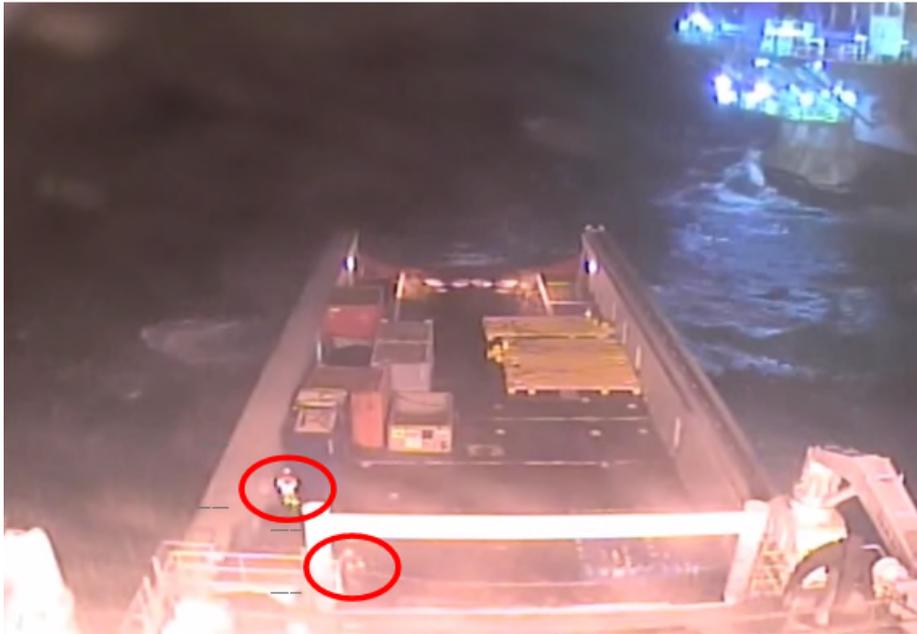
- 4.19 In order to execute their plan, the primary chain first needed to be slackened by paying out the tugger winch⁸. At 0522, the Integrated Ratings began preparing the secondary chain to connect to the crash rail whilst one of IR went to the deck store to get the shackle.

Figure 7: CCTV image of deck at 0522 hours: positions of IR's marked

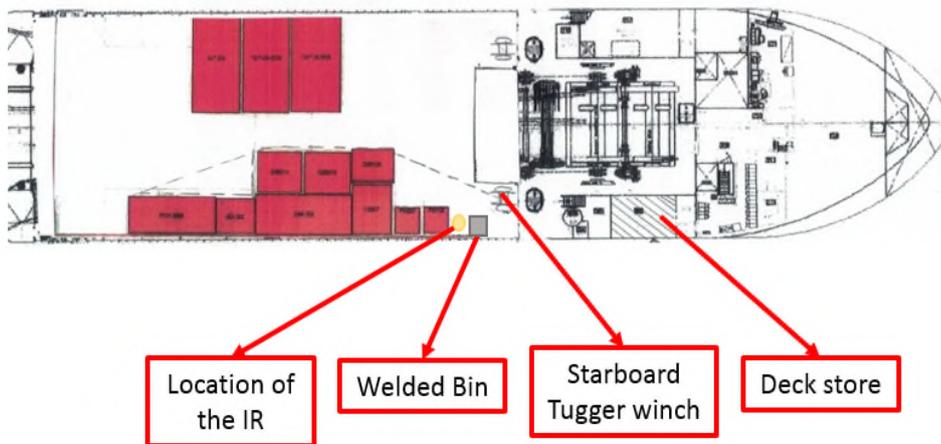
4.20 The second IR was standing inboard of the slackened primary chain, in between the mini-container and welded skip bin (Figure 8).

Figure 8: Aft deck plan

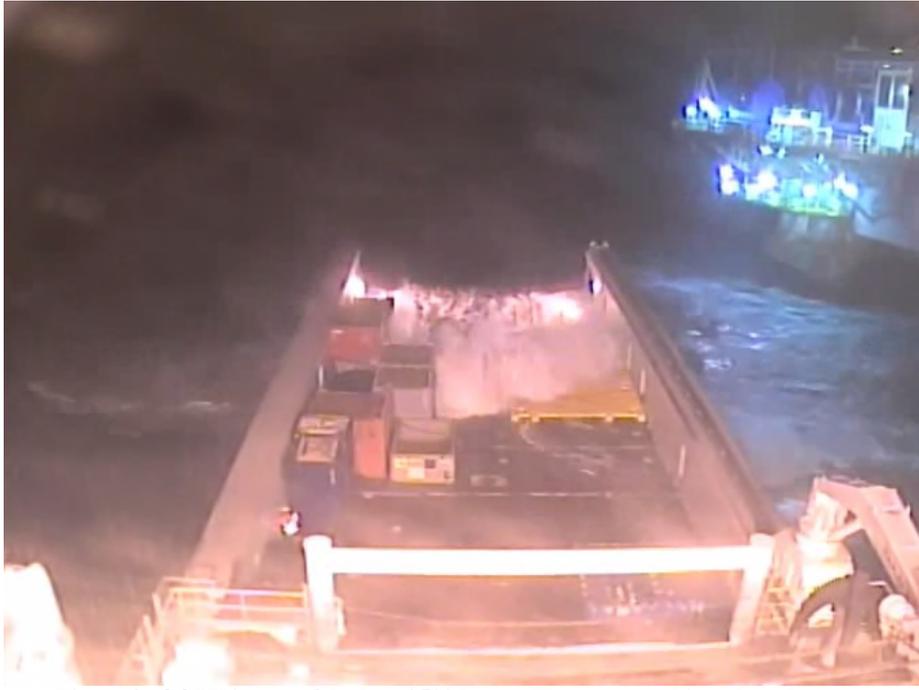
4.22 At 0523, a large wave shipped over the transom (see Figure 9) and the Chief Officer who witnessed the shipped seas gave a warning to the Integrated Ratings to “*watch out, water on deck*” via UHF radio.

Figure 9: CCTV image of deck at 0523 hours: Heavy wave shipped on the stern

- 5.4.3 From 0450 till the time of the incident the water was consistently shipped on deck due to the heavy swell. Two successive waves broke over the stern between 0502 and 0503 as the vessel pitched heavily. Adverse weather conditions are referenced in the company Cargo Securing Manual which is based on best practice in the offshore industry. The guidance uses the following text: *'always stop work in adverse weather conditions'* without expanding more clearly on the defined weather and sea parameters for cargo operations. No warning to stop cargo operations was provided to the IR's working on deck which indicate that from the perspective of the Chief Officer, the weather was not adverse enough to cease cargo operations.

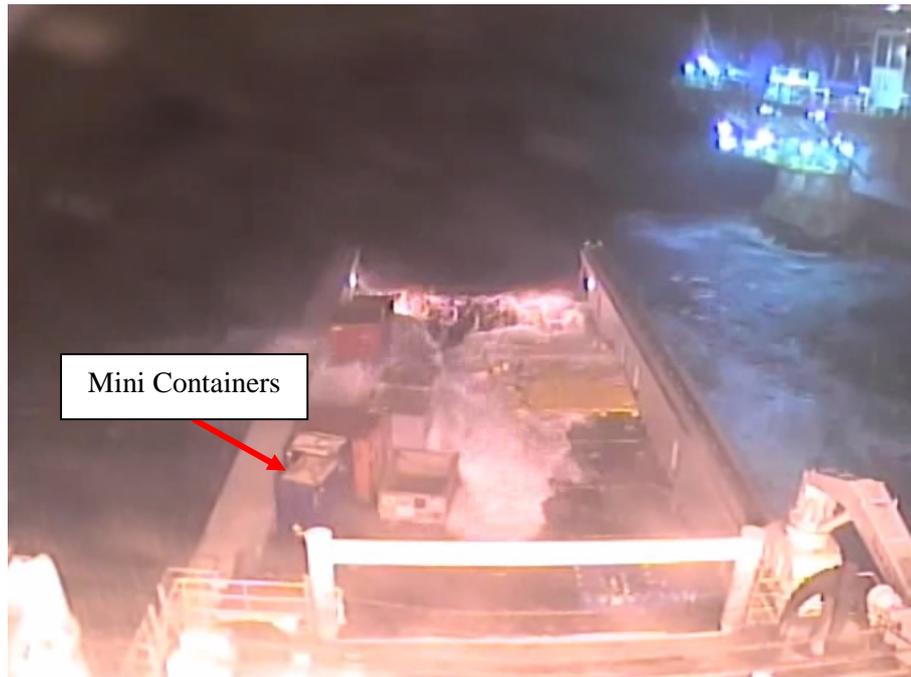
- 4.23 As the primary chain was already slacked and due to the water ingress, the unsecured cargo shifted, trapping the IR between the forward mini container and skip bin. The impact resulted in him sustaining severe injuries.

Figure 10: CCTV image of containers moved due to the water force

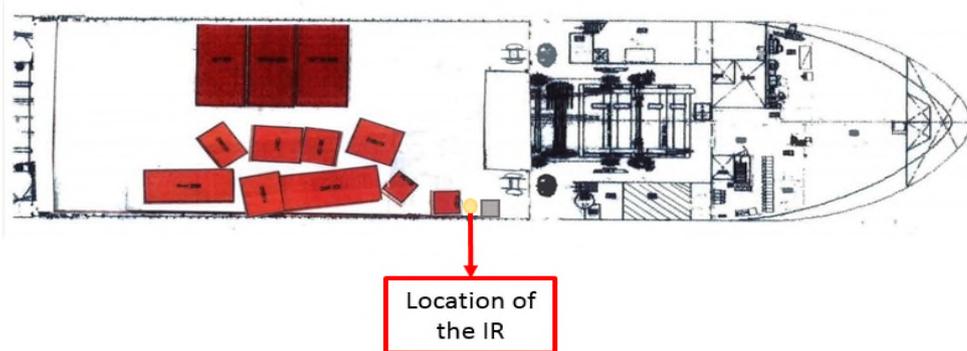
Figure 12: Location of IR immediately after the incident

- 4.24 The IR returning from deck store heard the Chief Officer's warning of the water on deck on UHF radio. The injured IR had the VHF radio and the IR returning from deck store had the UHF radio.
- 4.25 The IR returning from the deck store observed the situation and immediately reported the incident to the Chief Officer who came on deck and observed that the injured IR was trapped between a mini container and a welded skip bin.

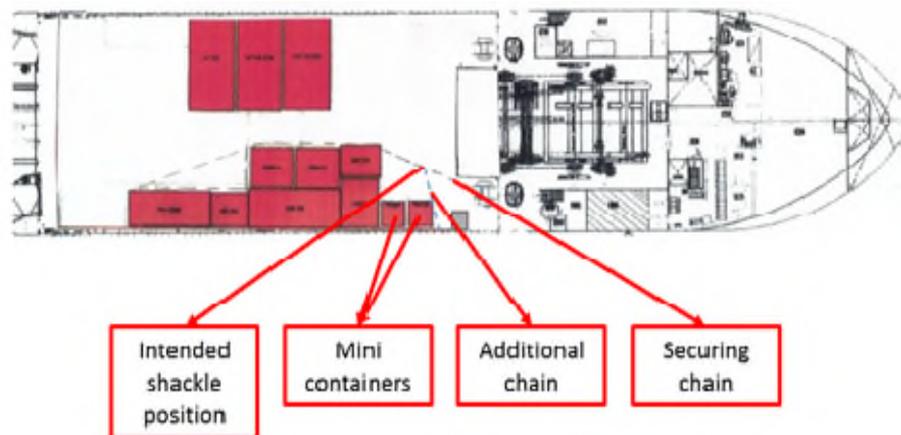
- 5.1.6 While checking the starboard side cargo, the Integrated Ratings found that the fastening arrangement was inadequate to lash the two mini-containers at the forward end of the aft deck. The Integrated Ratings decided to use additional rigging by means of a smaller secondary chain to secure them. Their intended plan was to place the smaller chain around the tugger wire and secure the chain to the crash barrier rail using a shackle to tighten it in order to create a locking point around the mini containers. To carry out this plan, the tension on the tugger winch was slackened, leaving several containers unsecured.

Figure 14: Securing arrangement and shackle position to secure mini containers

- 5.1.7 One of the IR went to the deck store to get the shackle for the chain while the other remained on deck, standing inside of the lashing chain, in between the mini-container and bin skip. A large wave shipped along the length of the deck, shifting the cargo on deck from aft to forward by 3-4 m. On the bridge, the Chief Officer visually sighted the large wave strike at 0523 and broadcasted a precautionary alert via UHF for the men to “*watch out*”. The crewmember on deck and securing the cargo did not have a UHF radio and instead was carrying a VHF radio. The IR who left the scene to proceed to the deck store carried the UHF radio and heard the warning but was not in a position to relay the message before the impact of the wave against the unsecured cargo.

- 7.1 Review the vessel's operating procedure to ensure specific guidance to identify hazards relating to cargo handling operations in adverse weather conditions is encompassed.
