**The Bahamas
Maritime Authority**

M.v AMAZON
IMO Number: 9138616
Official Number: 732165

**Report of the investigation into a crew
fatality during an abandon ship drill on the 12th April
2016**

Date of Issue: 14th September 2016
Bahamas Maritime Authority
120 Old Broad Street
LONDON
EC2N 1AR
United Kingdom

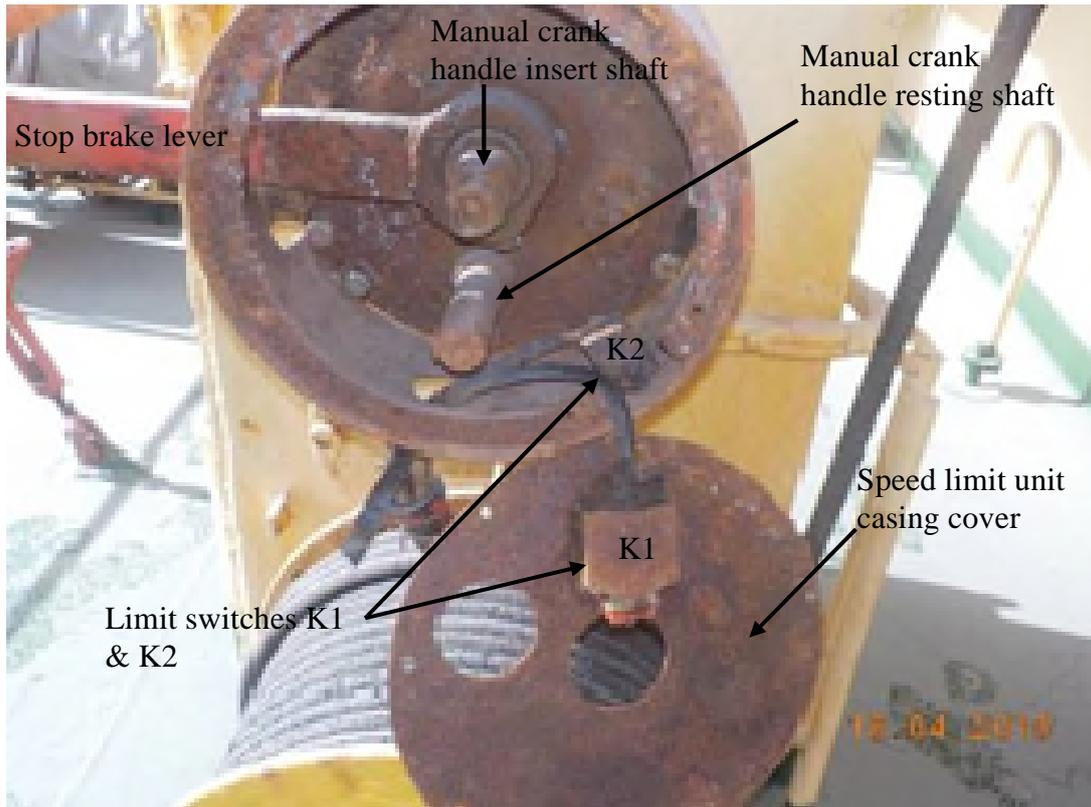
Figure 4: View of speed limit unit with face cover removed

K2 was found dismantled from the designated position in the speed limit unit, rendering the limit switch out of order. Although the mechanical part of the limit switch was still functional, the electrical connection to the motor's power supply network was absent. The inspection further confirmed that the manual crank-handle had its mechanical safety interlock (racket-pawl mechanism) compromised in way of the safety pawl (pin) spring brake which is designed to prevent reverse rotation of the handle during hoisting.

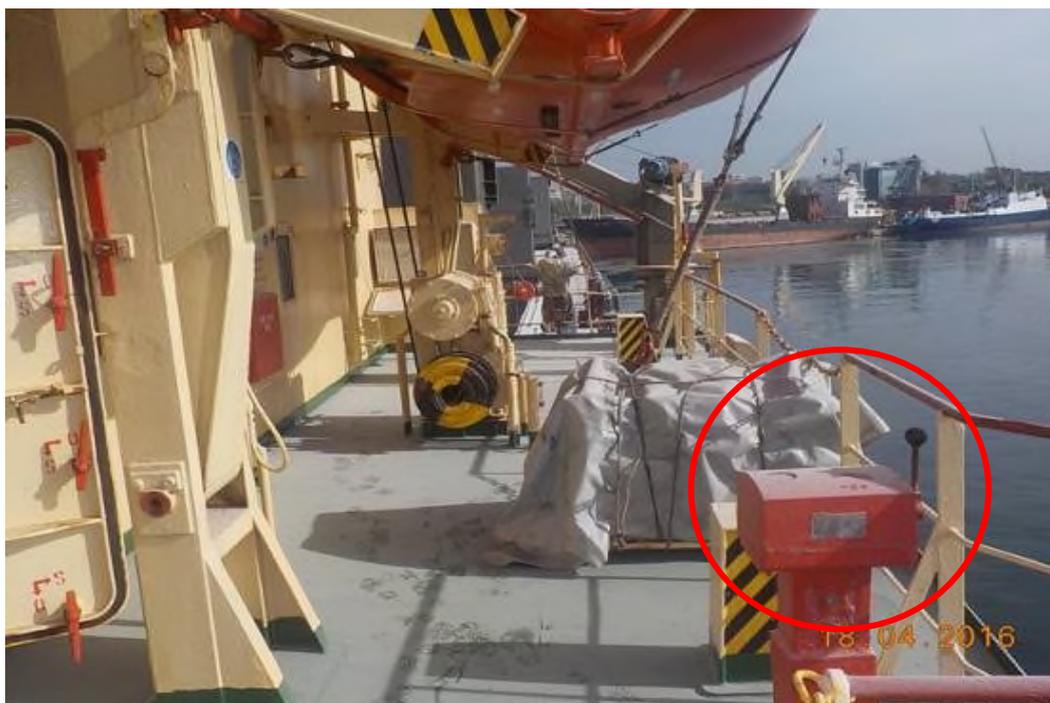
- 1.3 The master control speed selection lever was initially engaged for a slow speed recovery, however due to there being no power available to the winch motor the speed selection lever was redundant up until the power was restored, at which point the motor rotated at a speed previously selected by the speed selection lever.

Figure 5: Master controller with hoist speed selection lever (circled)

- 3.14 The 2nd Officer, who returned on deck after failing to find the Electrician, found the master control speed selection lever engaged and returned it to the neutral (middle) position moments after the casualty. The handle had stopped rotating on completion of two (2) to three (3) full rotations.

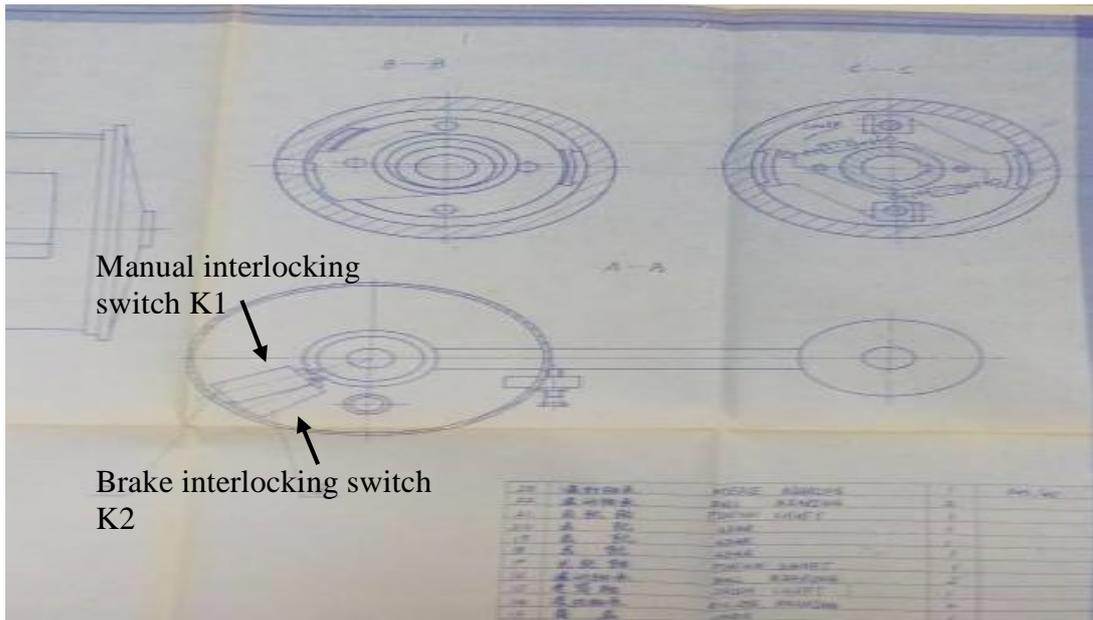
Figure 6: Schematic of the safety-interlocking limit switches K1 & K2

- 4.3.3 Subsequent to the casualty, an inspection of the vessel’s starboard lifeboat winch was conducted on the 19th April 2016 in Constanta by local service provider²¹ who verified that the manual interlocking limit switch K1 was inoperable and in a poor state of repair. The brake interlocking limit switch

- 4.4.5 The worn-out condition in which the limit switches K1 and K2 were found, and the application of hardwiring (in the switchboard) to bypass their design function, is an indication of a temporary solution established to override the operation of the safety features of the system. No replacement parts were ordered to replace the existing faulty limit switches; the electrical bypass of the limit switches was a solution that alleviated the problem caused by their occasional malfunction.

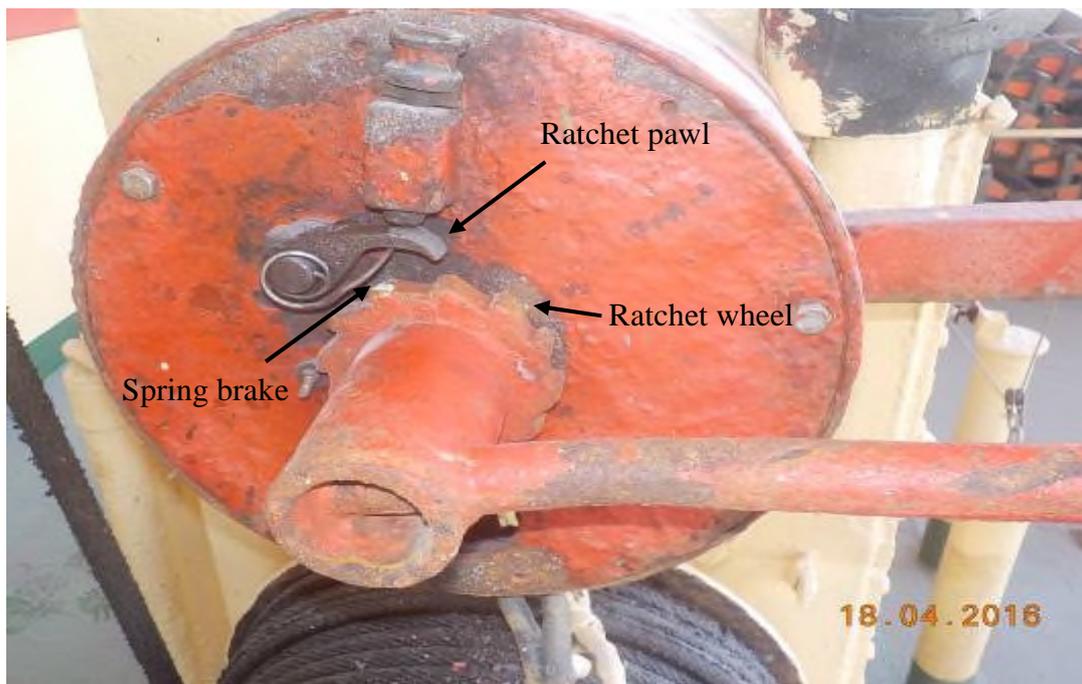
Figure 7: Ratchet pawl mechanism

- 4.3.2 Apart from the electrical safety interlocks (limit switches), neutralization of the mechanical safety mechanism installed on the manual crank-handle ratchet wheel¹⁹, to avoid reverse rotation of the handle during hoisting, was also identified. The compromise of this mechanical safety interlock²⁰ is not considered a contributory factor to the accident but is indicative of the lack of safety culture and the unsafe practices followed.

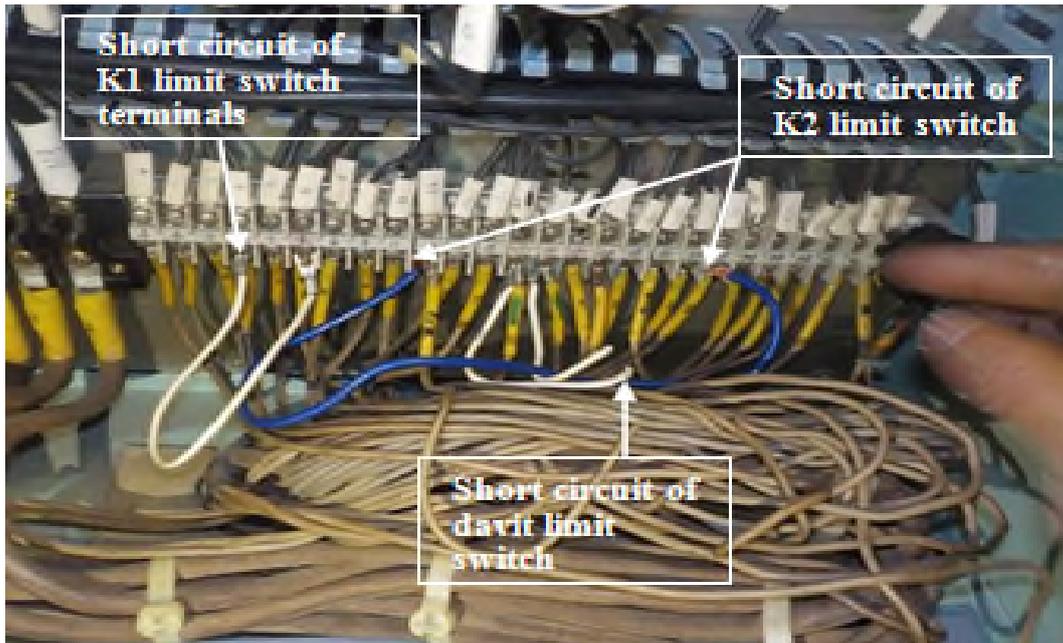
- 3.11 The Electrician reportedly found the starboard winch switchboard turned off (circuit breakers were down). Upon opening the board's casing, he found a connector (short circuit) between the winch control terminals bypassing the manual interlocking limit switch K1 (which cuts-off the power supply to the winch motor when the manual crank-handle is inserted for hoisting). Another connector (short circuit) was found bypassing the davit arm limit switch (which cuts-off the power to the winch motor when davit arm is fully retracted).

- 3.12 The Electrician determined by several measurements that the cause of the winch power failure was the activation of the brake interlocking limit switch K2, which cuts-off the power supply to the winch motor when the stop brake is released (i.e. when the hand brake lever is raised). In order to neutralize the action of the K2 limit switch, the Electrician installed a further connector in the switchboard bypassing its terminals. Immediately thereafter, at 1205, the Electrician turned on the main switch providing power to the winch controller.

Figure 8: Starboard winch switchboard with pre-existing white cable connectors (short circuit) and the connector fitted by the Electrician (blue cable) bypassing the K2 limit switch to restore power to the winch motor controller.

- 4.2.3 According to the vessel’s Electrician, the bypassing of the safety interlocks took place prior to the annual lifeboat inspection on the 23rd February 2016 carried out by TENME. The investigation was not able to determine the exact time the bypass was applied or who had applied the bypass in the switchboard affecting the limit switches.

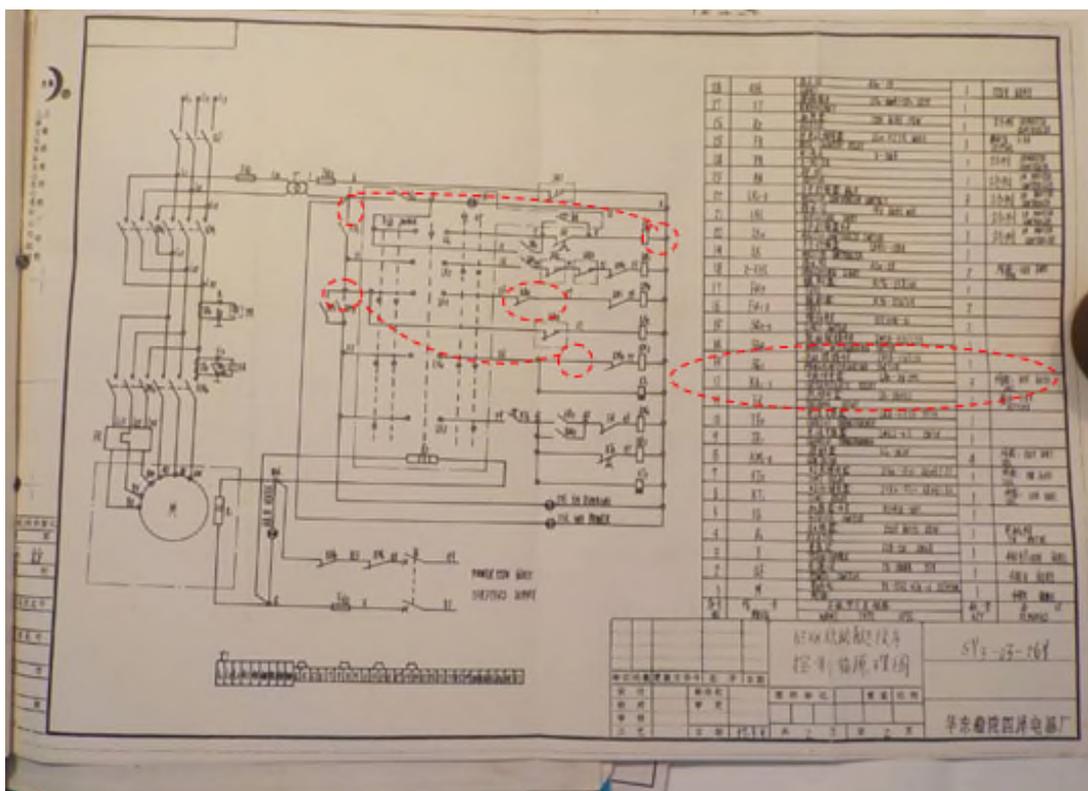
- 4.2.1 It was determined during the course of the investigation that a number of electrical and mechanical safety interlocks on the starboard davit winch system had been intentionally compromised in contravention to SOLAS Chapter III Regulation 20.2¹⁷ and procedures established under section 8 of the ISM Code.
- 4.2.2 In particular, the starboard winch circuitry in the switchboard located in the A/C Room was found non-conforming to the electrical circuit drawings by way of the installation application of direct connectors (short-circuits) fitted to the terminals of limit switches cutting-off the power supply to the winch motor. The short-circuits deactivated the limit switch safety interlocks designed to prevent the winch from rotating when electrical power is applied.

Figure 9: View of the electrical diagram indicating short-circuit contacts on the starboard winch motor power supply

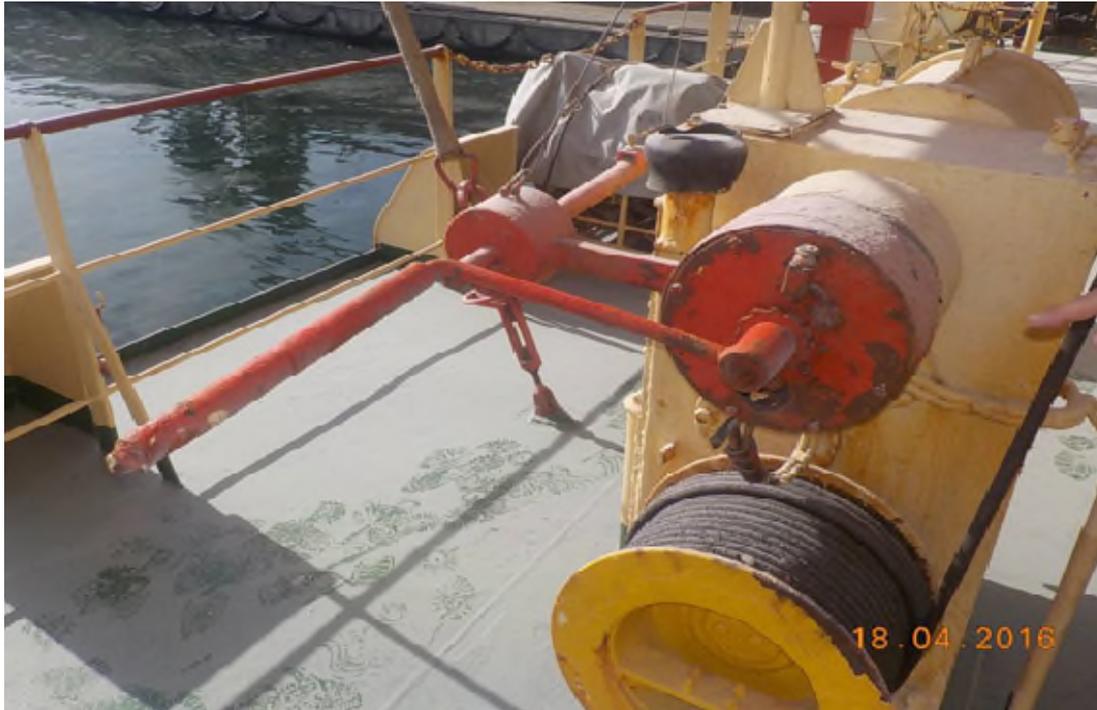
- 4.5.3 The investigation determined that none of the crew involved with the drill fully understood how the safety interlocks (limit switches) of the winch worked. This could be attributed to the presentation of information used in the manufacturers' instruction manual and on notices inside the lifeboat, which despite being in English were clearly not very well understood by the crew. Further, there were no markings/special notices or instructions in the vicinity of the launching appliances (winch, davit and the master controller) illustrating the purpose of the various controls and the procedures for operating the appliance (lowering and hoisting, both under power and manual handling). More importantly, posting of warning notices at the winch and master controller starter boxes drawing attention to the various hazards that may occur during the lifeboat lowering/recovery operations were not present.

Figure 10: Winch motor and manual crank-handle devoid of warning notices, operating procedures and hazard identification

- 6.1 The operator should consider a review of the Safety Management System with respect to winch assembly and davits to ensure inspection and verification procedure sufficiently identifies faults with the winch assembly and interlocking limit switches.
- 6.2 The operator should ensure that safe operating procedures and potential hazards are displayed prominently in vicinity of the master controller and winch assembly unit to highlight safe and proper operation of the appliance.
- 6.3 The operator is to ensure the vessel operating procedure (VOP-S-07) is reviewed to incorporate specific guidance and instruction, including identifying associated typical hazards and safeguards relating to the recovery of both lifeboats.
- 6.4 The operator should consider reviewing the process of instructing the crew on relevant safety matters prior to conducting any drill.

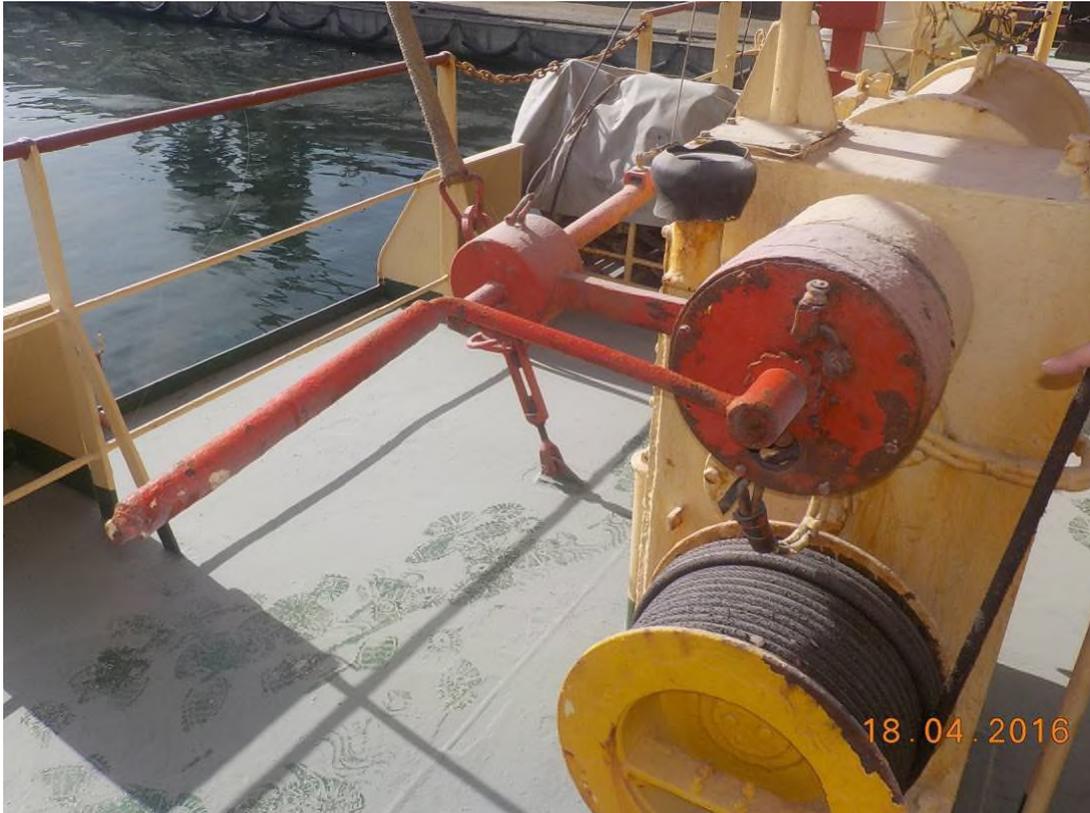
- 3.13 The electric motor of the starboard lifeboat winch started rotating immediately after the power was restored at the switchboard. The manual crank-handle, which was still installed in the manual cranking position, also started rotating. Due to the location of the Bosun and the Oiler at the time the winch came under power, the crank-handle hit the Bosun on the base of the skull and struck the Oiler on the right side of his hip.

Figure 13: Winch assembly unit and manual crank-handle

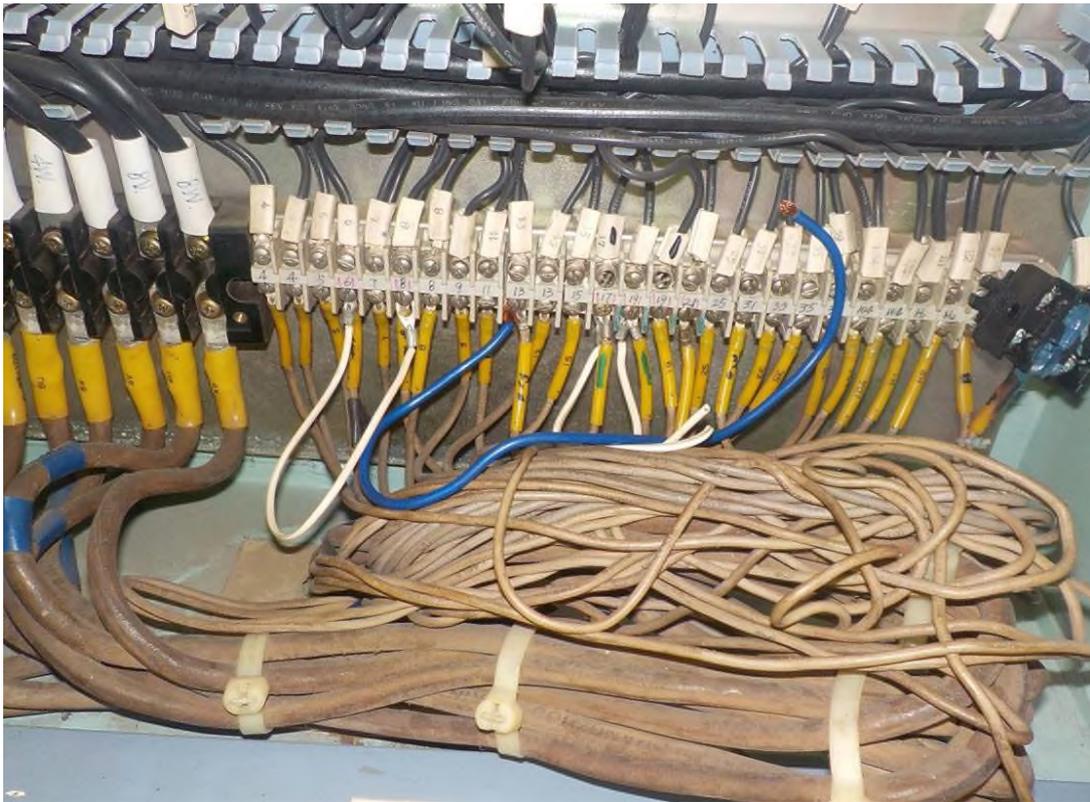
Figure 17: View of bypass connections within switchboard
