**The Bahamas  
Maritime Authority**

**“BRAEMAR”**

**Report of the investigation into  
Entrapment of Fourth Engineer in Engine Room  
Watertight Door**

**26<sup>th</sup> August 2009**

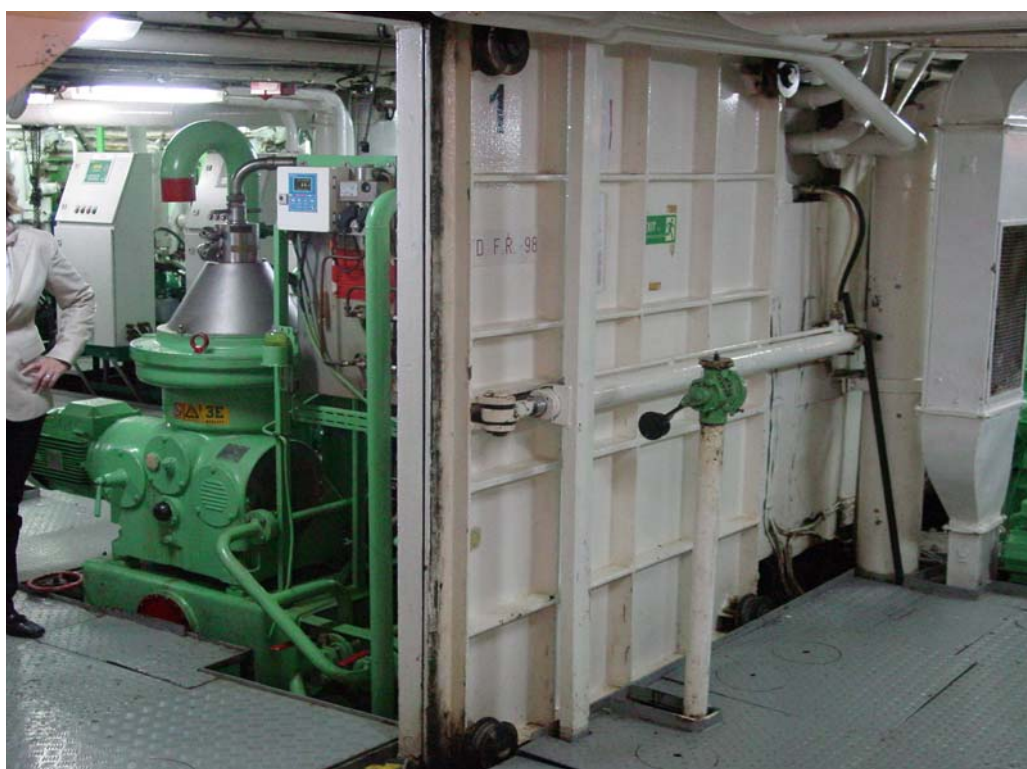
- 4.8** Watertight door No 1, in which the Fourth Engineer was trapped, is typical of these doors – see photograph below. They are conventional side-rolling electro-hydraulically operated doors, fitted with a local electric switch (“Switch 1”), a local control lever (“Lever 1”) and a hand pump for emergency operation, in the event of power failure.

- 4.38** There was no evidence to indicate any malfunction of No 1 watertight door at the time of the incident. The fact that the Fourth Engineer was trapped indicates that he did not follow the practice in section 4.35 above; the known facts indicate that he attempted to pass through the door while it was closing.

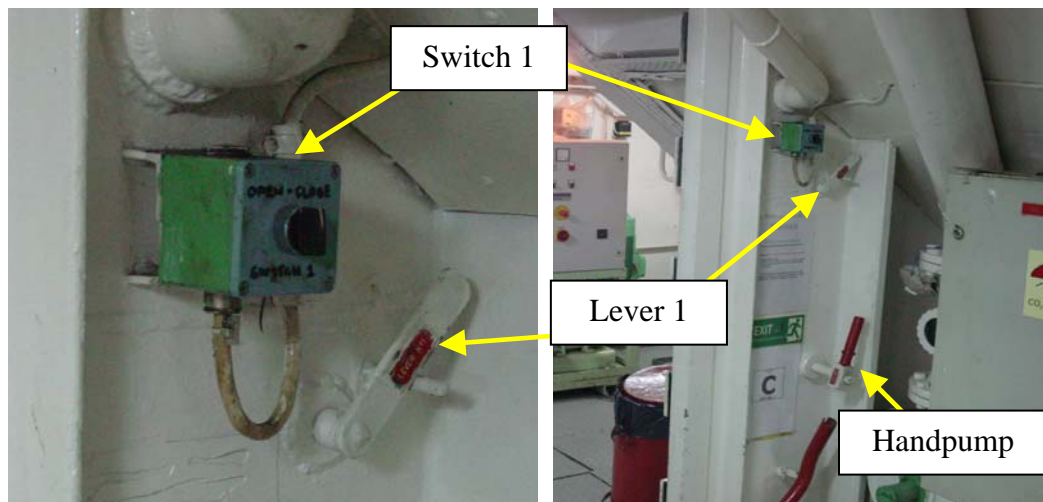
- 4.9** The operation of the local electrical switch (“Switch 1”) sets the door either opening or closing and once activated, the door will normally continue in motion until it reaches the fully open or fully closed position; however, if the switch position is changed whilst the door is in motion, the door will immediately respond to the new command - i.e. without completing its normal travel. There is no neutral or lock-off position, and the door cannot be stopped in any intermediate position.

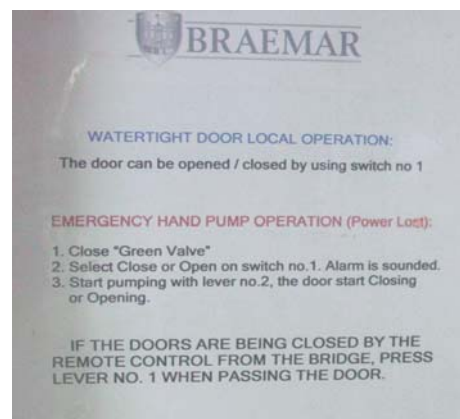
- 4.11** Operation instructions are posted locally for all three methods of operation (above left). These can also be seen in the photograph above the hand pump handle and below “Switch 1” and “Lever 1”, above. There is also a visible and audible alarm (above right).
- 4.12** When the vessel was lengthened, additional watertight doors were fitted in the new section, frames L1 to L48 (and one at frame 78 in the original hull section) as follows:-

- 4.15** There were no instructions to open the doors fully before passing through or not passing through whilst the door is in motion; there were also no notices or posters to indicate the potential dangers of entrapment if the correct transit procedures were not followed.

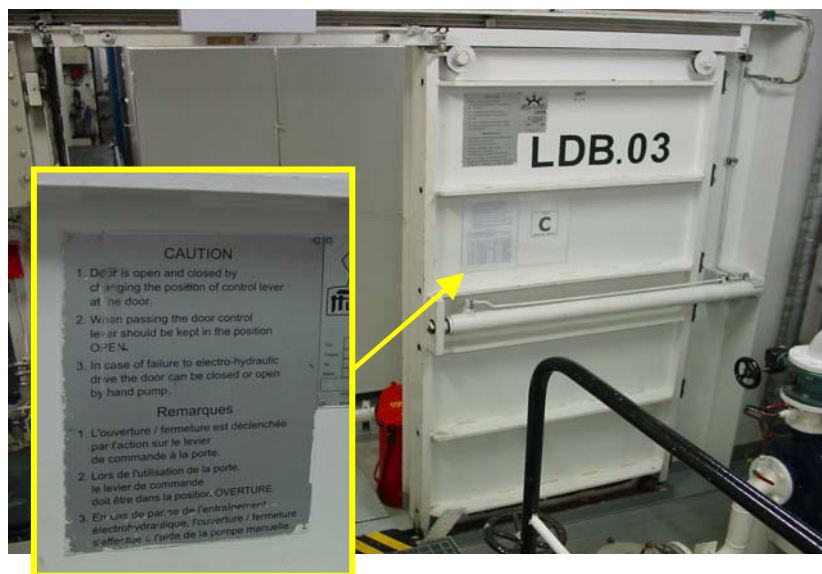
New Section Watertight Door (LDB 3) and instructions

- 4.13** The watertight doors in the new section are of a different design to those originally fitted, the principal operational difference being that these doors *can be stopped in an intermediate position* by releasing the operating lever into the “neutral” position.

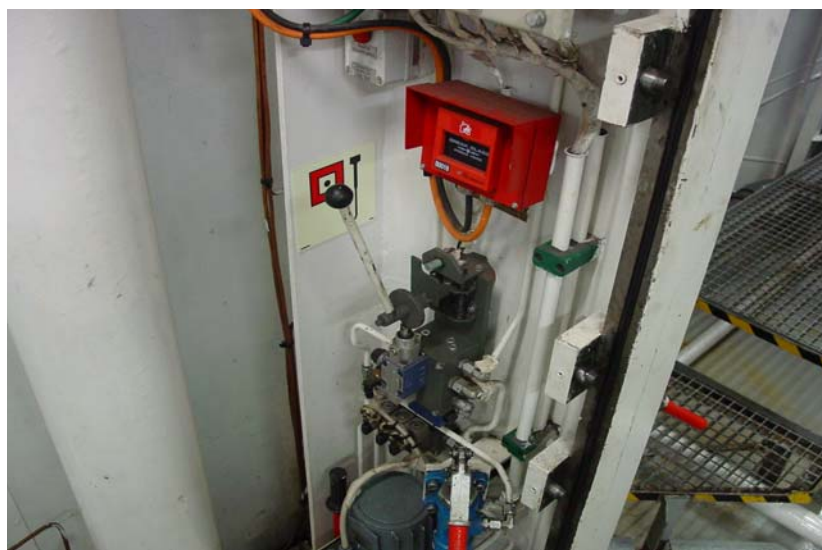
“New Section” Watertight Door (LDB 3) – Controls

- 4.14** Instructions are posted in the working language, English, at the operating consoles; instruction on how to operate the door in the event of power failure is also posted, as shown in the photographs above. For the old type doors, the operating instructions do not clearly state that the operating lever should be held in the open position while transiting the door.

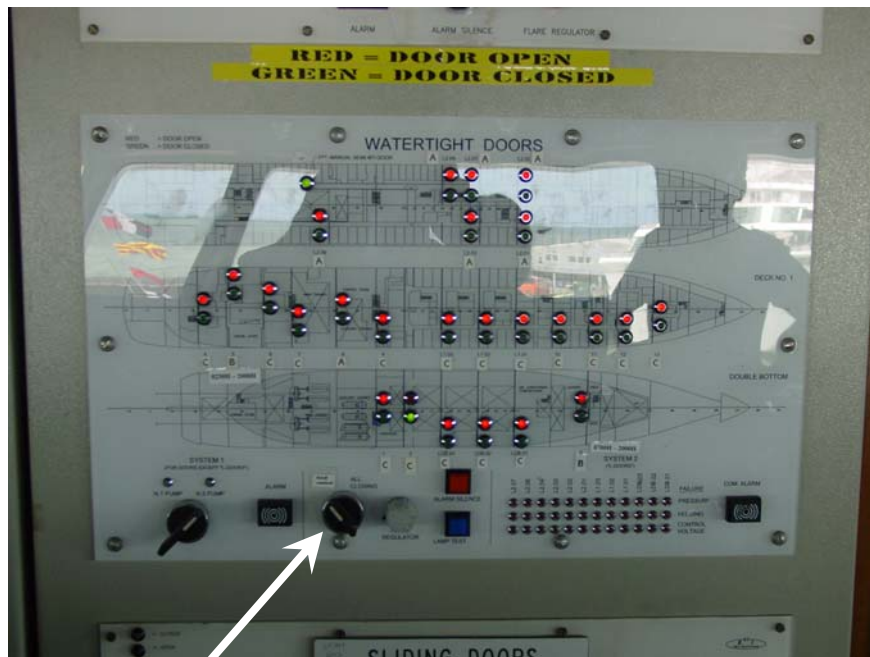
Operating Console on the Bridge

- 4.16** There is no indication at the door to show whether remote or local operation is selected.
- 4.17** An operating console is provided on the bridge, which shows the positions of all watertight doors. Doors can be set to “local control” or “all close” from this console by the switch indicated:

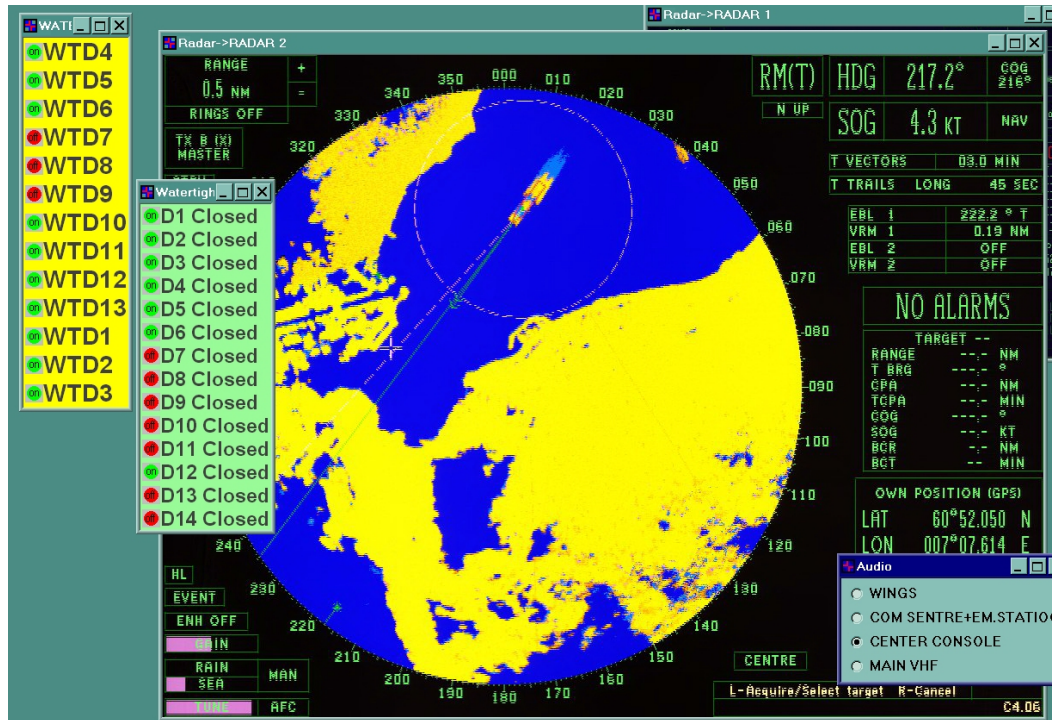
## VDR Playback.

- 4.27** In fact, the data shows that many watertight doors were opened during this period for varying durations. Some doors were open continuously for several hours; e.g. No 1 W/T door was open from 20:16 to 03:31 (7 hours 15 minutes) and W/T door No 8 was open from 20:16 to 09:21 (13 hours 5 minutes).

Green dot indicates door closed and red dot indicates door open
