**GRYF**

**IMO Number: 8818300**

**Report of the marine safety investigation into a  
fatality of a crew member on a roll-on, roll-off  
passenger ferry  
on 04<sup>th</sup> May 2019**

## GRYF – Marine Safety Investigation Report

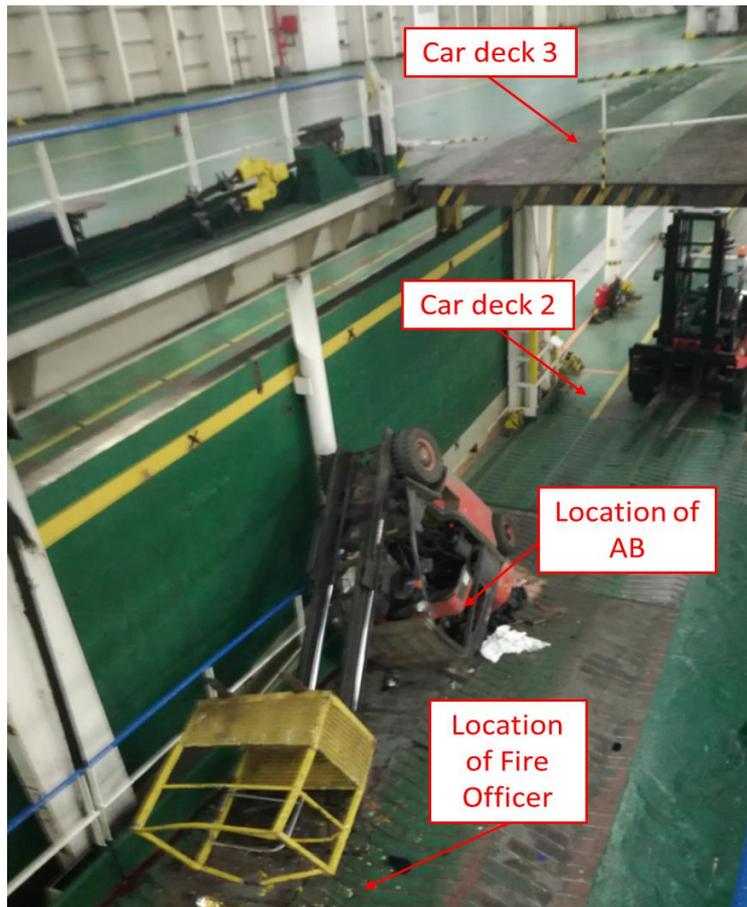
The Engine Storekeeper observed some blood coming from the forward side of the forklift and rushed towards the source. The Fire Officer was found lying unconscious near the basket of the forklift truck (figure 3).

Figure 3: Location of the AB and Fire Officer after the incident (source: Polska Zegluga Morska P.P.)

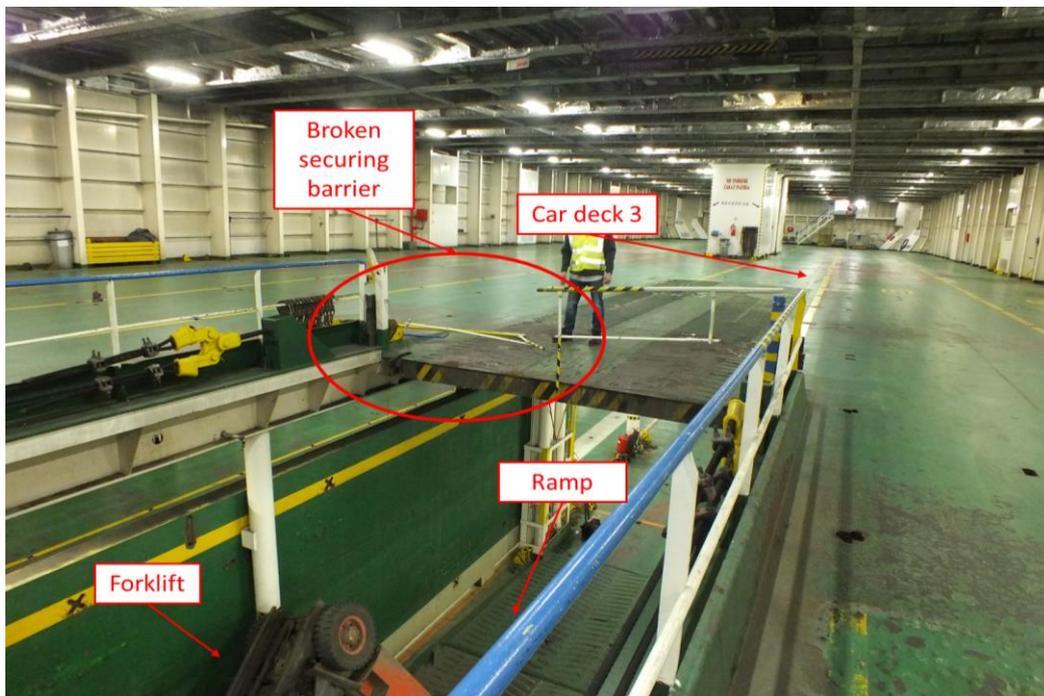
Figure 4: Broken securing barrier after the incident as viewed from Deck 3 (source: Polska Zegluga Morska P.P.)

The forklift truck was found on the ramp turned over with the forks facing upward. The securing barrier on deck 3 was broken, indicating that the forklift had fallen from deck 3 whilst reversing. The basket was attached to the forks and the forks were extended to the top of forklift mast.

The design works are in progress to replace the railings on car deck 3 with heavy-duty barriers to provide a resistance against accidentally rolling lorries.

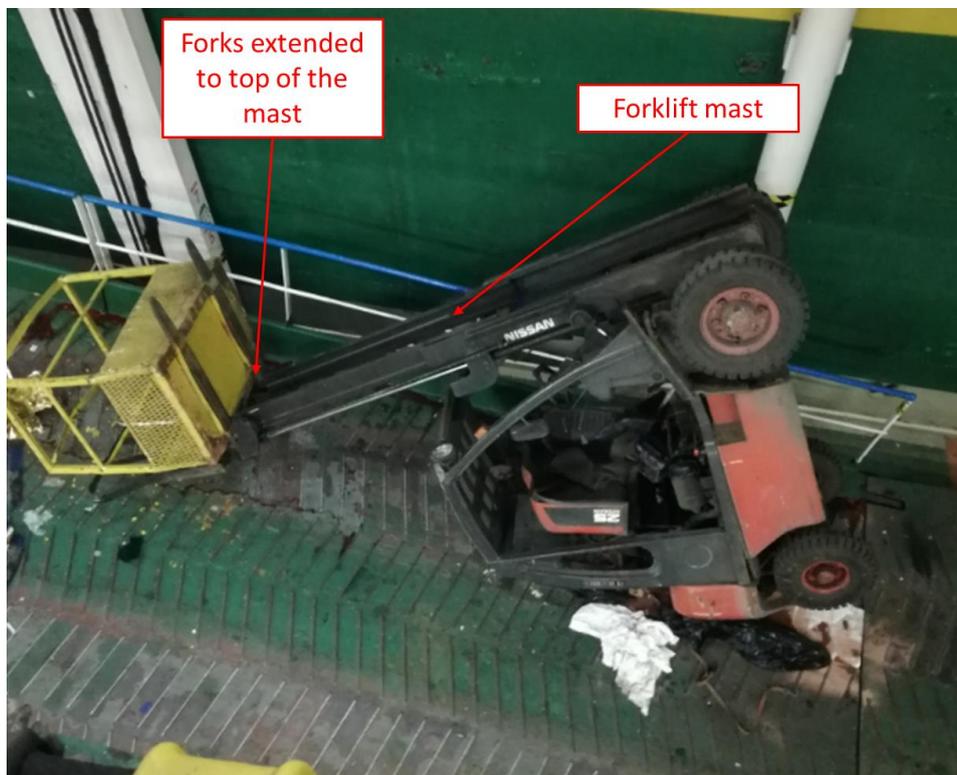
Figure 5: Forklift location after the incident (source: Polska Zegluga Morska P.P.)

This type<sup>7</sup> of forklift truck usually has a three-point suspension system, two on the front tires and one on the centre of the rear axle. While operating the forklift, if the combined centre of gravity of the load being carried and the forklift truck is within the safe region of these three suspension points, the forklift remains stable. Further, using a forklift with the load raised up in the mast, shifts the combined centre of gravity of the forklift upwards. Which reduces the safe manoeuvrability, as the safe region narrows down with height, making it more likely for the combined centre of gravity to move out of the safe region while operating or manoeuvring the forklift truck, resulting in tipping over or overturning.

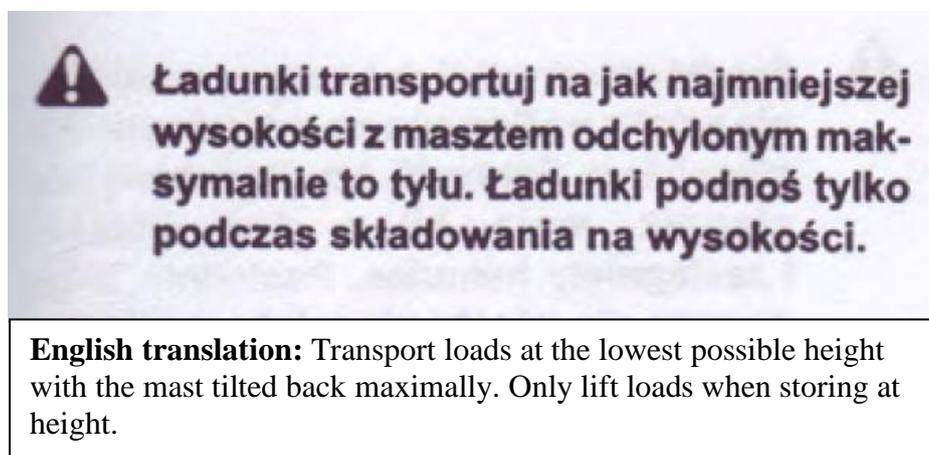
The forklift truck operation manual included the safety warning with regards to the load to be carried at the lowest possible height and to lift the load only when storing at height.

Figure 6: Extract from forklift truck operational manual

The basket on the forklift was not designed to carry personnel in it. Further, the forklift truck's operational manual included the safety warnings not to drive the truck with load extended at the height of the forklift mast. However, the crew members did not adhere to this safety warning.

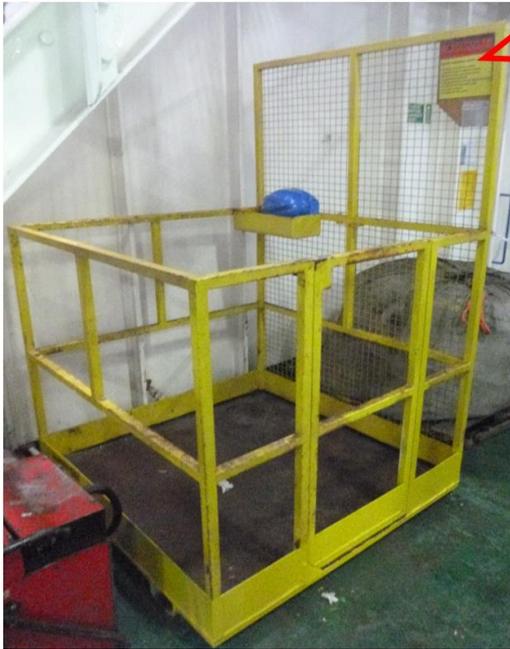
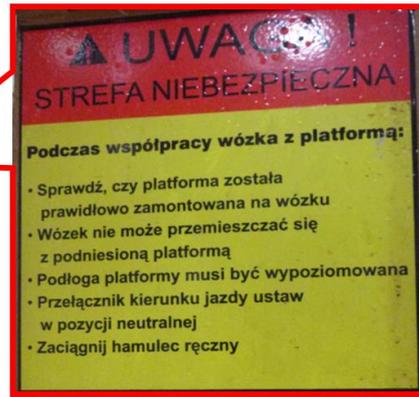
The basket which was attached to the forks of the forklift was not designed to transport personnel. The vessel had a designated forklift basket for carrying personnel onboard (figure 7).

**Figure 7: Designated basket for personnel carriage available onboard and warning sign**

The warning on the designated personnel carriage basket stated that the forklift truck should not be driven with a raised platform. Not only were the crew members using an incorrect basket while driving the forklift truck, the basket was raised to the top of the forklift mast with a person in it, which was contrary to both safety warnings on the designated basket for personnel carriage and the operational manual of the forklift truck.

This designated basket for personnel carriage had a warning sign on it with the text written in Polish only. The Bahamas Merchant Shipping Act, Paragraph 76 (2) states: *'All written signs displayed on board Bahamian ships shall be in the English language with, if it is considered necessary by the Master, a foreign language version appended thereto.'* Even though all the crew members had the knowledge of the Polish language, the warning sign was not in compliance with the Bahamas Merchant Shipping Act requirement.

Review all the written signs onboard and ensure compliance with the Bahamas Merchant Shipping Act.

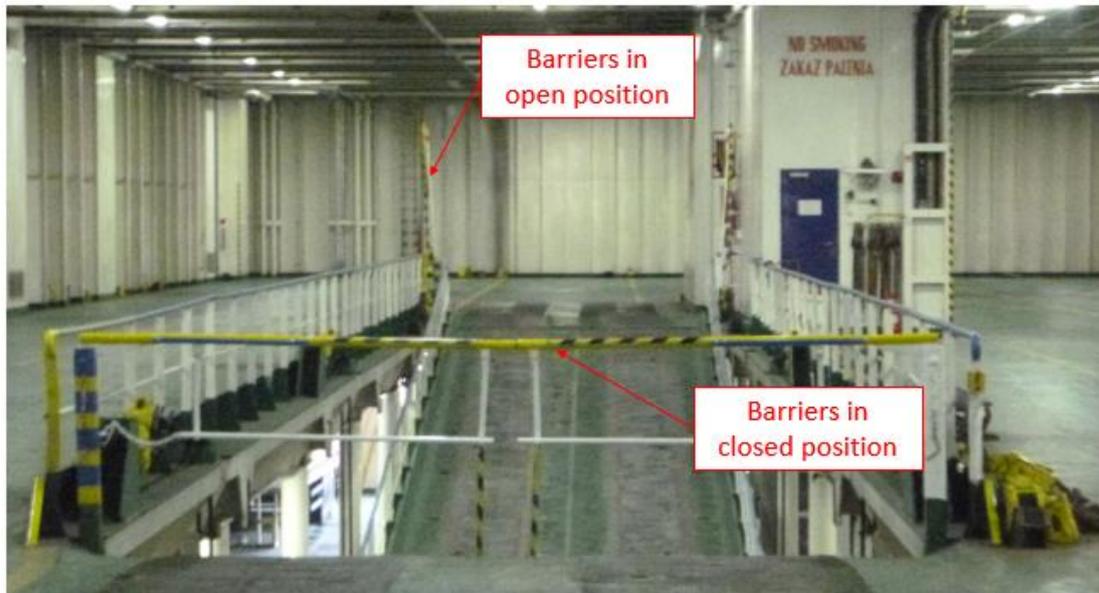
The ramp opening on car deck 3 had manually operated securing barriers forward and aft (figure 10).

Figure 10: Standard arrangement of securing barriers on car deck 3

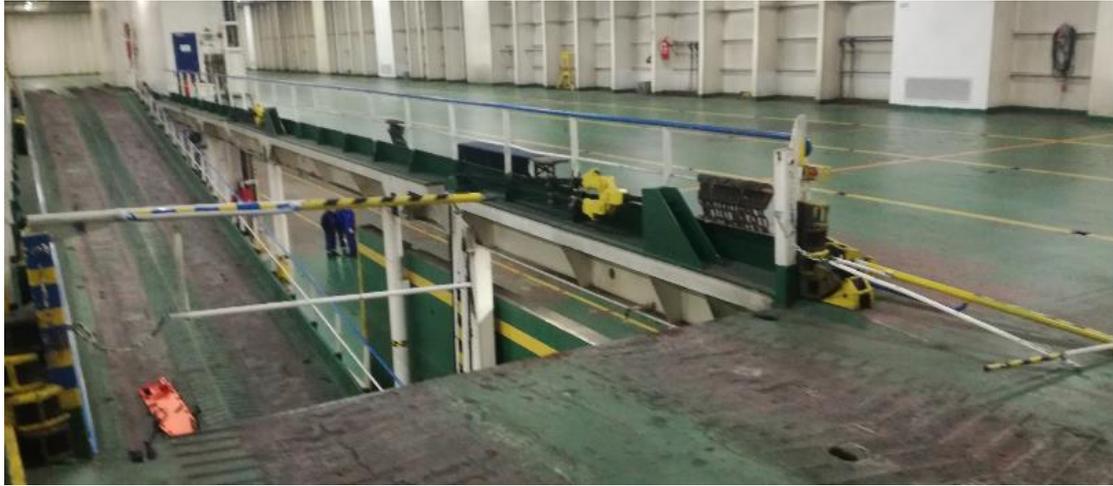
After the incident, the securing barrier on car deck 3 was found broken as the forklift fell from car deck 3 on to the ramp on car deck 2. The barriers were made of steel tubes and were not designed to take any heavy load or impact of the moving vehicles.

Figure 11: Condition of securing barrier after the incident (Source: Polska Żegluga Morska P.P.)

The securing barriers at the ramp on car deck 3 were made of steel tubes and were not designed to take the impact of moving vehicles on the car deck.

Conduct a risk assessment for the ramp operation and a comprehensive review of the vicinity of the ramp openings to ensure robust physical barriers and adequate visible safety signs are in place for the prevention of a fall from height.

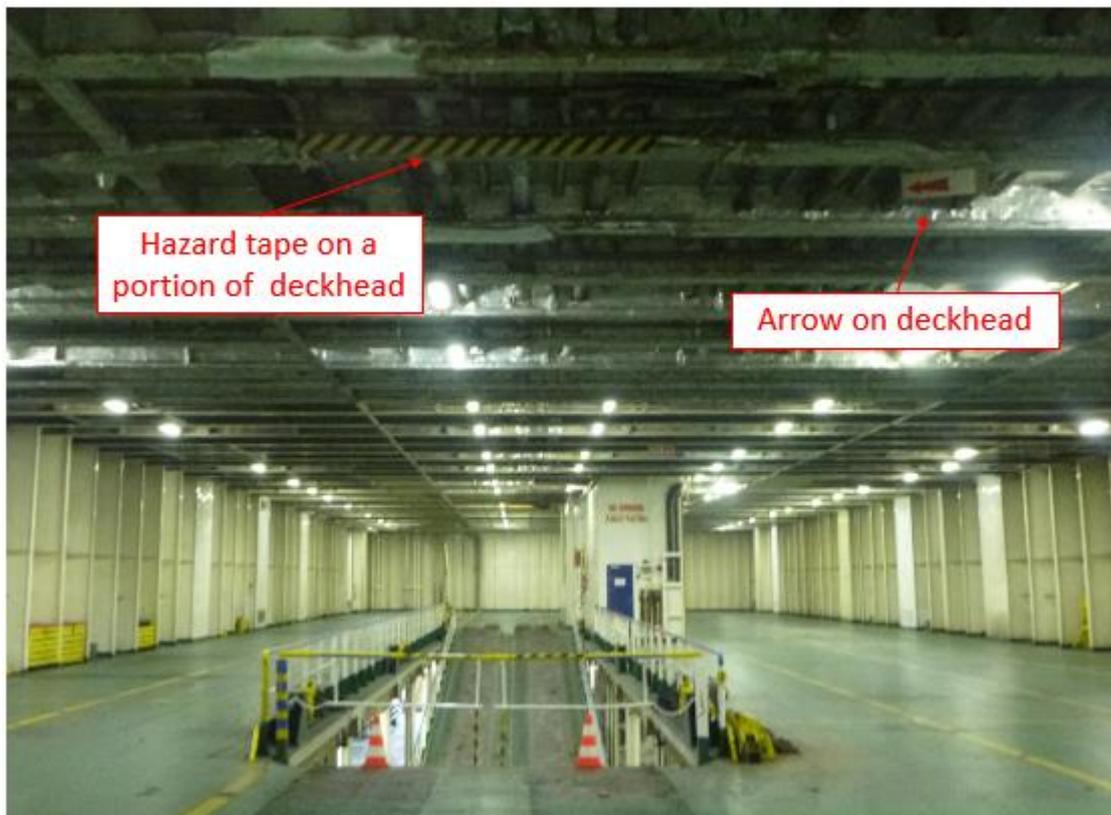
The securing barriers had a yellow and black hazard tape covering a portion of the barriers. The deckhead of car deck 3 also had a portion of yellow and black hazard tape and red arrow signage (figure 12). However, the tape and signage did not signify any information or highlight the risk related potential fall from the ramp opening to drivers operating vehicles on car deck 3. There were no signs to indicate the location of the ramp opening on the car deck.

Figure 12: Hazard tape and arrow on deckhead of car deck 3

The vessel usually carried cars, trailers and heavy goods vehicles (HGV) onboard. Due to the location of the portions of hazard tape on securing barriers and the deckhead, it was highly unlikely that drivers were able to see or identify any hazards,

especially while reversing vehicles. The drivers were guided by the deck crew during the loading and discharging operation. However, there were no clear safety signs in the vicinity of car decks or a pictogram for the drivers to identify the potential hazard of fall due to ramp opening while operating the vehicles.
