**Majesty of the Seas**

**IMO Number 8819512**

**Report of the investigation into a crew member  
fatality on a passenger vessel  
on 5 April 2017**

Date of Issue: 02 January 2020  
The Bahamas Maritime Authority  
120 Old Broad Street  
LONDON  
EC2N 1AR  
United Kingdom

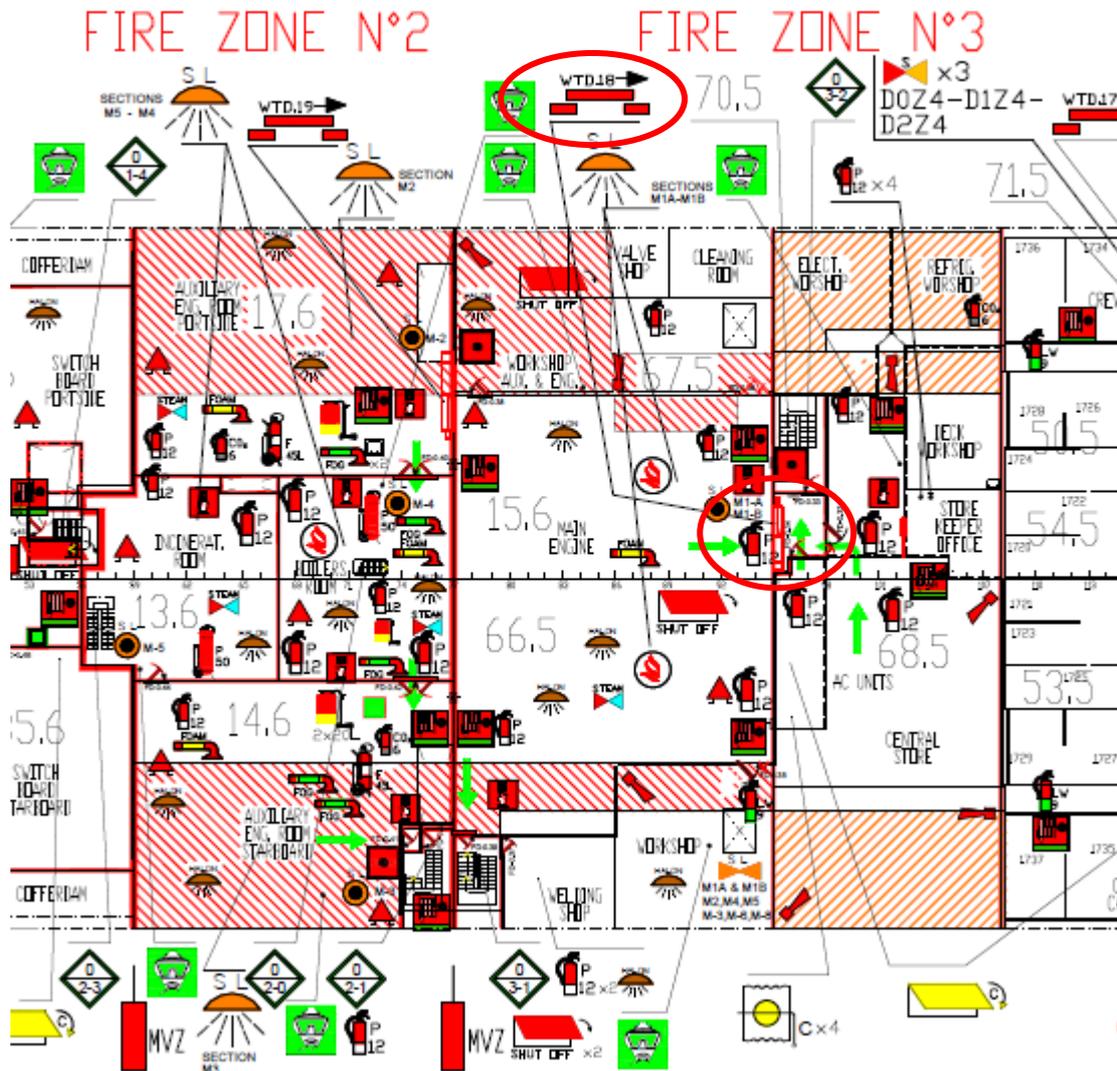
Figure 2: The layout of the engine spaces at Deck Zero and watertight door #18 marked

Watertight door #18 is located at the forward end of the engine room. The printed schedule for all watertight doors is attached to this report as Appendix 1.

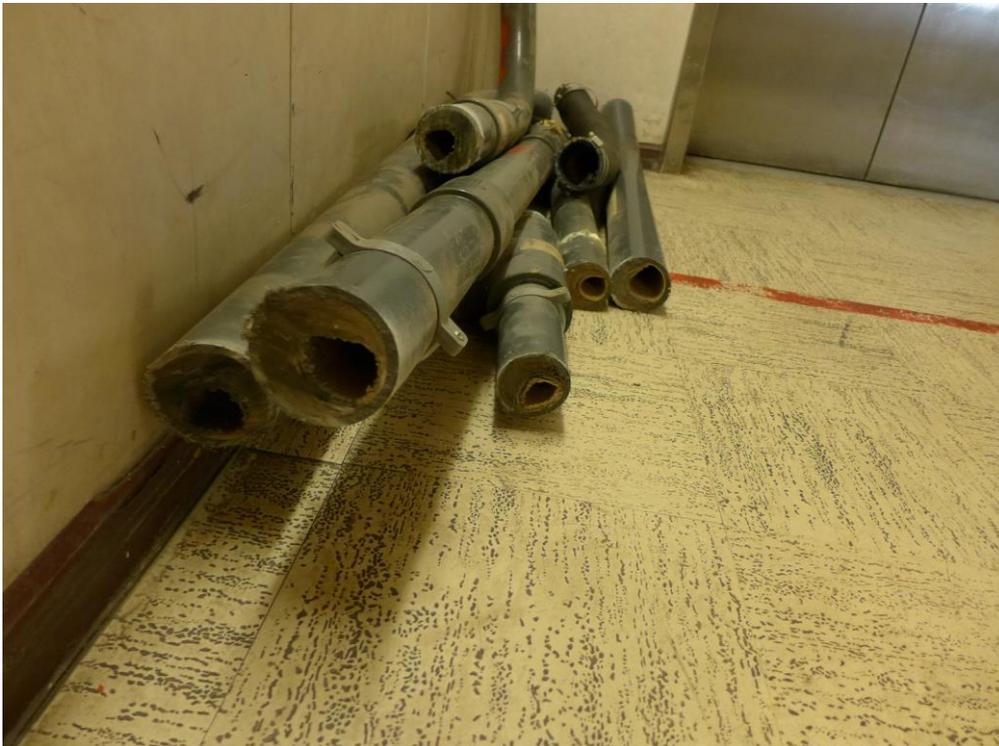
**Figure 5: Pipe sections removed due to internal build-up of sediments**

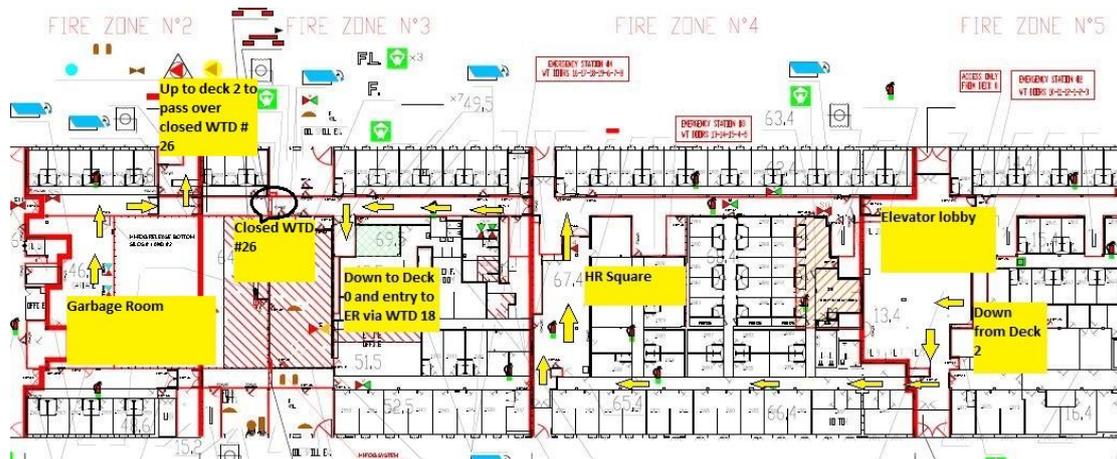
The team member's route to the engine room workshop was observed on CCTV located throughout the vessel. His movement to and from the engine room workshop is summarized in table 1 and marked in figure 6.

**Figure 6: Crew member's route on deck 1 indicated by yellow arrows**

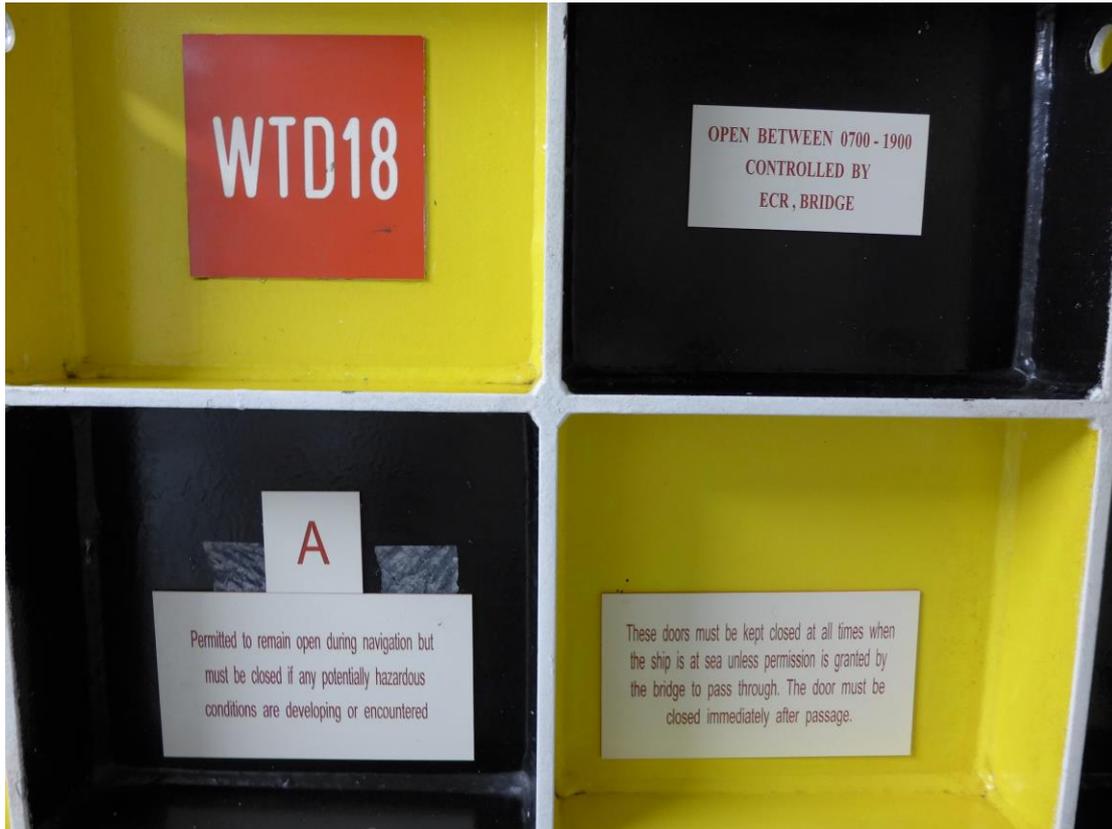
As shown in figure 7 below, WTD #18 door signage comprises of a number of statements and instructions; the sign reads that the door can remain open from 0700-1900 (Class B) the sign below that requires the door be closed at all times except for passage (Class C) and the sign to the bottom left indicates the door is permitted to remain open during navigation (Class A). The signs on the door qualify the door for Class “A”, “B” and “C” at the same time.

**Figure 7: Signage on the door indicates the door belongs to all three classifications**

A review of both the vessel's type (Mega Class) and individual door schedule indicates that WTD #18 should have been classified as:

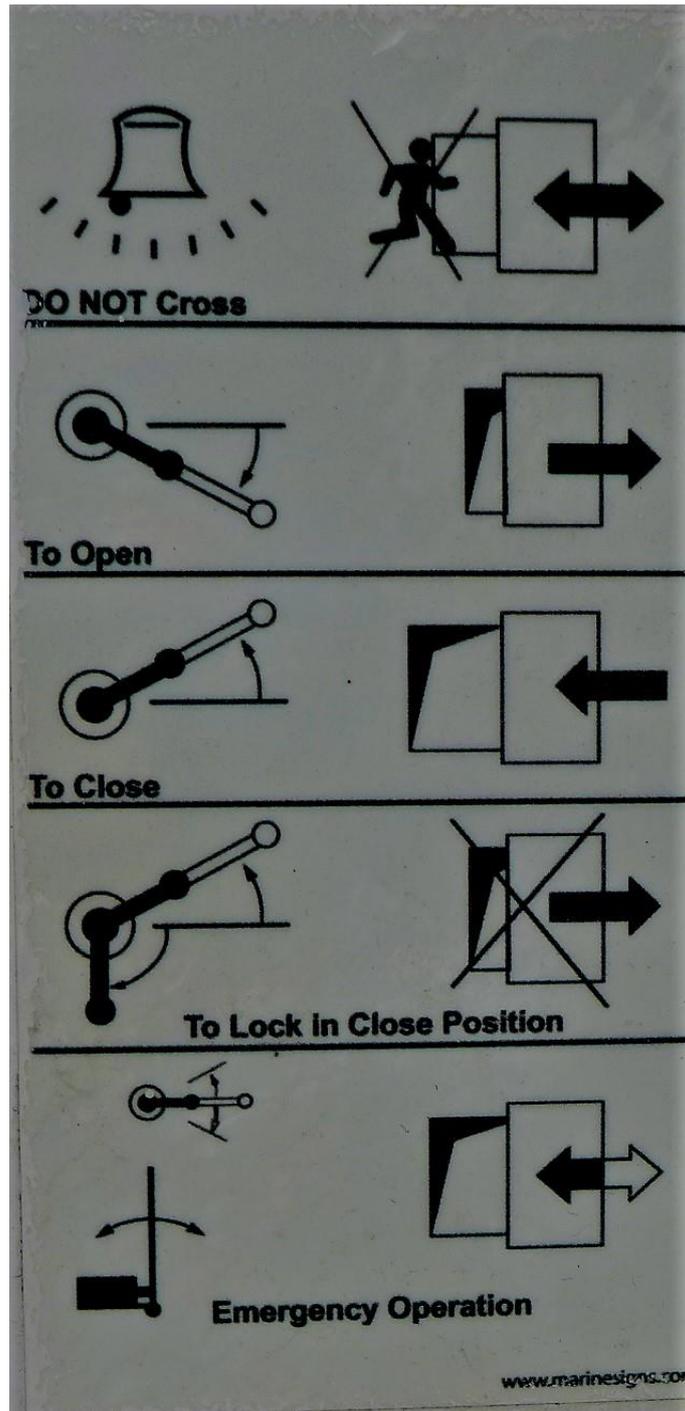
To open the WTD required the operating lever to be pushed down and held, to close the WTD required the operating lever to be pulled up. To lock the WTD in the closed position, pull the locking lever (shorter of the two levers) down to secure the door (figure 8). Emergency hand pumps are located on each side of the door.

Figure 8: Posted signage indicating operation of the WTD

The procedure requires that the operating lever be held down until the door is fully open, the operator then reaches through the door and moves the operating lever on the opposite side down to the open position and holds both levers in the fully open position. The door can then be safely passed through before releasing the initial lever.

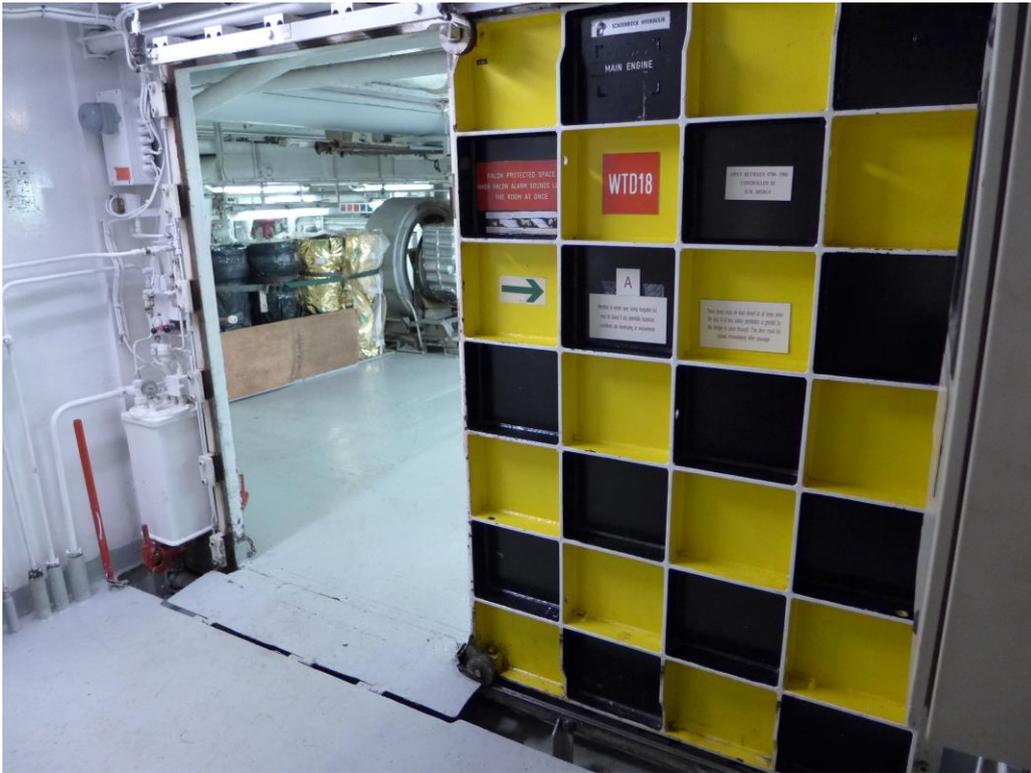
Figure 9: Watertight door #18 viewed from the outside engine room

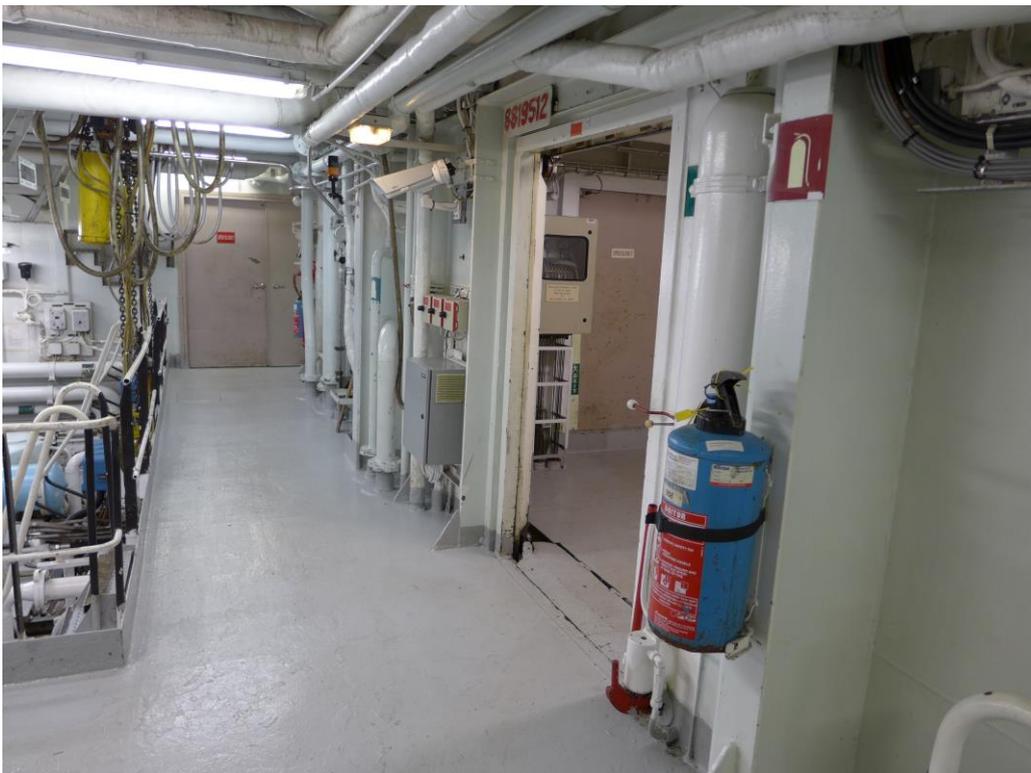
Figure 10: Watertight door #18 viewed from the inside engine room

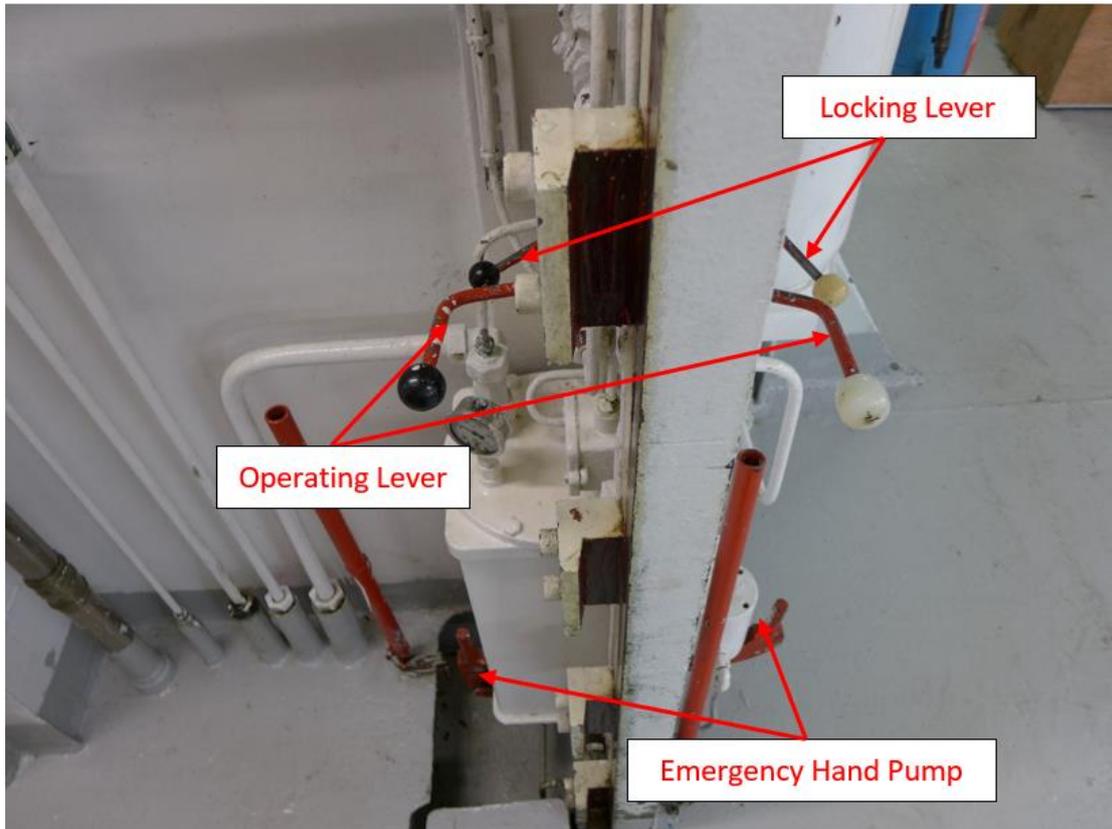
Figure 11: Watertight door #18 operating levers

As part of this investigation, watertight door #18 was examined, the door was operated and the controls seen to function as designed and according to posted instructions. Lights and bells were noted to be working. No defects were found in the door's operation.

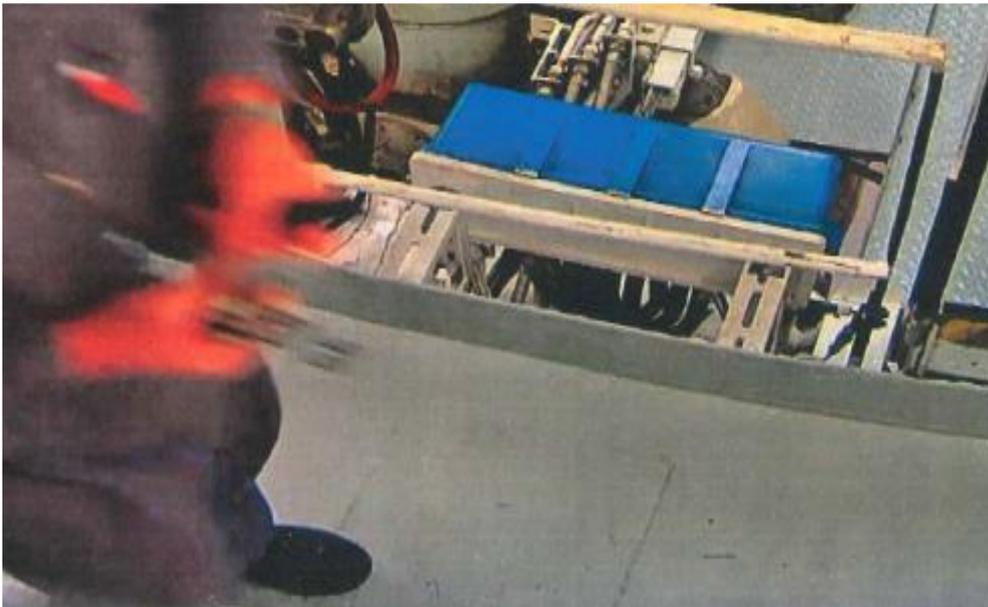
The team member was working outside passenger cabin 4033 on deck 4 on the day of the incident. From the CCTV footage, it was found that prior to the incident the team member was carrying a pipe clamp in one hand and its rubber washer in the other hand as he approached WTD #18.

**Figure 12: CCTV footage of the team member walking from the workshop towards WTD #18 prior to the incident**

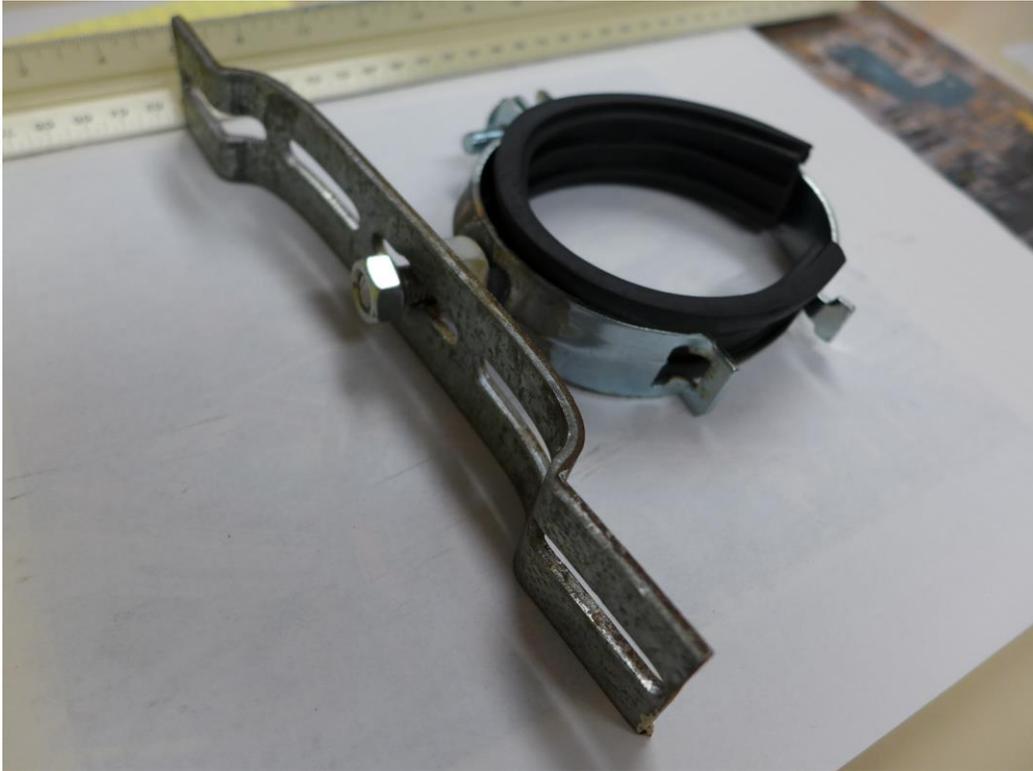
The inspection of the pipe clamp revealed that the retaining bolt had been cut to a shorter length. The rest of the RCMT team members were interviewed and it was determined that to do this would involve the use of tools located in the engine room workshop. The same clamp was pictured in the team member's hand as he passed through the incinerator room on his way to the engine room at 1019 hours (figure 12). A drill bit was also recovered from the accident scene.

**Figure 13: The pipe clamp carried by the crew member is pictured below (fully assembled)**

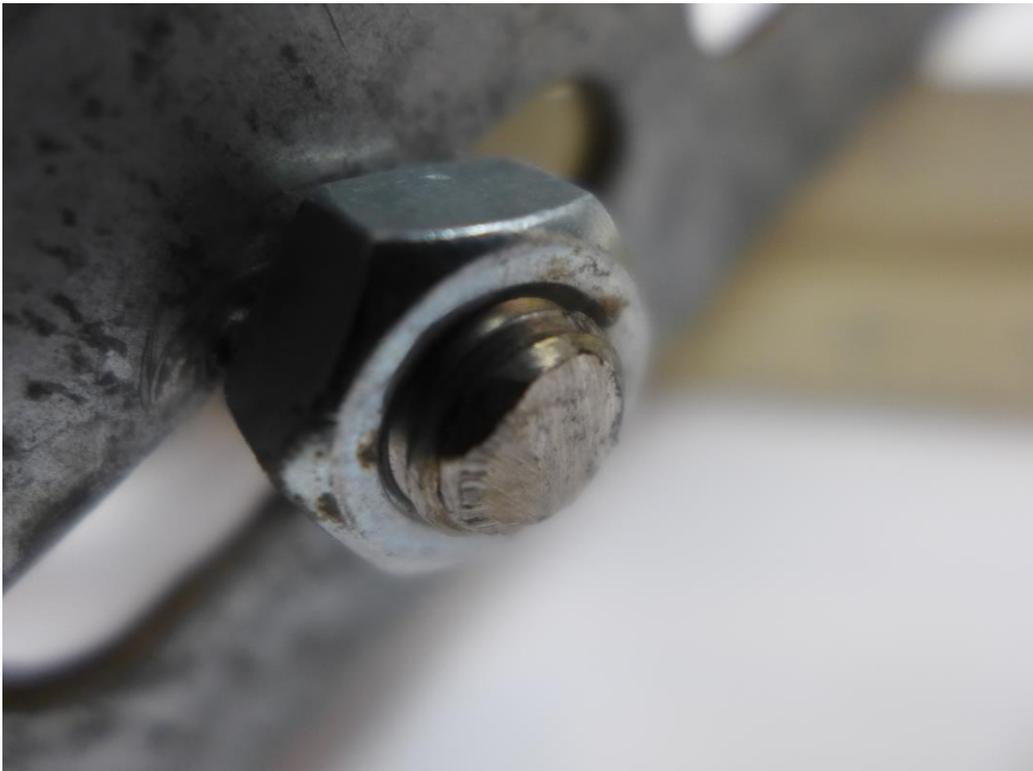
**Figure 14: Image of the shortened bolt**

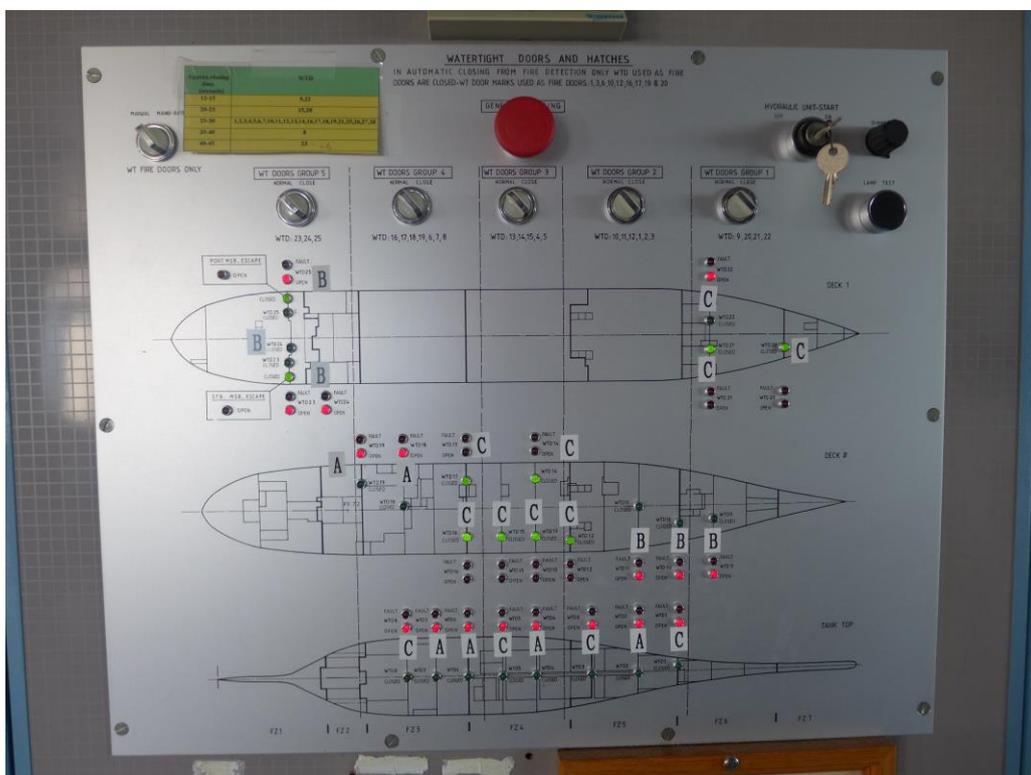
The company watertight door policy requires that the bridge be notified prior to opening any closed watertight door. This policy was not adhered to by the team member. The panel on the bridge does not alarm if a door is opened and the bridge team would be unaware a door was operated unless standing at the panel.

Figure 15: The vessel's navigating bridge watertight door control panel

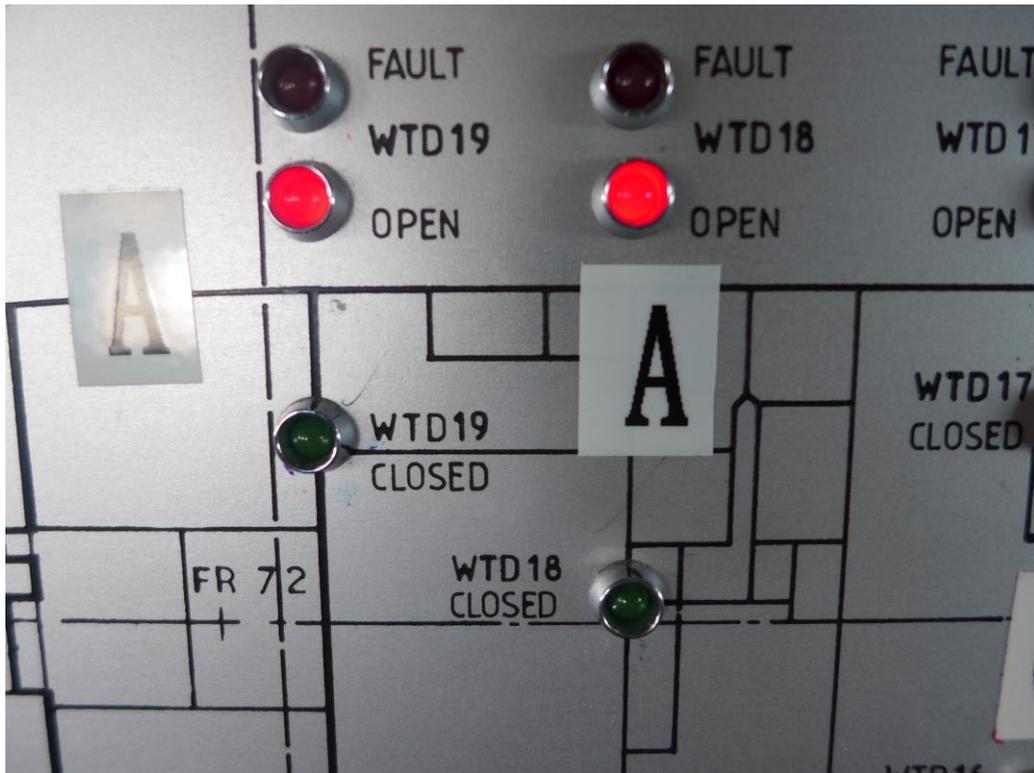
Figure 16: The wheelhouse panel indicator for watertight door #18
