## **“M.V. Mozu Arrow”**

**IMO Number: 8918227  
Official Number: 726183**

**Report on the investigation into the fatal injuries which were  
sustained by a crew man during an enclosed space rescue drill on the  
26<sup>th</sup> January 2013.**

Date of Issue: 12th September 2013

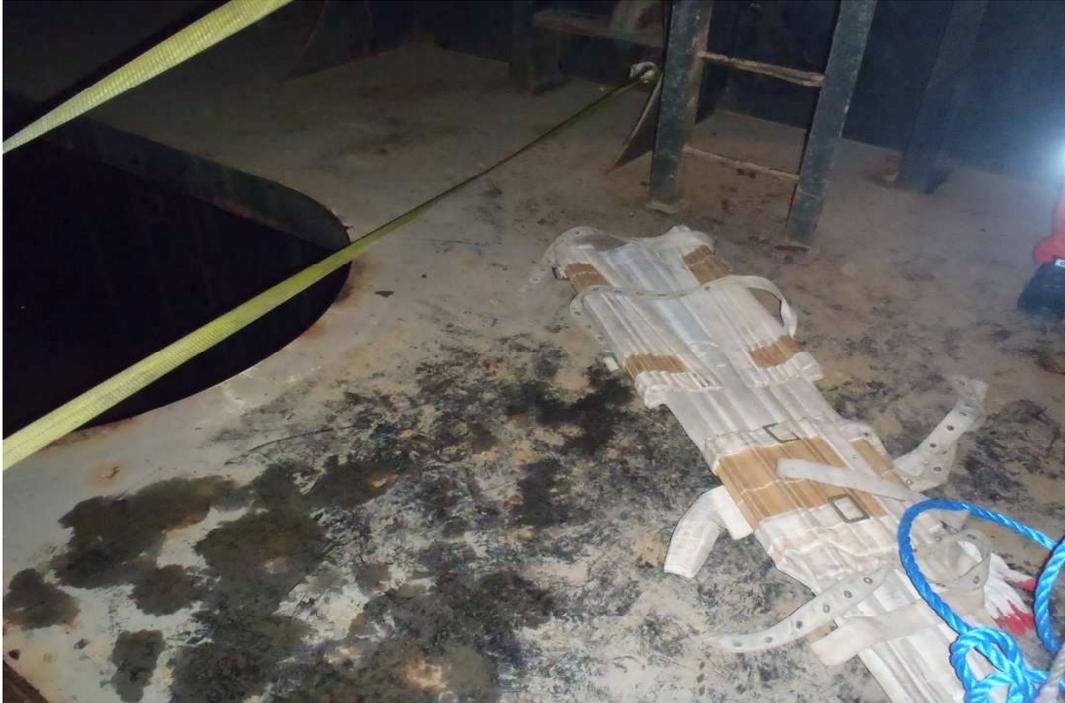
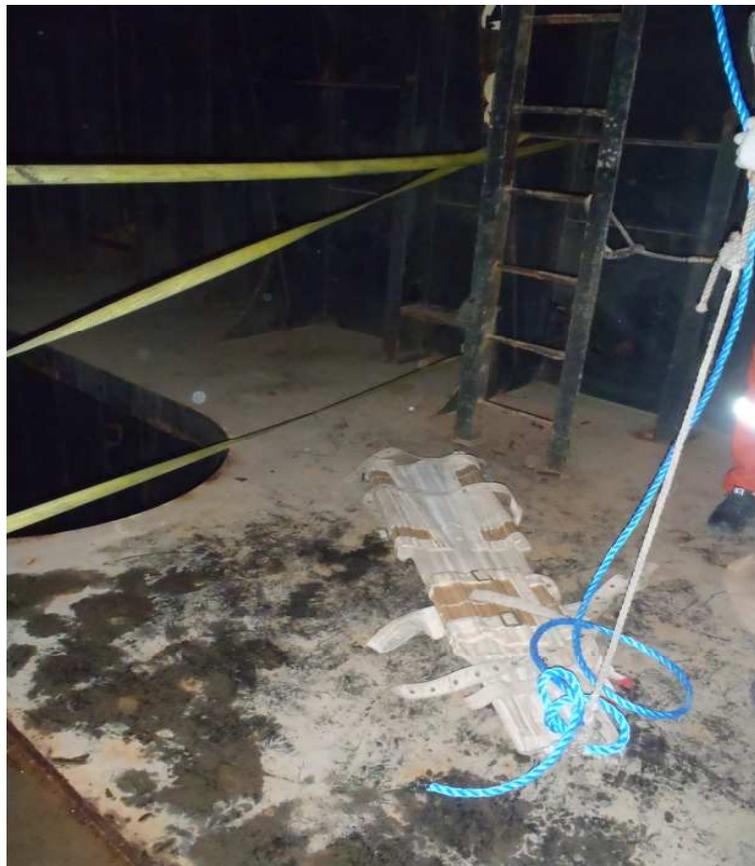
**Appendix I: No. 4 Port Ballast Tank 1<sup>st</sup> Stringer Platform**  
*(Note: Location of simulated casualty and proximity to plate opening)*

- 1.4 With a number of openings in the deck plating and no guard rails or fall barriers in place to protect the crew members involved however, this platform presented serious risk to the planned operation.

- 1.5 Whilst attempting to secure the dummy on to the ship's stretcher, the Bosun fell backwards into an opening in the platform plating.
- 1.6 The investigation found that the tank had been prepared and well ventilated, both naturally and forced, to enable an internal inspection of the space earlier that morning. The atmosphere had also been tested by the Chief Officer using a calibrated test meter both before and during the course of the exercise and was found to be suitable for entry.

- 4.6 The working area that was available on the first stringer platform inside No. 4 Ballast Tank was indeed restrictive and the lack of any guard rails or fall barriers made the location potentially more hazardous to the two crew members who were involved.

- 4.7 The No. 4 Port Ballast Tank was reportedly adequately illuminated to ensure maximum situational awareness. It was considered within the course of this investigation therefore, that the Bosun was indeed aware of his surroundings and the location of the deck plating opening which was directly behind him.

- 6.6 Under the requirements of the M.S (Health and Safety – General Duties) Regulations 1984, the operator should ensure that appropriate fixed or temporary structural measures (e.g. railings, barriers etc.) are put in place to protect crew members working at height.
