**The Bahamas
Maritime Authority**

M.v. Platinum Explorer

**Report of the marine safety investigation into
the fatal accident of the Trainee Driller on 25th February
2016 at Labuan Anchorage, Malaysia**

Date of Issue: 26 March 2018

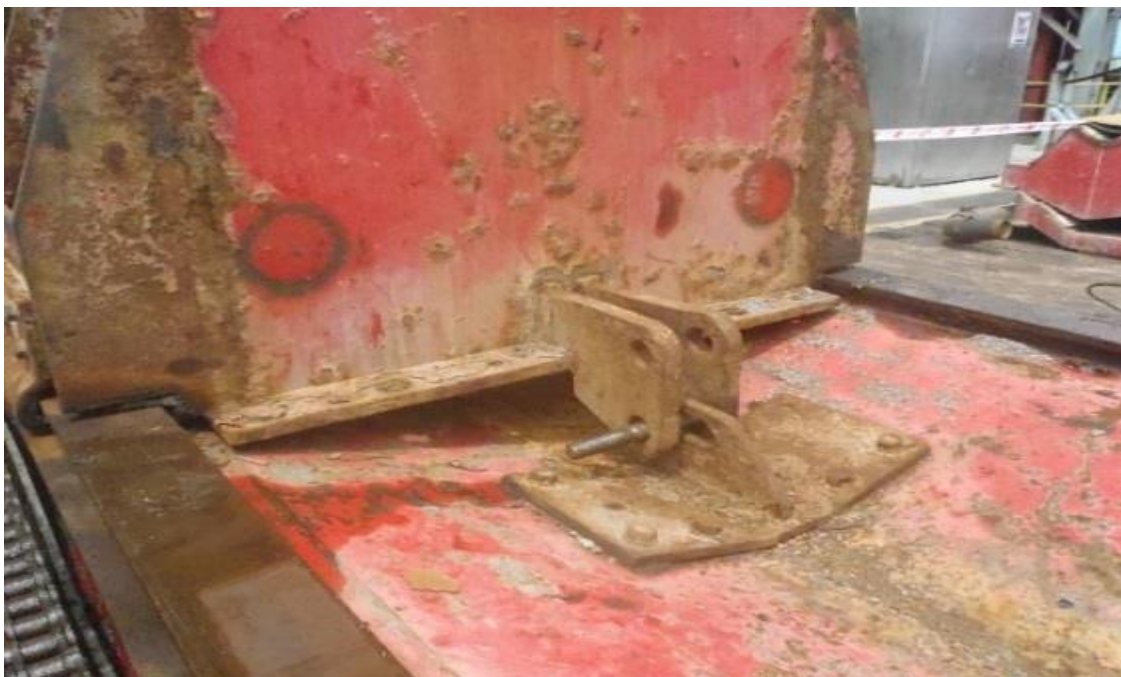
- 3.6.2 The rail assembly is installed horizontally on the aft pipe deck and connected to the drill floor. The top level of the rail section is flush with the drill floor level. The skate is running on top of the rail section between the rear stop position and the well center. The skate is a v-shaped steel frame, which is driven by a hydraulically driven rack & pinion drive system. The trolley is running on top of the skate between the rear and front stop positions. The riser support (cradle) was fixed to the front of the skate by a bolt and nut fastened to an eye plate bolted to the skate. (Figure 7).

Figure 7: Riser support Fixed to Skate with a bolt (nut is not connected to the bolt)

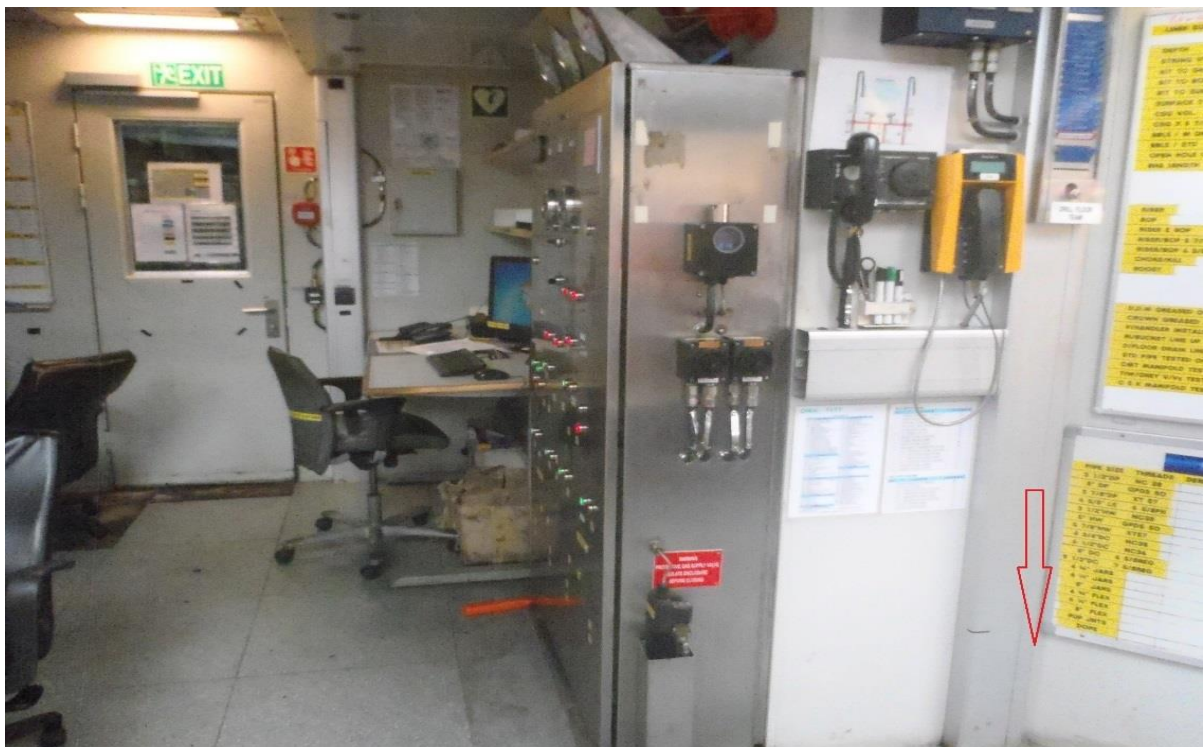
Figure 12: Inside the drill house (arrow indicating location where Trainee Driller was found)

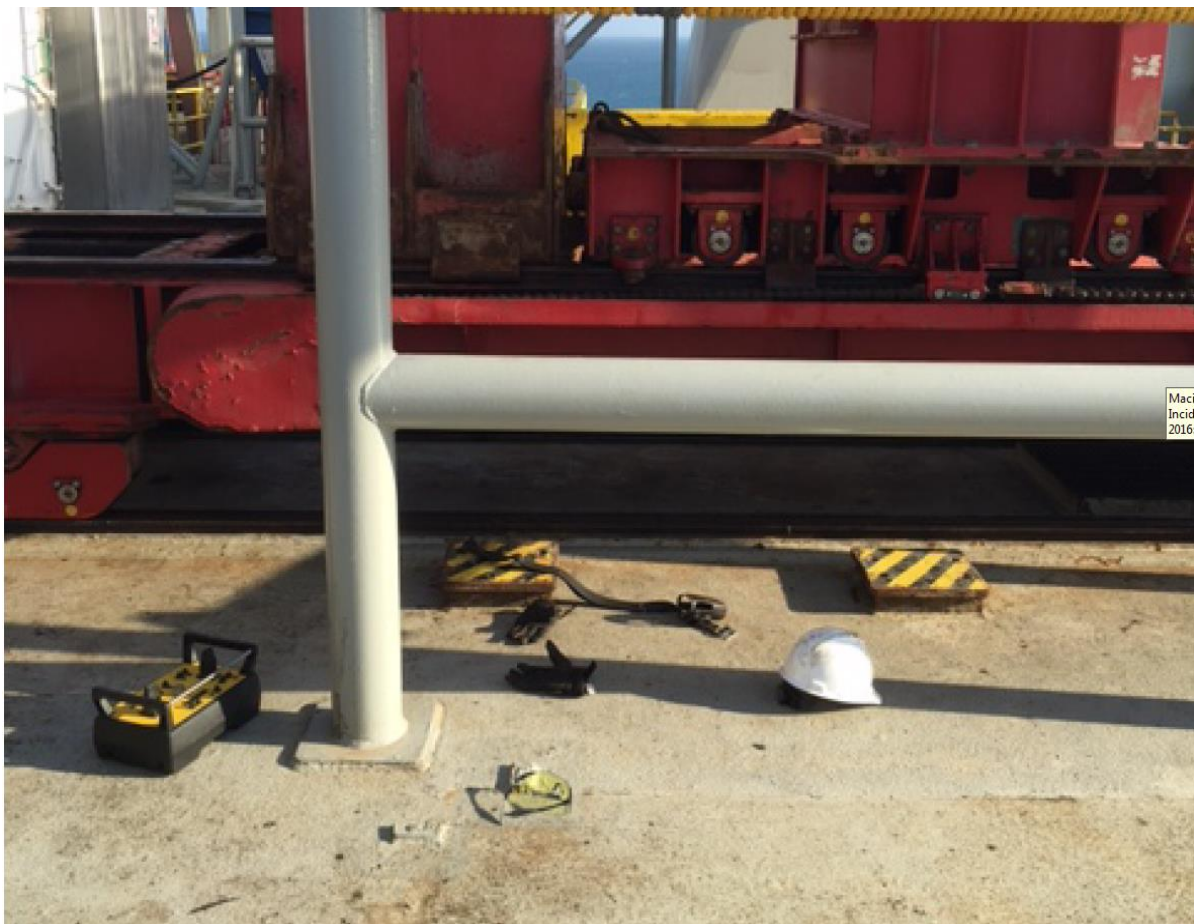
- 4.1.10 The Senior Toolpusher arrived at the drill floor, walked forward from the RFM, aft of drill floor and saw the RFM remote control, work gloves, safety helmet and walkie-talkie belt with holster on the port side beside the RFM (figure 13). He found the Trainee Driller alone in the drill house on his hands and knees. The Senior Toolpusher questioned the Trainee Driller on what had happened, and he responded with “*RFM*”. Shortly after the Crane Operator arrived at the drill house with the stretcher followed by the Master who was closely followed by the Chief Officer and the Medic.

Figure 13: Remote Control Panel & PPE located adjacent to RFM (port side)

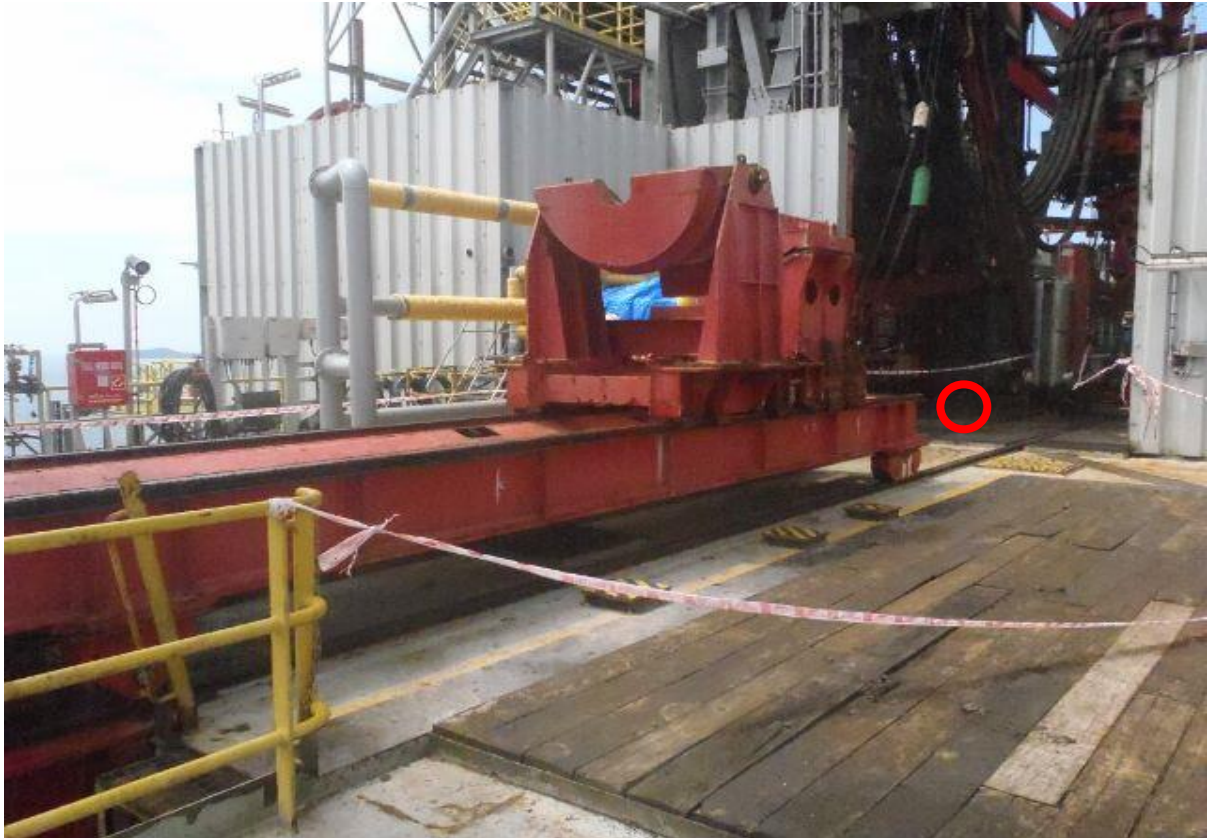
Figure 18: RFM, drill floor and drill house in the background with location of UHF circled

- 5.7.7 The normal means of communication between individuals on board but not in sight of one another was via individual's personal hand-held UHF radio. After the accident, the Trainee Driller's UHF unit was located almost equidistance between the RFM and the drill house (figure 19), indicating that enroute to the drill house he abandoned the UHF unit. During the course of the investigation, the UHF unit was not tested to confirm whether it was working.

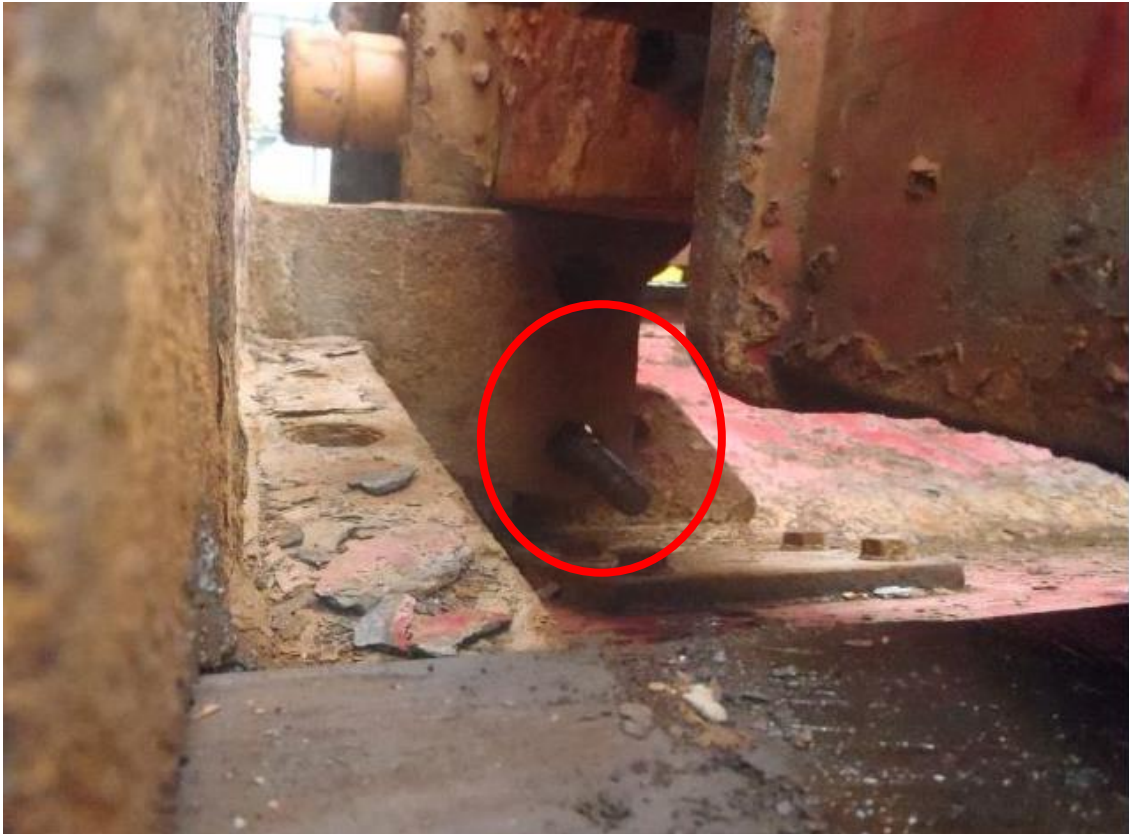
Figure 20: Riser support secured to the skate – bolt indicated without nut attached

- 4.2.2 Figures 20 to 23 were taken the following day (26 February) and it is understood to the best of the investigators knowledge that neither the bolt or the nut had been moved from this location when the pictures were taken. The nut was found on top of the frame of the trolley which was adjacent to the riser support (see figure 23).

- 5.7.4 At the scene, it was found that a threaded bolt was being utilized in place of a pin to secure the trolley to the skate via a pad eye secured to the skate (figure 29, top picture). The bolt was situated in the securing device attached to the pad eye and the nut was located in the vicinity of the bolt but not attached. The normal method of fixing was a pin as this was not as susceptible to corrosion compared to a threaded bolt. The pin was also attached to a piece of string, so it could be removed without leaning over and into the centre of the skate. When interviewed as to the origins of the nut and bolt, the Senior Toolpusher did not know why a threaded bolt was used instead of the pin, or why the Trainee Driller possibly took it upon himself to remove the threaded bolt and replace with the pin at that time.

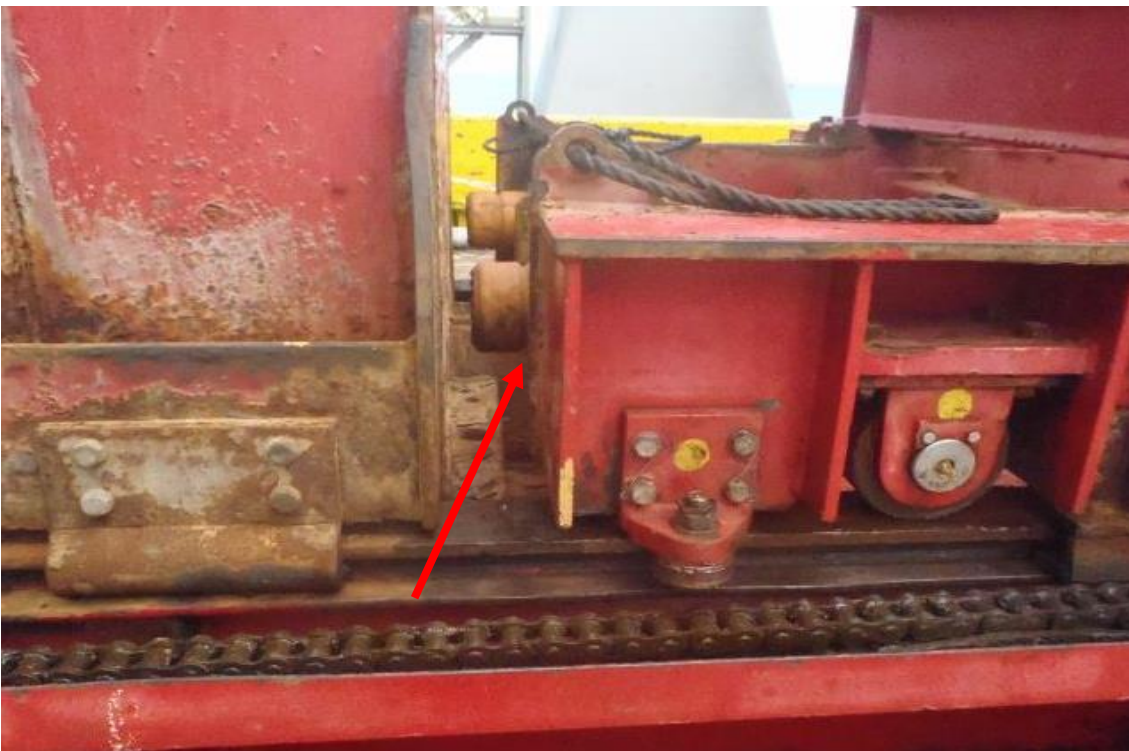
Figure 21: Riser support (left) next to trolley (right), location of securing nut indicated but not visible

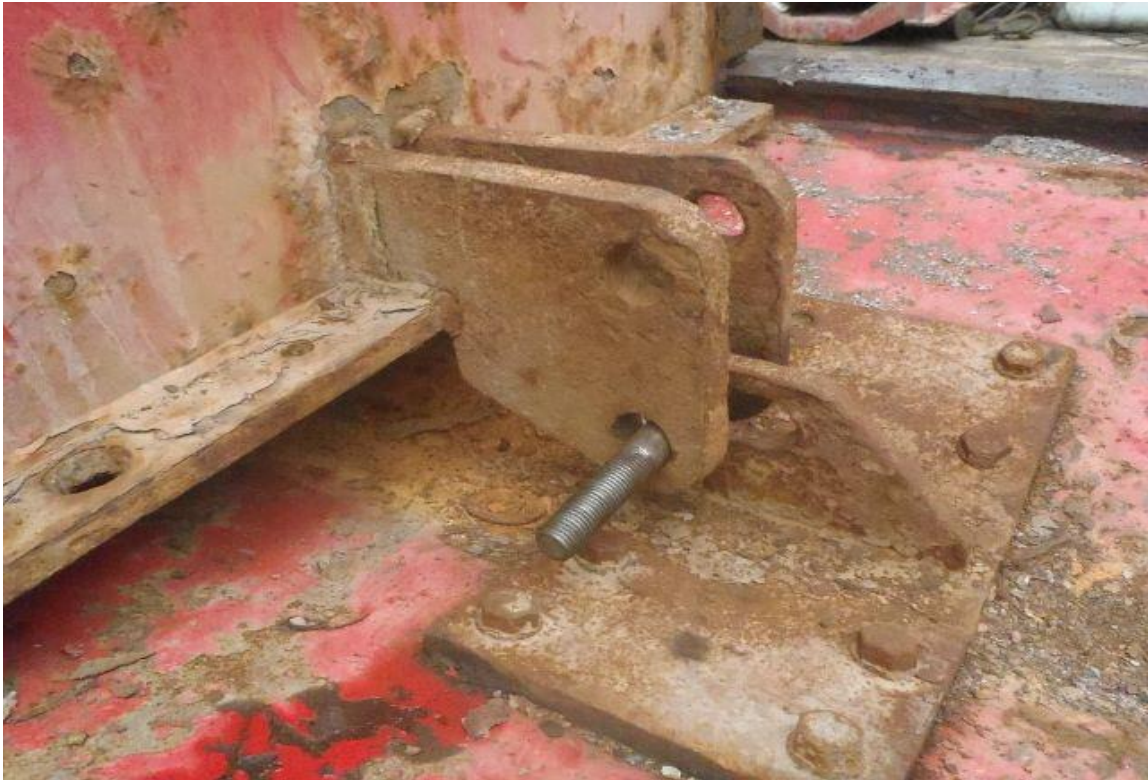
Figure 22: Condition of the bolt

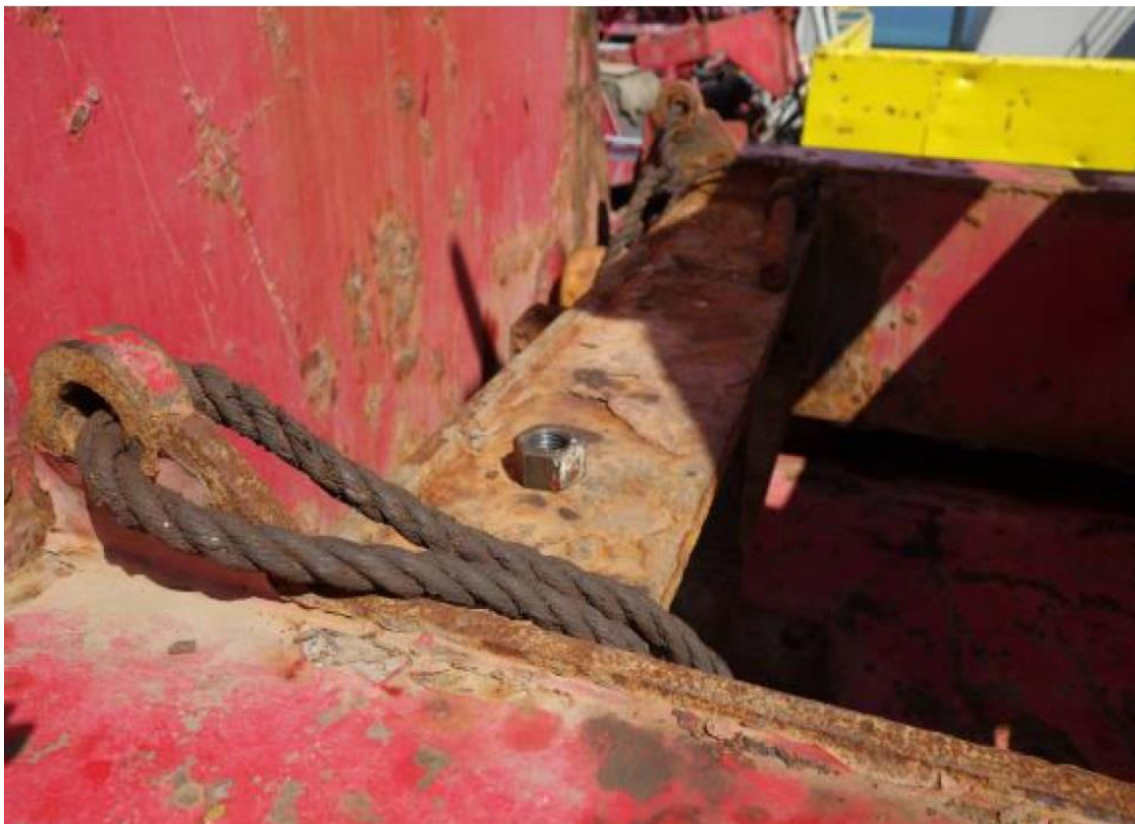
Figure 23: Location of the nut found on top of the trolley

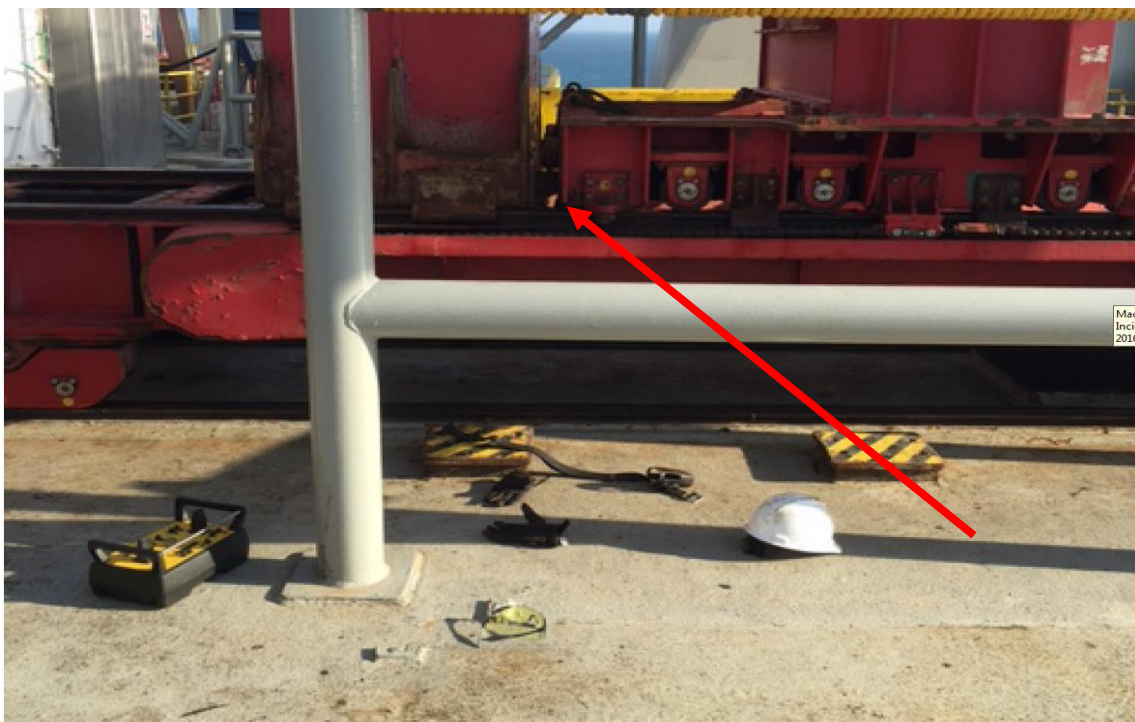
- 5.2.1 The Trainee Driller is believed to have sustained fatal injuries whilst conducting maintenance on the Riser Feeding Machine. The Trainee Driller's injuries were localised in the region of his torso and consisted of major internal haemorrhaging which is consistent with an injury sustained by blunt force trauma.
- 5.2.2 There were no witnesses to the accident and no CCTV covering the RFM or drill house access and therefore the investigation was unable to determine categorically how the Trainee Driller came to receive the fatal injuries. Based on the testimony of the Trainee Driller and the location of the personal protective equipment removed at the scene, it has been determined with a high degree of probability that he came to receive his injuries in vicinity of the forward end of the RFM where the trolley and the cradle were positioned on the skate.

Figure 24: Location of PPE, RCP and stopped position of the riser support and trolley, gap indicated by arrow

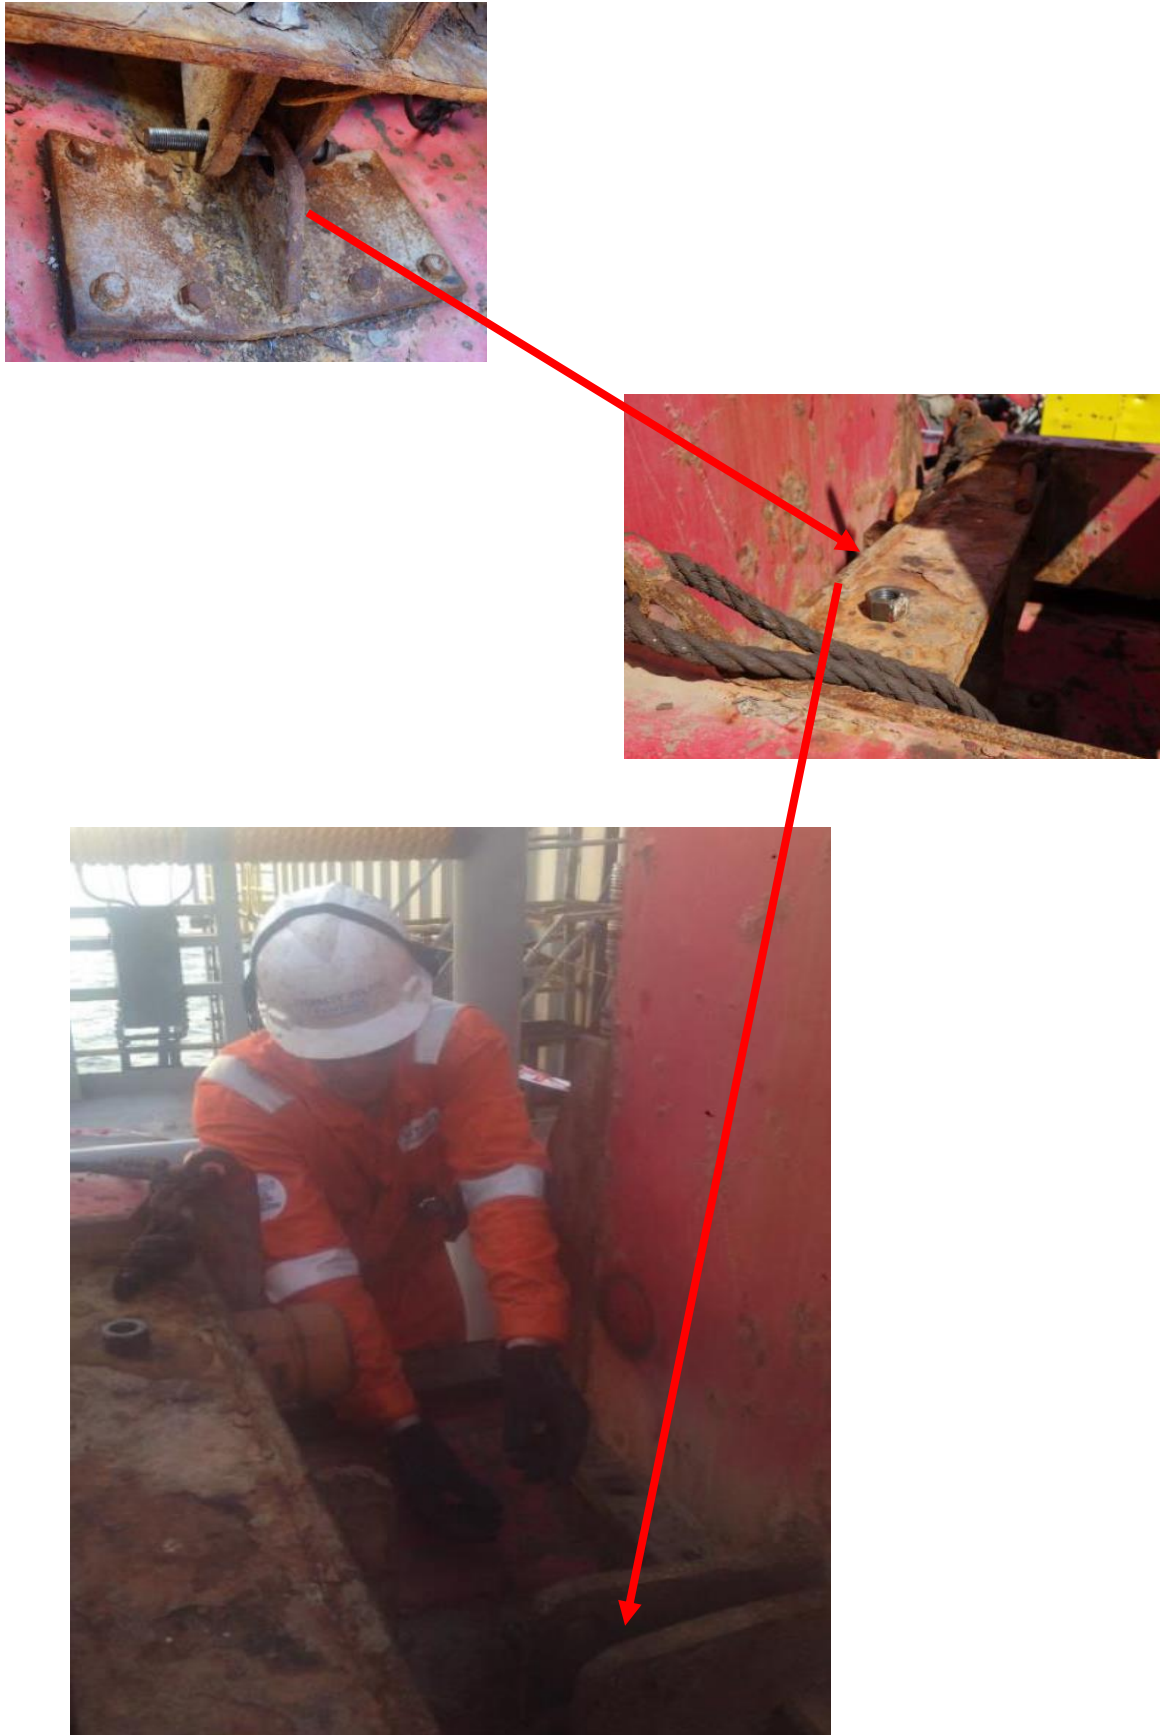
- 5.7.6 In noting that the RCP was located in the vicinity of the RFM and in close proximity to the Trainee Driller's PPE, it is considered likely that the Trainee Driller was in possession of the RCP at the time the injuries were sustained. If the trolley lever on the RCP unit was accidentally moved the trolley would move in the direction the command was given as the system was confirmed to be in an active condition. If this occurred at the point when the Trainee Driller was positioned between the trolley and the riser support, there is no safety mechanism preventing either mechanical part from closing.

Figure 29: Images depict the process considered to possibly undertaken by the Trainee Driller at the point of impact between the riser support and trolley

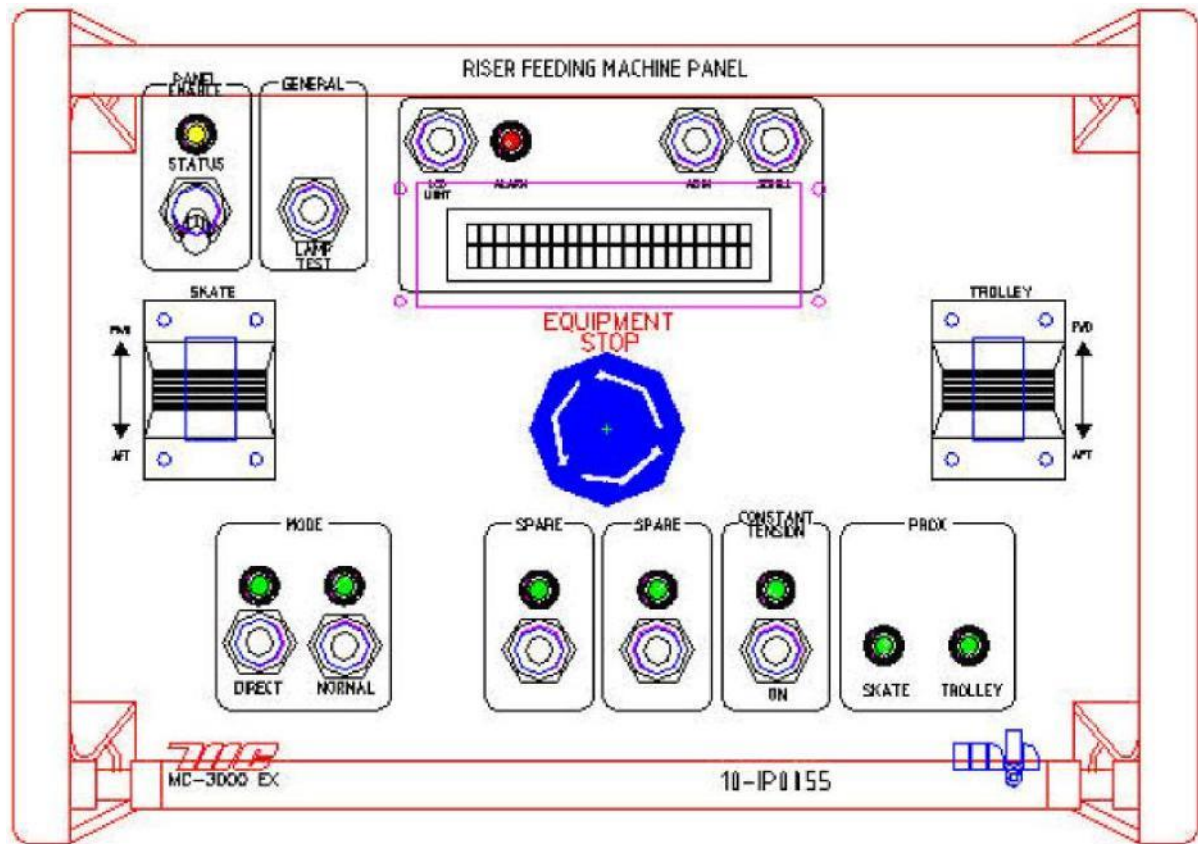
Layout of Radio Remote Control Panel (RCP) for Riser Feeding Machine

- Direct mode switch – Occasionally mode is not selectable and/or mode reset, found it is more stable if the RCP is placed and stationed at a fix place. (recommend to replace new RCP for operations)
- Normal mode switch – Occasionally mode is not selectable and/or mode reset, found it is more stable if the RCP is placed and stationed at a fix place. (recommend to replace new RCP for operations)
- Normal mode, Skate Fwd and Aft – ok
- Direct mode, Skate Fwd and Aft - ok
- Normal mode, Trolley Fwd and Aft – Occasionally function and mode reset with an alarm “Trolley - Low Velocity or Wrong Direction”
- Direct mode, Trolley Fwd and Aft - ok
- Constant Tension function - ok

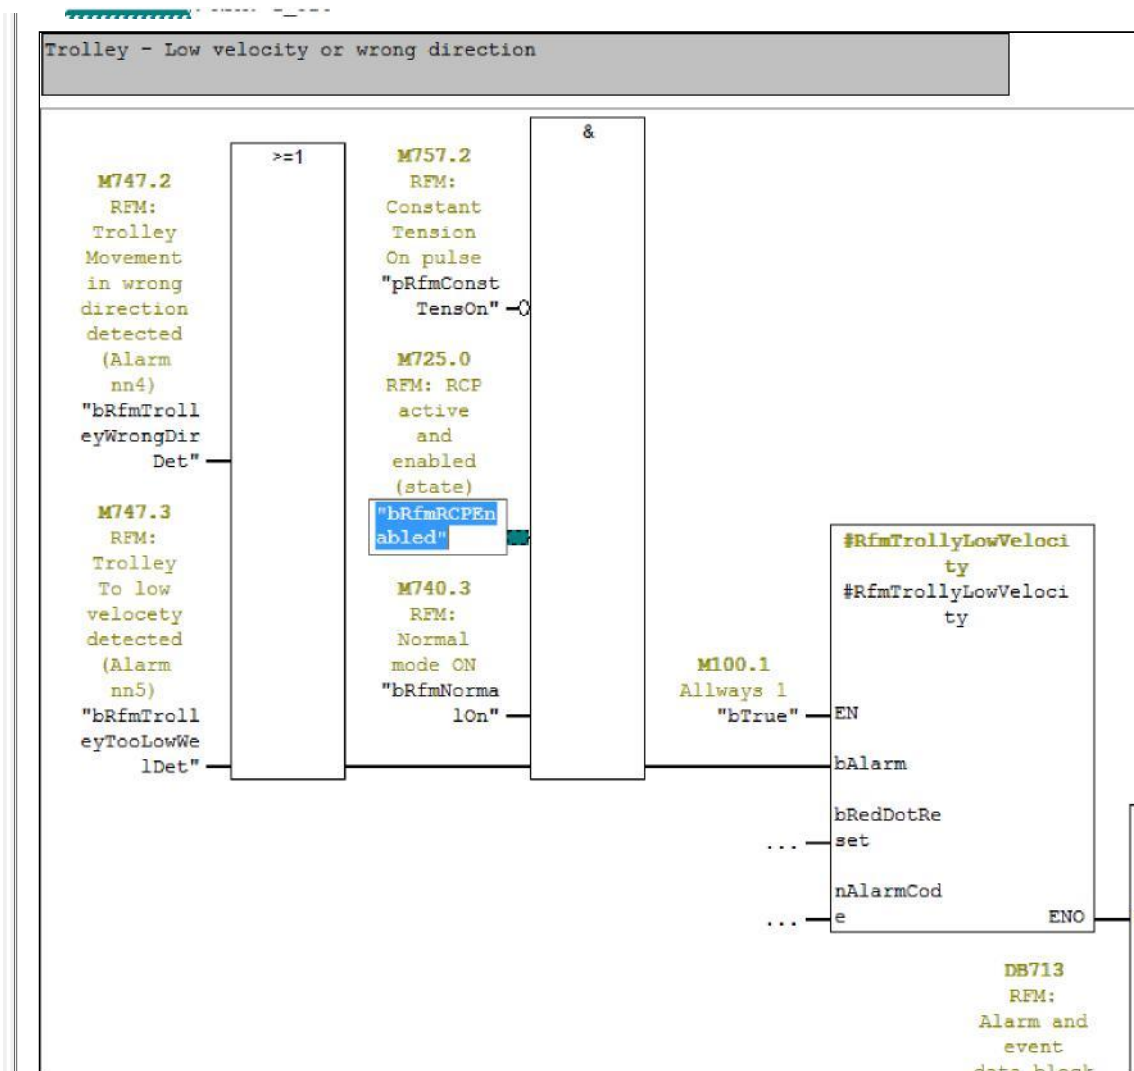
The latest alarm in the RFM system is the “Trolley - Low Velocity or Wrong Direction”. This alarm only occurs in Normal mode and is only active until the system is out of mode. From the alarm list we can see that the alarm is activated two times (Final state = G), and mode is reset within one second both times (Final state = R). This is according to the functionality described in the functional description for the equipment.

Coding of “Trolley - Low Velocity or Wrong Direction” alarm;
