**The Bahamas
Maritime Authority**

M.v. Skandi Skansen

**Report of the marine safety investigation into a
fatality on an Anchor Handling Supply vessel on 21
February 2015**

Date of Issue: 14 June 2018
Bahamas Maritime Authority
120 Old Broad Street
LONDON
EC2N 1AR
United Kingdom

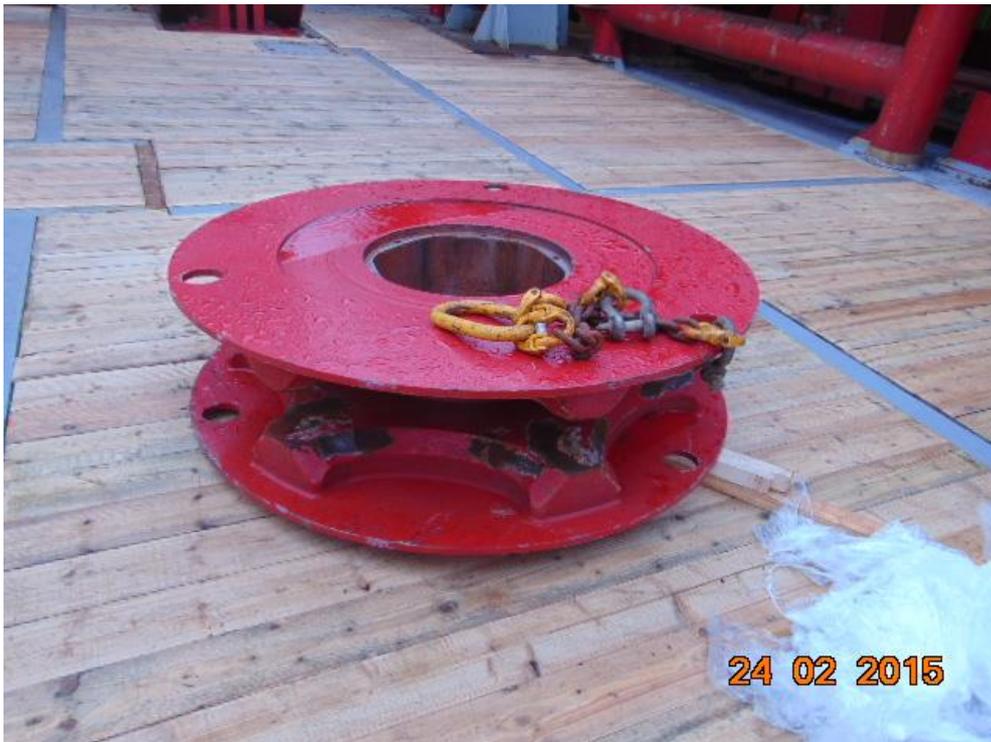
Figure 2: 84mm Gypsy

- 4.3 The deck crew was engaged in replacing the starboard side AHT Winch Cable Gypsy (Chain lifter) by removing the 105mm Gypsy and installing the smaller 84mm Gypsy which weighed approximately 2492 KG.
- 4.4 The 105mm Gypsy was uninstalled and transferred to a storage area on the main deck without any incident.
- 4.5 The Deck crew then connected the lifting sling to the 84mm Gypsy using the main crane whip line with a safe working load (SWL) of 20 tonnes at 40 meters.

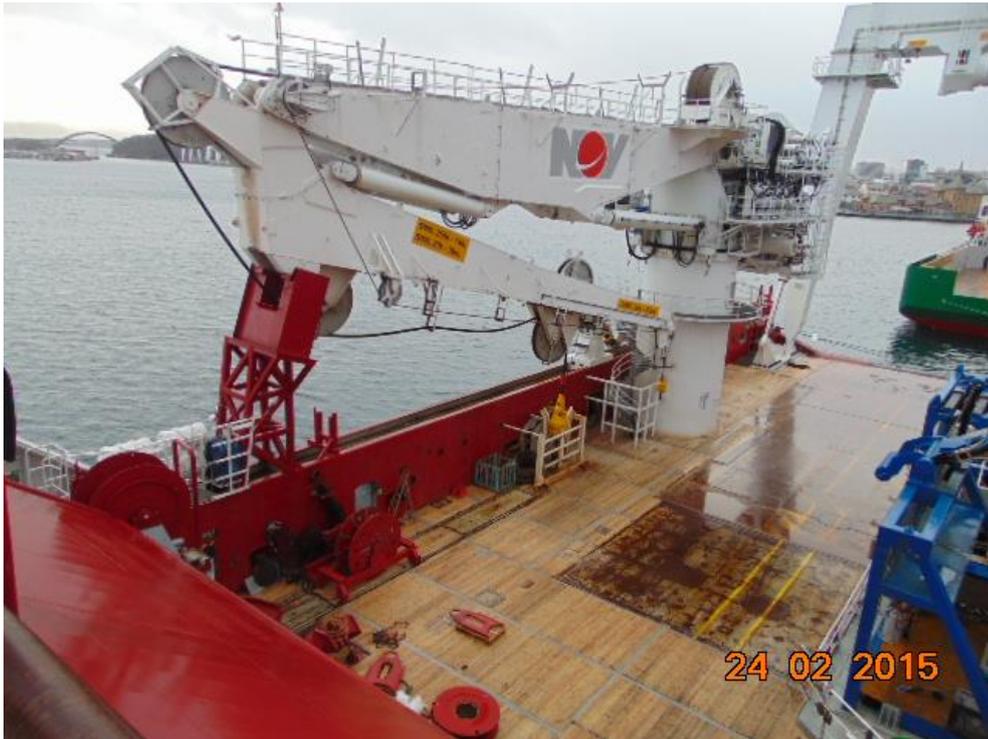
Figure 4: Crane (20-tonne) for lifting Gypsy

- 5.1.1 When the crane hook and slings were connected to the Gypsy, the crane hook was not directly above and in line with the center of the Gypsy. Therefore, when the crane lifted the Gypsy it swung out into the working area.
- 5.1.2 There were no guide-lines or chain block attached to the Gypsy to control swing or careful positioning of the Gypsy on the hatch cover when lifting or lowering.
- 5.1.3 When the Gypsy was finally landed longitudinally, it was not landed in its intended location. Instead, it was landed to starboard of its intended position with the starboard side Gypsy rim on the edge of the chain hauler guide rail.

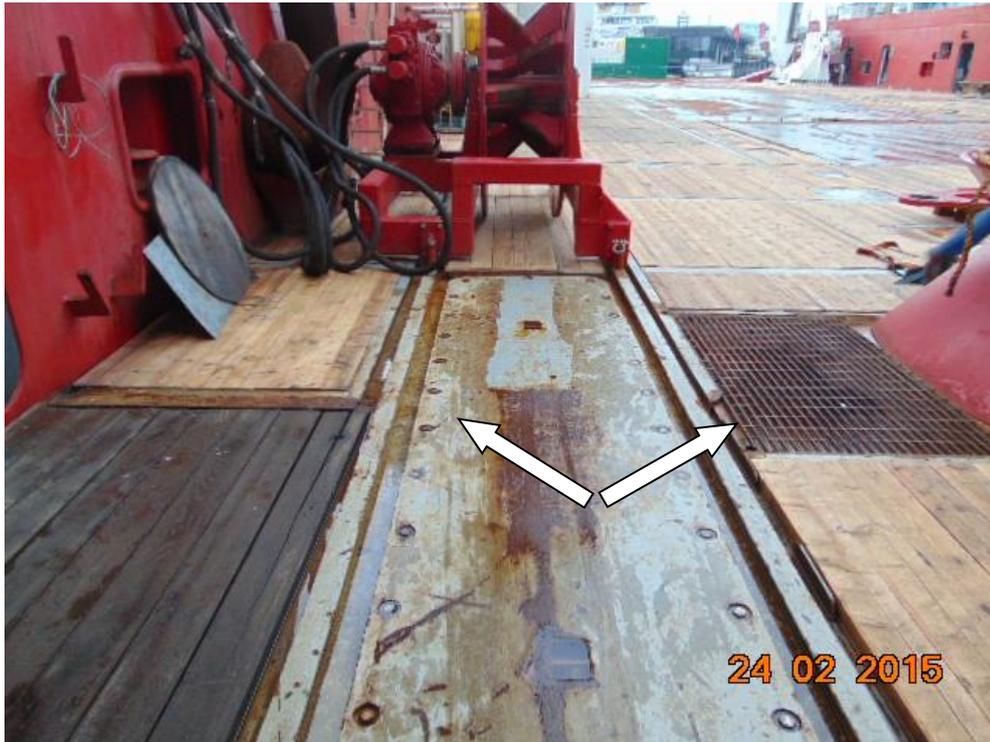
Figure 5: Chain hauler guide rails

- 4.6 The 84mm Gypsy was released and lifted from the stowage area. It was then lowered landing longitudinally aft of the starboard side AHT winch on the deck hatch cover between the chain hauler guide rails.
- 4.7 The crane sling was disconnected and the five (5) deck crew began to roll the Gypsy forward.
- 4.8 One rim of the Gypsy dropped into the starboard side chain hauler guide rail and became unbalanced, it immediately tipped over falling towards two (2) of the deck crew standing on the starboard side.

5.2.7 The description of hazards identified did not have hazards related to the chain hauler guide rails, the hatch cover coaming or the risk of manual handling of a Gypsy weighing 2492 kg.

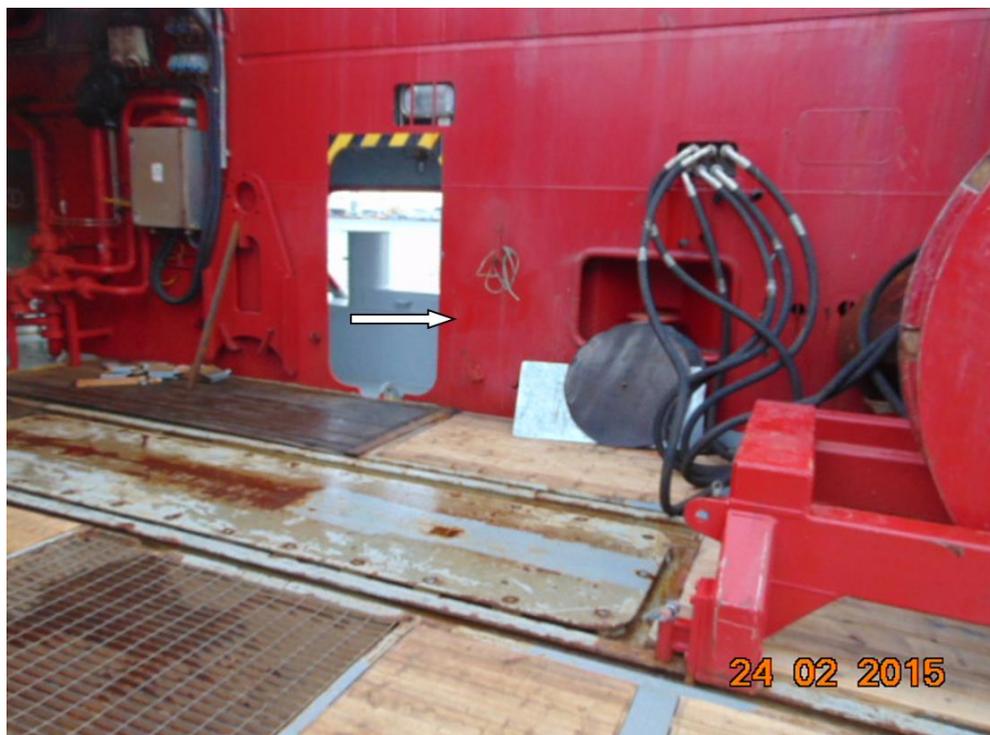
Figure 6: Location of crew member trapped between Gypsy and bulkhead

- 4.9 One (1) of the deck crew was caught between the Gypsy and the bulkhead as indicated by the arrow within figure 6 below. The Gypsy struck the crew member on the chest, pinning him to the bulkhead. Several members of the crew who witnessed the incident immediately attempted to free the crew member by lifting the Gypsy but due to its weight, were unable to do so.

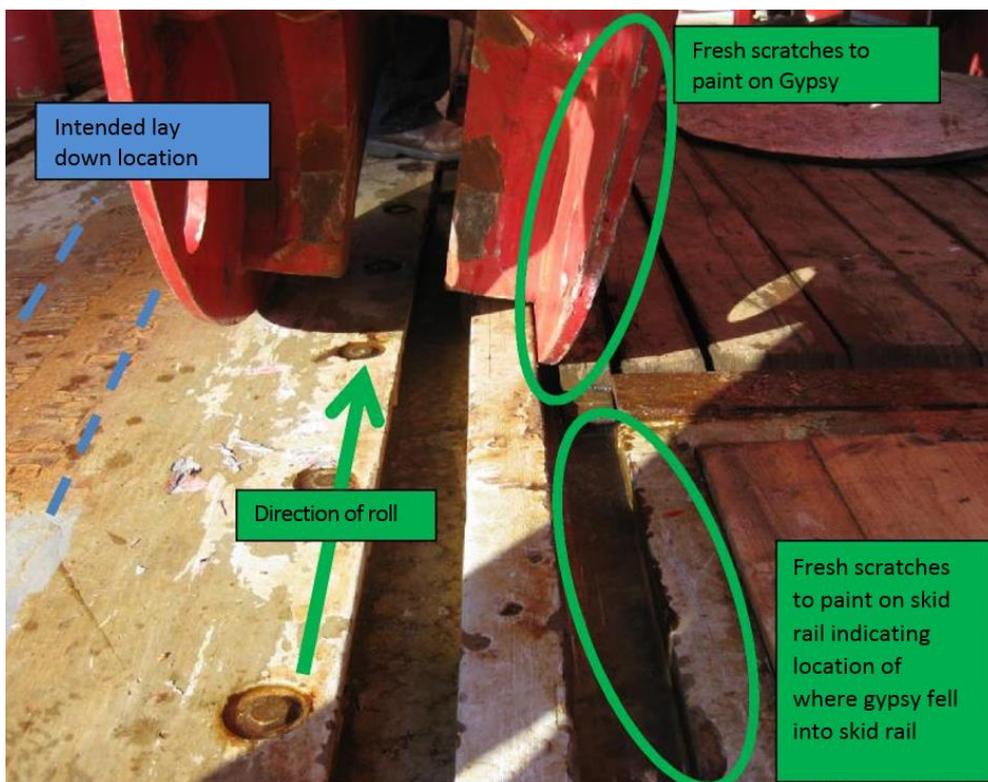
Figure 7: Demonstration of Gypsy dropped into the starboard side guide rail

- 5.1.4 From the evidence collected it was observed that none of the deck crew were concerned with the positioning of the Gypsy, they were all concentrating on manually steadying the Gypsy in a vertical plane (weighing 2492 Kg) and disconnecting the crane hook.

- 7.1 It is recommended to develop an effective safe working procedure for the manual handling of the Gypsy on deck.
- 7.2 It is recommended to review the risk assessment and permit to work procedures to facilitate an effective identification of hazards and mitigation of risks related to the handling of the Gypsy and associated equipment.
- 7.3 It is recommended to consider each task as a separate operation if more than one task is scheduled to take place involving manual handling of heavy equipment.
