M.V. Tropical Star

**Report of the marine safety investigation into a
crew fatality on a refrigerated cargo vessel
on 15 June 2019**

M.V. Tropical Star – Marine Safety Investigation Report

Date of Issue: 19 November 2019

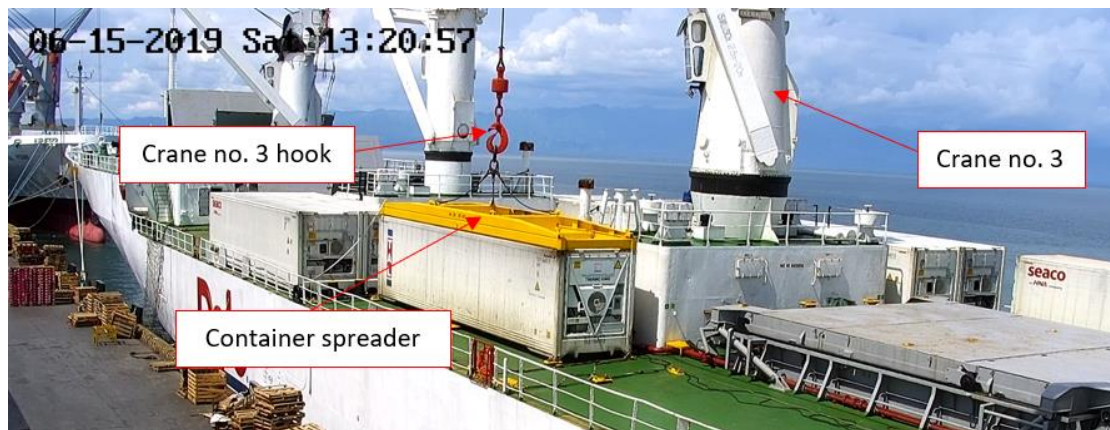
- 4.5 The duty AB and OS tested the proximity switches of crane 1, 2 and 4.
- 4.6 As the hook of crane no. 3 was connected to a container spreader attached to a container placed on deck, the AB and OS needed the assistance of additional deck personnel to operate the crane to test the switch, while they could unhook the crane from the spreader.

Figure 4: Location of the hook of Crane no. 3

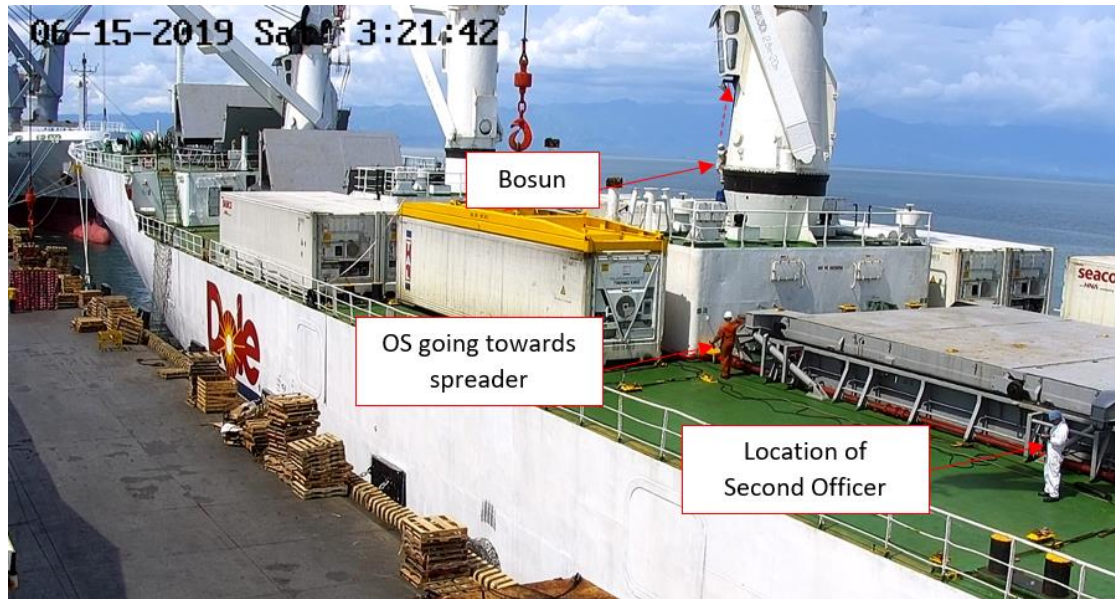
Figure 5: CCTV footage screenshot of Bosun climbing up the outside vertical ladder and OS going towards the spreader

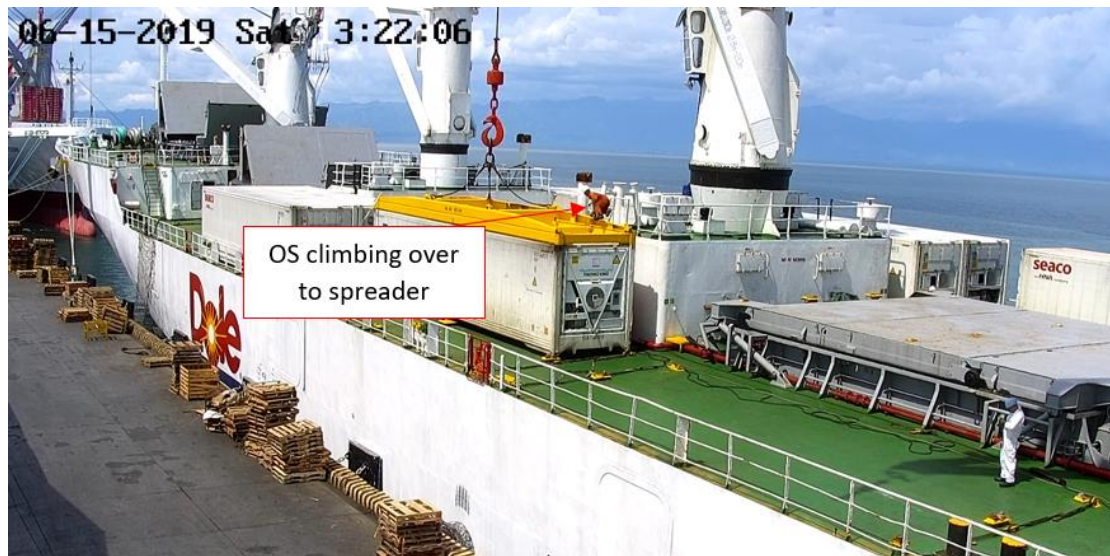
Figure 7: CCTV screenshot of OS climbing over from the crane mast house to the top of the spreader

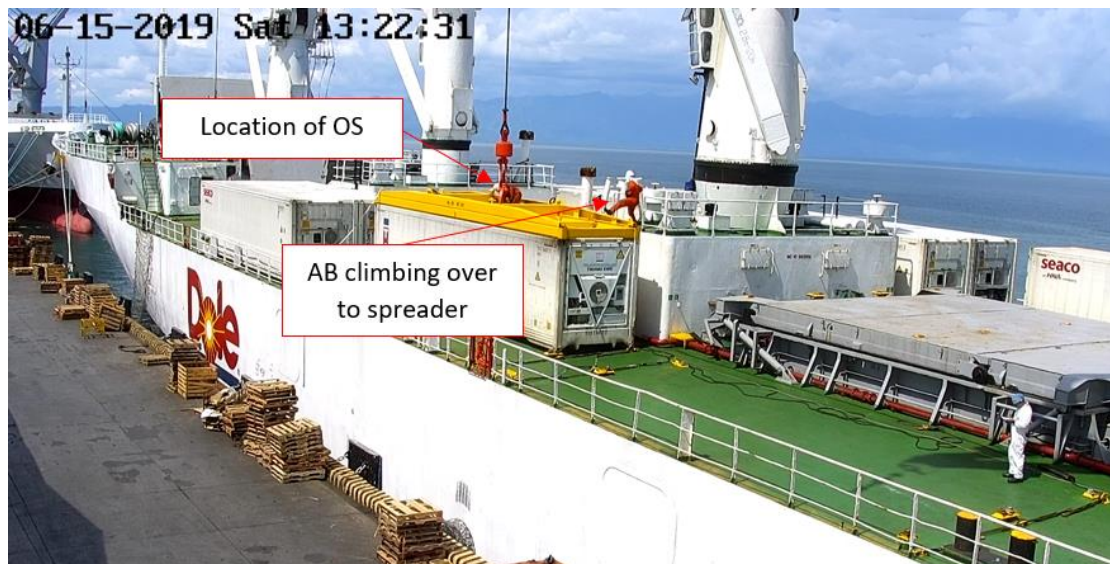
Figure 8: CCTV screenshot of AB climbing over from the crane mast house to the top of the spreader

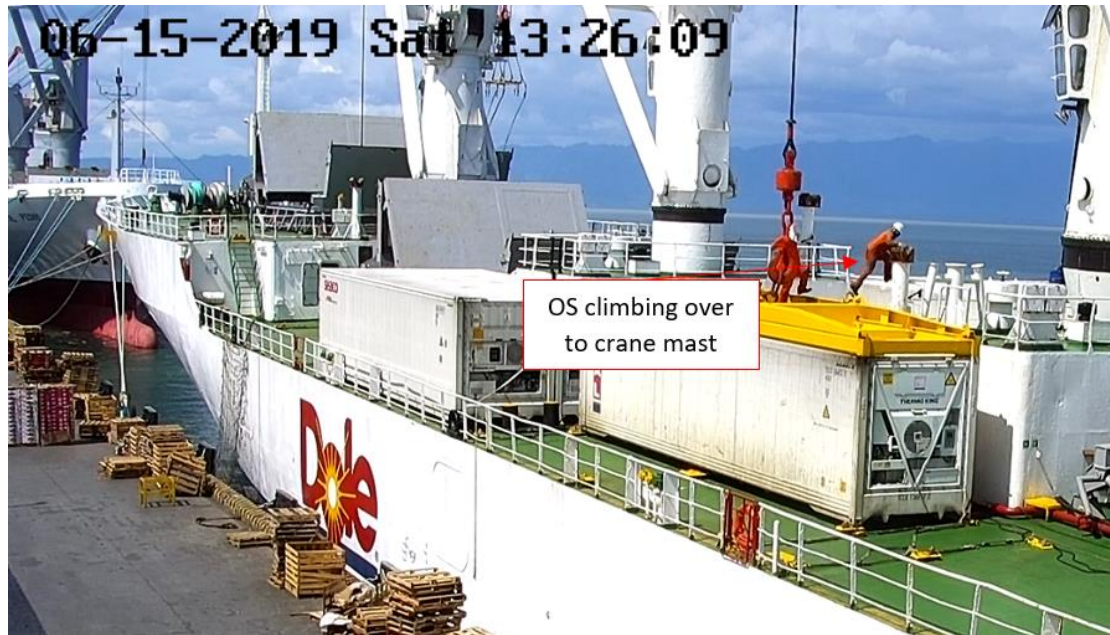
Figure 11: CCTV screenshot of OS climbing on to the crane mast house over the crane mast house railing

- 5.2.4 After completion of the test, the AB and the OS connected the hook of the crane back to the spreader and climbed back to crane mast over the crane mast house railing (Figure 11 and Figure 12). The Bosun accessed the crane using the outside vertical ladder and was using the same ladder to descend on completion of the work activity.

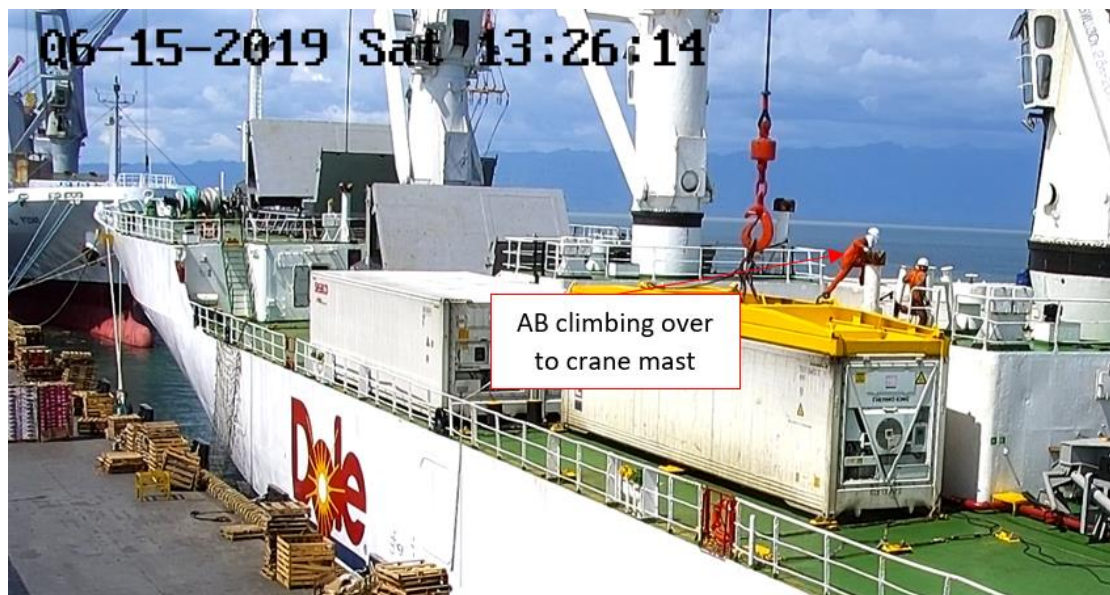
Figure 12: CCTV screenshot of AB climbing on to the crane mast house over the crane mast house railing

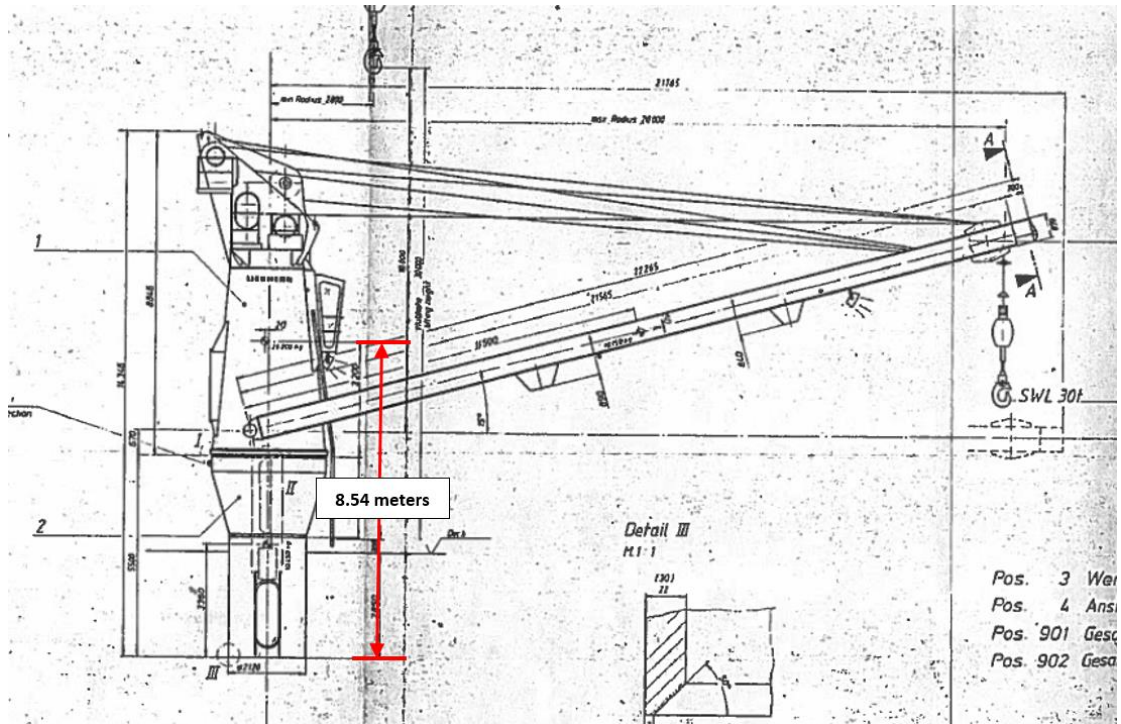
- 4.14 Moments later the Bosun came out of the crane cabin and climbed upwards for a few steps on the ladder and then commenced to descend the ladder. From the evidence available during the investigation, it could not be determined why the Bosun took a few steps upward on the ladder before he commenced his descent.
- 4.15 While descending the ladder, the Bosun fell from a height of 8.54 meters on to the ship's deck, in between the cargo hold and crane structure.

Figure 13: Bosun's fall distance from crane cabin to the ship's deck

- 6.1 The deceased Bosun fell from a height of 8.54 meters on to the ship deck while descending from the crane cabin using the outside vertical ladder. This vertical ladder was the ladder for emergency descent as per the crane's technical manual.

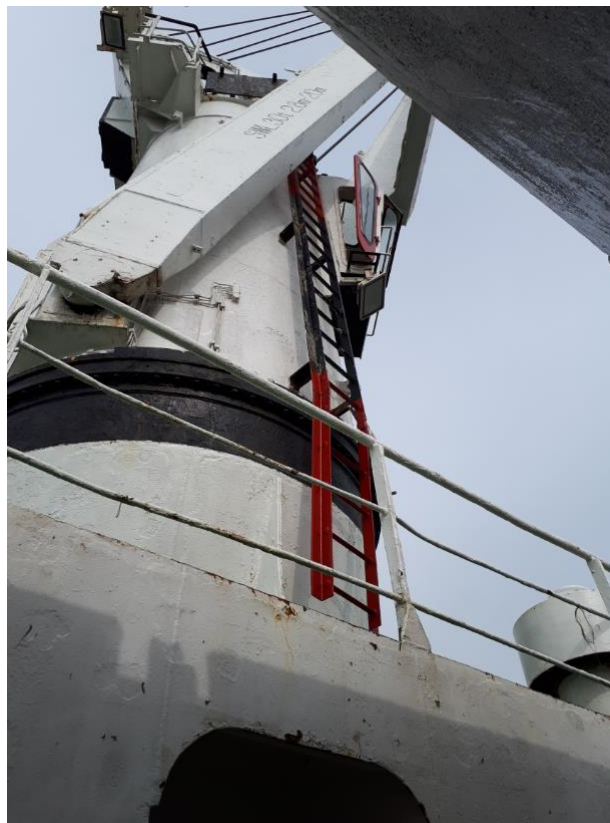
Figure 16: Outside vertical ladder (used by Bosun to access crane cabin)

- 5.1.5 The ship's crew was aware of both access ladders. However, the outside vertical ladder was usually used to access the crane cabin by the crew and the Stevedores.
- 5.1.6 The outside vertical ladder had a height of 8.54 meters from the ship's deck and 5.39 meters from the crane mast housetop. The vertical ladders onboard did not have any protection structure (such as a safety cage) or any fall prevention mechanism as part of the ladder structure design. Also, no fall prevention device was used by the crew members or Stevedores while using the outside vertical ladder to access the crane cabin. Neither the Flag State regulations nor the Company's² SMS procedure(s) stipulates any requirement to have protection structure incorporated as part of the ladder structure design or the crew members to use any personal fall prevention device.

- 6.3 The Company does not have any specific training requirements for crew members operating the crane.
- 6.4 Neither crew member involved in the work activity on the day wore a safety harness or fall prevention device. Further, the crane structure did not have any fall prevention mechanism in place to prevent the fall from height.

- 7.1 Consider providing training to deck crew focusing on effective risk assessment and appropriate hazard identification such as fall hazards while working on deck and accessing any structures on deck.
- 7.2 It is recommended to update the Company SMS with appropriate procedures and specific checklist(s) ensuring mitigation of the hazards involving risk of fall from height.
- 7.3 Consider providing a physical solution to prevent crew members from falling from height.
- 7.4 Consider reviewing the process of updating the PMS records after installation of any equipment or part thereof.
- 7.5 Consider implementing safety training for crew members focusing on the safe operation of the cranes onboard.

- 7.6 Consider updating the BMA regulations and/or BMA requirements to include specific requirements to ensure that suitable control measures and physical solutions are implemented on all Bahamas registered vessels to mitigate the hazards involving risk of fall from height.

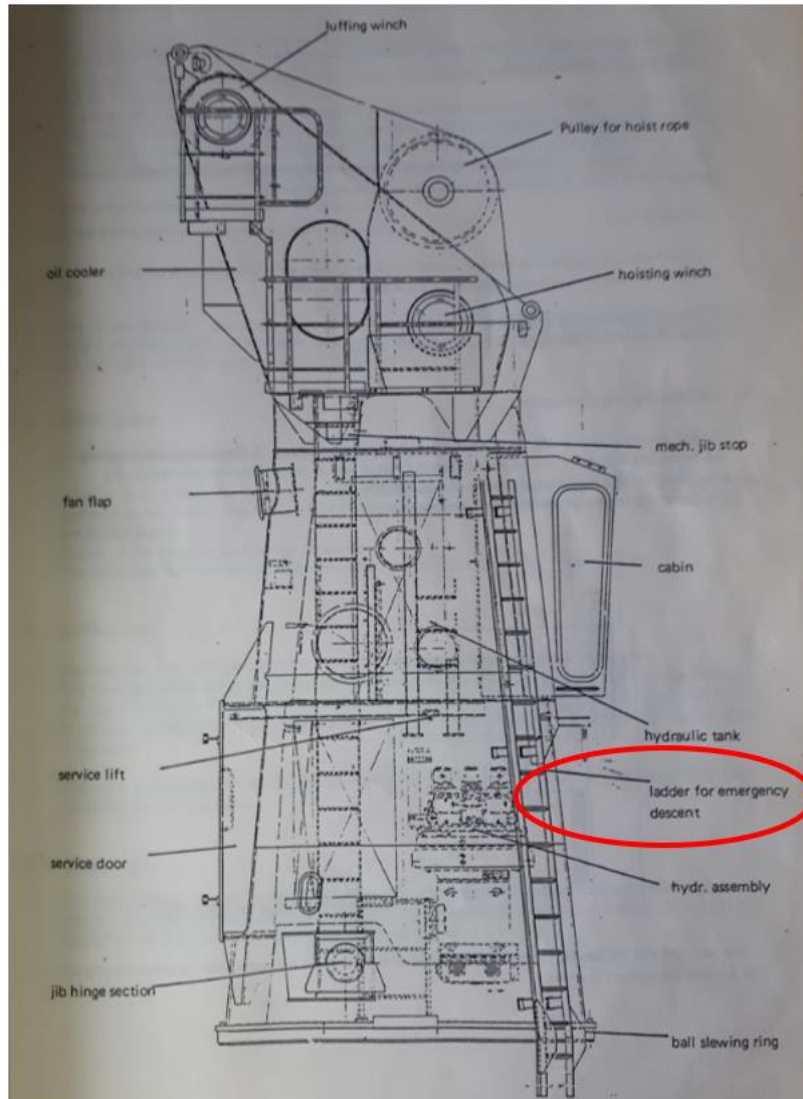
- 5.1.4 As per the crane technical manual the outside vertical ladder is the ladder for emergency descent.

Figure 18: Scan of the crane drawing from the technical manual

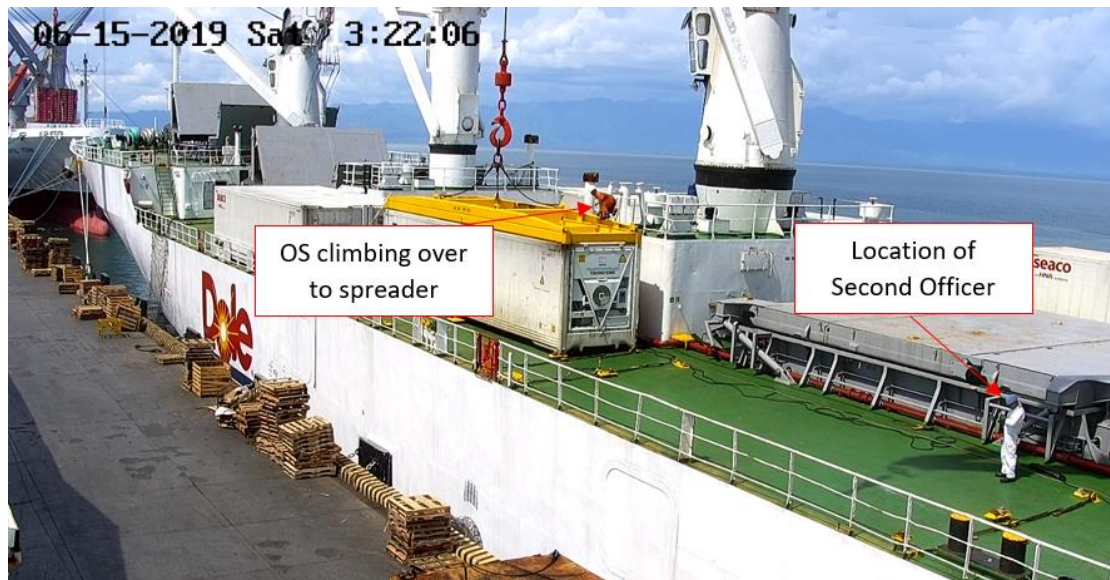
Figure 19: CCTV screenshot of OS climbing over from the crane mast house to the top of the spreader

- 5.2.5 The OS and AB were exposed to the fall hazard at various instances while climbing on the container top and on the crane mast house ladder without any fall prevention safety measures in place. However, these hazards were not identified and mitigated by the crew members or the Second Officer on deck.

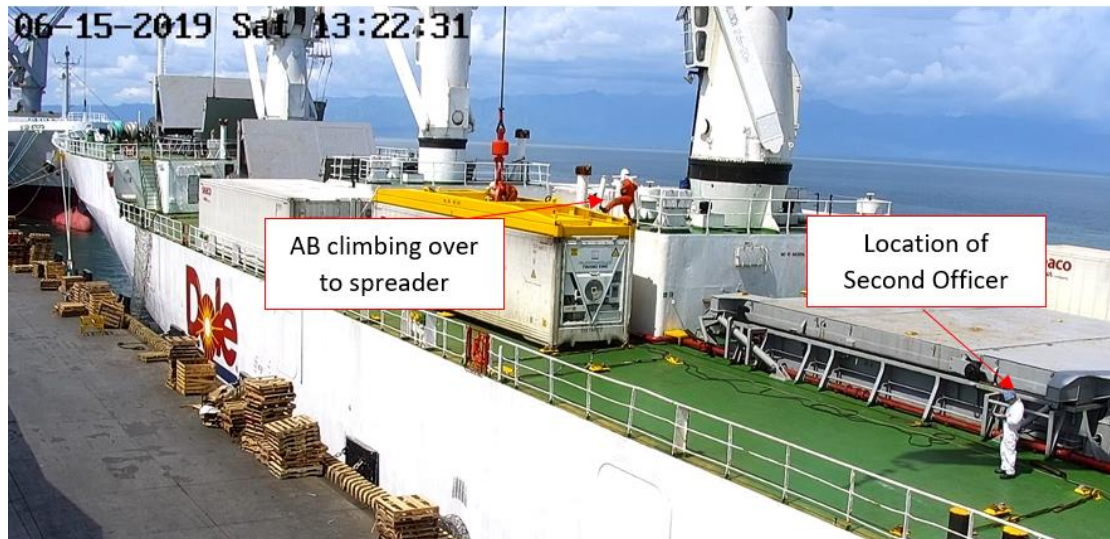
Figure 20: CCTV screenshot of AB climbing over from the crane mast house to the top of the spreader

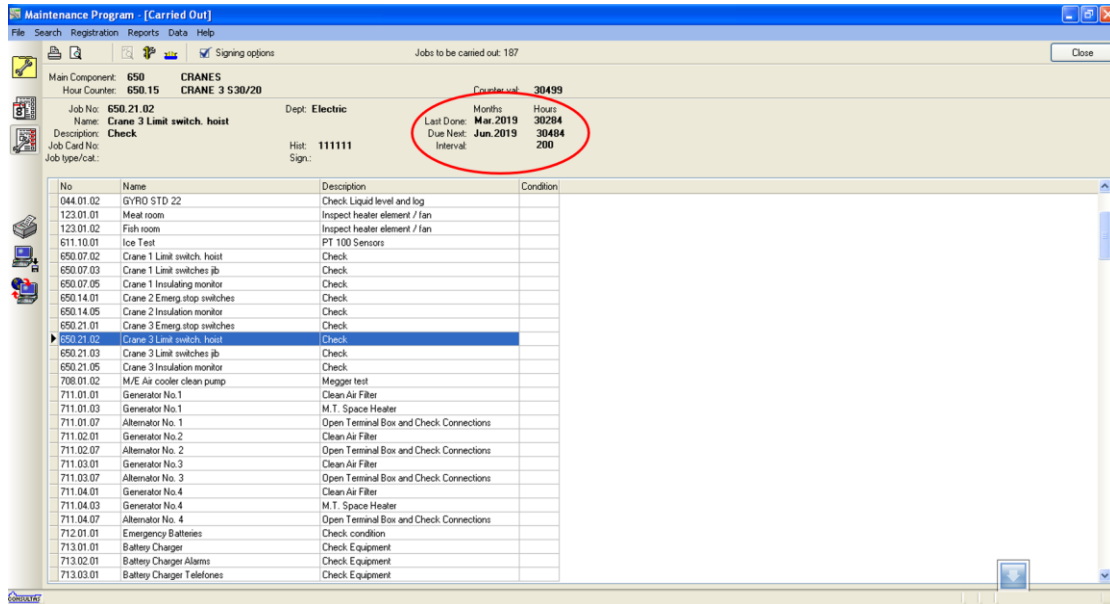
switch test for crane no. 3 limit switch⁶ as June 2019 and the Chief Officer decided to test the switches while the vessel was in Davao.

Figure 21: PMS screenshot image for crane no. 3 limit (proximity) switch test

- 6.5 Although the new proximity switches were installed in May 2019 replacing the mechanical limit switches, the PMS records calculated running hours of the crane for limit switch test (200 hours) from the last test conducted on the mechanical limit switches in March 2019 and not from the date of the newly installed proximity switch.
