**The Bahamas  
Maritime Authority**

**M.v SEAHERO  
IMO NUMBER: 9315642  
OFFICIAL NUMBER: 7000820**

**Report of the marine safety investigation into the  
disappearance of a crew member off the coast of Angola,  
Gulf of Guinea on 18<sup>th</sup> May 2018**

## M.v Seahero – Marine Safety Investigation Report

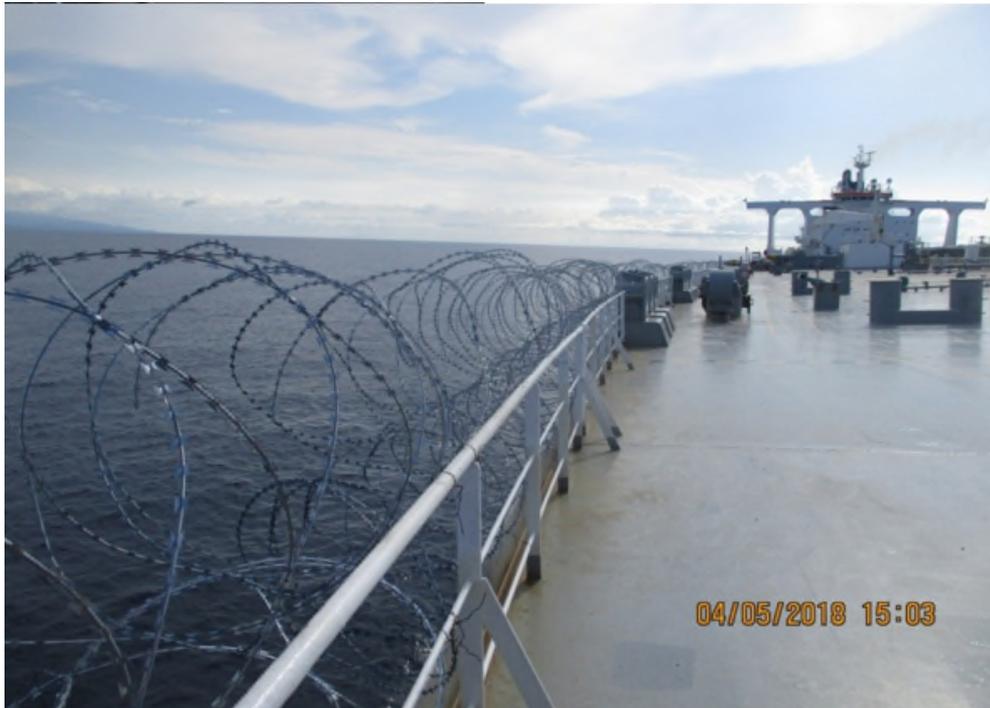
- 4.3 Due to the existing threat of piracy and armed robbery in the region of the west coast of Africa the vessel on departure from Sao Tome had rigged razor wire around the entire upper deck connected to the guard rails as a self-protective measure in accordance with the vessel's security procedures (see figure 3). Once the Master deemed the threat no longer existed taking into account the vessel's geographic location, the razor wire was dismantled by the evening of 17 May.

Figure 3: Starboard side razor wire in place as a self-protective measure against threat of unauthorised boarding

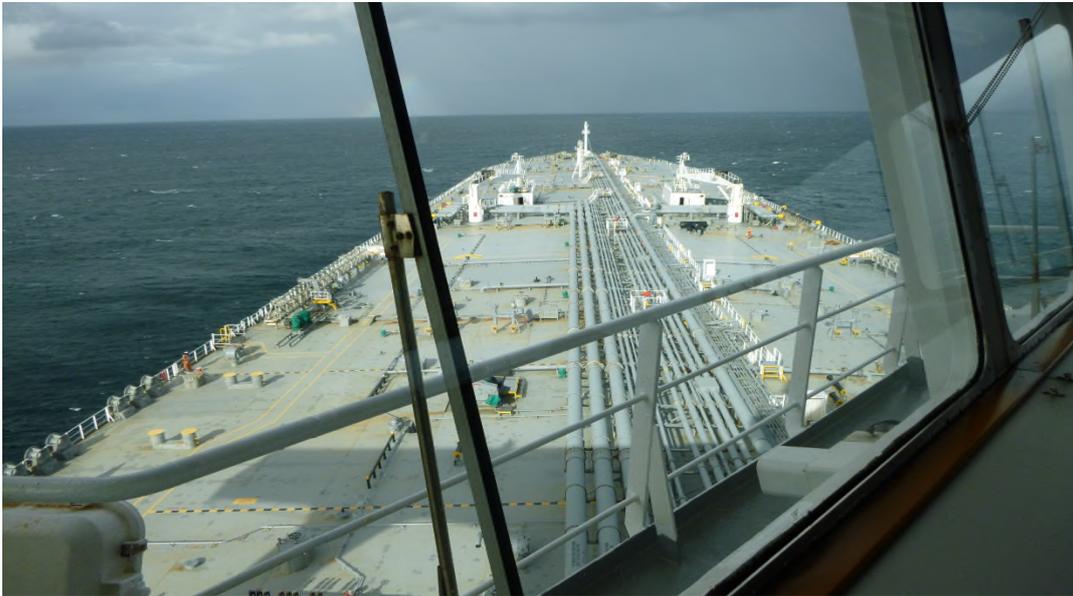
- 5.1.3 The weather was not favourable for a Man Overboard search despite relatively good visibility, with a moderate southerly wind of 11-21kts, small to moderate waves, numerous whitecaps and some spray, it could be considered extremely difficult to sight an object the size of an adult human in the water, even at relatively close range. As a perspective, the image taken below was taken on 28 May 2018 with a strong breeze between 16-20kts with numerous white caps visible in the foreground. At night the moon provided limited light while at 50% illumination. The current experienced in that region was set to the north west between 0.5 and 1.5kts and was taken into consideration when searching the area, in particular to the north of the datum which was used a reference point of the last known sighting.

Figure 4: View from bridge taken on 27 May 2018

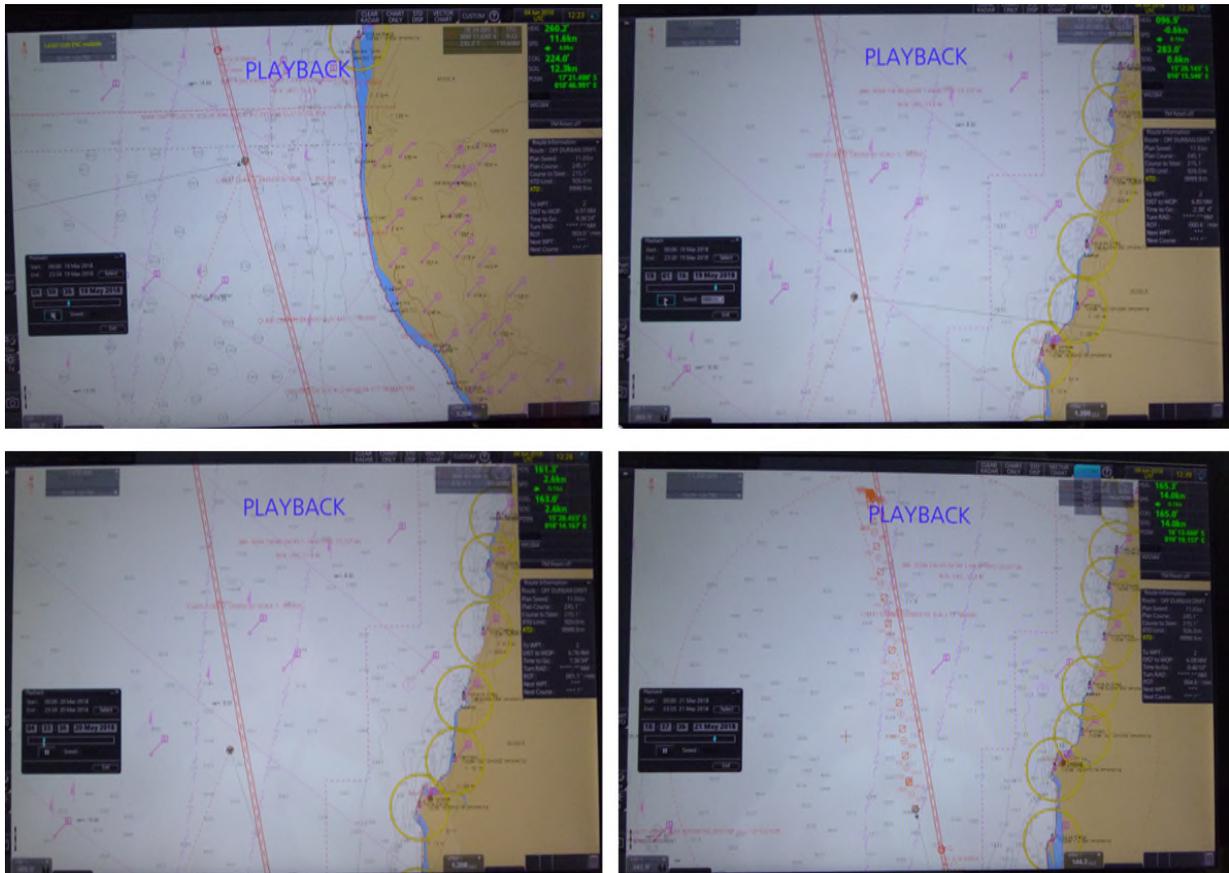
- 5.1.5 The following screen shots taken from the ECDIS playback show the vessel's route over the course of the three days between 19 and 21 May. The vessel's transit north and south along the previous track, maintaining a holding position during the hours of sunset and sunrise before continuing the search at first light. On average, the vessel covered approximately 80nm per day scouring the Gulf of Guinea for the missing Electro Technical Officer.

Figure 5: ECDIS screenshot of location of the vessel during the various stages of search; clockwise from top left: 0950(UTC+1) 19 May 2018, 1901(UTC+1) 19 May 2018, 0435(UTC+1) 20 May 2018 and 1637(UTC+1) 21 May 2018.

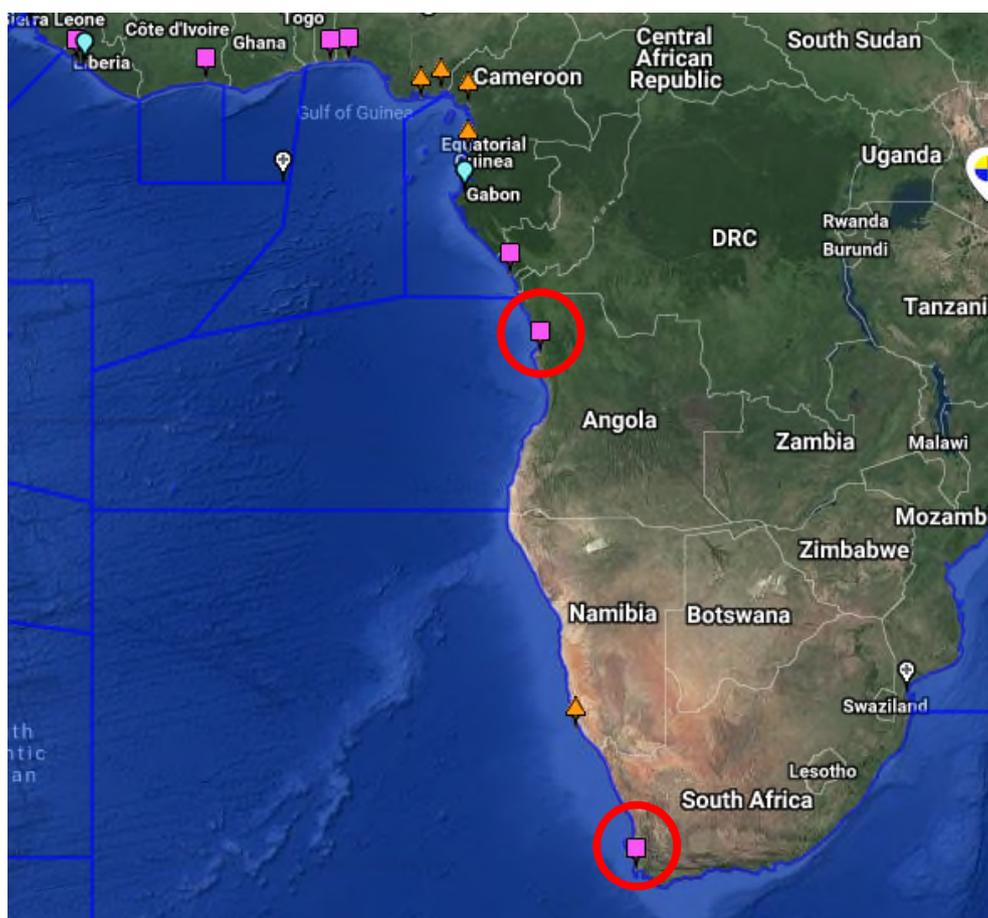
- 5.2.1 In accordance with the relevant sections of the Emergency Preparedness & Training Manual pertaining to external communications, the vessel notified MRCC Angola and MRCC Namibia via satellite phone, medium frequency (MF) and Digital Selective Calling (DSC) but did not receive a response. The only MRCC station to respond to the vessel was MRCC Cape Town who relayed the May Day message and maintained two-way communication via satellite phone throughout the search operation.
- 5.2.2 Despite multiple efforts by the vessel, MRCC Cape Town and JRCC Piraeus were the only coordination centres to acknowledge receipt with the vessel. MRCC Angola was the only search and rescue capable organisation within 200nm however as they did not respond to a request for assistance, no assistance was rendered to the vessel.

Figure 6: Location of MRCC Angola (top red circle) and MRCC Cape Town (bottom red circle)

- 6.4 Despite multiple requests for assistance from the nearest Maritime Rescue Coordination Centre in Angola, no acknowledgment or support was provided. MRCC Cape Town remained in communication with the vessel throughout the operation but were unable to render an available asset to aid the search due to the distance between the search area and location of available assets.

7.2 It is recommended that the Maritime Rescue Coordination Centre of Angola investigate the reliability and operational effectiveness of the centre in order to provide reassurance to the maritime community operating in the region of the availability of this vital resource.

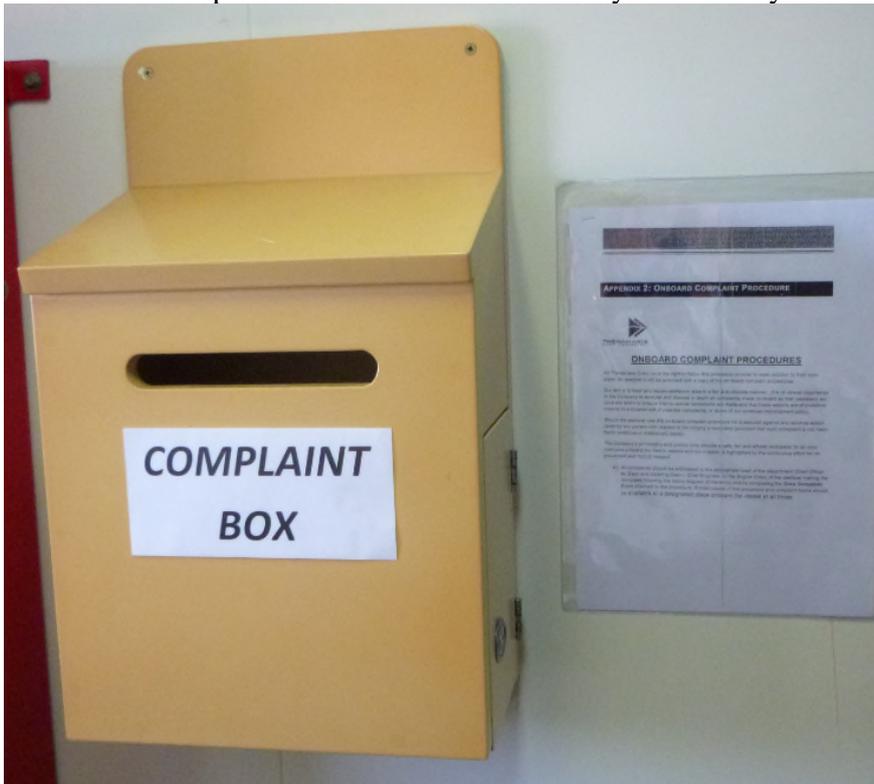
5.3.8 On board any Thenamaris Ships Management Inc. managed vessel, including Seahero, the crew have the right and access to the onboard complaint procedure. The aim of the complaint procedure is to provide a discreet and anonymous reporting system whereby any complaint can be treated fairly and without recourse to the reporting individual. A box is provided for any submissions which is accessed only by the Master. The Master confirmed that there were no complaints received between 04 May and 19 May 2018.

Figure 7: Onboard complaints box and instructions for use displayed alongside
