**M.v. Pine Galaxy**

**IMO Number 9272682**

**Report of the marine safety investigation into an engine  
room fire which resulted in the death of an Able Body  
Seaman on 13<sup>th</sup> August 2014**

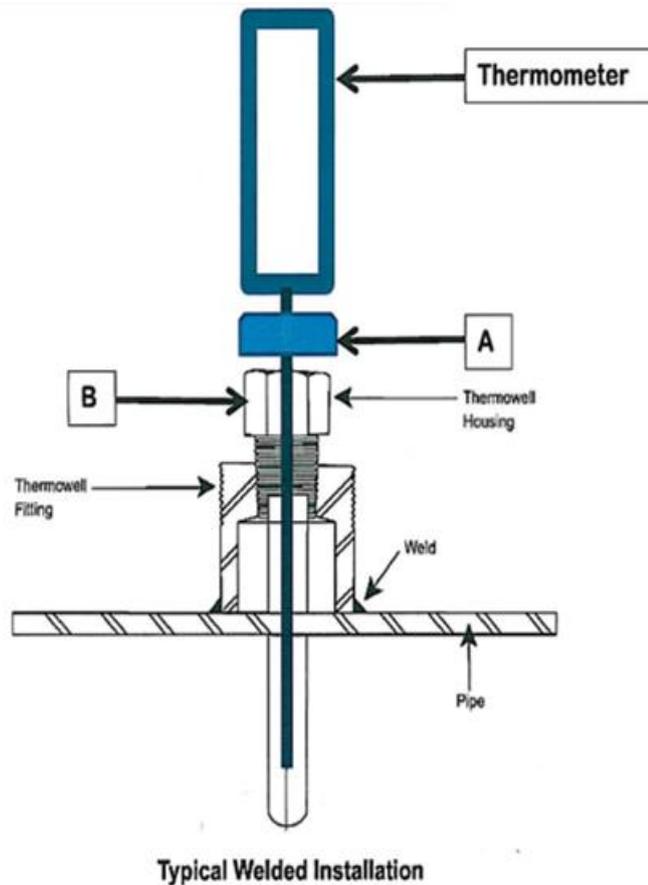
Figure 2: Thermometer installation diagram

- 4.8 The Second Assistant Engineer went to the No. 3 generator with the spare thermometer and pocket. Refer to figure 2, the pocket is marked as 'B'. He also had a spanner for the correct size for the pocket only. As he removed the pocket, the lube oil escaped through the hole at approximately 4.5 bar pressure contacting the exhaust manifold and igniting instantaneously.

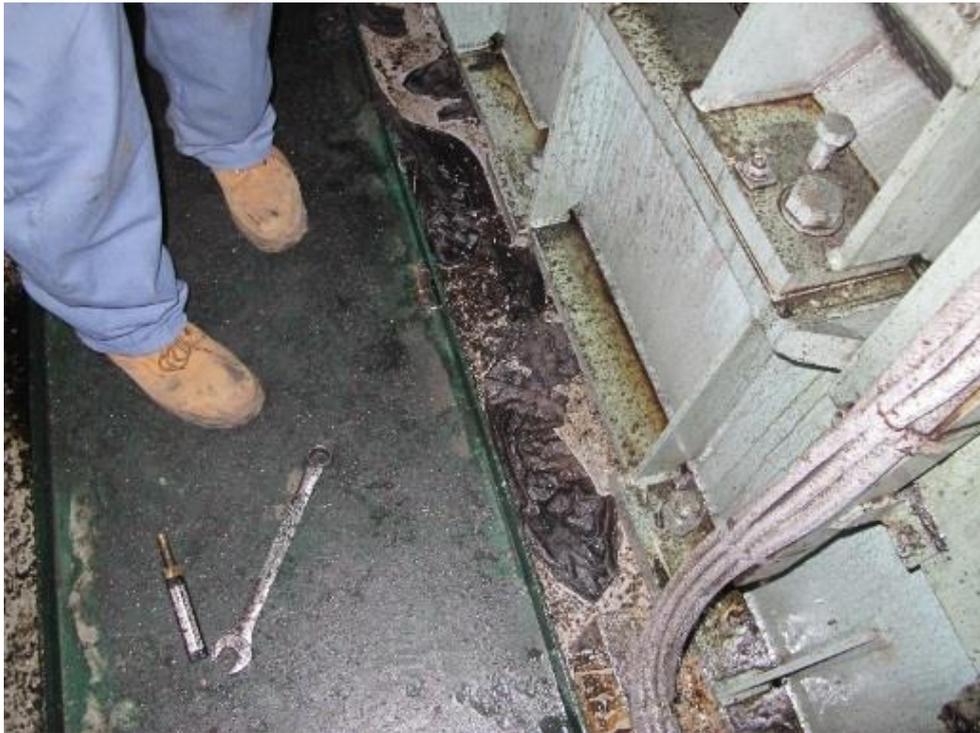
- 4.9 The Second Assistant Engineer was sprayed slightly with hot oil, without any burns reported. He dropped the replacement pocket, thermometer and spanner beside the generator before he exited the vicinity.

Figure 3: Replacement pocket, thermometer and spanner

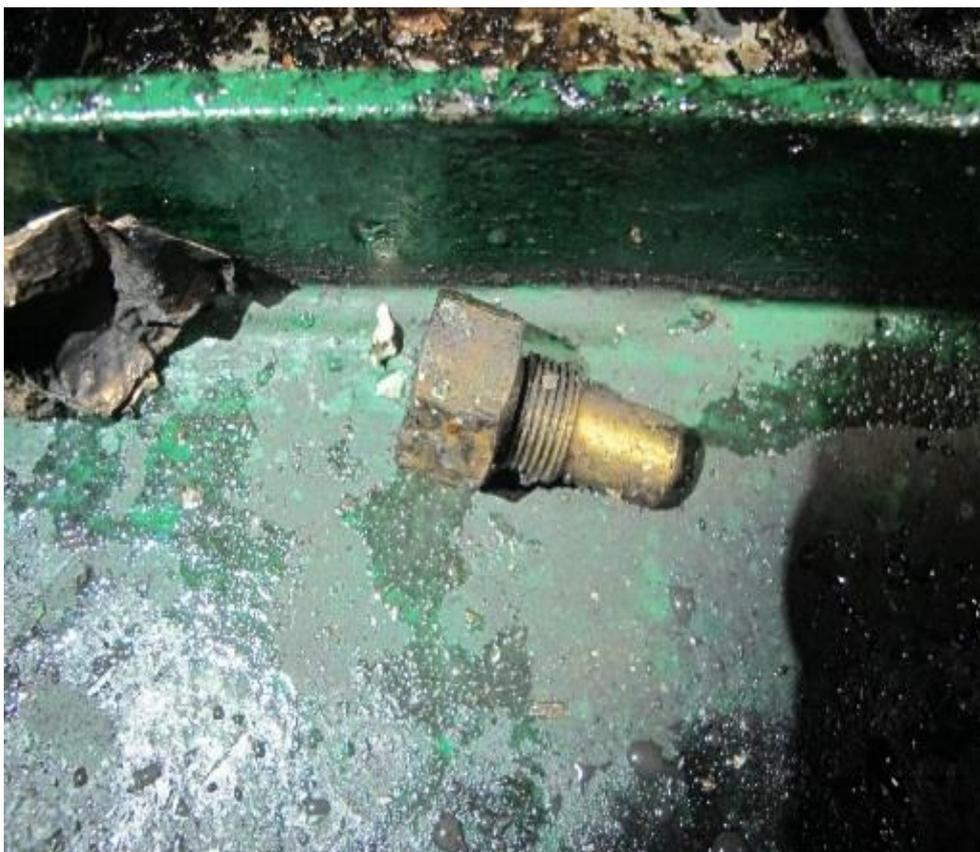
Figure 4: Old damaged pocket

6.2.3 The thermometer on the lube oil system was damaged during the routine maintenance on generator No.3. To replace the thermometer, the Second Assistant Engineer removed the complete pocket assembly instead of only the thermometer causing lube oil to spray vertically at approximately 4.5 bar pressure and directly contacting the exhaust manifold having a temperature of around 320° Celsius, while the generator was running.

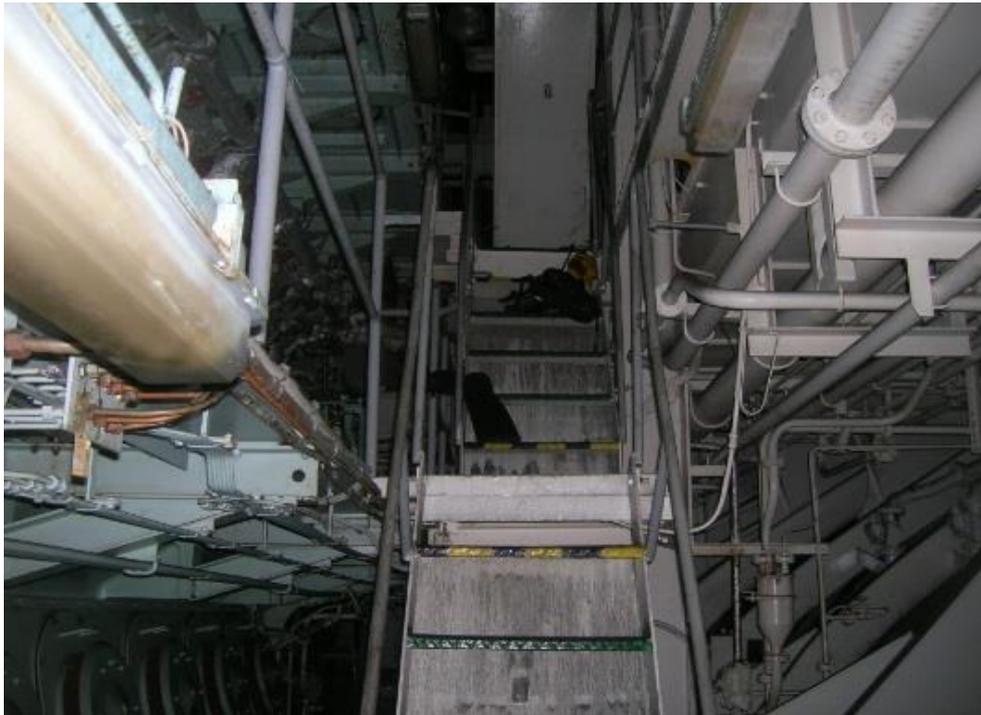
- 4.29 Subsequently, the Oiler, Second Assistant Engineer- C and another AB<sup>3</sup> entered to continue searching for the missing AB, who was found by the Oiler on the stairs, port side of the engine and 1.5 decks above the bottom plates. The casualty was found with his SCBA removed, helmet missing and gloves off.

Figure 5: Location where AB was found

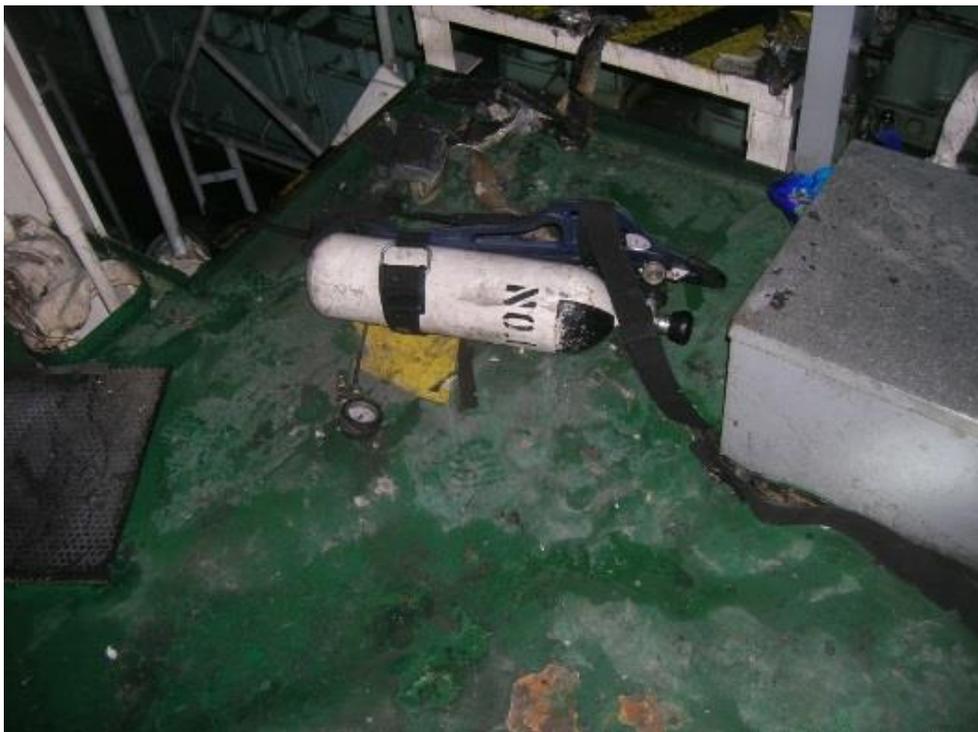
Figure 6: Removed SCABA set of AB

- 6.7.2 The test results indicated that the SCBA passed its functional tests, but the following faults were recorded:
- The gauge accuracy failed at its lowest pressure test by 16 psi under range. Based on this information the user will have had less air than indicated on the gauge.

- The face mask was found with a broken strap on the head harness.
  - A torn diaphragm on the 2<sup>nd</sup> stage regulator.
- 6.7.3 Global Fire & Safety concluded that it was likely the unit had not undergone a complete overhaul as required.

- 9.1.10 To improve SCBA communications throat microphones (2 per ship) had been sent to the fleet.
  - 9.1.11 Service stations used for annual servicing of the SCBA sets to be better evaluated for compliance with manufacturers requirements and recommendations.

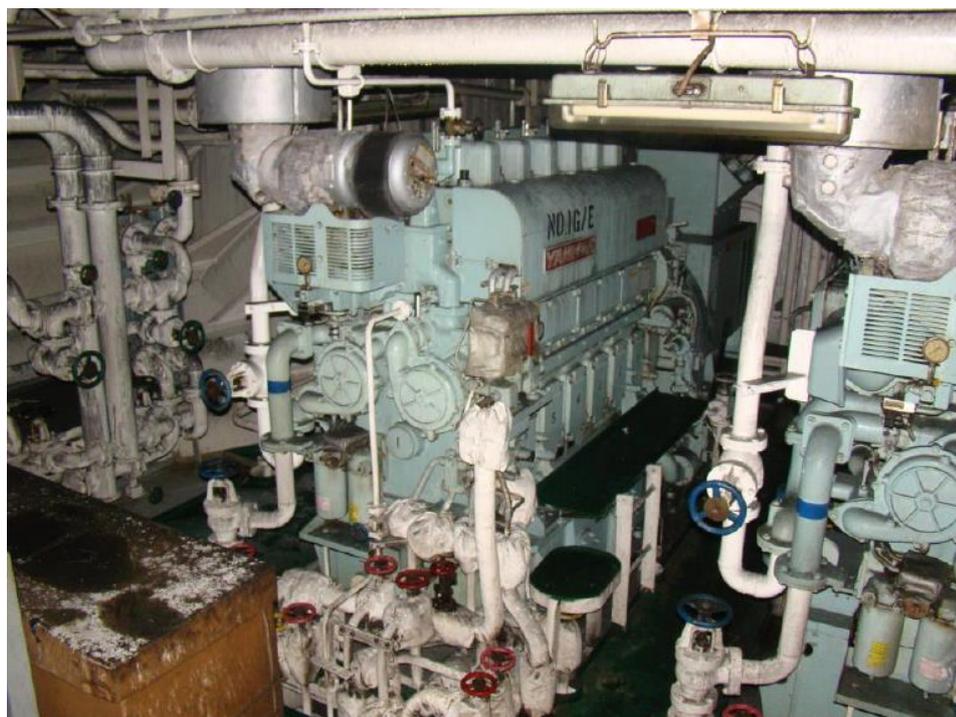
- 5.4 The cabling from the generators to the main switchboard located in the engine control room was heavily damaged. Refer to [Appendix 1](#).
- 5.5 Generator No. 1 had some oil residue on its surface but sustained negligible heat or direct fire damage. Generator No. 2 had a significant amount of oil on it, especially on the side facing generator No. 3.

Figure 7: Diesel engine of generator number 1

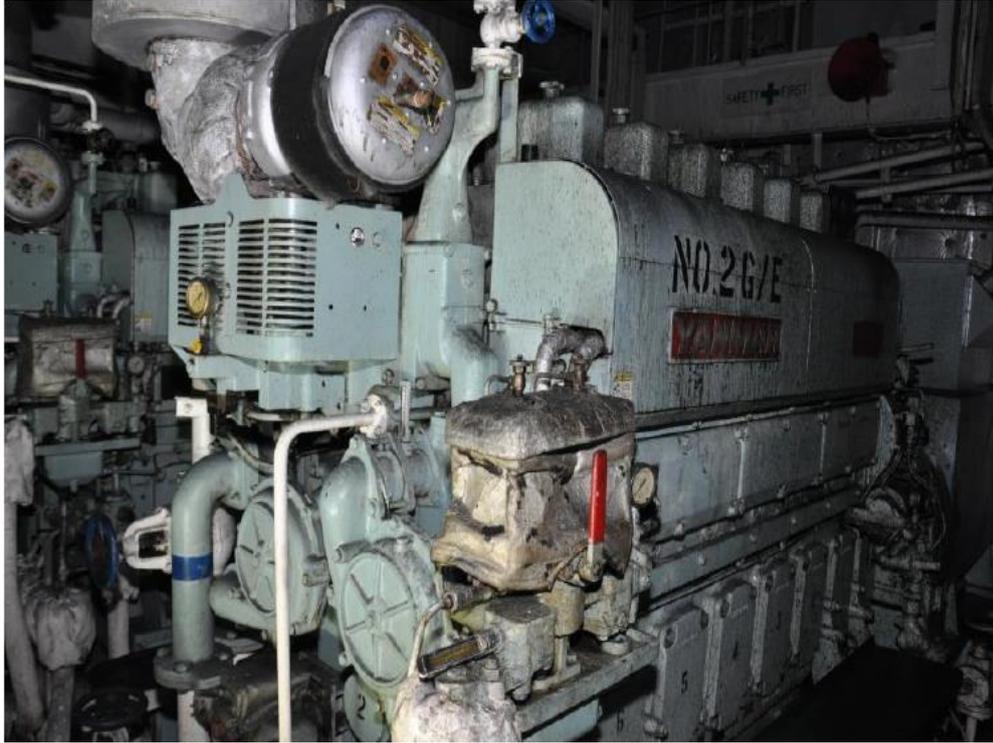
Figure 8: Diesel engine of generator number 2

- 5.6 Items directly above generators No.2 and No.3 showed signs of significant heat and fire damage, including the cables that carried power from the diesel generators to the engine control room.
- 5.7 The workshop area was subject to heavy fire and smoke damage.
- 5.8 The reason for the failure of the emergency generator was later determined to be a faulty voltage regulator.

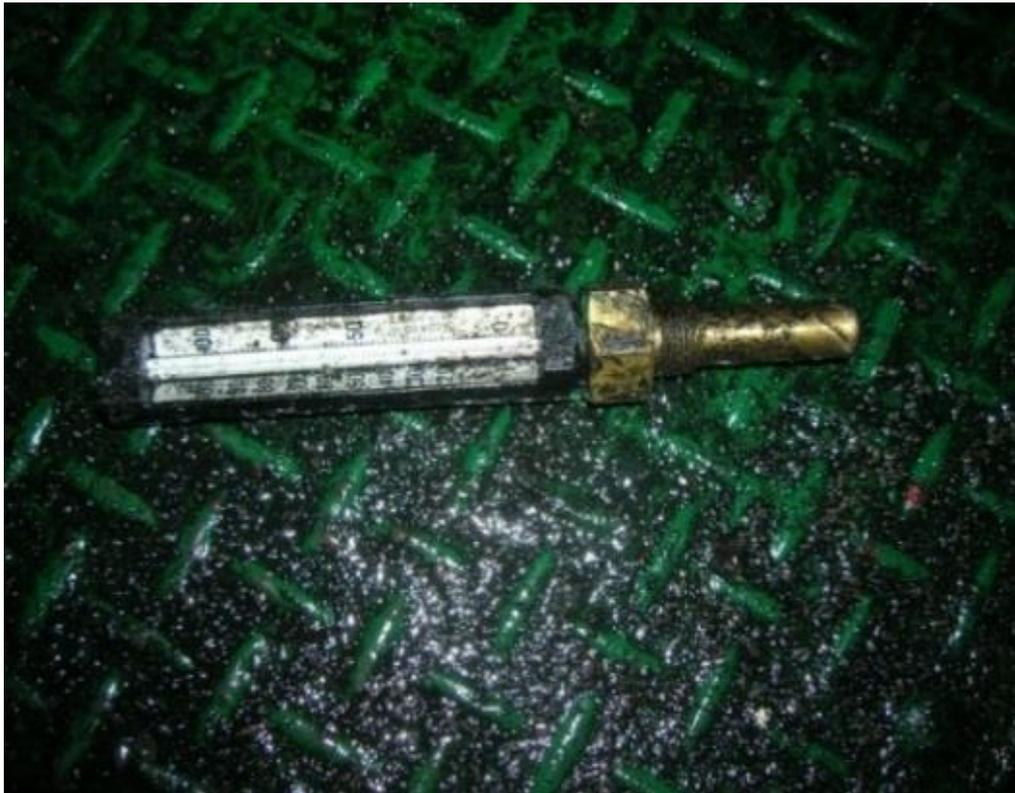
Figure 9: Replacement probe and pocket

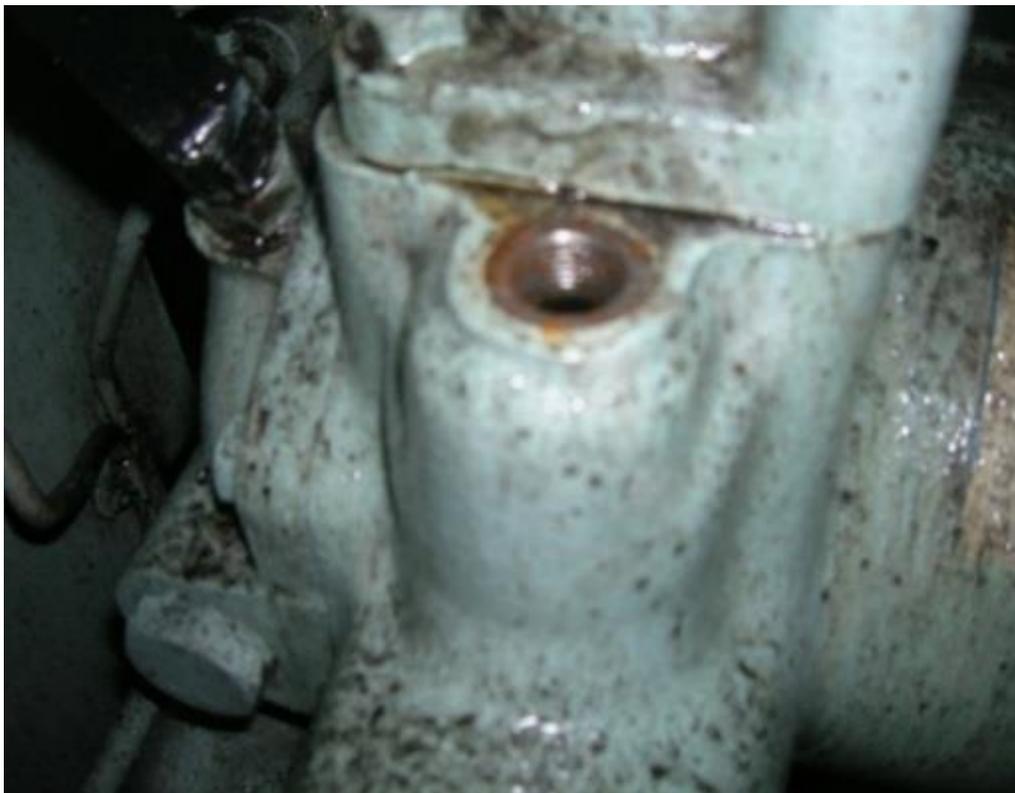
6.2.4 The Material Safety Data Sheet (MSDS) indicated that the lube oil had an open cup flashpoint of 185° Celsius. This means that, if a cup of the oil is heated to 185° Celsius in the presence of a competent ignition source, a flash fire can propagate through the vapour.

Figure 10: Location of probe on lube oil system

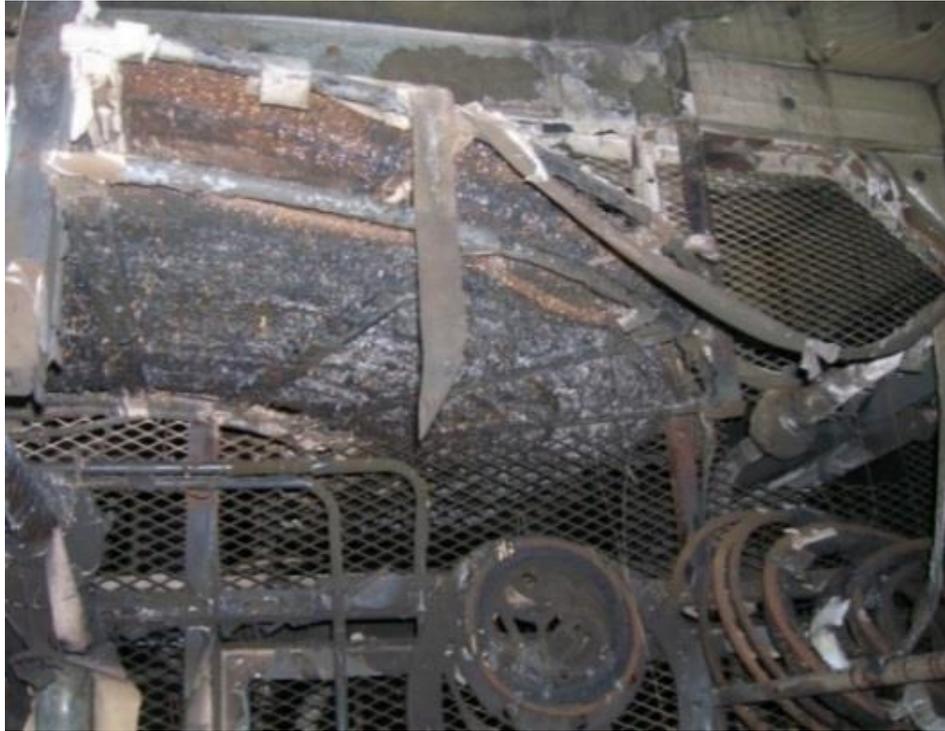
6.2.5 The fire started immediately at the deck head area above the generator and passed along the cable run towards the engine room workshop.

Figure 11: Workshop cable runs from generators to the main switchboard

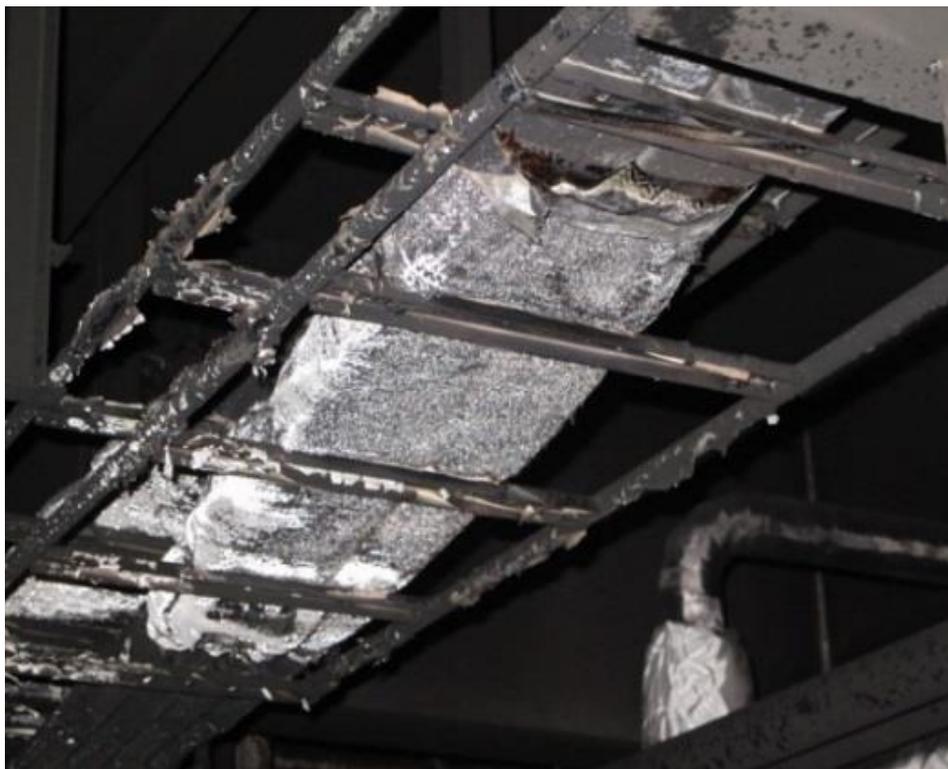
Figure 12: Damaged cables

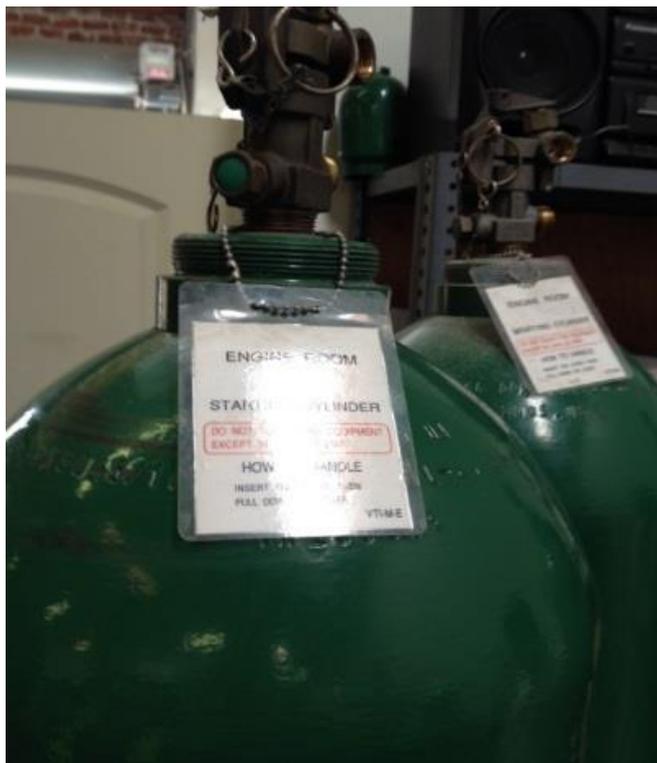
6.4.3 The CO<sub>2</sub> pilot bottles were not prominently marked to differentiate them from the regular bottles, the only marking consisted of a small plastic tag hanging around the neck of the cylinder.

Figure 13: Tags on pilot bottles

- 8.5 It is recommended to review the competency and experience requirements of Officers onboard with responsibilities of designated equipment.
- 8.6 Consider clearly marking CO<sub>2</sub> system pilot bottles to differentiate them from normal bottles.

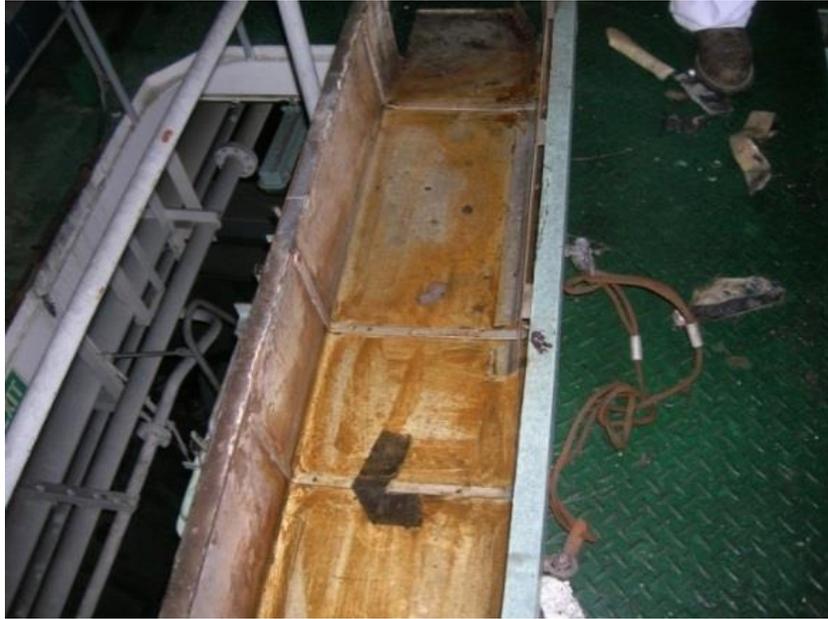
6.2.2 Generator No. 3 was put to service without the exhaust manifold cover in place. No explanation was given as to why the generator was run for an extended period of time with the exhaust manifold cover removed, other than it was necessary for checking for any leaks.

**Figure 14: The No. 3 generator exhaust manifold cover not in Position**

- 8.3 It is recommended to initiate a safety campaign to ensure all staff are aware of the hazards of running diesel engines with critical safety features removed.

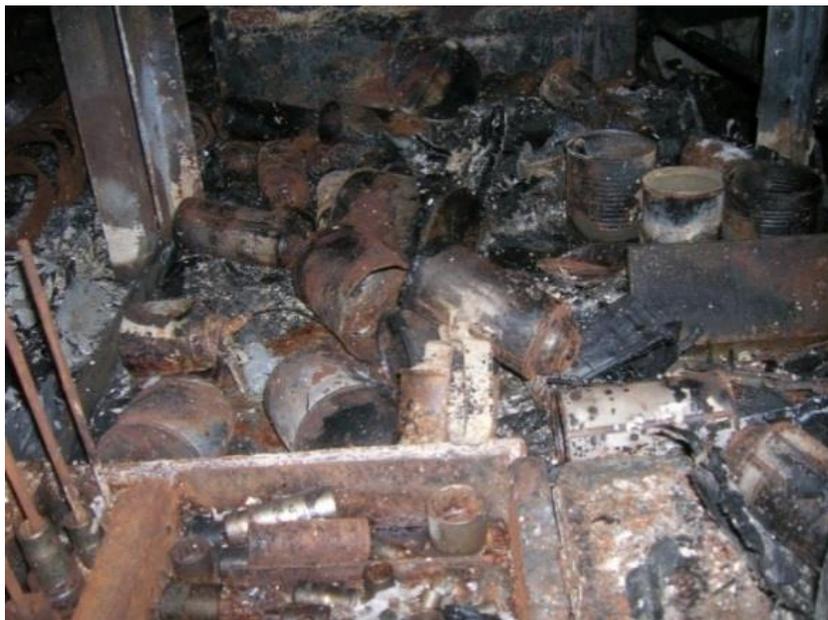
**Figure 15: Aerosol cans in Engine room workshop**

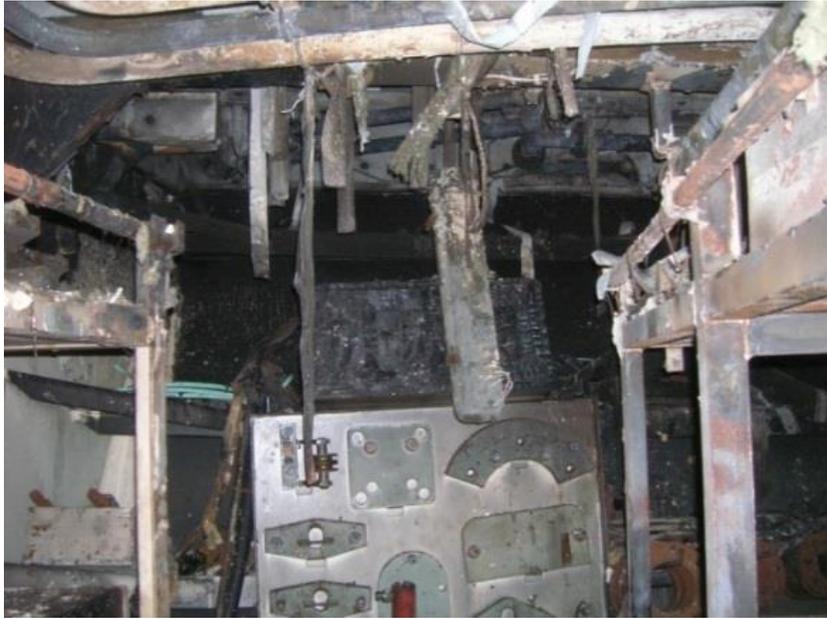
Figure 16: Damaged workshop area

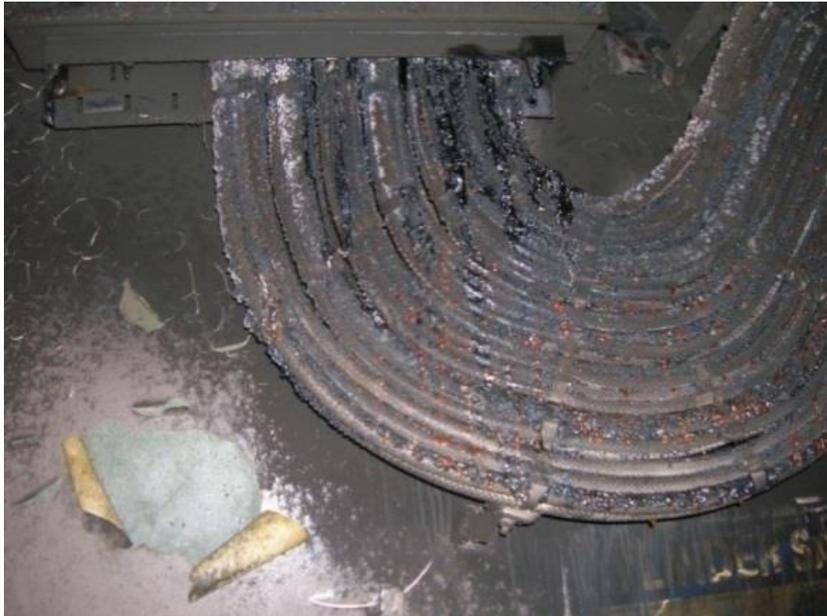
Figure 17: Damaged cables

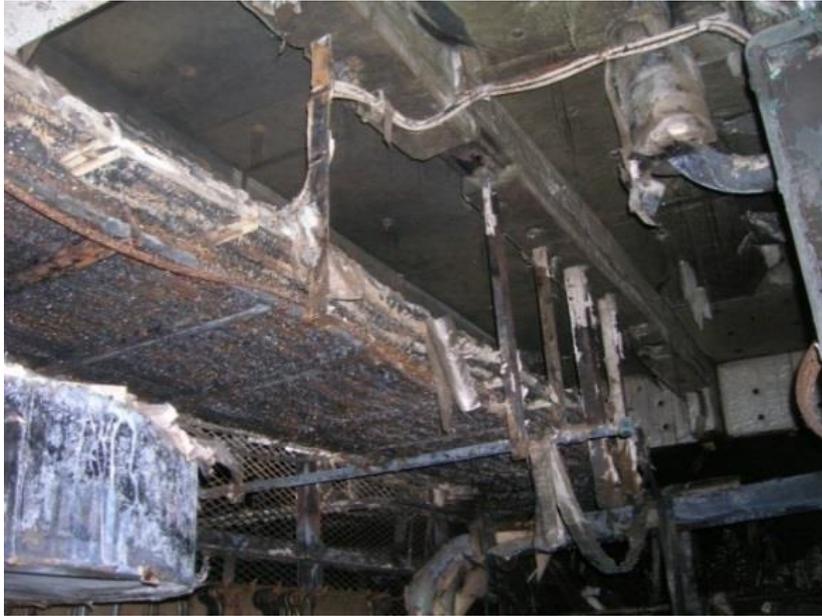
**Figure 18: Wire runs in engine room workshop**

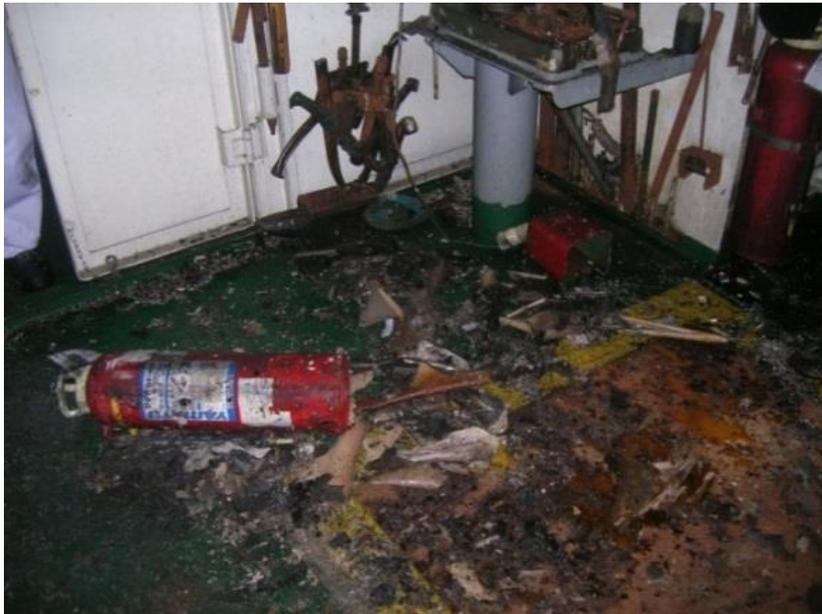
**Figure 19: Engine room workshop entrance**

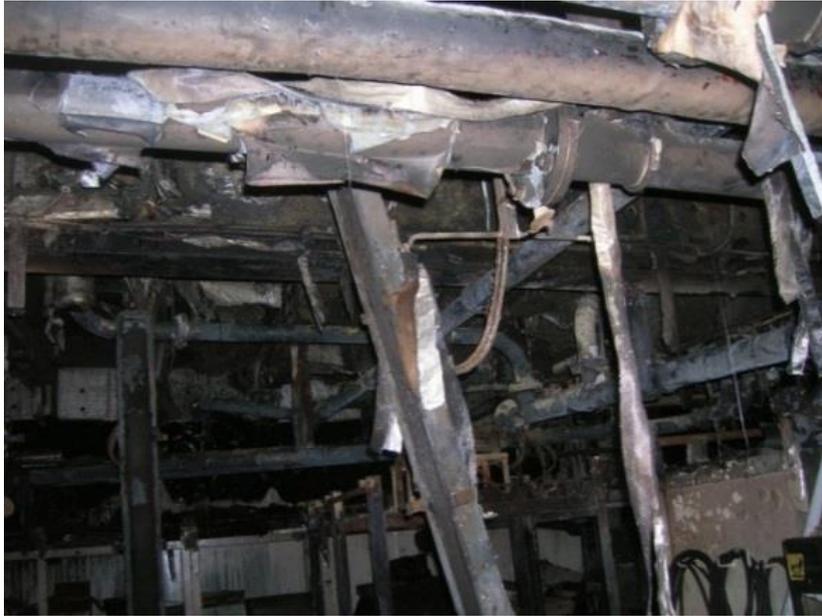
**Figure 20: Engine room workshop area**

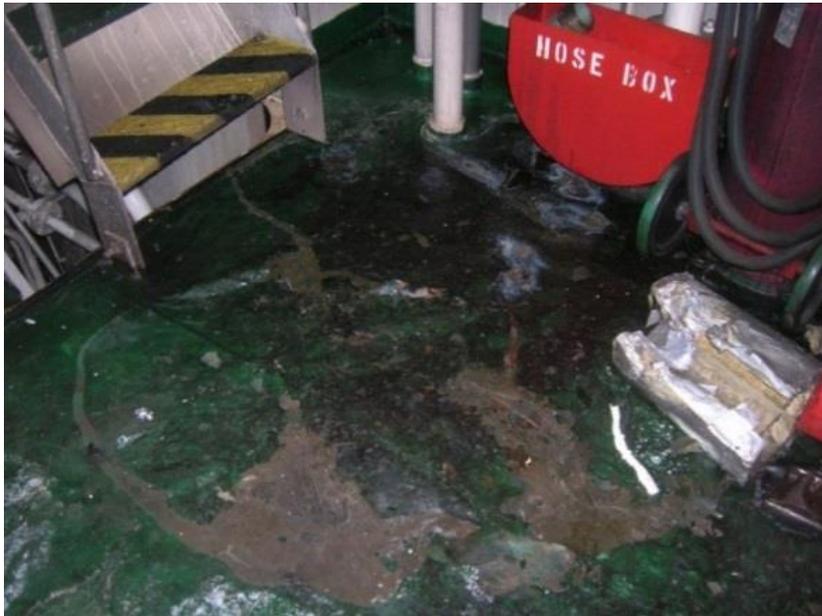
- 5.2 There was minimal structural damage overall and localised deck plating damage in vicinity of the fire.
- 5.3 Numerous light fittings were destroyed.

**Figure 21: Deck above workshop buckled due to heat**

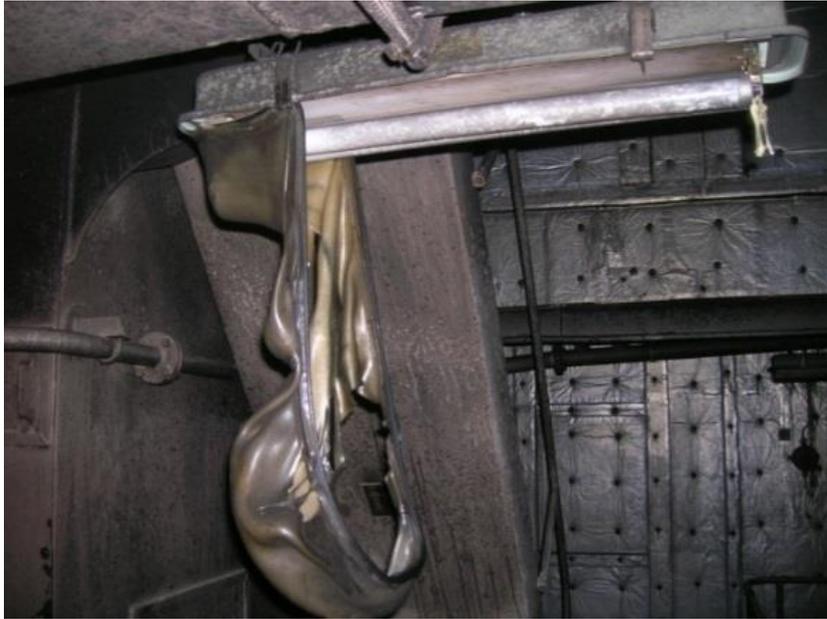
Figure 22: Light fitting

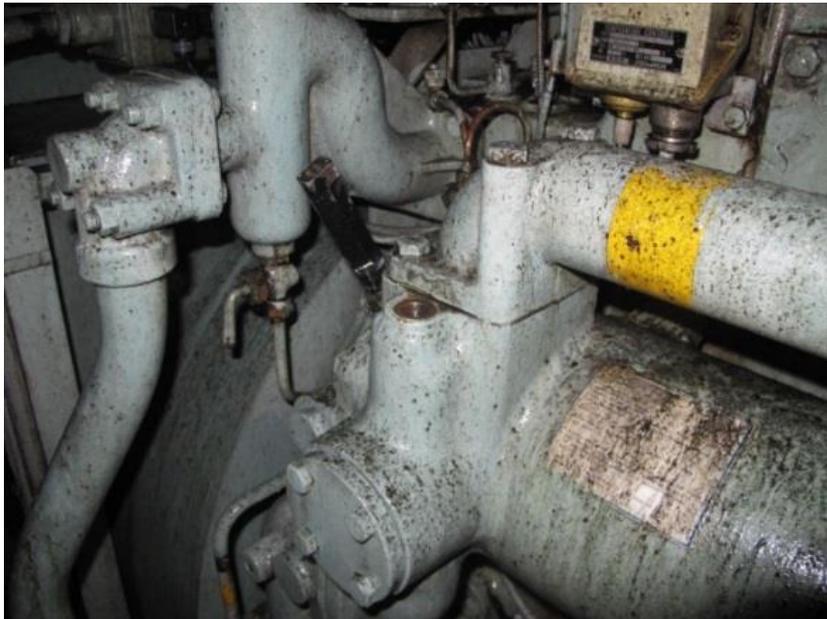
Figure 23: Location of removed pocket
