M.v. SEADREAM I

**Report of the investigation into an engine room fire
on 01st September 2016 approximately 43nm off the
South West Italian coast.**

M.v. SEADREAM I - Marine Safety Investigation Report

Date of Issue: 07 July 2018
Bahamas Maritime Authority
120 Old Broad Street
LONDON
EC2N 1AR
United Kingdom

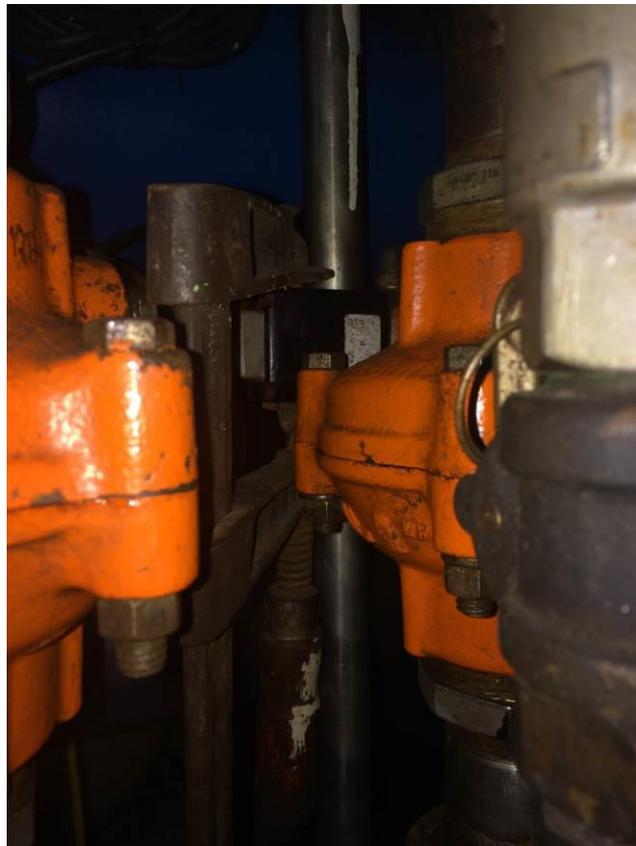
valves (figure14) for the main engine 1, main engine 2, boilers and generators. One of the solenoid valves was not staying in the open position, so the Chief Engineer kept it open with the assistance of a G-clamp (figure15).

Figure 16: G-clamp holding open solenoid release valve

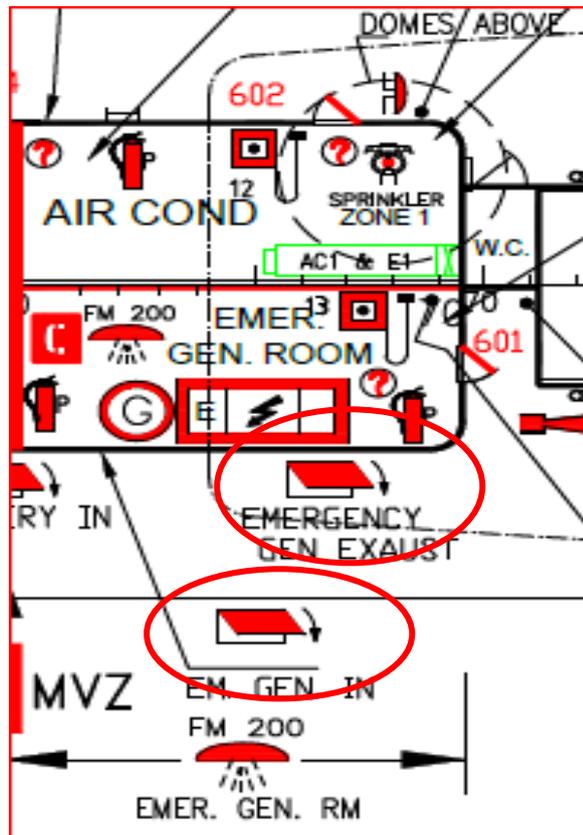
Figure 17: Emergency generator room air inlet and exhaust

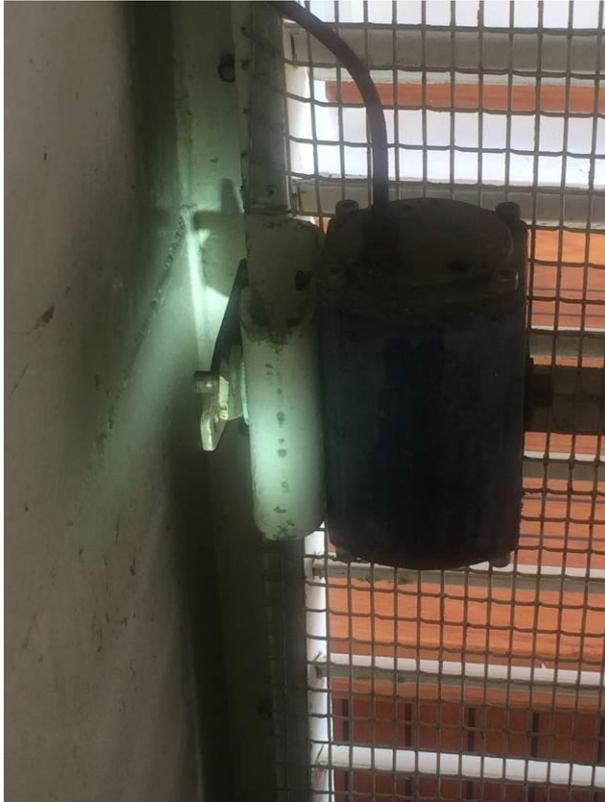
- 4.25 The Chief Engineer instructed the electrician to open the dampers manually and this had to be done by disconnecting the damper mechanism from the air actuated cylinder (figure 18). The Chief Engineer also instructed the Electrician to override the High-Temperature shutdown, which allowed the generator to be restarted immediately. The generator was then put back online after approximately 15 minutes.

Figure 18: Air-actuated damper control for emergency generator

⁷ The damper in emergency generator room were designed to close on failure of air pressure. This had a secondary effect of cutting of the cooling air supply to the generator air cooled radiator, leading to overheating of the generator and subsequently shutting down due to high temperature alarm.

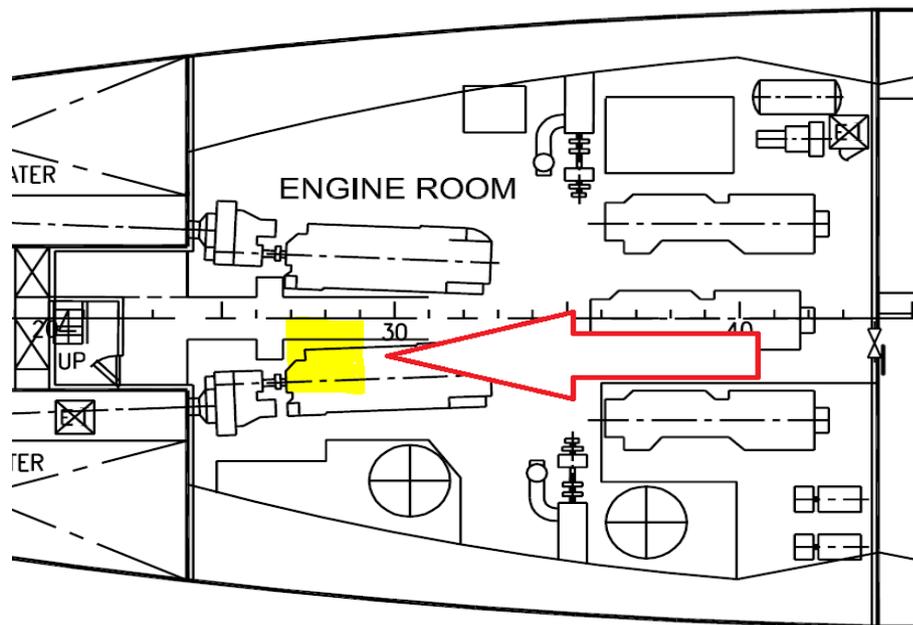
5.3.1 On initial investigation of the incident, it was observed that the seat of the fire was around the aft area of the Starboard main engine, on the engine room tank top level.

Figure 20: Location of the fire

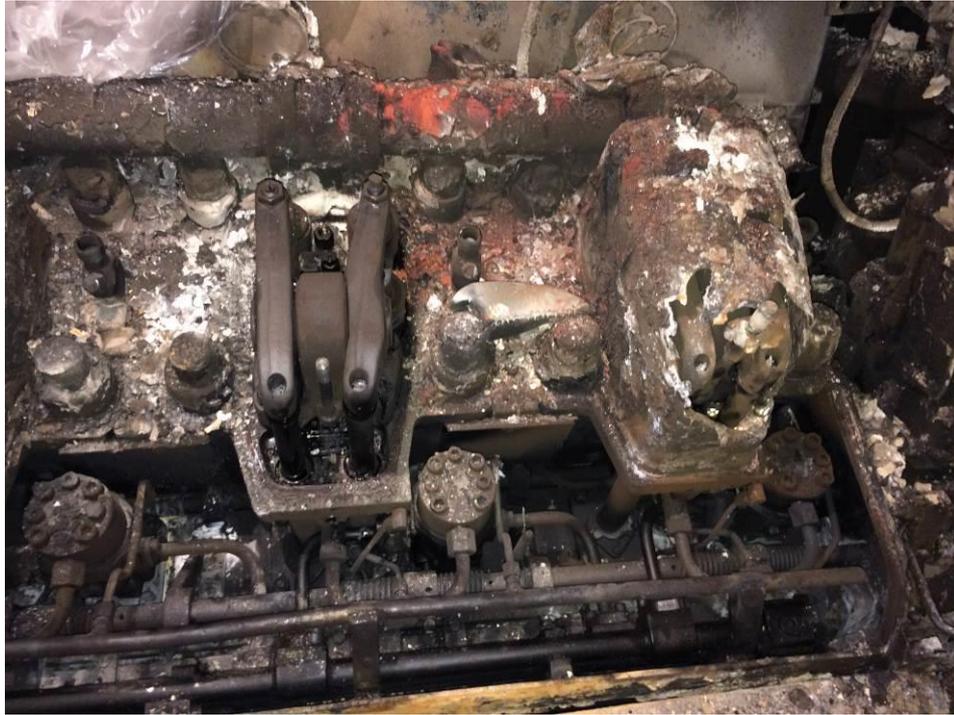
5.3.2 On closer examination of the scene of the fire, it was evident that the heat source was based at the aft end of the starboard main engine in way of #2 cylinder of the A-bank⁵ (figure 21).

Figure 21: Starboard main engine A-bank Cylinders 1 & 2

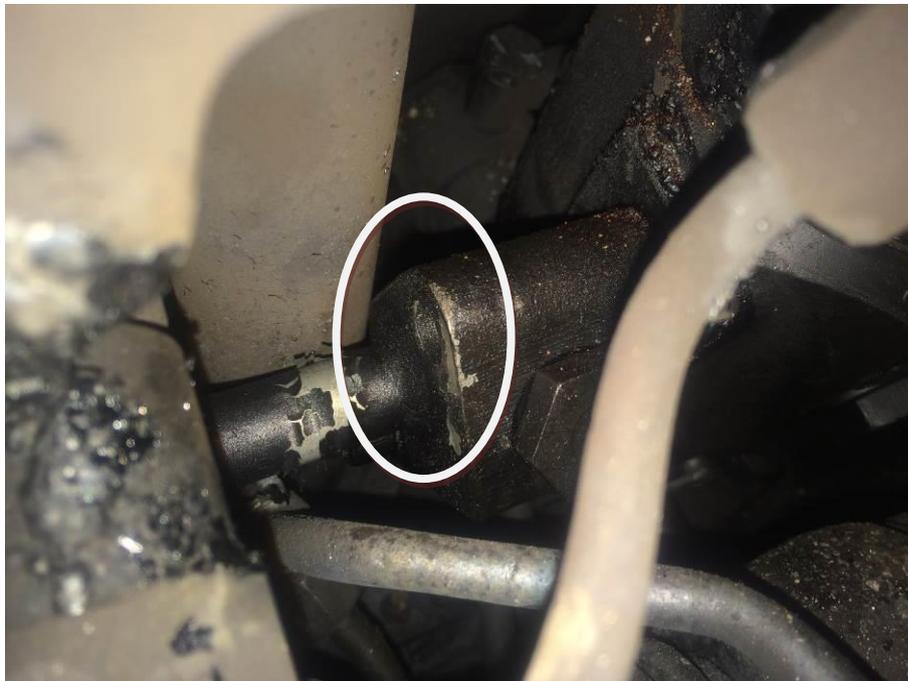
- 5.3.3 The hot box covers (covers enclosing the fuel pumps and fuel pipes) were removed from the inboard bank of cylinders of the starboard main engine and it was immediately evident that the top bolt was missing from #2 fuel pump fuel inlet pipe (figure 22).

Figure 22: Top bolt missing from fuel inlet pipe

- 7.1 Consider reviewing the Planned Maintenance System to incorporate the following:
 - 7.1.1 A periodic inspection regime of all fuel line securing arrangements.
 - 7.1.2 An inspection regime to verify the operation of all wire/pulley systems for remote opening/closing of fire dampers.
- 7.2 It is recommended to review the design mechanism of the fire damper system of the emergency generator room to prevent the inadvertent closing on the failure of the vessel's compressed air system.
- 7.3 It is recommended to have the fire alarm and all alarm systems synchronised to the vessel's master clock system at all times. If unable to synchronise, a procedure is to be implemented to account for any time difference between systems.

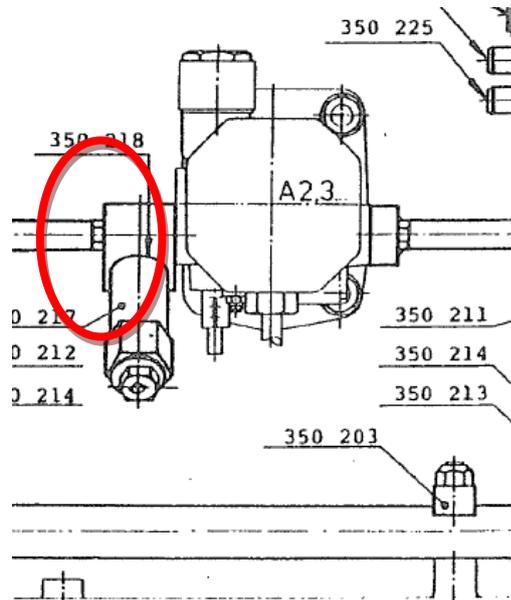
Figure 23: Fuel oil inlet pipe to the fuel pump

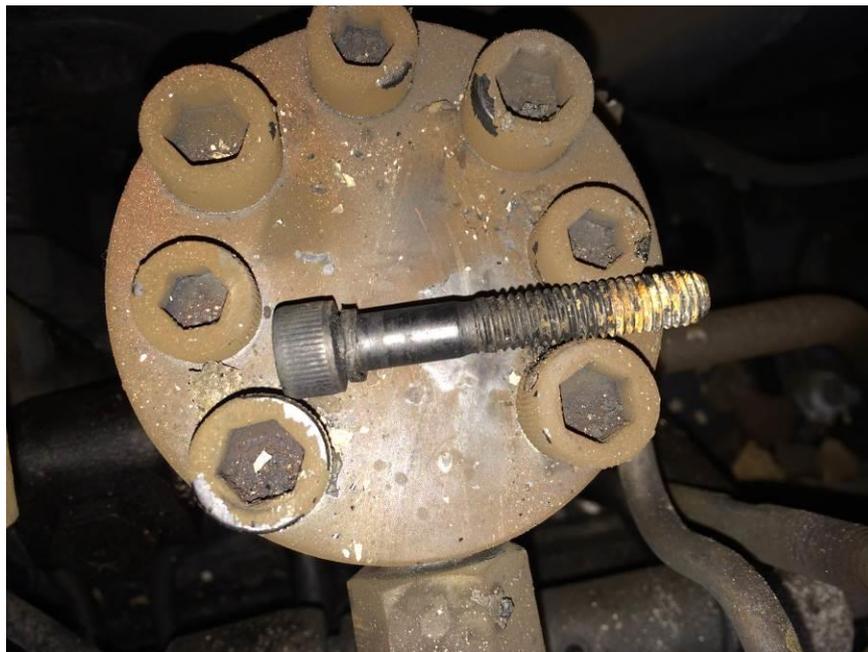
- 5.3.4 The missing bolt was found in the bottom of the hotbox, under the pipe. The bolt had not sheared and it appeared that the bolt had worked free by itself.

The bolt was not damaged and a washer was still present by the bolt head (figure 24.)

Figure 24: Bolt from fuel inlet pipe

- 6.1 On 01 September 2016 at 0150 hours the fire broke out in the vicinity of the aft inboard cylinder bank of the starboard main engine. From the evidence collected post incident, the probable fuel source for the fire was the diesel oil leakage from the fuel inlet pipe to #2 fuel pump where the top securing bolt had fallen out. It is unknown as to why the fuel line securing bolt fell out of the fuel pump, but it probably worked itself loose caused by vibration due to insufficient torque securing the bolt.

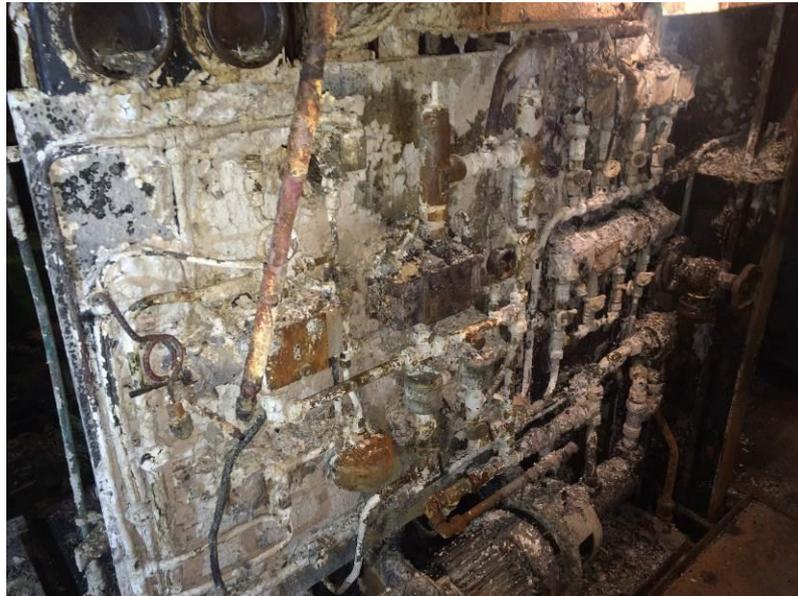
Figure 26: Gearbox instrumentation panel

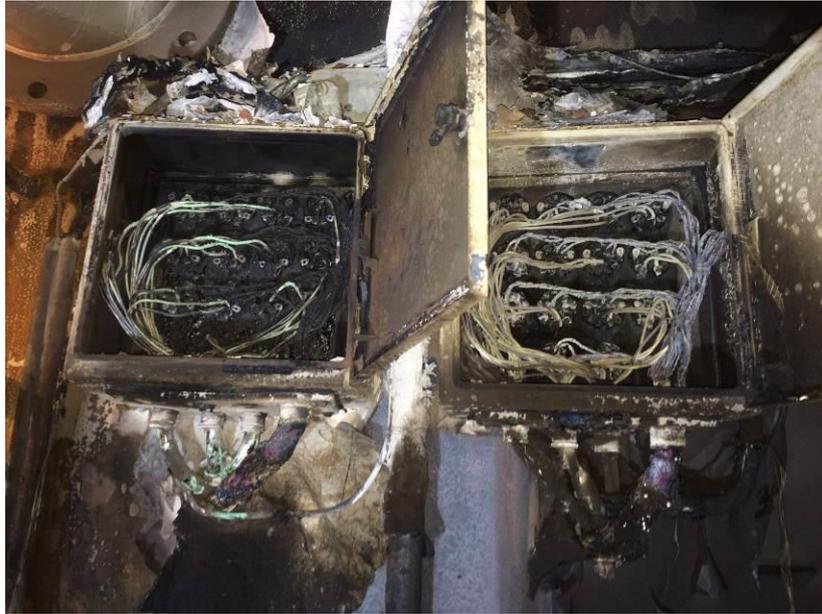
Figure 27: Control cabling junction boxes

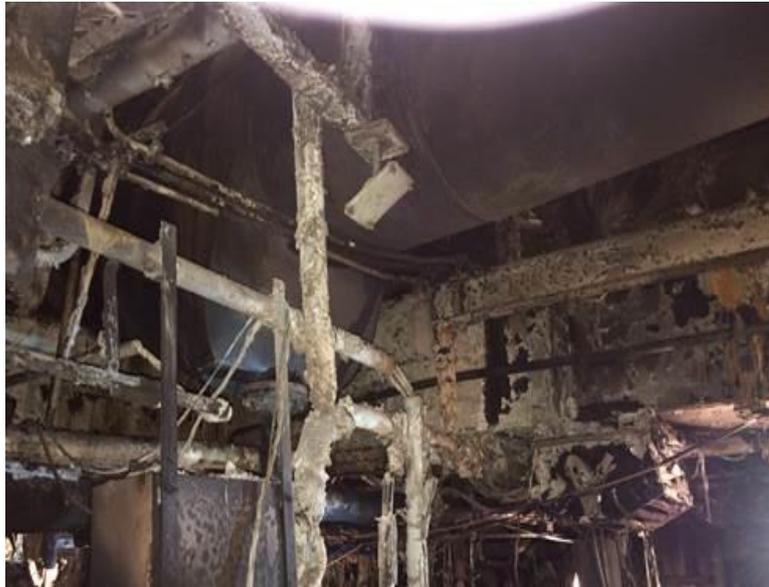
Figure 28: Damage above Starboard main engine

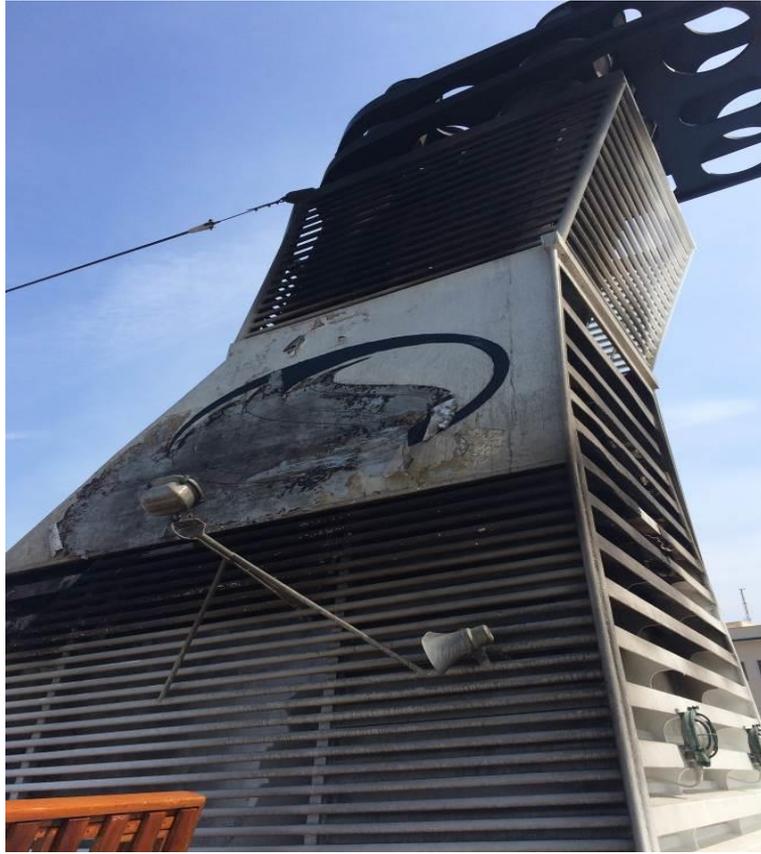
Figure 29: Heat and smoke damage to Portside funnel

- 5.5.7 The failure of the escape hatch to close in the funnel case at deck 5, contributed to the spread of the fire resulting in extensive damage in the funnel casing (figure 29).

- 5.9.3 The damage in the funnel area showed a clear path of the heat from the engine fire and this heat was evident as far as the top of the funnel (figure 29) showing that the fire damper in way of deck 5 funnel space was ineffectual.
- 5.9.4 The inability to close the fire damper on deck 5 of the funnel space hampered the ability to extinguish the fire quickly and aided the spread of heat damage up the funnel space. There was no indication that the hatch was not closed

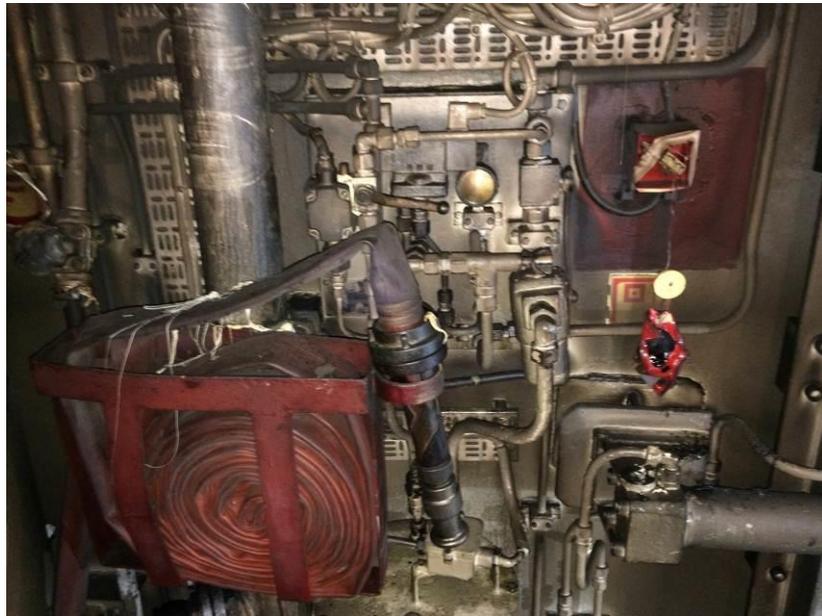
Figure 30: Heat and smoke damage to the engine room forward bulkhead

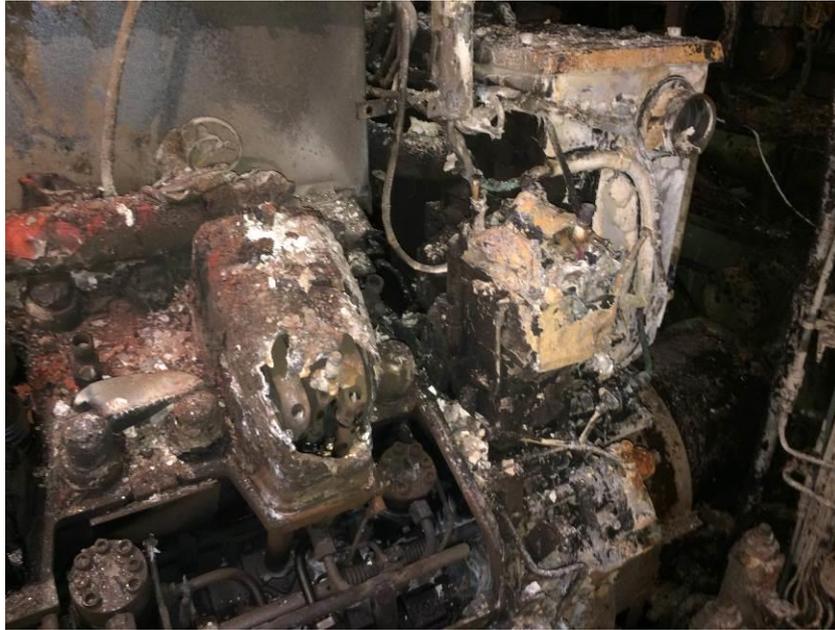
Figure 31: Fire damage to the aft section of starboard main engine

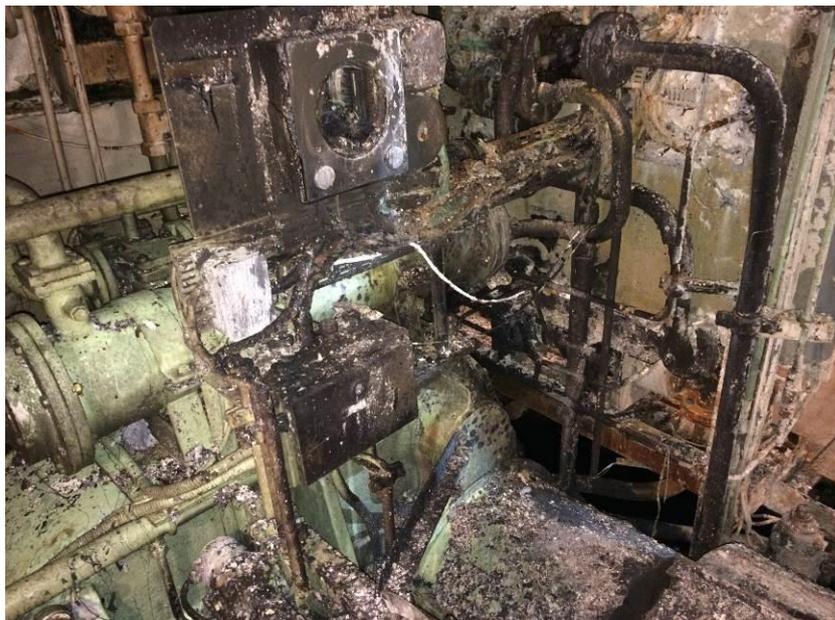
Figure 32: Damage to the area in way of starboard gearbox and oil cooler

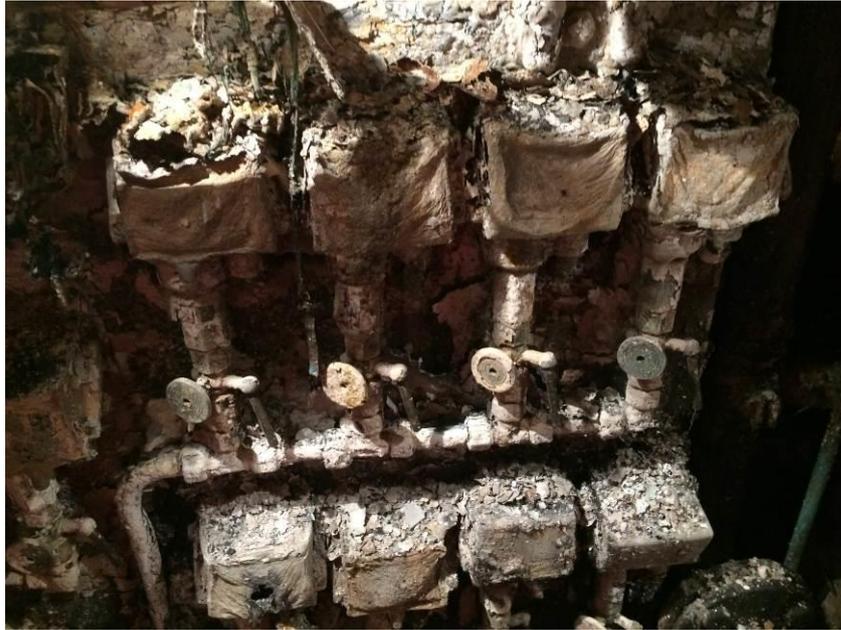
Figure 33: Starboard main engine pressure switches

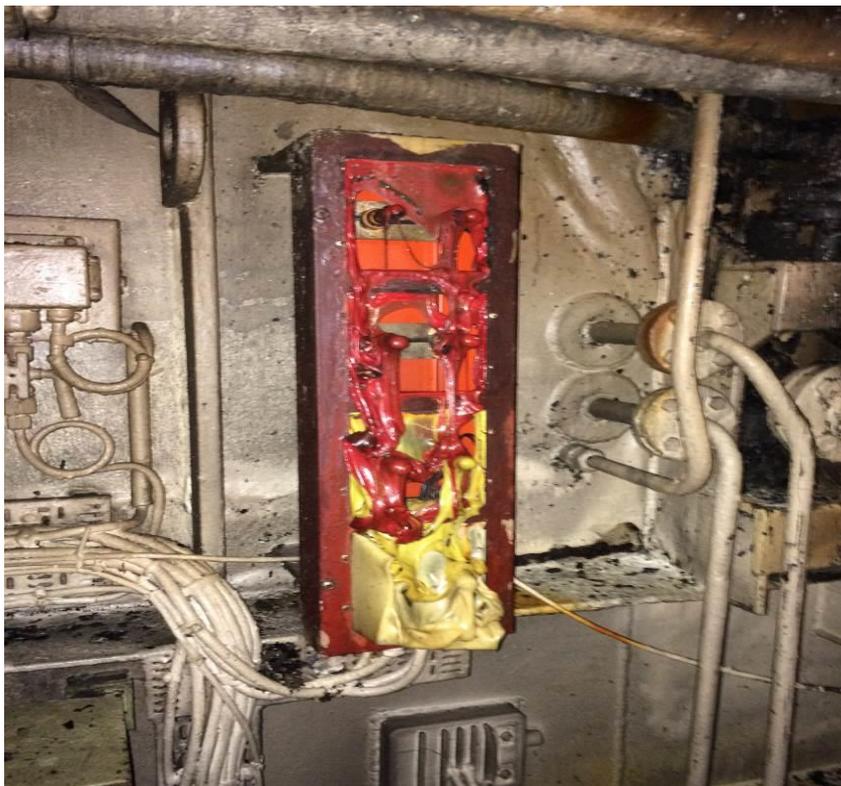
Figure 34: Local alarm column on forward ER bulkhead

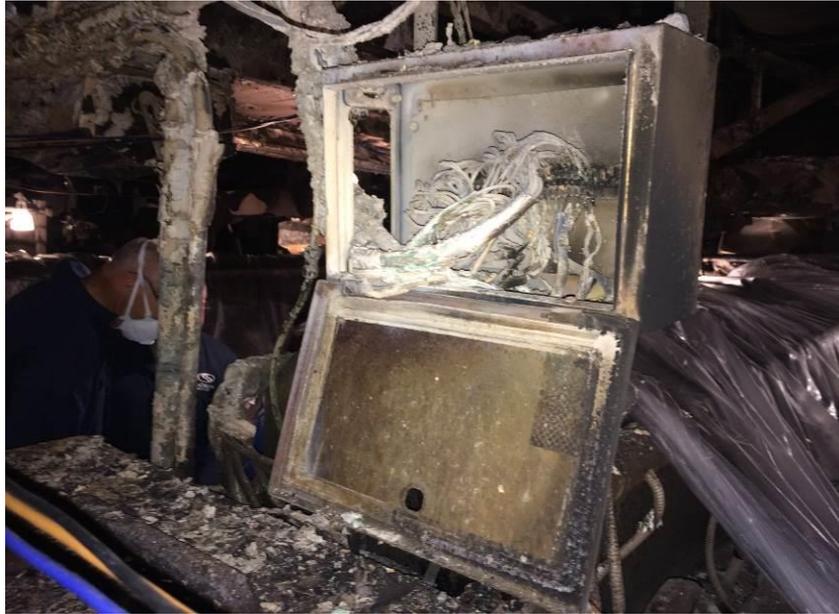
Figure 35: Starboard main engine control cabling

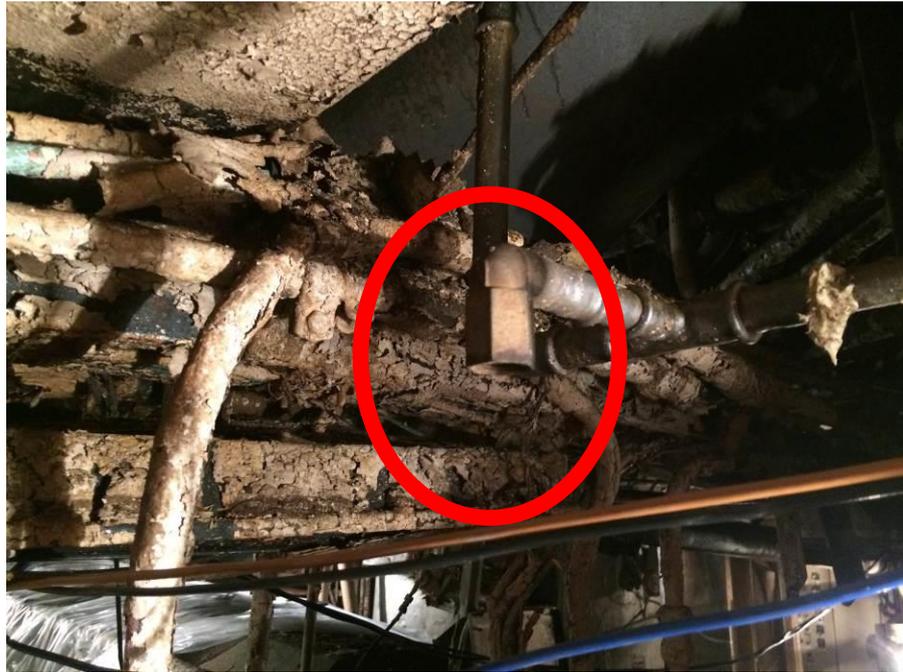
- The system Profibus interface cables and nodes in the engine room were burnt and ceased to function very early in the evolution of the fire.
- The loss of the nodes caused a short circuit and a loss of the 24V DC supply.
- The loss of the 24V DC system prevented the remote operation of the High-Risk Zone Release.
- The loss of the 24V DC system prevented the activation of the foam system. As the foam valve is activated from the same 24 VDC supply as the zone valves and was not activated due to loss of power when the Profibus Interface cables short-circuited by the fire. This valve had no manual override.
- One nozzle (figure 36) was missing in the Main Engine High-Risk nozzle grid.

Figure 36: Showing missing nozzle in the high-risk zone.

- 5.8.4 The missing nozzle from High-Risk zone of the FlexiFog system would have also contributed towards the reduction in the effectiveness of the system and this would have led to a delay in extinguishing the fire and hence potentially resulting in more damage. It is unknown as to when the nozzle disappeared from the pipeline and there was no evidence of it in the immediate vicinity. It is likely that the missing nozzle would have resulted in a reduced pressure in the system subsequently reducing the atomising ability of the other nozzles in the system.

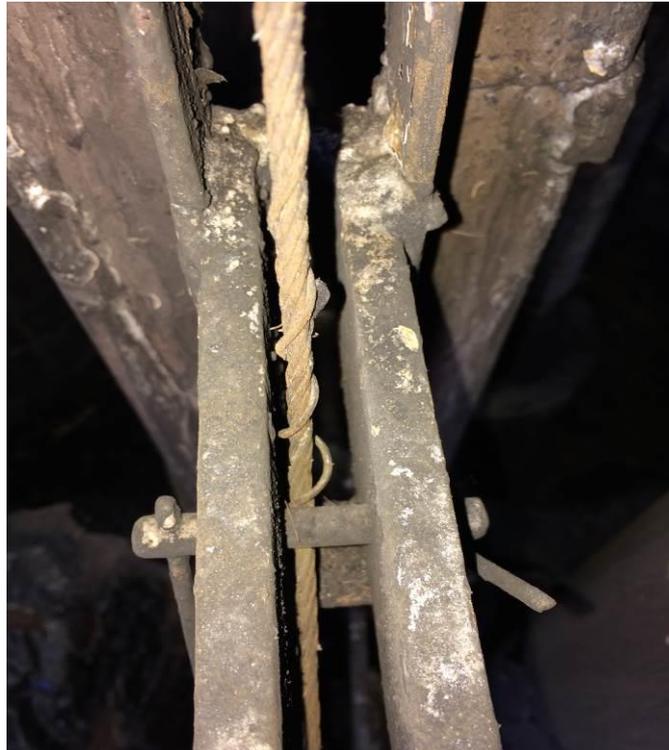
- 5.9.1 On inspection of the funnel space, it was noted that the escape hatch leading from the lower levels to deck 6 was not properly closed. This escape hatch would normally have the closing mechanism to be actuated as part of the damper system closing procedure in case of a fire in the space below.
- 5.9.2 The pulley system for the opening/closing of the hatch appeared to have a frayed wire (figure 37) that was fouling, preventing the hatch from fully closing. There was no mechanism to check this equipment in the vessel's planned maintenance system and the operation relied on the weekly testing rather a combined condition check and test.

Figure 37: Frayed wire on hatch closing mechanism

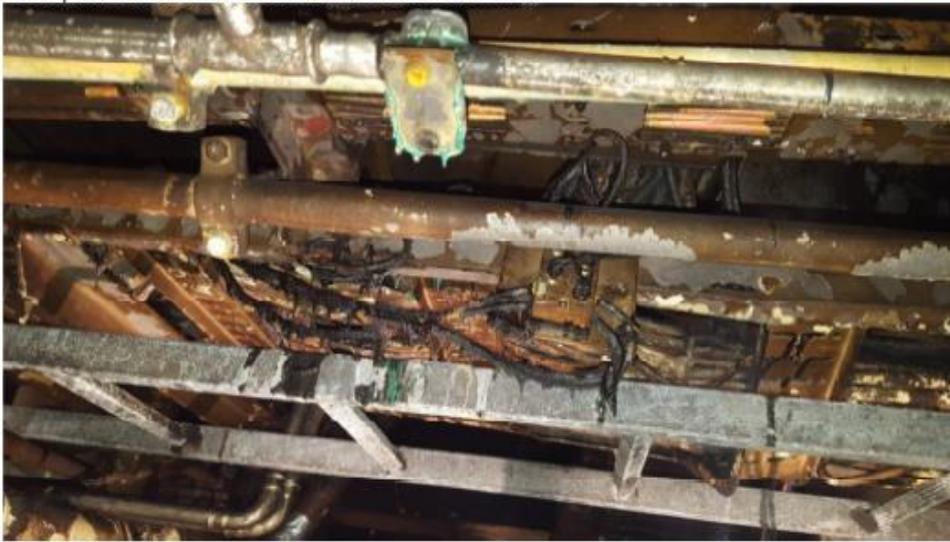
The cable and nodes in the engine room was burn and stop functioning early in the fire. From the faults in the fire detection log we see this happen after 2 minutes from the first alarm.

Below picture shows what is left of the Node for "Boiler 1+2".

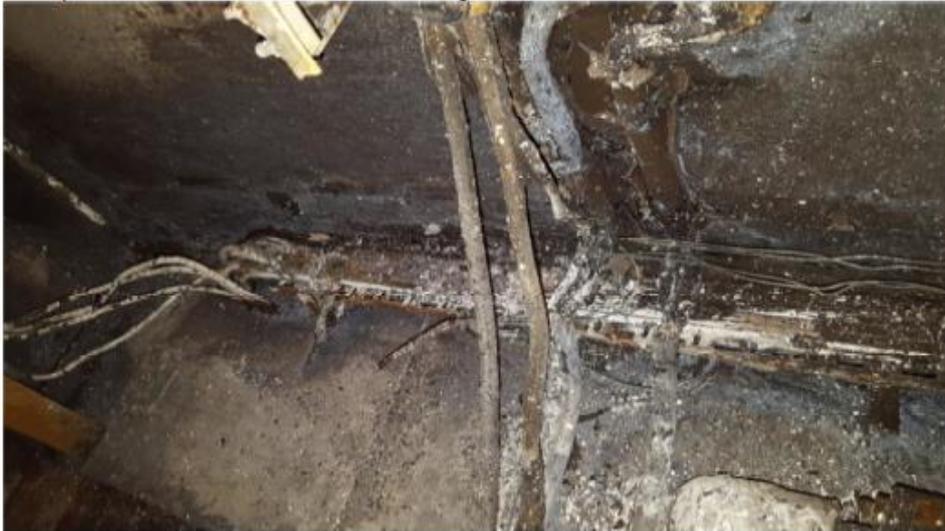
Below picture show the location where the "Main Engine" node was located.

Based on above missing (disintegrated) Node we conclude that the zone valve lost its 24 VDC supply immediately when the cables short circuited.
With the 24 VDC gone, the valve closed, cutting off the water supply to the nozzle grid.
The system is without an event log, so it's impossible to say when this happened.
When the officer on-duty in the ECR activated the system was probably the 24V DC on, since the pressure switch, located after the zone valve, turned on the "System released" light in the control room.
It was gone by the time the Chief Engineer reached the pump unit.

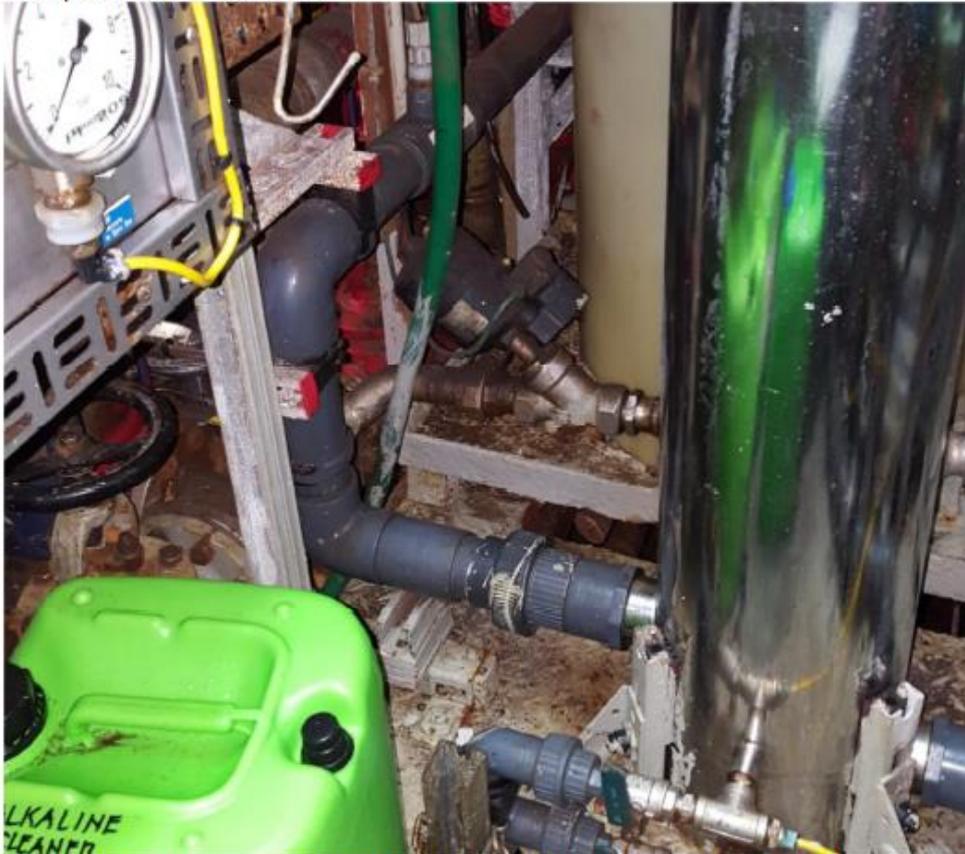
Below picture shows the foam valve.

This valve is activated from the same 24 VDC supply as the zone valves, and lost its activation power when the Profibus Interface cables short circuited. This valve is without a manual override.

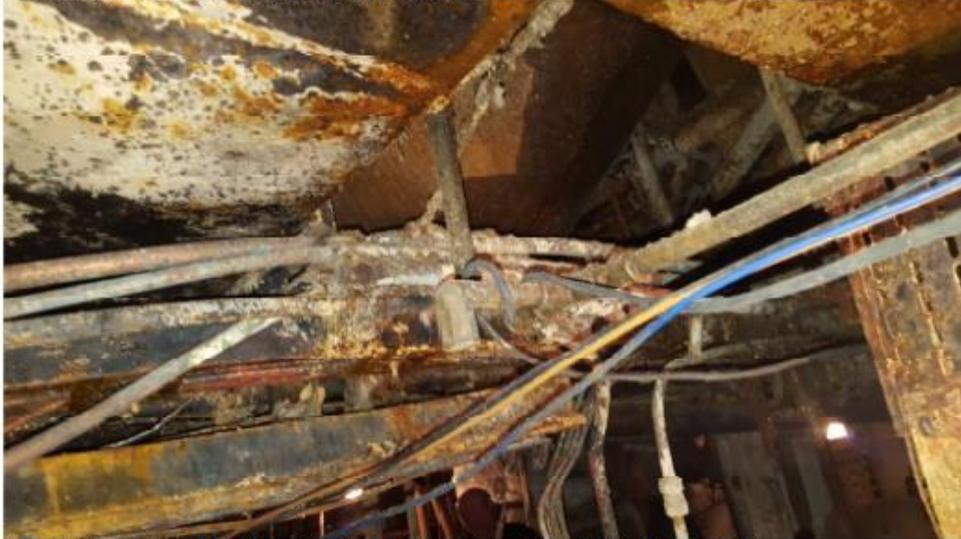
Below picture shows the "missing" nozzle location.

Above empty pipe fitting is where the missing nozzle should have been (was) installed. The missing nozzle created a deluge in the area instead of a fine water mist blanket. We don't know when the nozzle was removed.
