**The Bahamas  
Maritime Authority**

### **FOUR C'S ADVENTURES 37ft Aluminium Catamaran 'Unnamed'**

**Report of the marine safety investigation into an explosion resulting in loss of life and multiple serious injuries on board a 37ft charter boat at Exuma, Bahamas on 30 June 2018**

Date of Issue: 01 October 2018  
Bahamas Maritime Authority  
120 Old Broad Street  
LONDON  
EC2N 1AR  
United Kingdom

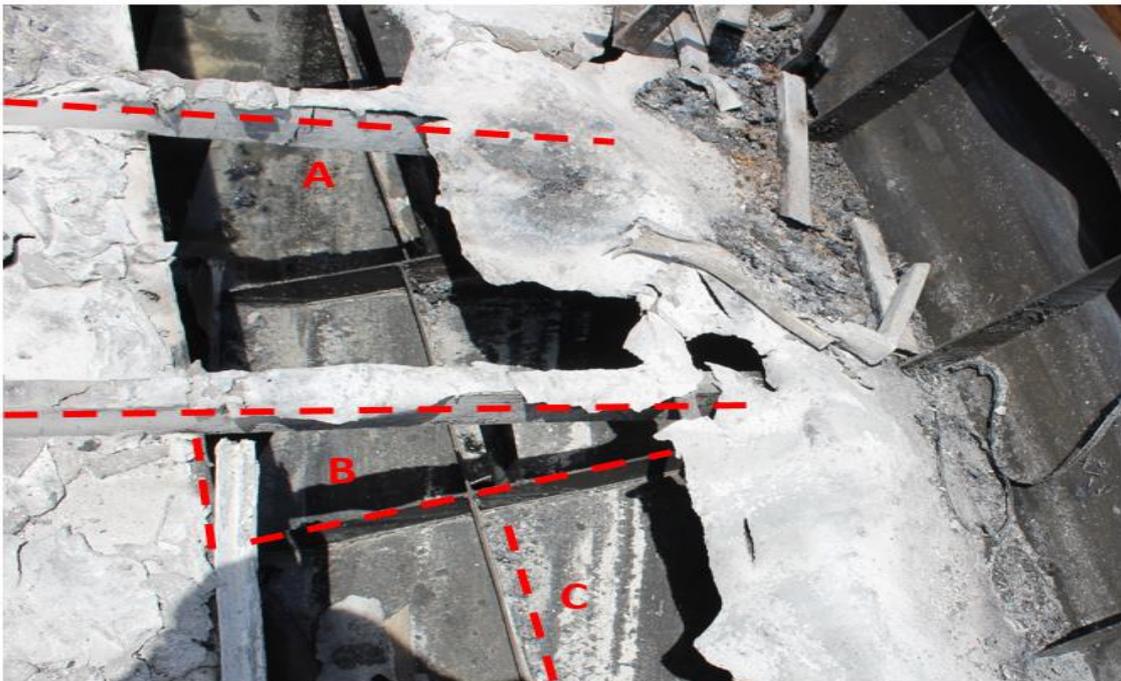
**Figure 5: Photograph of the actual starboard pontoon of the 37ft Boat after the explosion and fire – transverse beam (A), partial transverse frame (B) and longitudinal stiffener (C)**

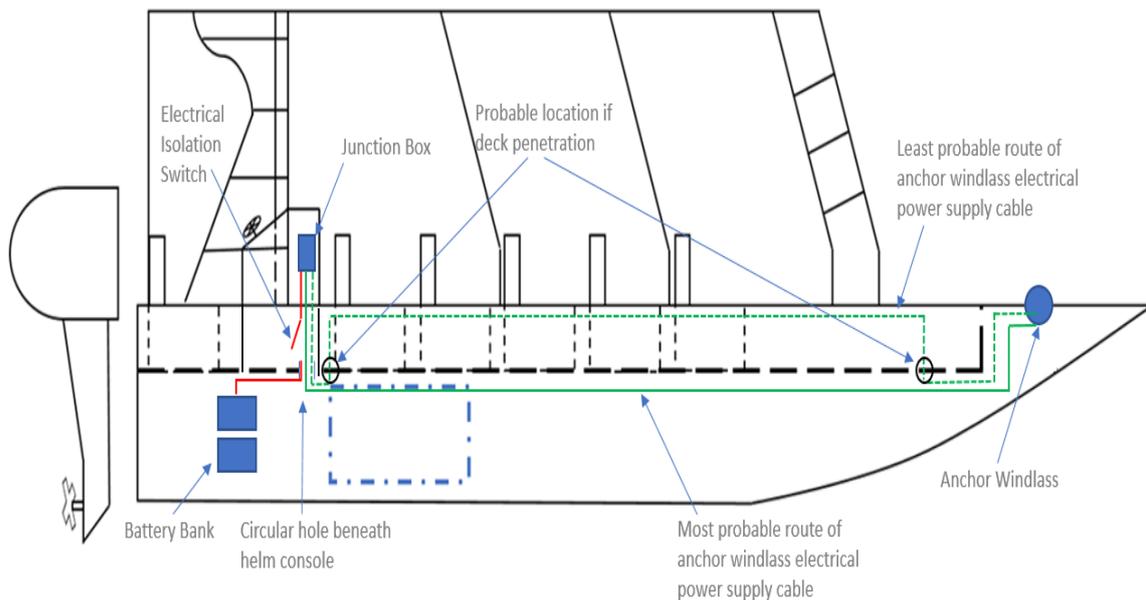
5.3.2 The electrical cable to the anchor windlass was reported as being located under the topside of the boat. Although this could not be visually verified after the accident, the location of the electrical cable as it runs between the junction box and the anchor windlass remains a key factor of the investigation. It is known that all electrical cables from the junction box within the helm console and beneath the deck plate. The most probable scenario during construction would be to run the electrical cable forward, beneath the deck plate to the bow and connect to the anchor windlass avoiding any electrical cables on deck or any deck penetrations being required. If, however the electrical cable was run as suggested by the Owner, above the deck, two penetrations would need to be made in the deck to service the electrical cable; above and then beneath the deck plate, as indicated within figure 14 by the green pecked line.

**Figure 14: Electrical system schematic and anchor windlass circuit**

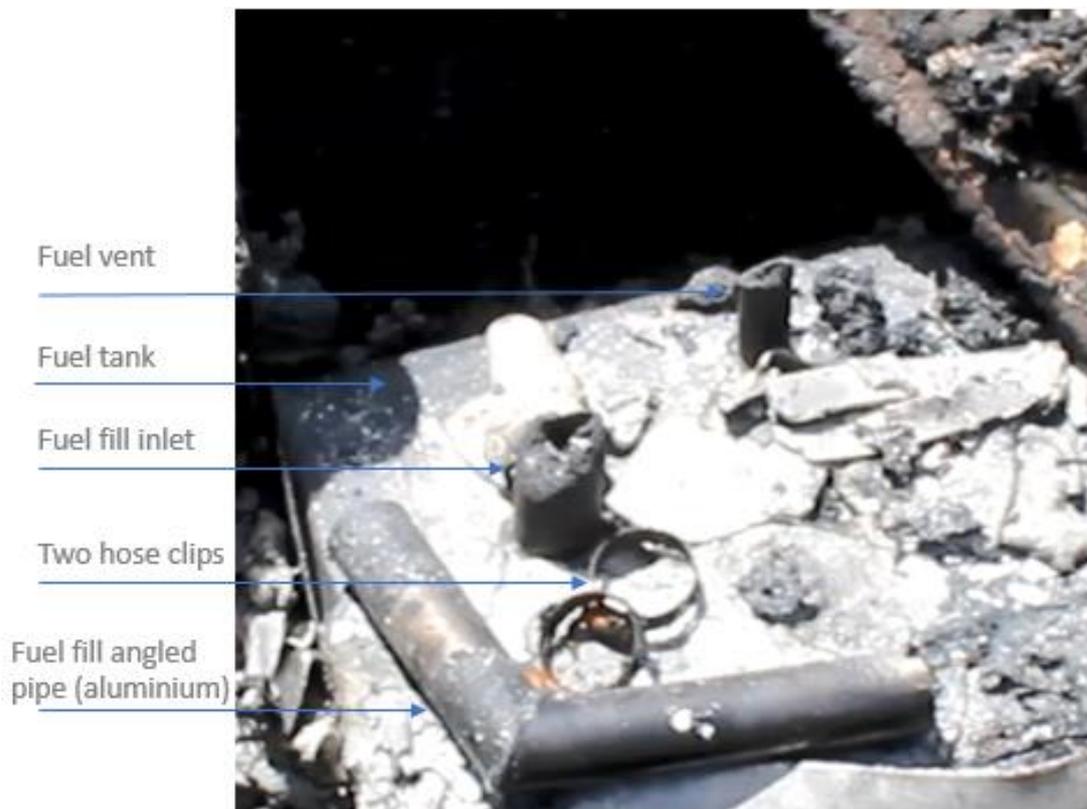
Figure 18: Fuel inlet and vent holes on top of the starboard fuel tank

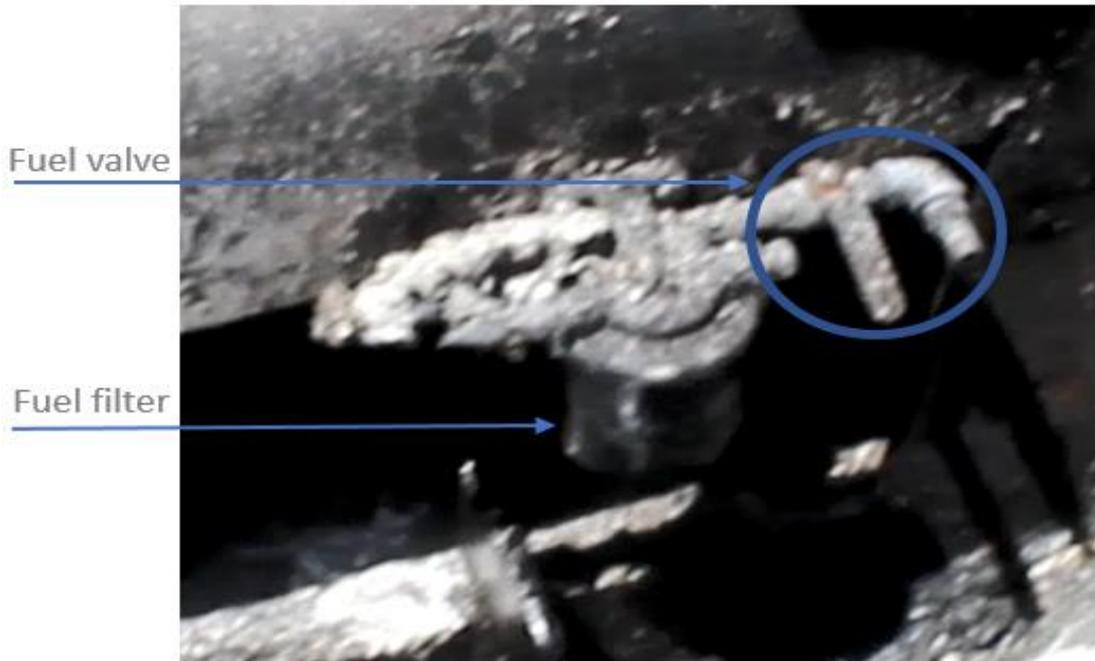
**Figure 19: Remnants of port fuel filter and fuel valve**

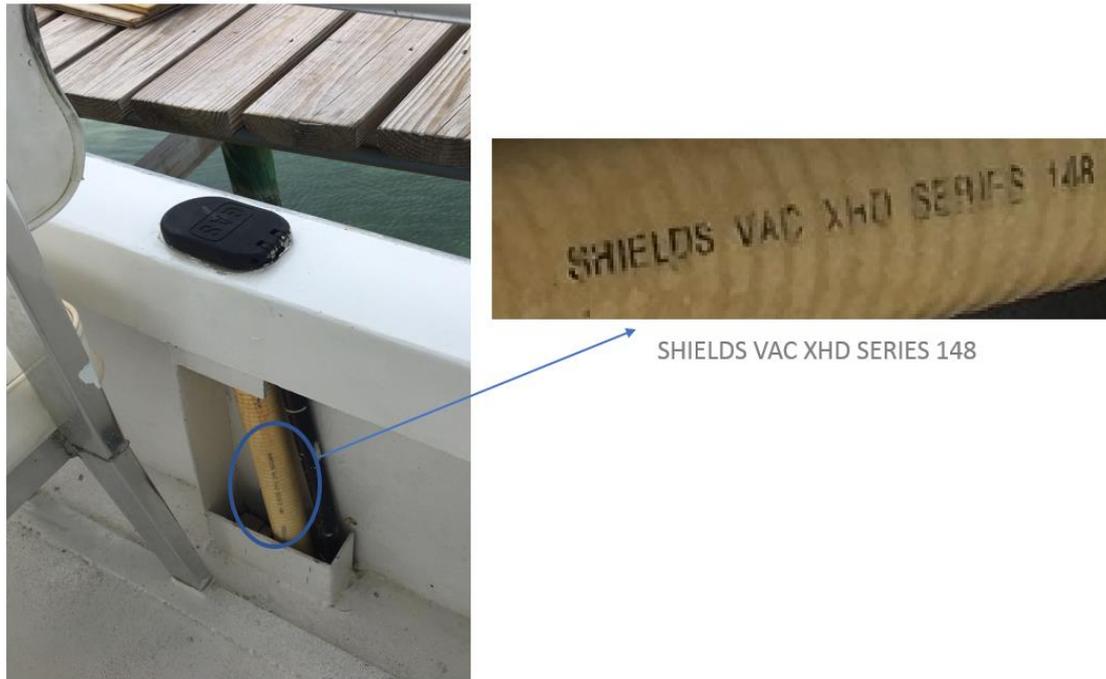
- 5.4.4 The fuel fill hose used during the construction process of the boat could not be identified after the fire due to the extensive damage. However, the fuel hoses identified in figure 20 were taken from another Four C's Adventures boat and it was confirmed by the Owner that the same make and model of fuel fill hose was used on all boats constructed by the Owner. The fuel fill hose is manufactured by Shields, a marine hose manufacturer. According to the manufacturer, model XHD (Extra Heavy Duty) series 148 is designed for use in bilge water discharge, specifically in the application of submersible, remote and hand bilge pump applications. It is not designed and not recommended for use with any gasoline/alcohol blends or liquids. Further, the Series 148 Extra Heavy Duty hose is resistant to mild chemicals, permeation and saltwater and should not be used with gasoline or alcohol blends as it does not meet the required SAE J1527 Type A2 and ISO 7840<sup>8</sup> Type A2 NMMA/CE Type accepted standards.

**Figure 20: Example of the exact fuel fill and vent hoses installed on board the 37ft Boat**

5.4.5 There are two consequences when gasoline and alcohol blends come into contact with this type of hose and both have the same outcome. The first will result in the hose to harden, eventually the hardened hose will fracture and potentially result in a leak of gasoline. The second consequence is that gasoline and alcohol blends will degrade the structural wall of the hose to such an extent that the hose will no longer contain the gasoline in liquid or gaseous form. In both cases, gasoline will then be able to permeate the surrounding environment. The manufacturer was contacted during the course of the investigation and stated that *“the series 148 hose should under no circumstances be used in the application of a fuel fill hose”*.

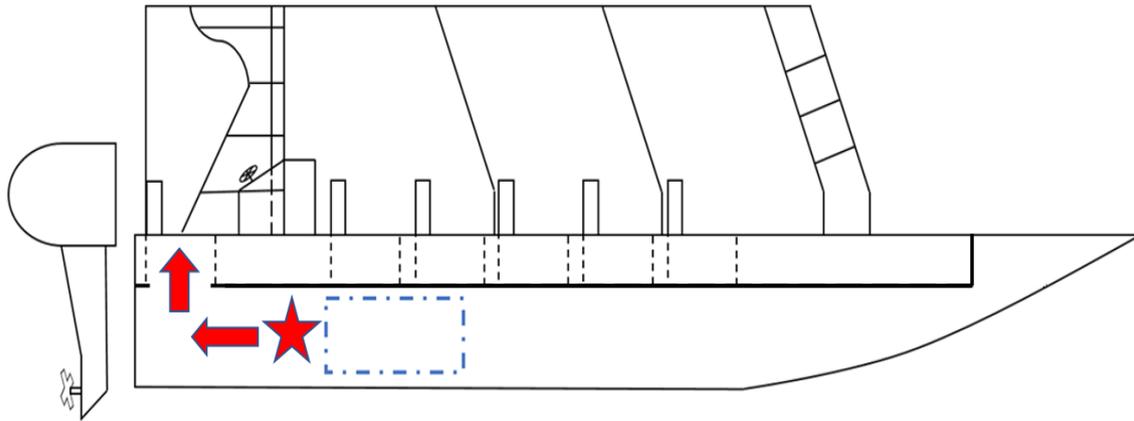
- 5.7.4 It was confirmed by the Owner that space surrounding the starboard fuel tank was limited by the surrounding hull plates located approximately four inches from the fuel tank on all sides. Access aft of the starboard fuel tank, beneath the Master's helm seat, where the majority of the electrical cables were located including the two batteries could be gained. This part of the starboard pontoon was not sealed with the exception of the base of the seat cushion on which the Master was sitting at the time of the explosion. If the explosion of gas and vapours of combustible liquids occurred behind the starboard fuel tank, it could be considered with a high degree of probability that the initial increase in pressure generated by the explosion, expanded whilst proceeding along the path of least resistance. This path of least resistance would have almost certainly been through the open deck beneath the helm seat in an upwards direction, pushing the helm seat up as it disperses into the rear section of the boat (see figure 22).

**Figure 22: Diagram of explosion aft of the starboard fuel tank and resultant direction of travel of the blast wave**

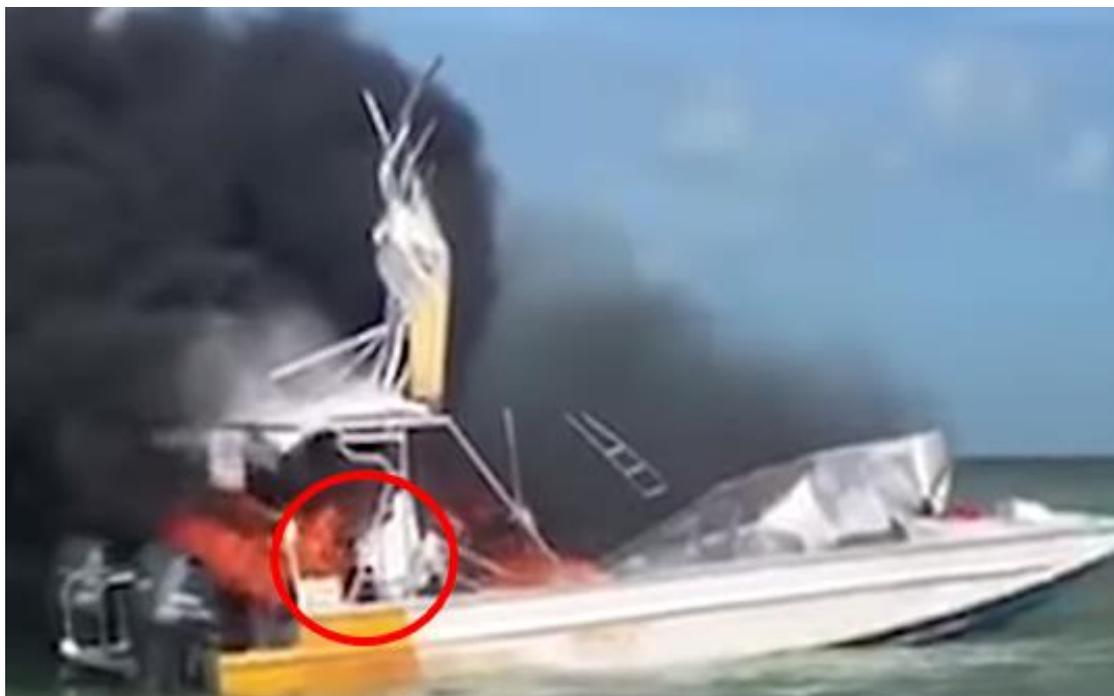
5.7.5 Figure 23 (below) provides a good indication, in the moments after the explosion and in the early stages of the fire the damage sustained to the helm seat, console and superstructure before the fire destroyed the available physical evidence. If the explosion had occurred behind the starboard fuel tank, the probability that these fixtures would have been identifiable immediately before the fire engulfed the boat is considered extremely low.

**Figure 23: Moments after the explosion and prior to the fire taking hold of the entire boat. The helm console, helm seat and superstructure pictured remains relatively undamaged**

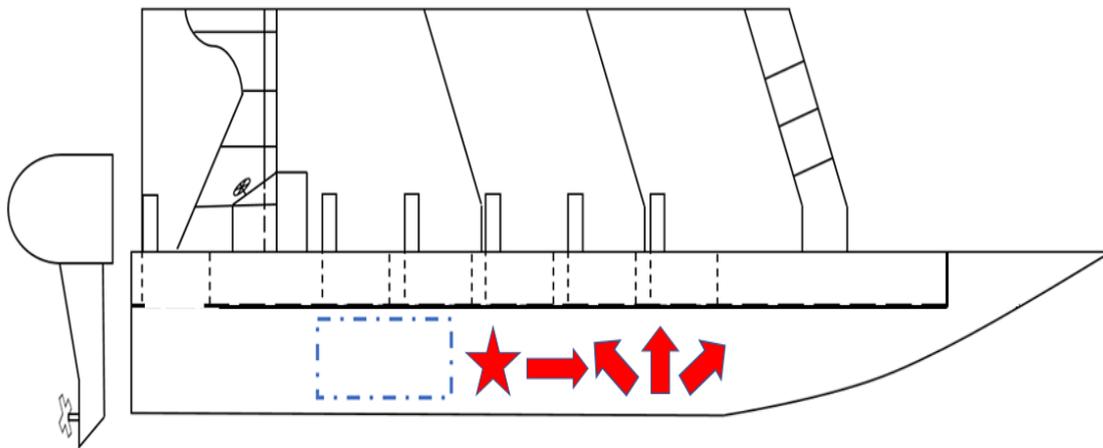
5.7.6 Based on the significant structural damage in the forward section of the starboard pontoon, the most likely scenario is that the explosion of gas and vapours of combustible liquid occurred in front of the starboard fuel tank. The explosion of a combustible atmosphere generated by gas and vapours in this section of the boat would result in the initial over pressure resulting in a blast wave dispersing forward, filling the void within the pontoon to a point where the structural integrity of the hull could no longer contain the over-pressurisation. The explosive pressure contained within the starboard pontoon, sought to find the path of least resistance. As indicated by the witness testimony, the analysis of the concentration of injuries and based on analysis of the debris found at the scene, it is determined that the explosive path was beneath the deck in the proximity of seats 1, 2 and 3 (see figures 24 and 25).

**Figure 24: Diagram of explosion forward of the starboard fuel tank and resultant direction of travel of the blast wave beneath seats 1, 2 and 3**

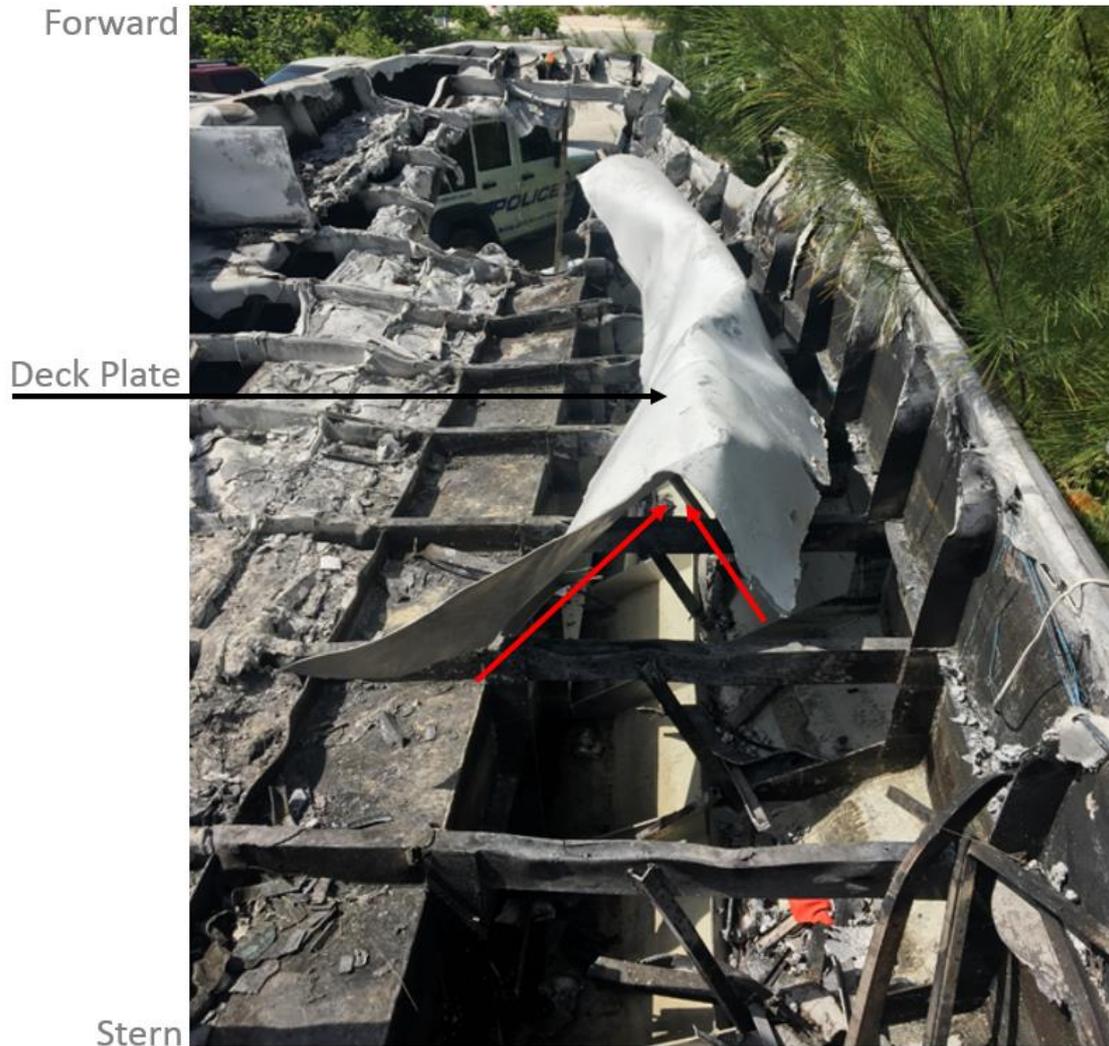
5.7.7 The deck plating shown within figure 26 below was placed back on the boat after the explosion once the boat was salvaged at Barratarre. The deck plates were matched to their probable starboard side location. As indicated by the red arrows, the 3/16” aluminium deck had been distorted in an upwards direction, indicating that the explosion occurred beneath the deck plate and the force of the explosion forced the deck plates up and away from the structural transverse frame.

**Figure 26: Distorted and damaged deck plate in proximity of starboard side pontoon**

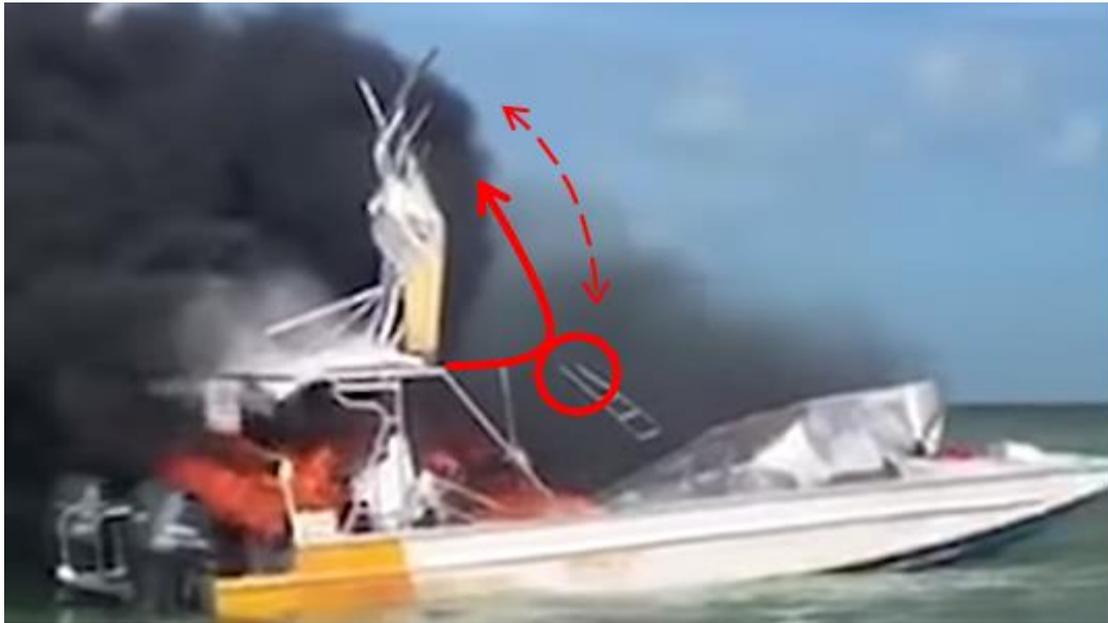
5.7.8 Likewise, as seen below within figure 27 the superstructure (canopy) was forced up and towards the rear of the boat by the force of the explosion separating from the forward stations normally holding the superstructure in place.

**Figure 27: Damage sustained to superstructure immediately after the explosion**

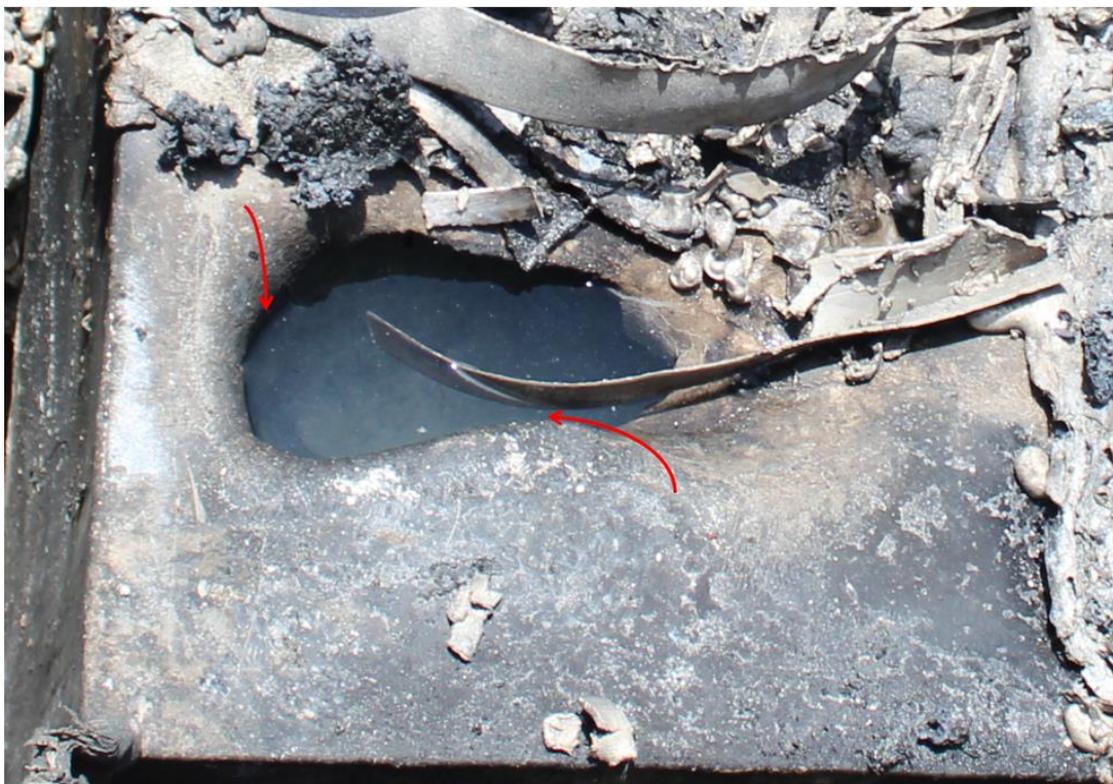
5.7.9 Figure 28 focuses on the starboard fuel tank, specifically the top side which was positioned approximately 4” beneath the underside of the deck plate. This hole was a result of the aluminium material of the tank melting due to the heat of the fire and confirms that the explosion did not occur within the starboard fuel tank. The tank was still able to retain fluid indicating no further structural damage beneath the water level.

**Figure 28: Damage sustained to the top of the starboard fuel tank by the heat of the fire**
