The Bahamas Maritime Authority

“HARBOUR KRYSTAL”
IMO Number 9330020
Official Number 8001246

**Report of the investigation into the explosion
and fatality on the 6th March 2013**

Date of Issue: 30th August 2013

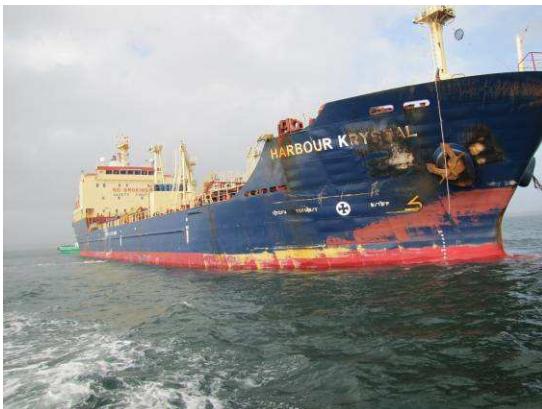
Hull: All Hull plating buckled outwards due to explosion pressure inside the forecastle space. Starboard side shell plating noted with burn marks

Hull damaged with burning marks

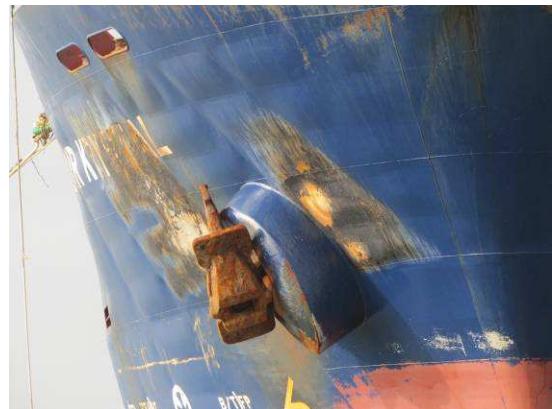
Hull buckled between frames and reinforcements

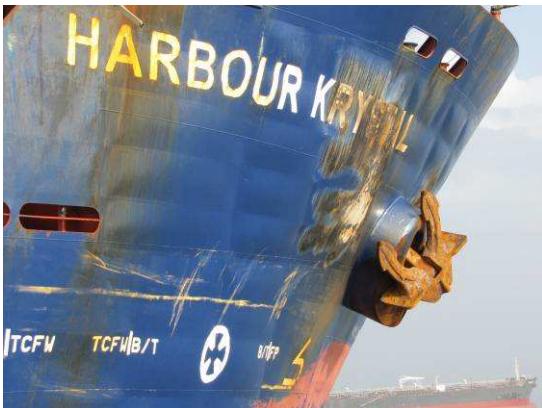
Hull buckled between frames and reinforcements

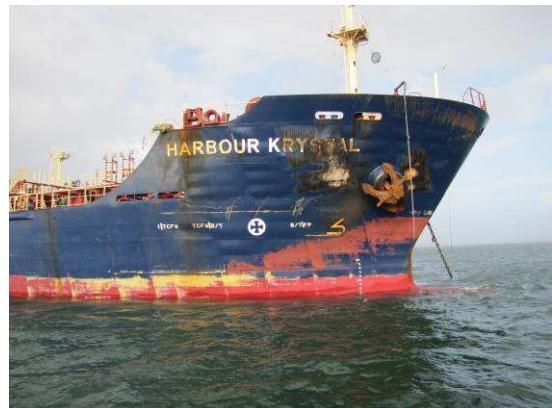
Hull damaged with burning marks

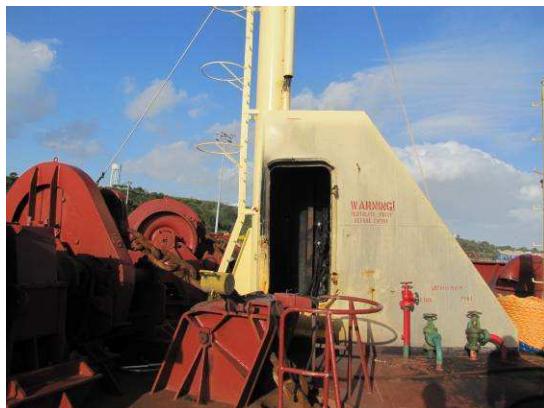
Forecastle Deck: All deck plating deformed due to explosion pressure inside the forecastle deck space. Entrance doors and hatch covers were ripped out and detached.

Forecastle entrance door missing

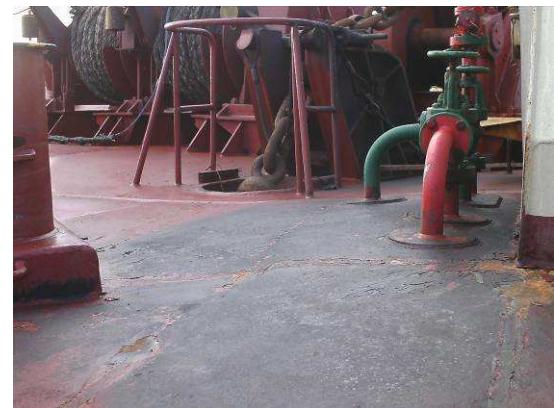
Inflated forecastle deck port side

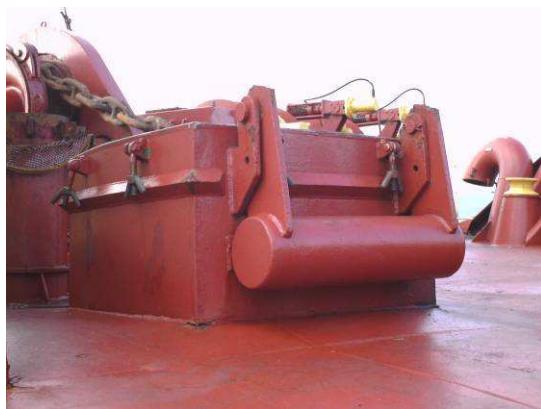
Forward port square hatch missing. Ripped out from counter weight

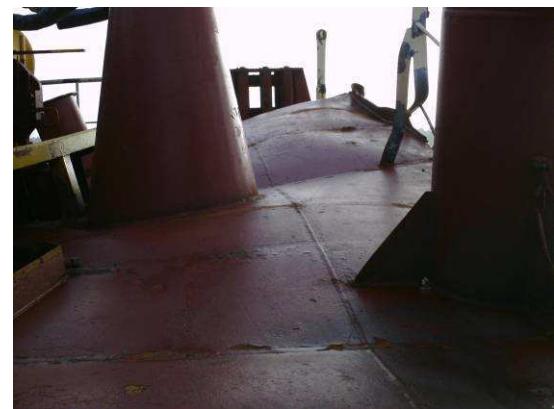
Inflated forecastle deck on starboard side

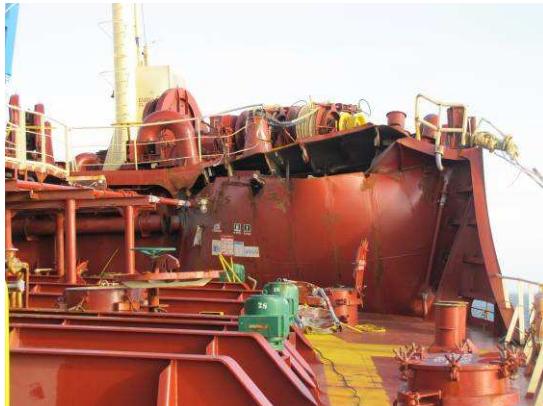
Upper Deck: Deck plating deformed due to explosion pressure inside the forecastle deck spaces. Entrance doors and hatch covers ripped out and detached.

Bulkheads pushed outwards due to explosion pressure

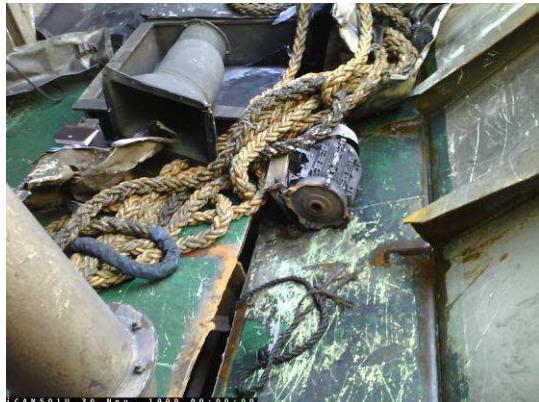
De-humidifier Room: Deck plating deformed due to explosion pressure. De-humidifier unit disintegrated into small pieces.

Deck pushed and broken. Motor from de-humidifier

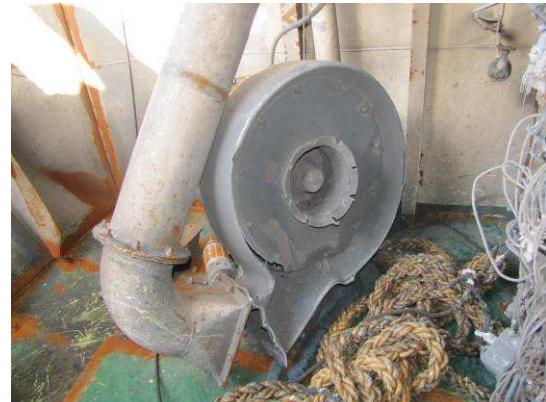
Fan with black soot

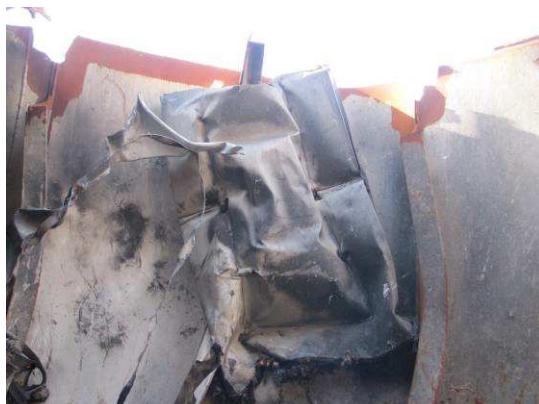
De-humidifier panel on aft bulkhead

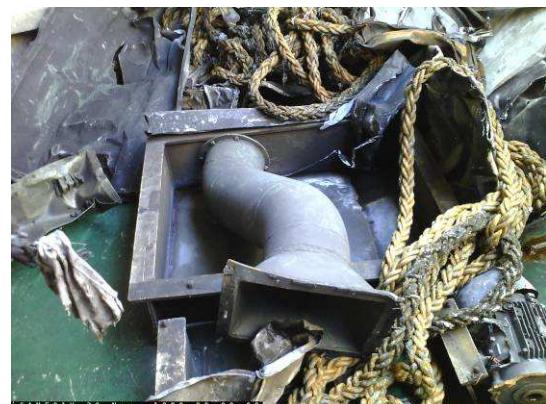
De-humidifier base with one air flow line

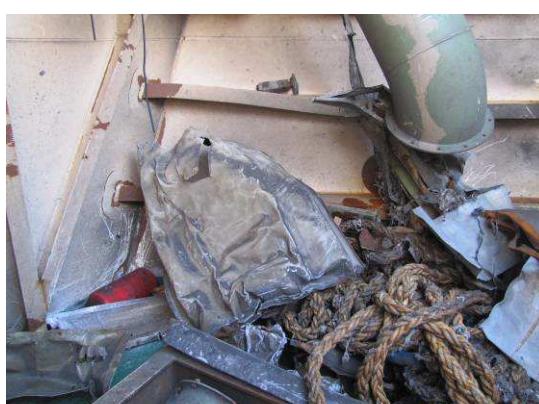
De-humidifier panel on starboard side

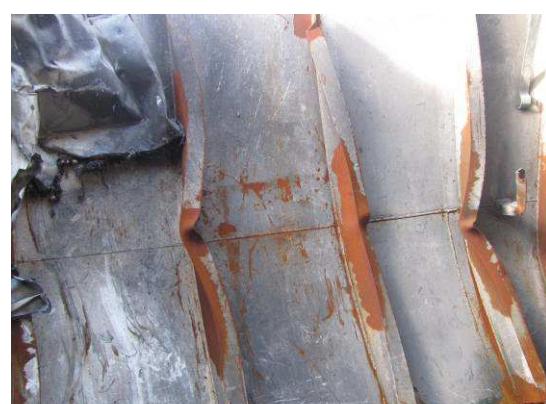
Aft bulkhead pushed outwards

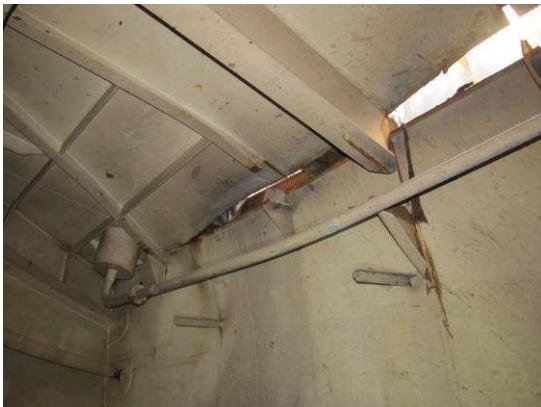
2nd Deck: Deck plating and bulkheads deformed due to explosion pressure.

Top deck (Upper deck) inflated/broken

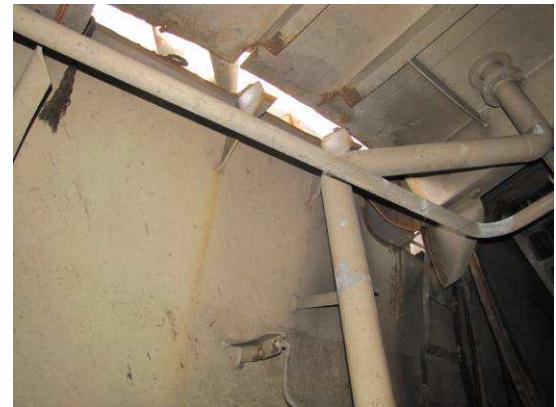
Top deck (Upper deck) inflated/broken

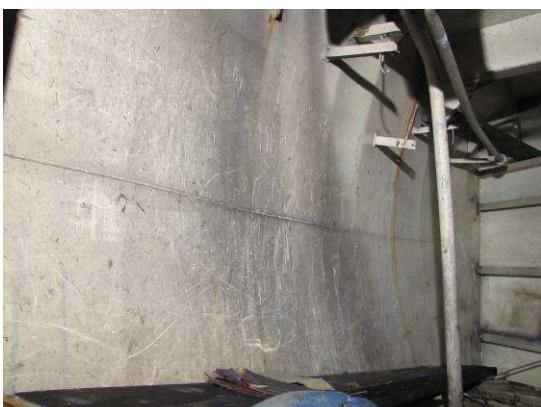
Aft bulkhead buckled towards the aft

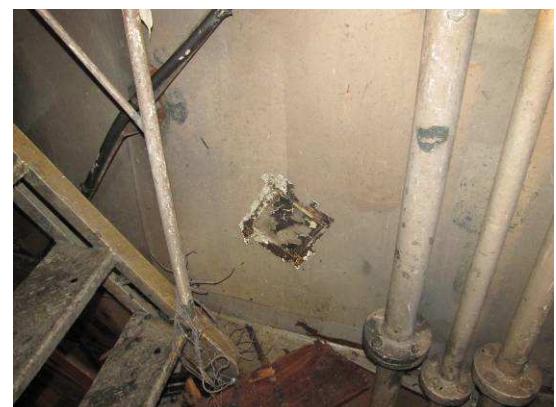
IMO sign burned

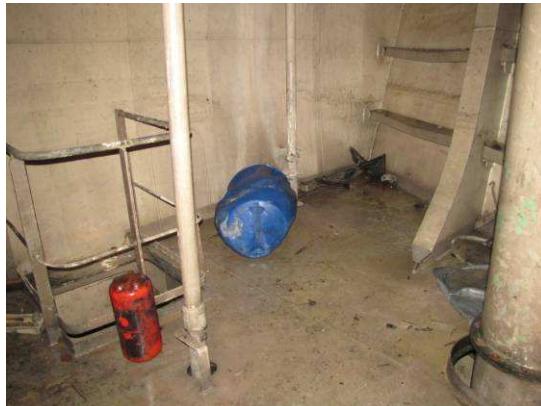
1st Deck: Deck plating deformed due to explosion pressure inside the forecastle space. Entrance doors and hatches ripped out.

Empty drums distorted, broken fire extinguisher

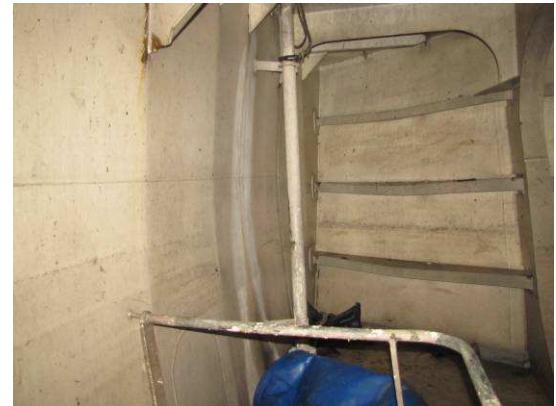
Aft bulkhead buckled towards the aft

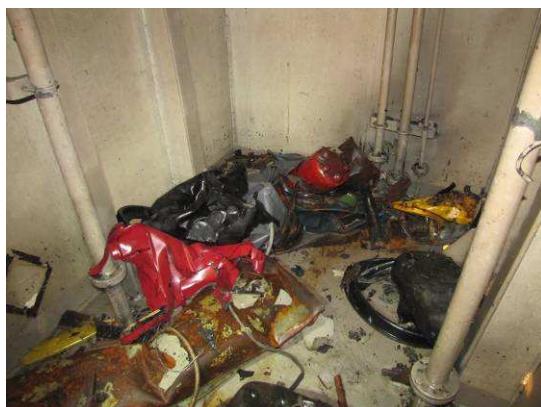
Aft bulkhead buckled towards the aft. Plastic affected by heat

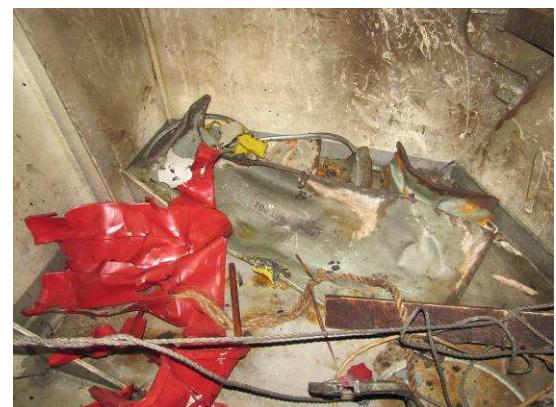
Debris left on deck

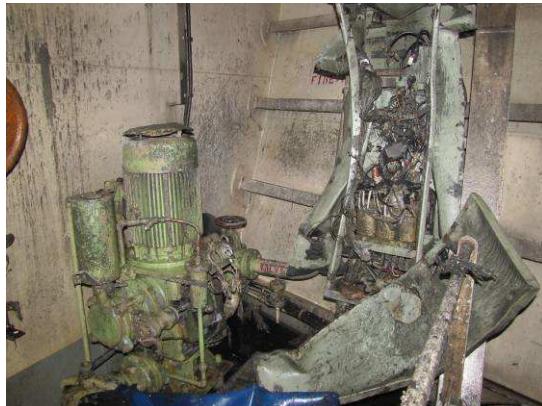
Emergency fire pump and electrical panel

Bow Thruster Deck: All electrical boxes broken. Signs burned. Hull framing bent.

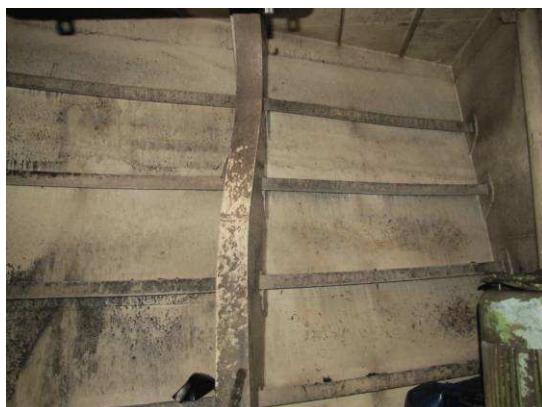
Distorted Hull frame

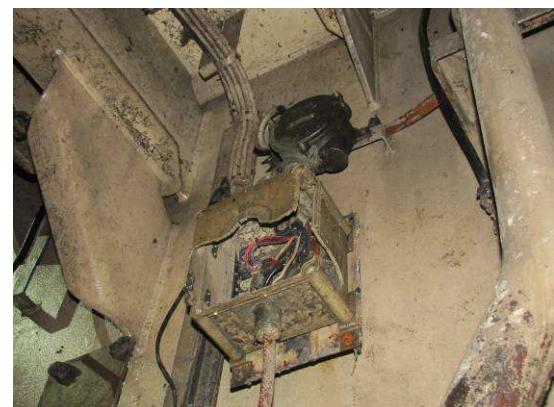
Broken electrical connection box

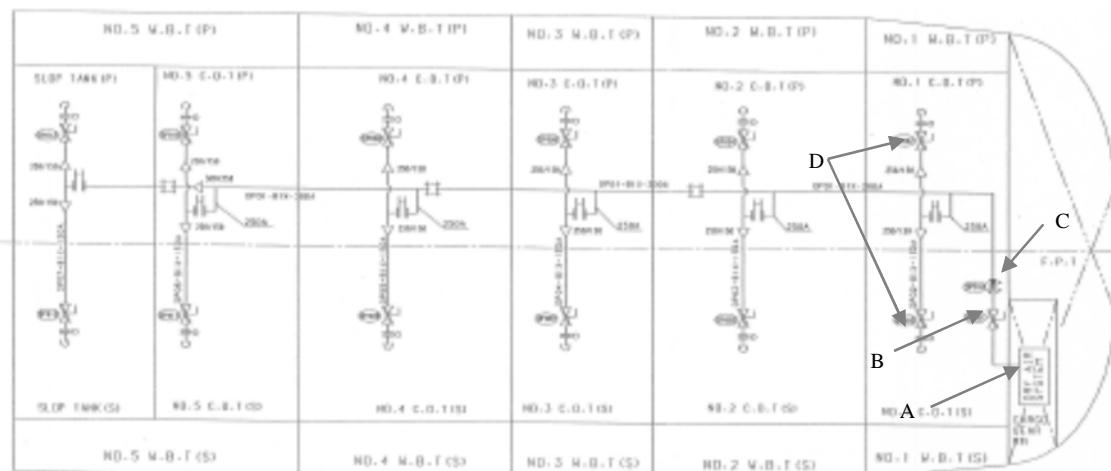
- 5.18 The de-humidifier (A) is built inside the bosun store in the starboard aft end. The unit is connected to an air fan which is directly connected to the dehumidifier line. The de-humidifier line is fitted with two safety valves, one hand operated isolating valve (B) and a non-return valve valve (C) to avoid leaking into the de-humidifier room. Additionally, the line is fitted with a small hand operated valve (D) fitted on each individual tank

- 5.19 It was confirmed by the operators that a safety warning was already sent to keep the line blanked with the non-return valve (spool piece) removed due to foreseen dangers of vapours leaking into the room. The email print out was posted onboard.
- 5.20 Despite the email sent and post-it on the control room the non-return valve (spool piece) remained in position and was reported to never been removed.

- 7.3 Consider the difficulty in removal of the spool piece (non-return valve) posed by the weight and position and install improved access and lifting points/equipment.
- 7.4 Initiate a safety campaign among the officers, ratings and crew in view that the smell noted on the 3rd March was not notified and that other number of safety issues were not properly followed.
- 7.5 Include all valves in the Planned Maintenance System and review the PMS for the de-humidifier system e.g. the de-humidifier (“air drier of tank ventilation”).
- 7.6 Review and audit the implementation of the Safety Management System related to oversight, safety checks, work standards, maintenance, inspections and duties onboard.

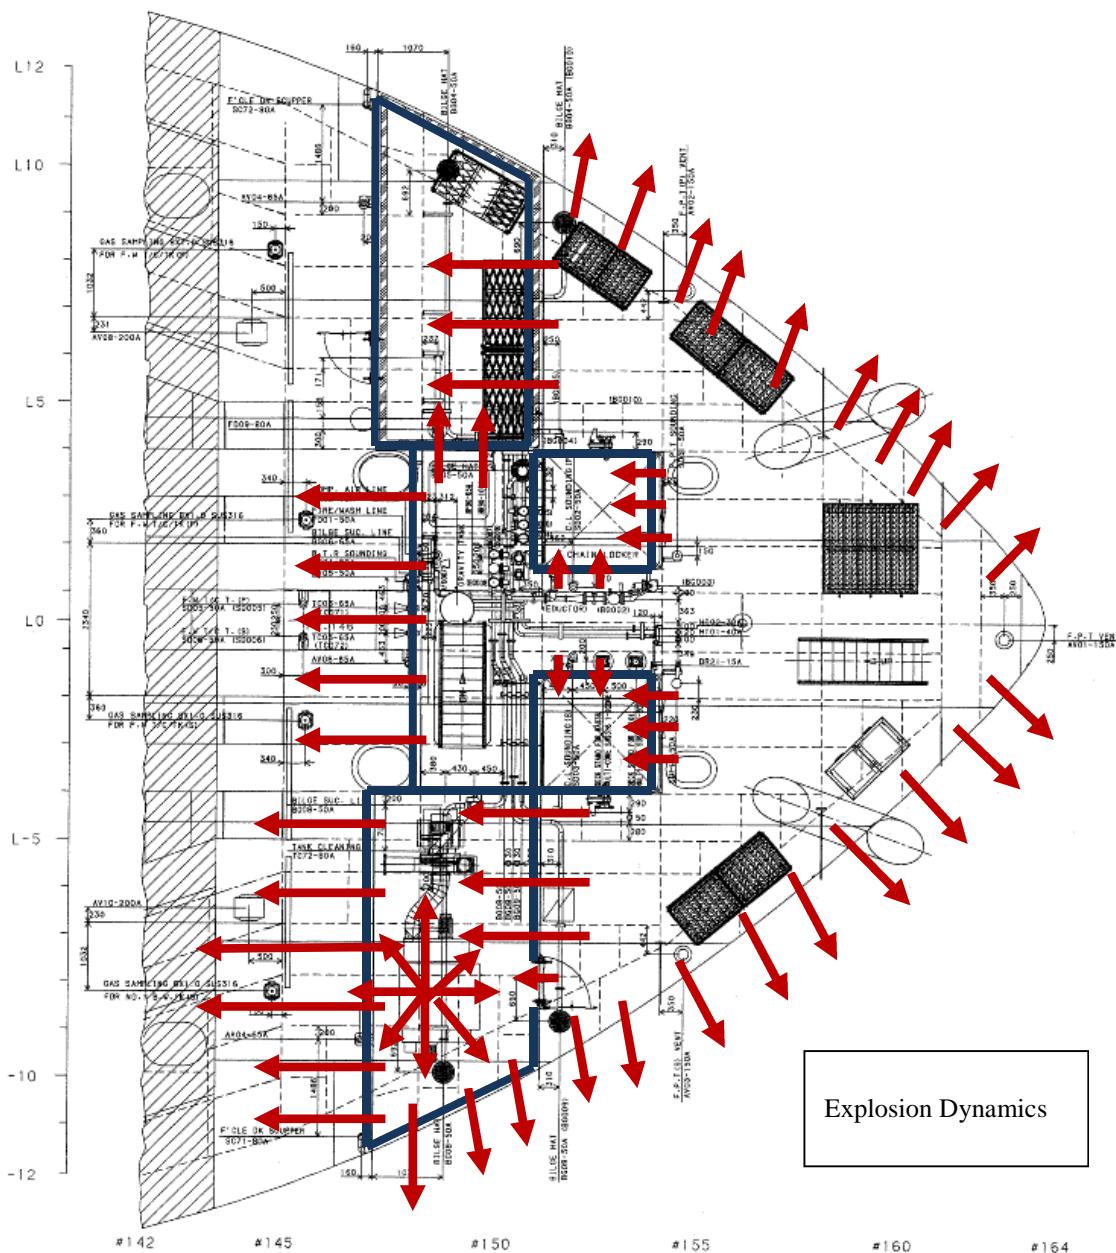
- 5.40 The below diagram shows the force vectors showing the path of the explosion. The direction of travel and the burned material on the starboard side denotes that the starting point of the explosion or the ignition point was in way of the ventilator motor fitted at frame #157 near the centre line to the port side.
- 5.41 The explosion moved towards the interior of the de-humidifier where the second gas pocket caused the second explosion, disintegrating the de-humidifier. It was confirmed by several officers and crew that two consecutive explosions were heard, however other testimony differs on this point.

- 5.42 The force of the explosion was greater on the upper deck and gradually decreases its pressure towards the bottom decks. Therefore gas vapours were mostly concentrated on the upper levels.

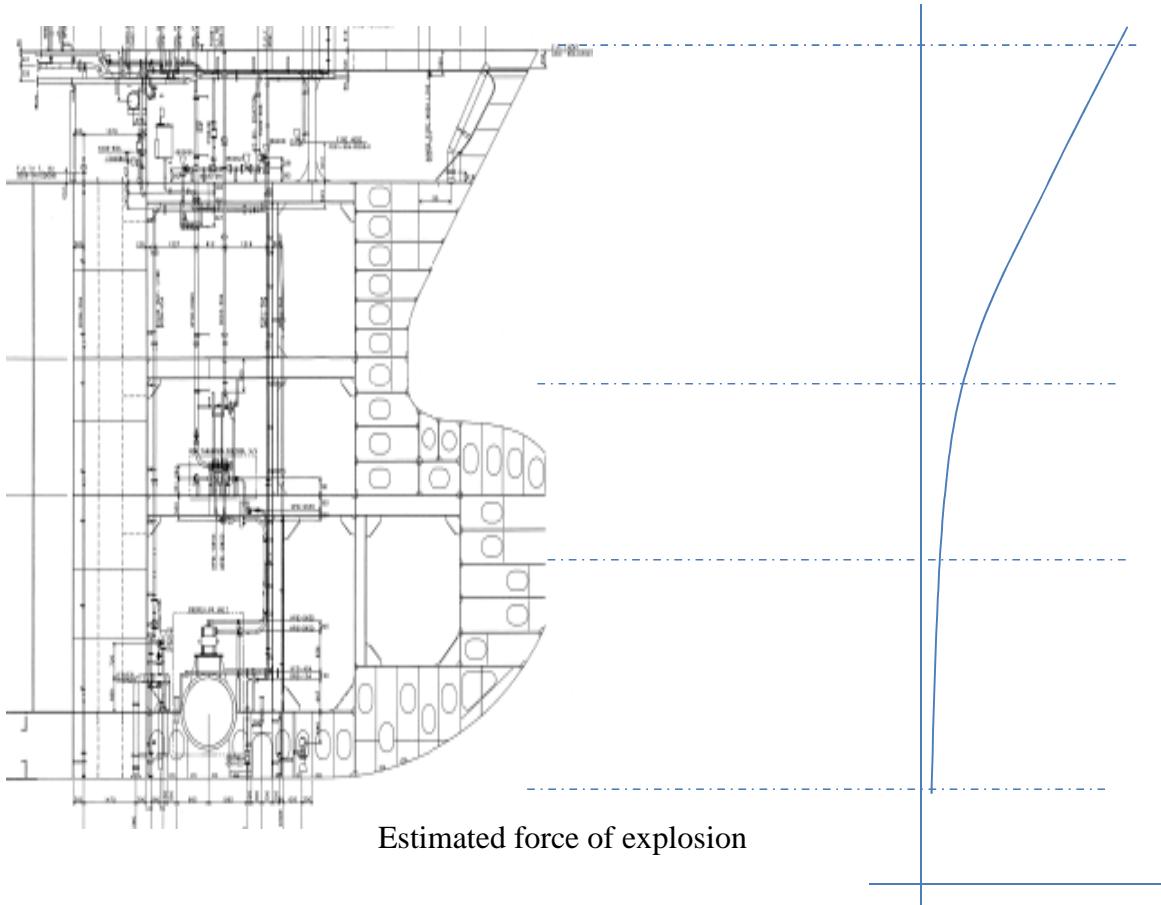
- 5.43 The force of the explosion seems to be more powerful towards the upper deck starboard side.

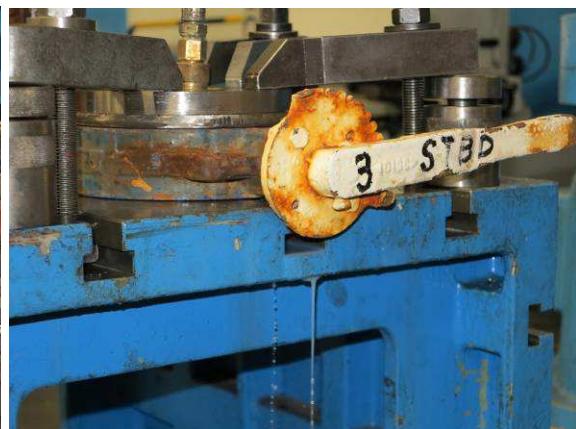
Tank valve leaking during test

- 5.50 The hydraulic tests concluded that all the tank hand valves were seized and could not be properly closed. The main manually operated valve could not close watertight and the non-return valve was not tight and fit for its purpose.

- 6.5 None of the valves were included in the maintenance system. Hydraulic tests on valves revealed that they were all partially seized due to lack of maintenance and that valves from 1 Port, 1 Stbd, 2 Port, 3 Stbd, 5 Stbd, main isolation valve and non-return valve were leaking.

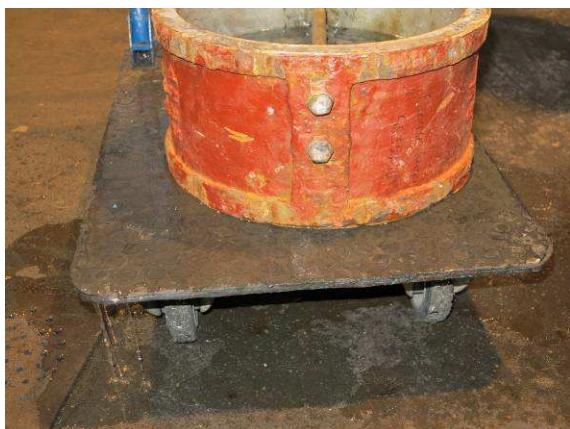
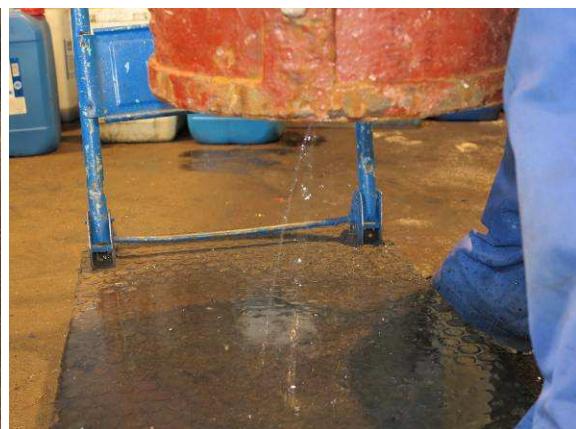
Non-return valve heavily leaking without pressure

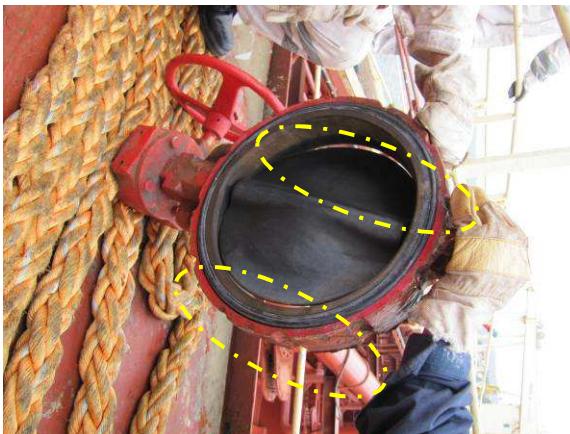
Isolating valve in closed position but not watertight

- 5.51 At the time of removal of the valves many were seen to be not closing properly and this could be seen either because the indicator was not parallel to the close position or the valve was not at a right angle to the line.
- 5.52 All light fittings on the forecastle area were of an explosion proof type. However the ventilator motor, de-humidifier and other electrical panels fitted on the forecastle were not explosion proof.

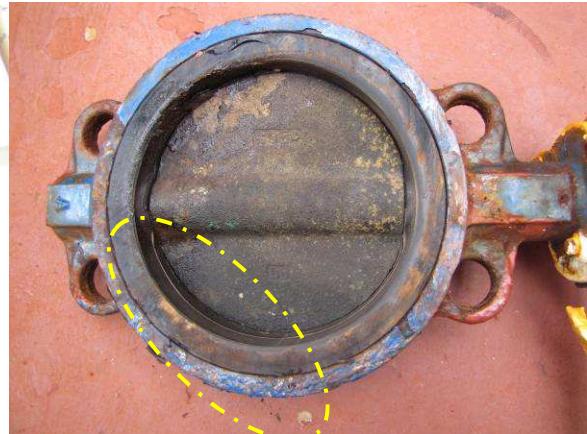
Tank valve in closed position with gap as marked

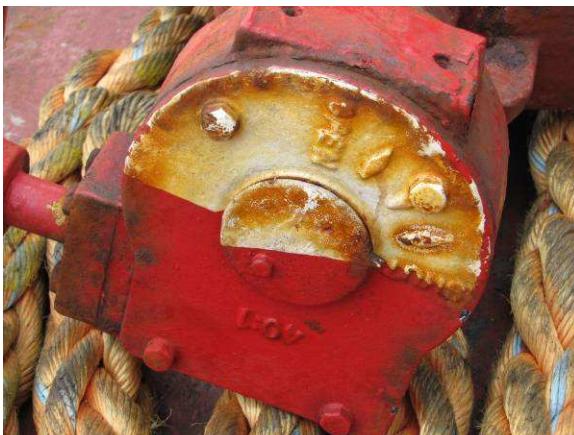
Isolating valve in closed position but in line with colours

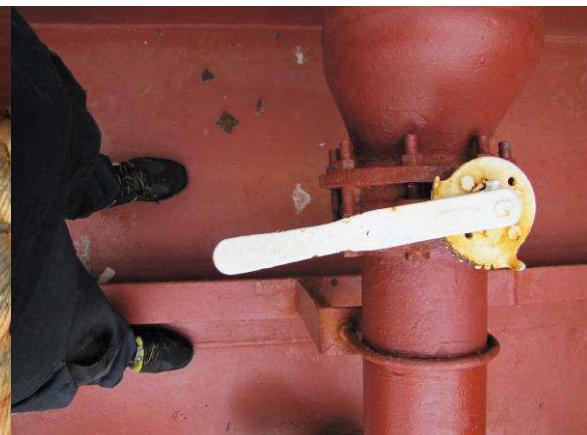
Tank valve in closed position not at right angle to line
