**The Bahamas
Maritime Authority**

IMO Number: 9116876

**Report of the marine safety investigation into a
fall from height overboard on 5th September 2019 in
Livorno, Italy**

Date of Issue: 04 December 2019
Bahamas Maritime Authority
120 Old Broad Street
LONDON
EC2N 1AR
United Kingdom

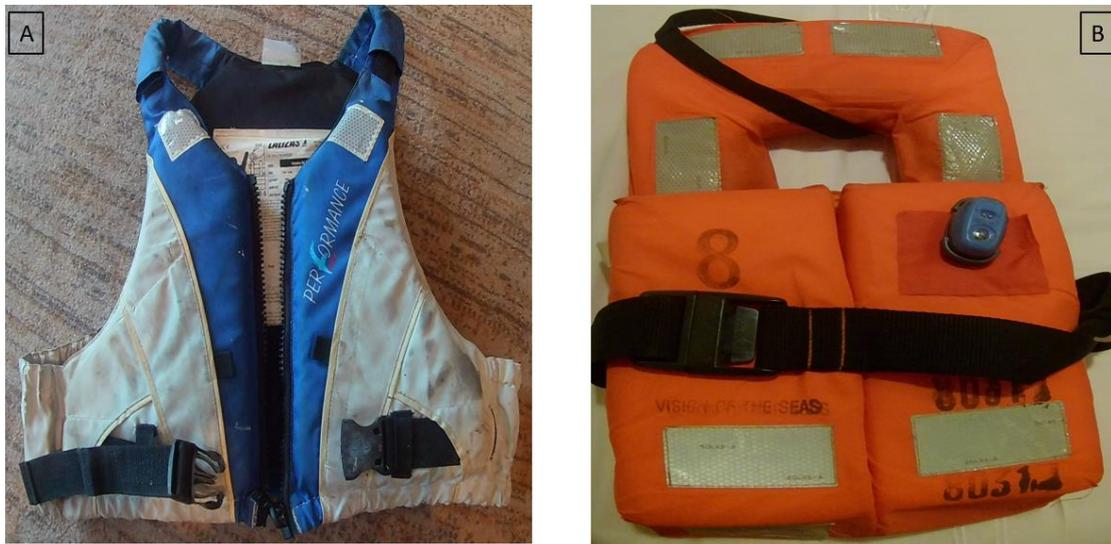
Figure 11: (A) life vest and (B) life jacket available on board for use by crew members

No life vest or flotation device (figure 11 left (A) and right (B)) was worn by the OS(2). It was well known and accepted by Deck department personnel, from the Staff Captain to the Ordinary Seaman on board, that life jackets were considered dangerous on account of the injuries that could be sustained on entering the water from any height. Further, the opinion shared amongst the same individuals when knowingly required to wear a life vest or life jacket is that it cannot be worn as it restricts the wearers ability to move freely and is deemed very uncomfortable. It was determined through witness testimony that discussions during the Shipboard Safety Steering Committee Meetings¹³ held on board that sections of the SQM and JSA regarding the wearing of a flotation device of any kind does not apply. However, no record of those discussions was documented within the minutes of the Shipboard Safety Steering Committee Meeting. The OS(2) who fell, entered the water wearing a harness,

RCCL require all personnel working aloft and overboard to wear a flotation device. No flotation device was worn by the OS(2) who, on entering the water was unable to maintain positive buoyancy. The SQM does not specify which flotation device is to be worn when working over the side, however the JSA does stipulate that a life vest should be worn. Despite both options, a life jacket and a life vest being readily available on board, the decision was made by the senior leadership and endorsed by the Deck department personnel that a flotation device of any sort would not be worn. There is no doubt that had a flotation device been worn, positive buoyancy would have been maintained and as such the recovery of the OS(2), from the water would have been achievable.

Require all personnel working overboard and at height²⁰ to wear an approved floatation device.

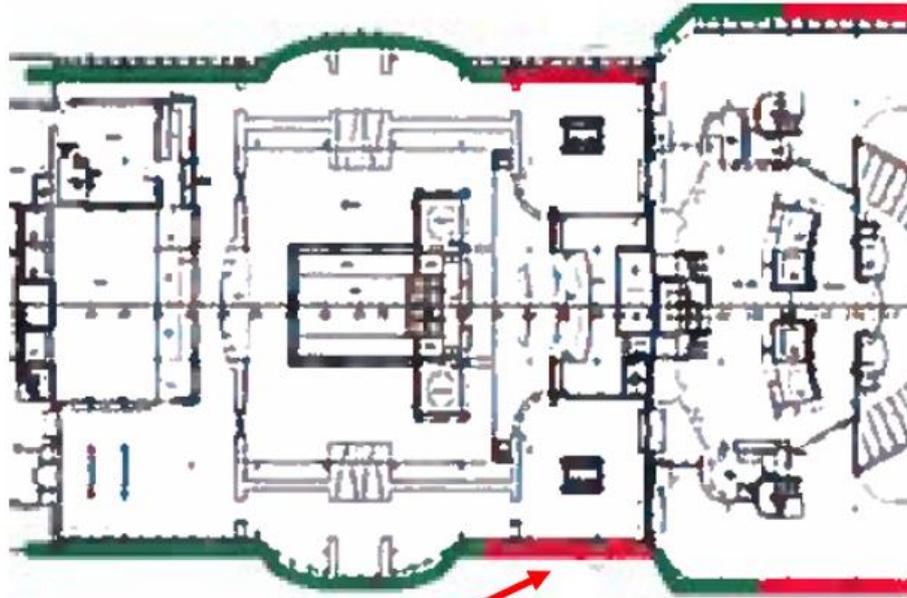
Location of fall

Figure 12: General arrangement of deck 9 external catwalk and safety rail locations. Area highlighted in red depicts no catwalk or safety rail, area in green depicts external catwalk and safety rail present

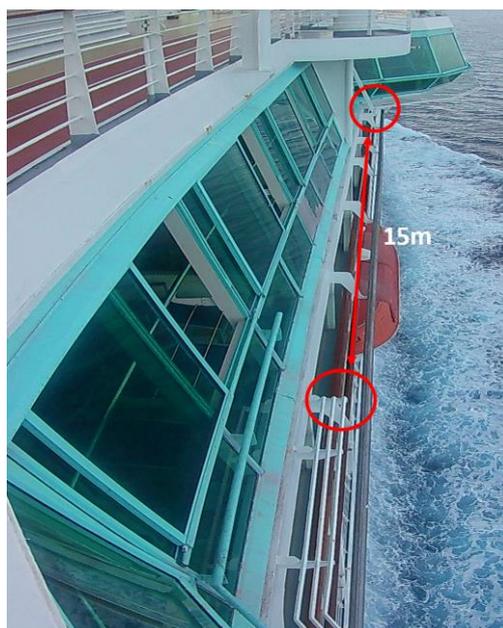
At this point, the maintenance of external windows cannot be easily achieved and is described within SQM 4.02 as inaccessible by virtue of there not being a platform/basket or shoreside equipment available. It recommends that the use of ladders, stages, bosuns chairs should be *“used with caution. The use of such equipment should be limited and considered only when an area is inaccessible.”* The investigation determined that the use of ladders, stages or a bosuns chair was not used nor was it considered by the Authorizing Officer, despite reservations raised as to how to safely navigate the external 15m section which was void of a catwalk or external securing mechanism.

Figure 13: External 15-meter section of missing catwalk and safety rail in the location where the maintenance work and fall occurred

The lack of adequate external securing anchors in the proximity of the Solarium windows, resulted in the OS(2) having to connect to a secure anchor point inside the frame of the window. This shortened the available reach and as such a temporary solution was determined necessary in order to conduct the maintenance required. The temporary solution complicated the securing method by introducing another failure mechanism in the form of a strop. The strop therefore had to be looped inside itself to provide an anchor point increasing the risk of confusing the secure end of the strop with the loose end.

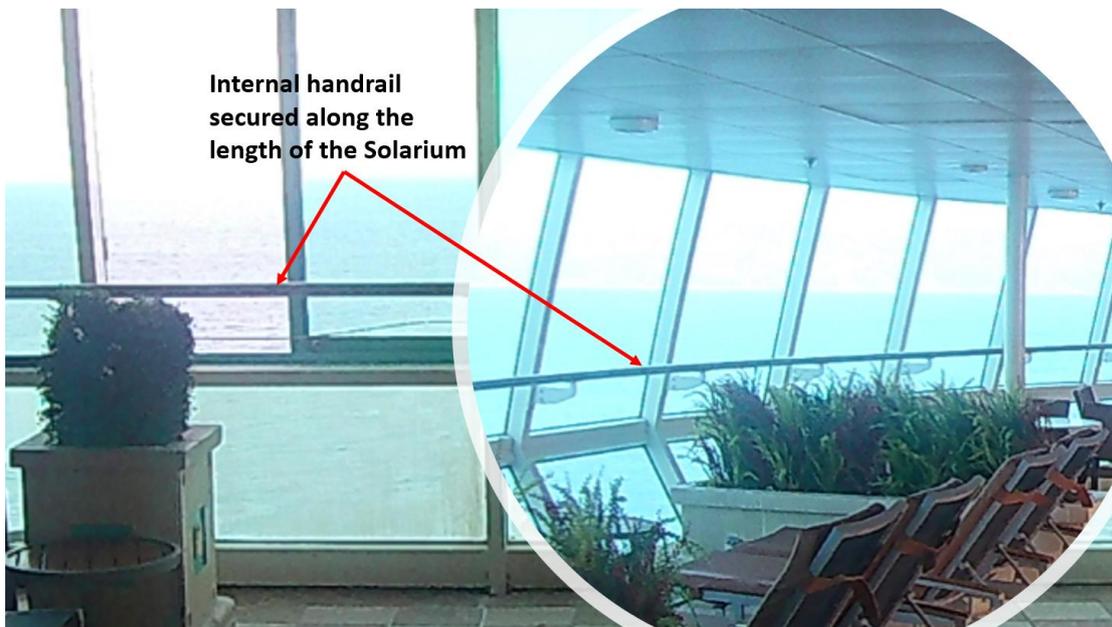
Figure 16: Internal view of the Solarium and handrail used as a secure anchor point

This restricted the free movement of each crew member as the hooks could not run unobstructed along the length of the Solarium. The window structure, by design, required the OS(2) to connect and disconnect more frequently in order to reach the glass that required maintenance either side of the window frame. The SQM 4.02 (working aloft and overboard) states: *'lanyards and lifelines are to be attached to an anchor point at all times during work. When moving from point to point, a two-lanyard method is to be employed'* as described within figure 17.

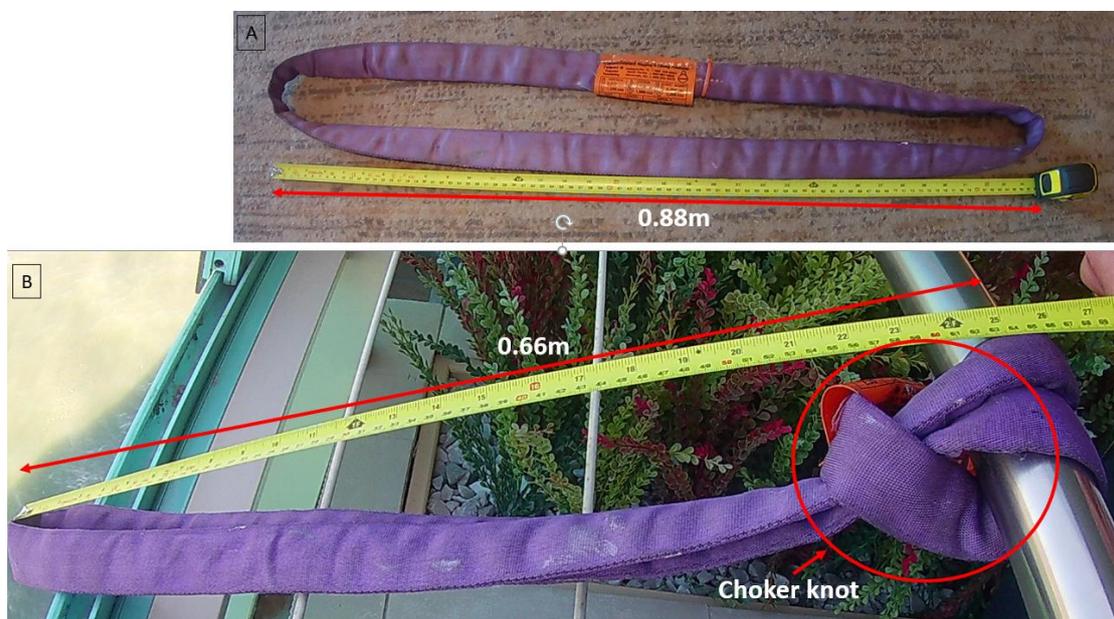
Figure 18: Description and dimensions of single strop connected via choker method to the internal handrail within the Solarium

The strop used was not a designated safety critical piece of equipment for the purpose of securing a lanyard to a securing point and is not covered directly by a safety policy or instruction. As can be seen within figure 19, the hook provided with the lanyard and attached to the harness will connect directly to the internal handrail without the need for a strop. The strop was determined by the maintenance team to be a necessity in order to extend the reach of the OS(2) in between the open window frames so the OS(2) could conduct maintenance furthest from the securing point. Additional risk was therefore introduced by this adhoc securing method which was in violation of the SQM procedure which requires the lanyard and lifelines to be attached to a secure anchor point at all times.

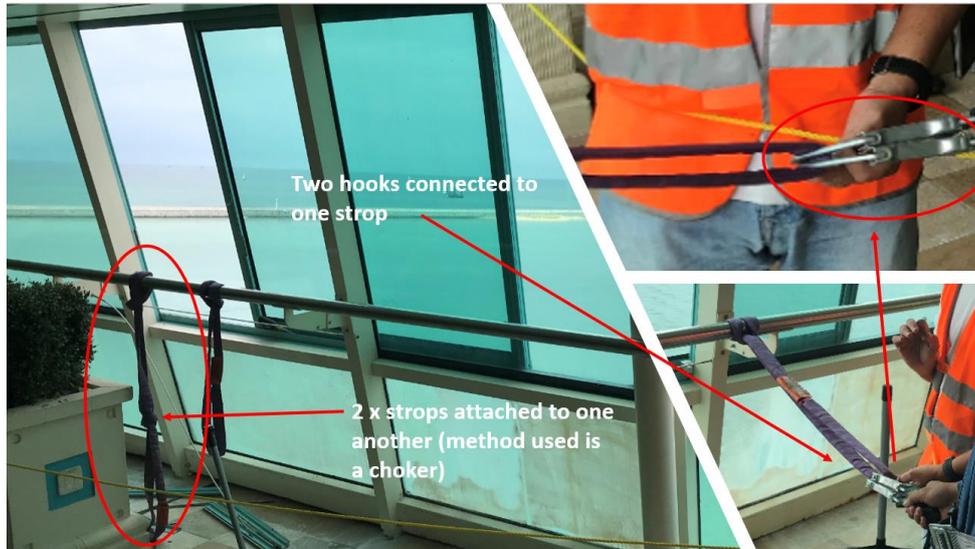
Within SQM 4.11.02 titled ‘General Safety Standards’ it states that when performing a job: *‘Do not use temporary solutions or arrangements that could compromise safety. In rare instances when a temporary solution is necessary, obtain the approval of you your supervisor to use it. Replace or correct it with appropriate equipment or procedure as soon as possible. While using the temporary solution, make others aware of it.’* It could not be determined during the course of the investigation if it was the understanding of the Supervisor that the use of a strop constituted a temporary solution or arrangement. However, on the basis that a strop is not a secure anchor point, this arrangement contradicts the procedure for Working Aloft and Overboard (SQM 4.02) as lanyards and lifelines are to be attached to an anchor point at all times during work. In accordance with SQM 4.02 it defines a suitable anchor point as a *‘bulkhead or other steel support, such as railings or frames’*. Therefore, a strop is considered a temporary securing method and as such approval for use should have been sought from the Supervisor. The temporary arrangement employed by the team in attaching the harness to a secure anchor point via a strop was not considered by the Team Leader to be temporary as it had been used on previous occasions, in particular on the port side of the external Solarium windows the week prior.

Figure 20: Actual image of the scene immediately after the incident. The strops used were known to be used by the OS(1). The pictures on the right was a demonstration to the Italian Coast Guard Officers on how the crew members connected to a single strop using both lanyard hooks.

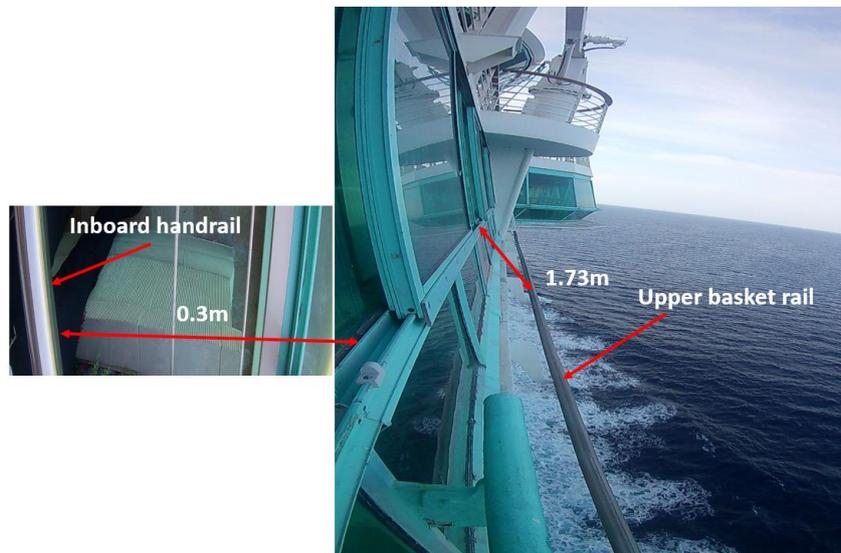
The location of the fall the OS(2) was stood on top of a metal circular tube designed to support the basket when cleaning and maintaining external windows beneath the Solarium. The circular tube was not designed to be stood on. No secure external anchor point existed on the external superstructure of the vessel in vicinity of the Solarium windows as seen in figure 21.

Figure 21: Dimensions of the internal handrail and external basket rail taken from the frame of the window of the Solarium in the location of incident

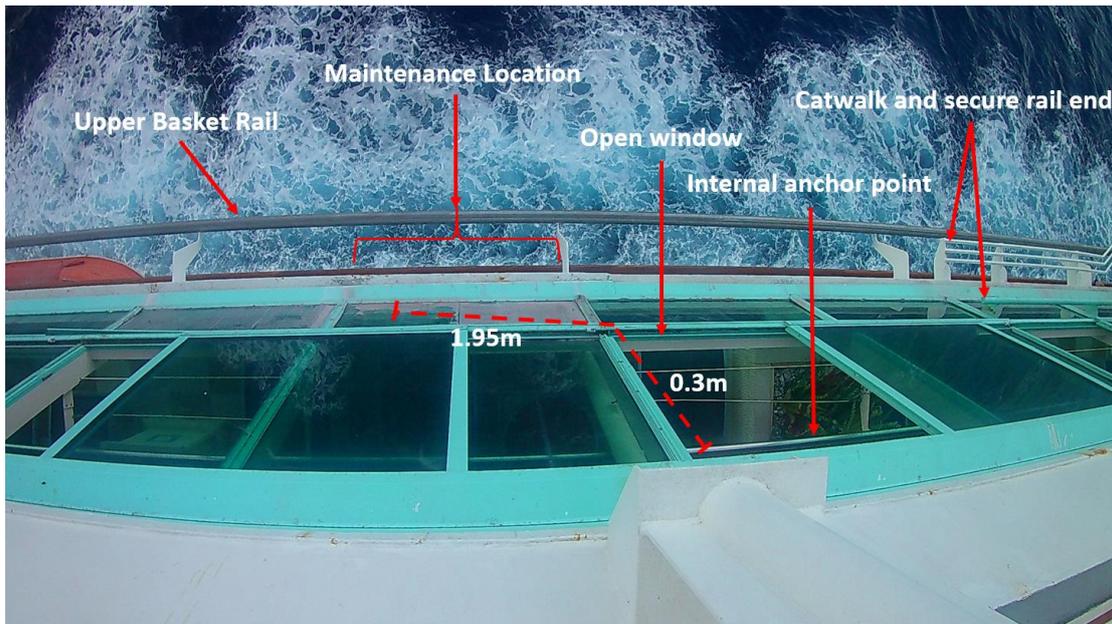
The lack of an adequate external catwalk and safety rail did significantly reduce the manoeuvrability of both crew members working externally with the safety equipment provided. As demonstrated in figure 22, the maximum length of the harness with

lanyard attached is 1.23m to the centre of the wearers back. The distance from the internal handrail (known securing point used) to the the centre of the precise work location was 2.25m. When being worn by the crew member who is 1.70m tall, the individual would be able to reach the centre of the work location but would be unable to extend a reach beyond that point. Therefore, the use of a strop would have provided an additional 0.6m of reach affording the individual more room to manoeuvre. A further strop attached to another strop was also utilised as indicated in figure 20 to further increase the users reach by an additional 0.6m.

Figure 22: Location of the incident with distances taken from the known secure anchor point (internal handrail)

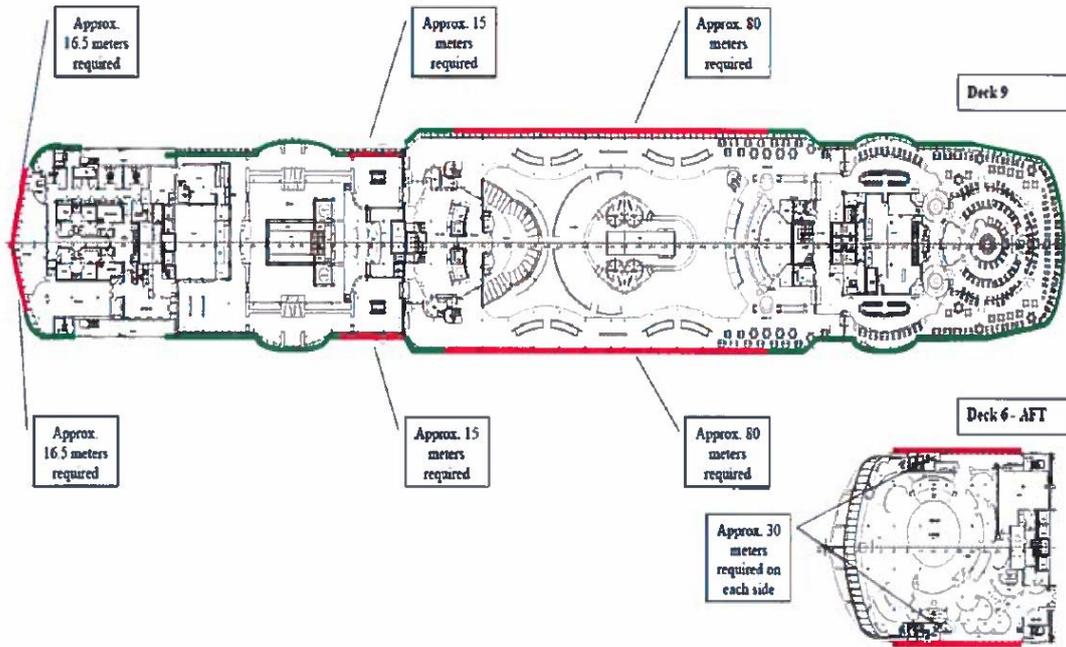
The Vision of the Seas was designed without a catwalk or securing mechanism in a number of locations on the external superstructure on deck 6 and deck 9. In total 283m of catwalk across deck 6 and deck 9 respectively is not fitted. The Staff Captain had identified that conducting maintenance to the external superstructure in these locations was “*less safe as no access is provided for maintenance*” compared to areas of the vessel where a catwalk and a securing mechanism was present. In September 2017 a proposal to install a catwalk and adequate securing mechanism in all vacant locations was devised and submitted for approval in a dry dock work specification proforma. The work requested was declined but no reason was provided.

Figure 23: General arrangement plan of catwalk and external rail proposal submitted to indicate locations (red line) where catwalk and rail are not present.
