Report on the investigation of
the fire and explosion on board

Yeoman Bontrup

Glensanda Quarry, Loch Linnhe, Western Scotland

Report No 5/2011
May 2011

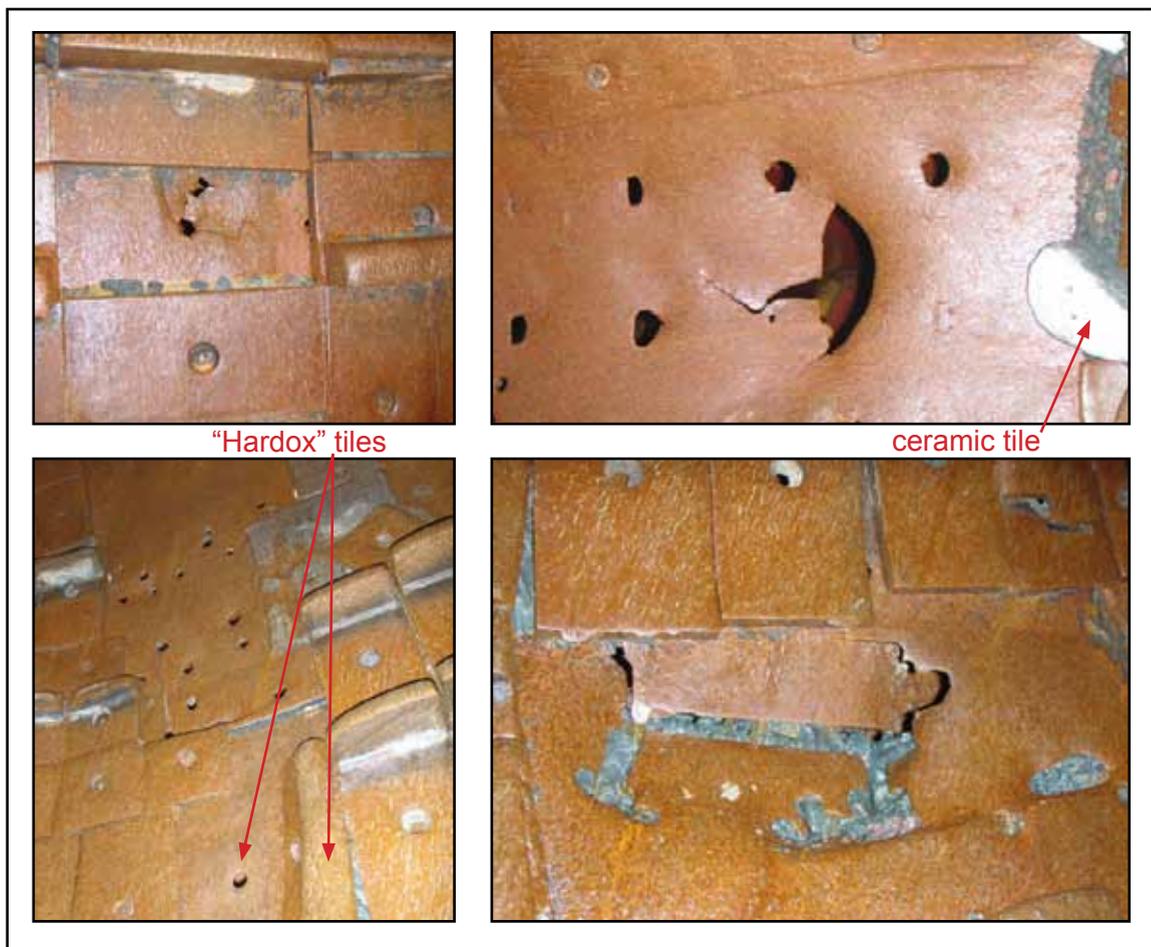
Figure 2

The inspection by the chief engineer and cargo engineer identified a small number of familiar defects associated with the SUS conveyor belts. It also identified that about 40 "Hardox" and 30 ceramic sacrificial tiles, fitted to the inside of the cargo discharge hopper, had been badly abraded or were missing. It was also found that the mild steel carcass of the discharge hopper had been holed in a number of places (**Figure 2**) by the hard sandstone cargo during the discharge operation. At 0807 on 1 July, the findings were reported, by e-mail, to the ship's manager and to the operator's technical manager.

Composite of photographs showing discharge hopper damage and wear to the "Hardox" and ceramic sacrificial protection tiles

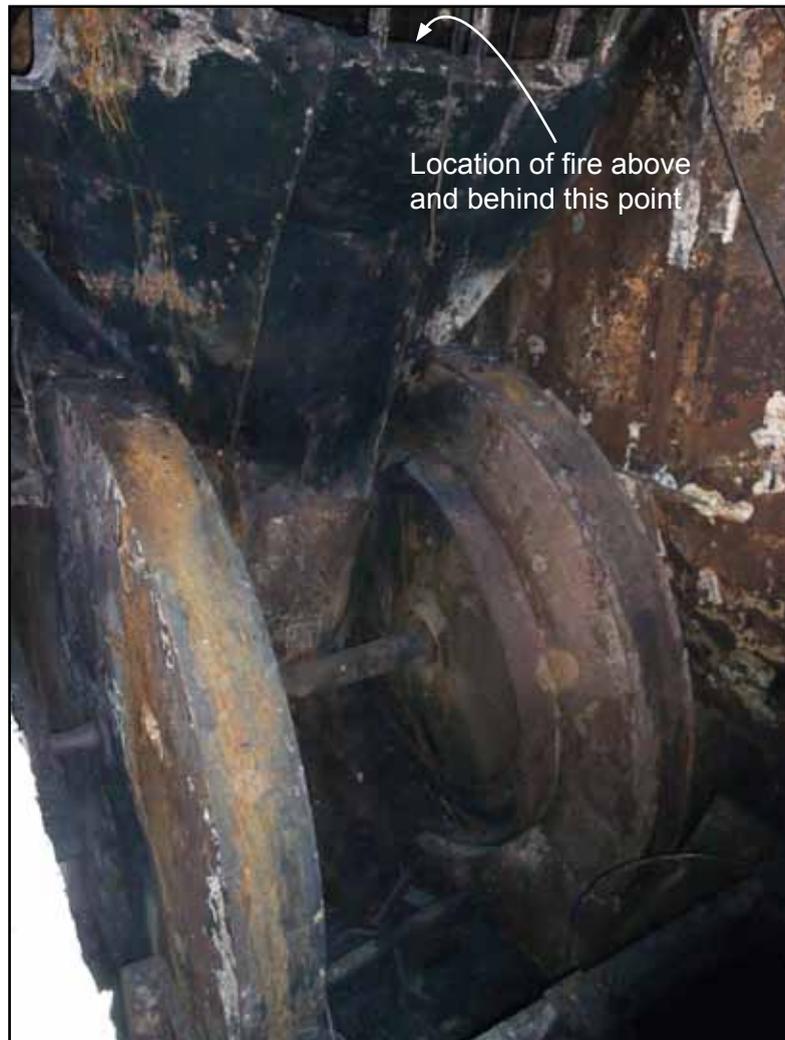
Figure 6

At 1519, the AB reached the lower platform of the vertical conveyor belt. He smelt smoke and, as he turned slightly, he saw a great deal of smoke developing and about 1.5m² of flame around the rising part of the vertical belt adjacent to the forward engine room bulkhead (**Figure 6**).

Area in which the fire was discovered

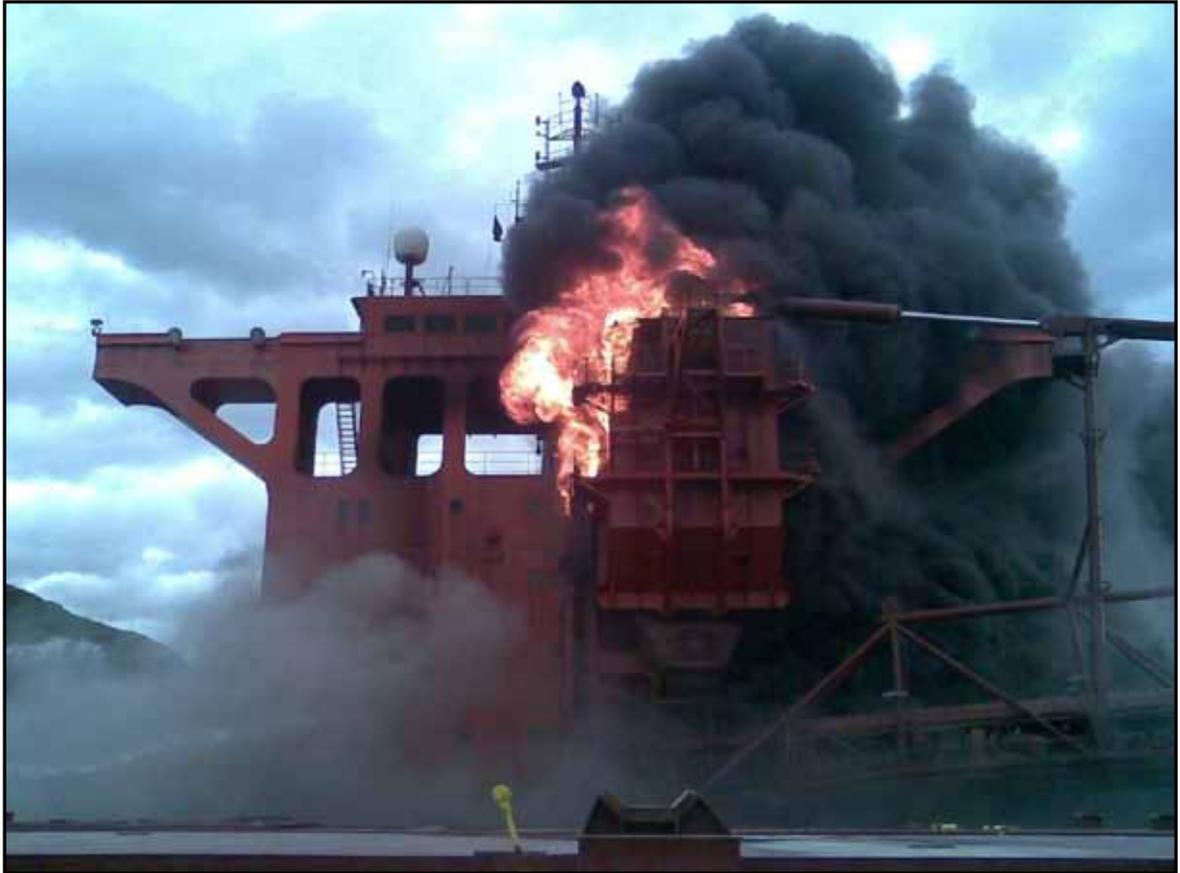
Figure 9

Fireball erupting from the SUS tower

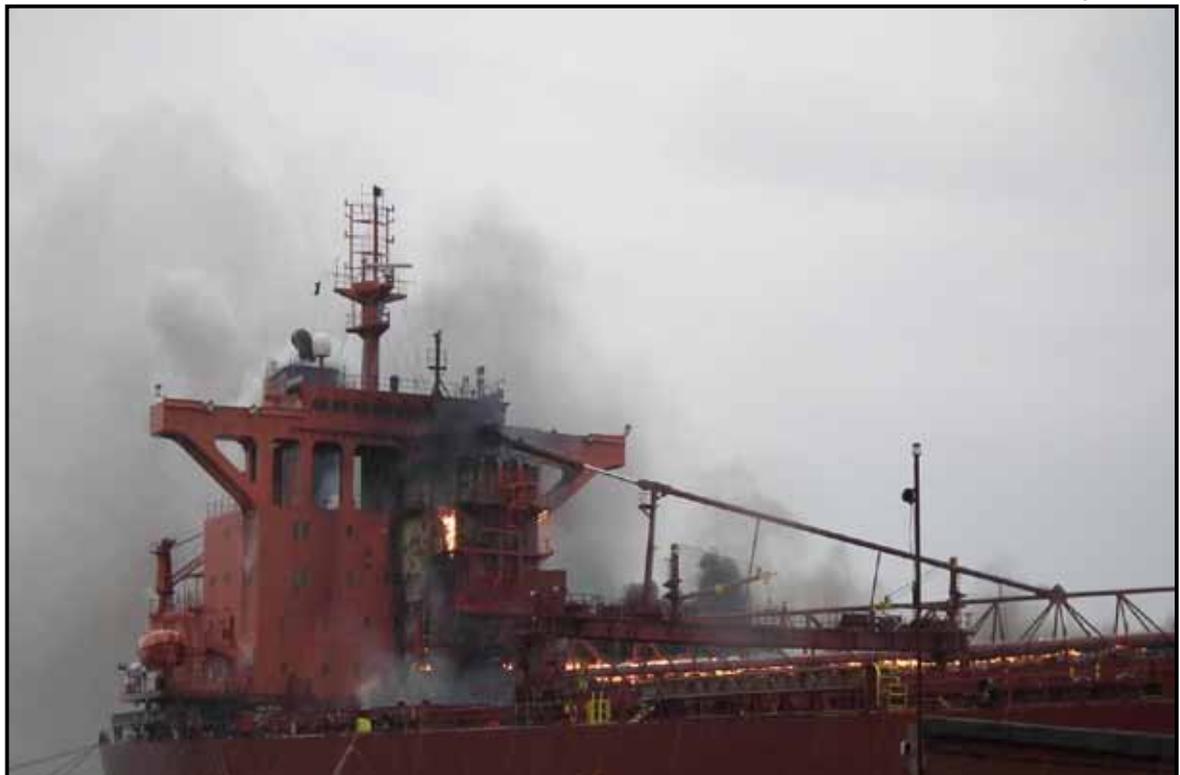
Figure 10

Fire spread onto the conveyor boom

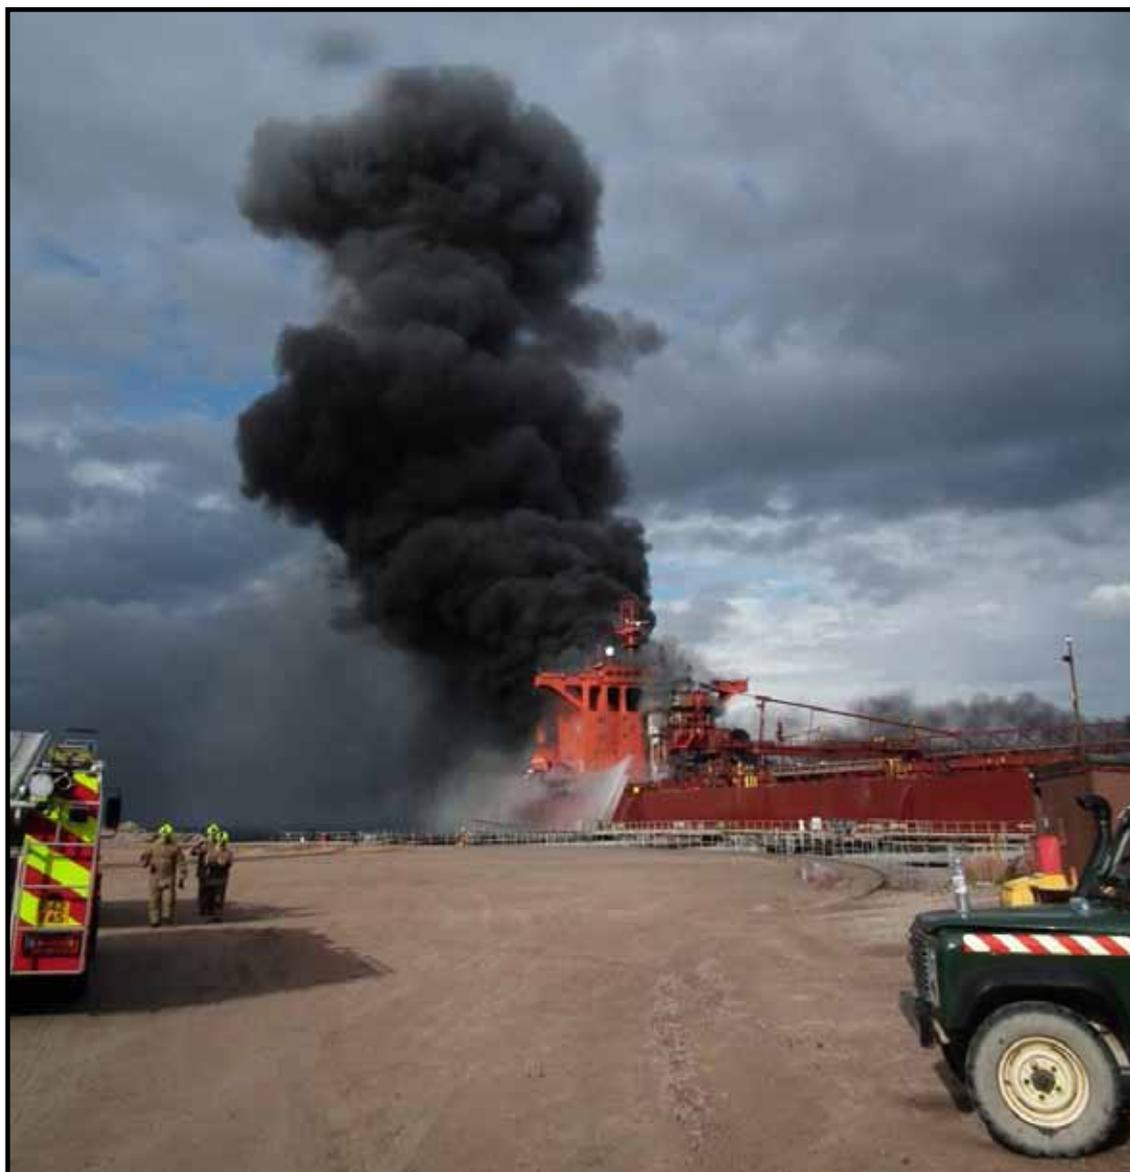
The HIFRS tenders arrived at 1825. The HIFRS had just established a 200m exclusion zone when a massive explosion (**Figure 11**) tore off the entire poop deck, projecting it up into the air and landing it on the port side of the funnel deck. Soon afterwards, flames were seen coming from *Yeoman Bontrup*'s stern area as the oils and chemicals stowed in the steering gear room, and the steering system's hydraulic oil charge, continued to burn.

Steering gear compartment explosion

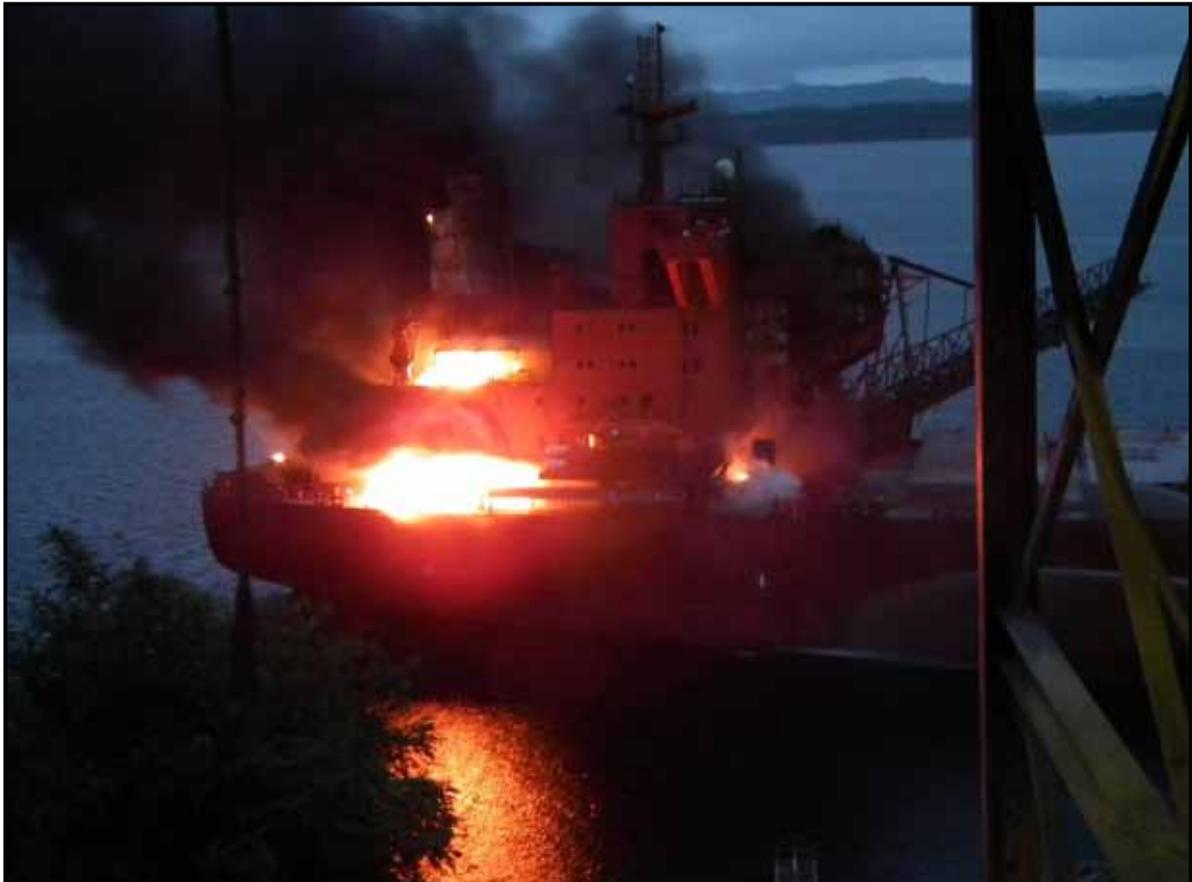
Figure 12

Fuel tanks “flaring” off

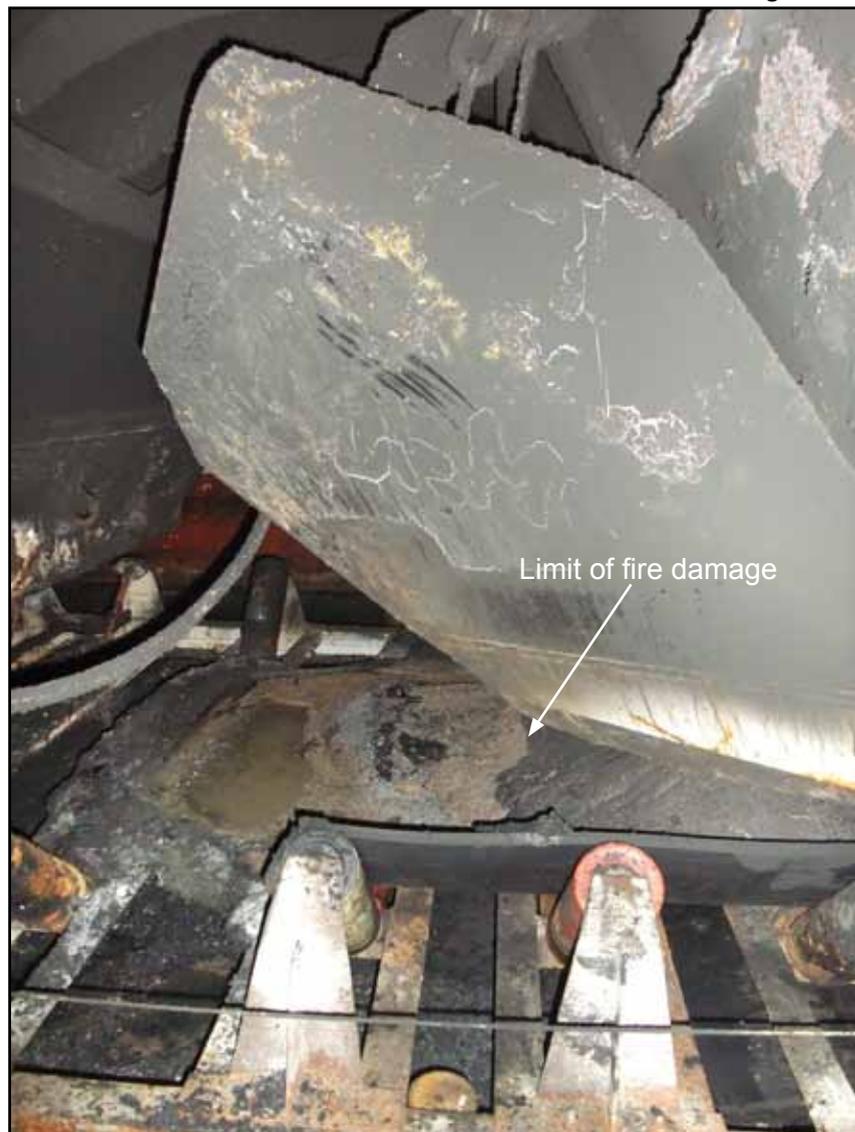
Figure 13

Extent of damage to tunnel conveyor belts

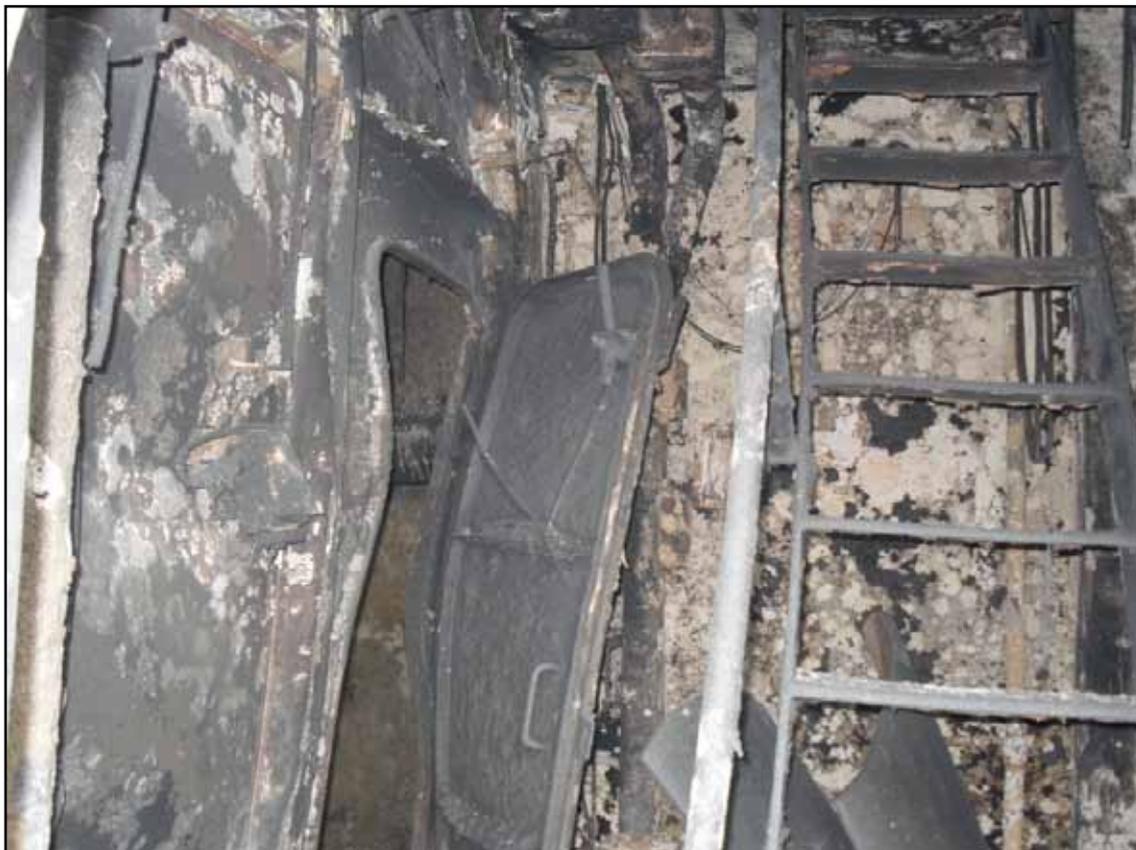
All flammable material in the vertical conveyor belt tower and the SUS hydraulic pump space was completely destroyed, and there was massive structural distortion to the steel doors, ladders and bulkheads (**Figure 14**).

Example of distortion in the SUS tower

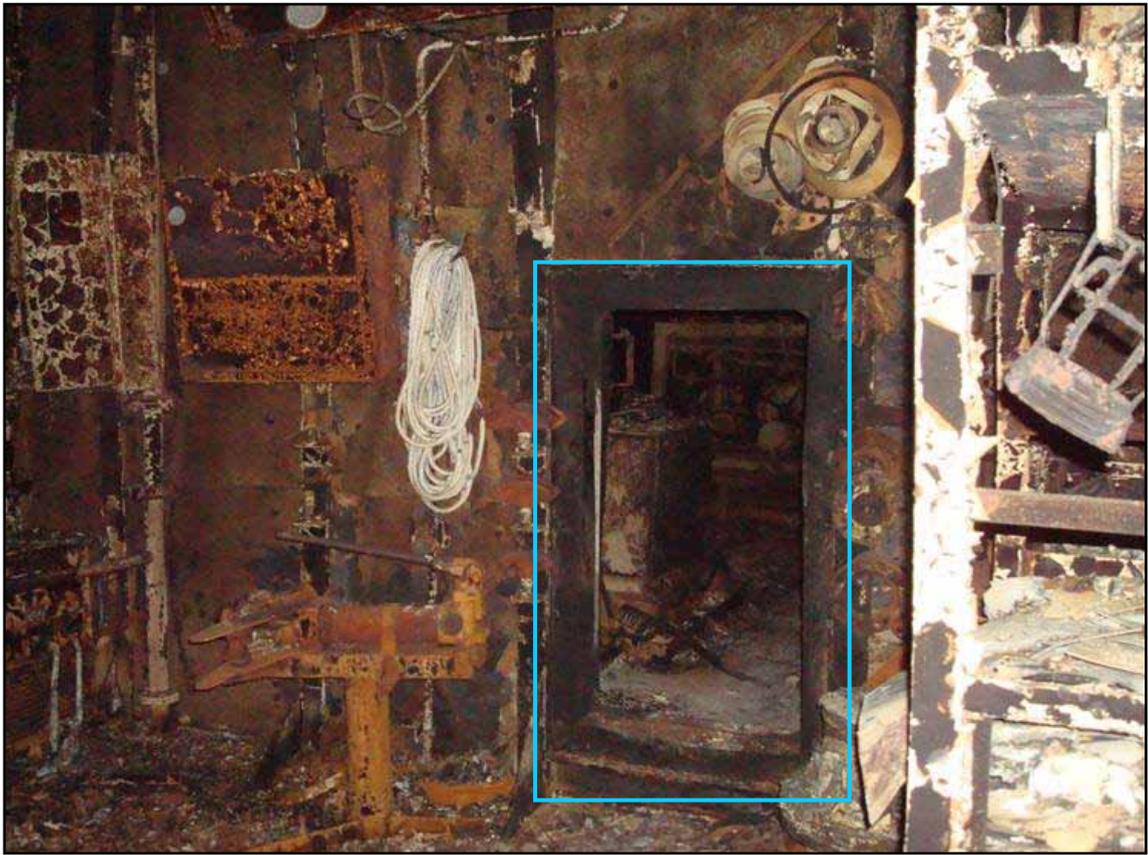
Figure 15

Engine room/SUS hydraulic pump space door

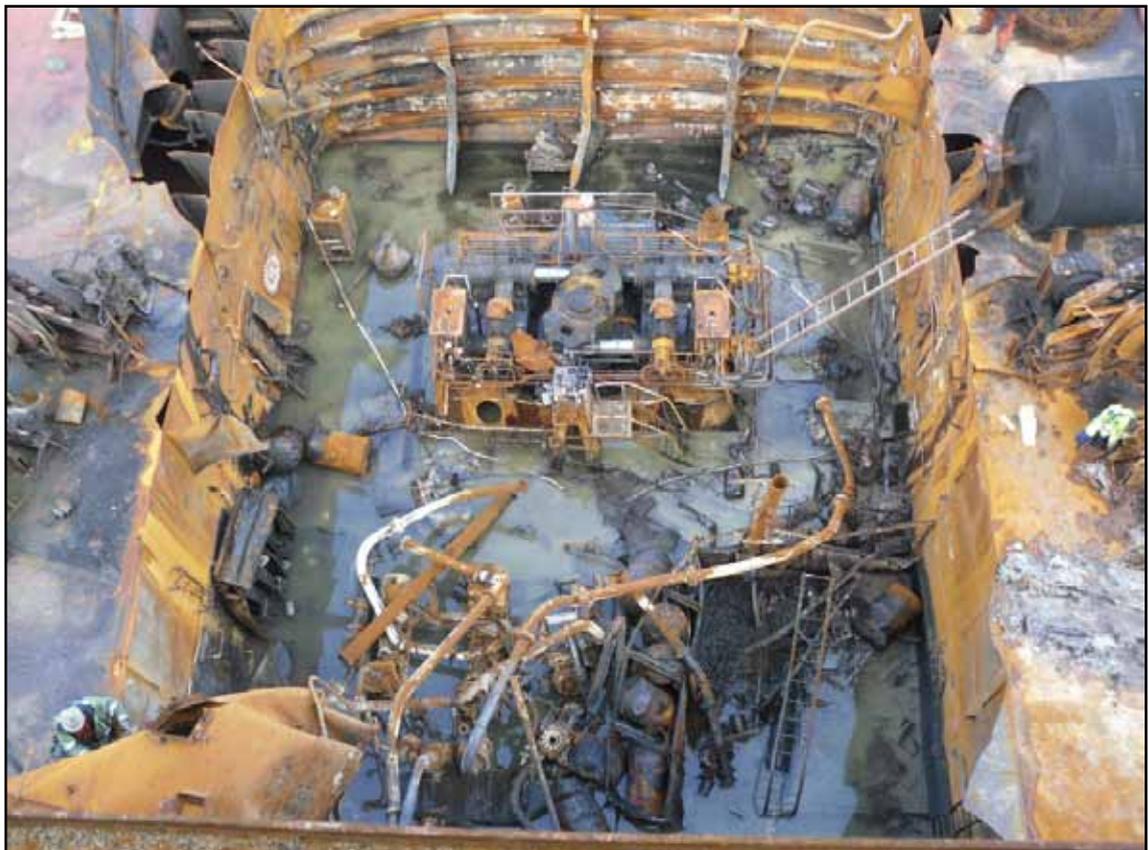
Figure 16

Exposed steering gear compartment

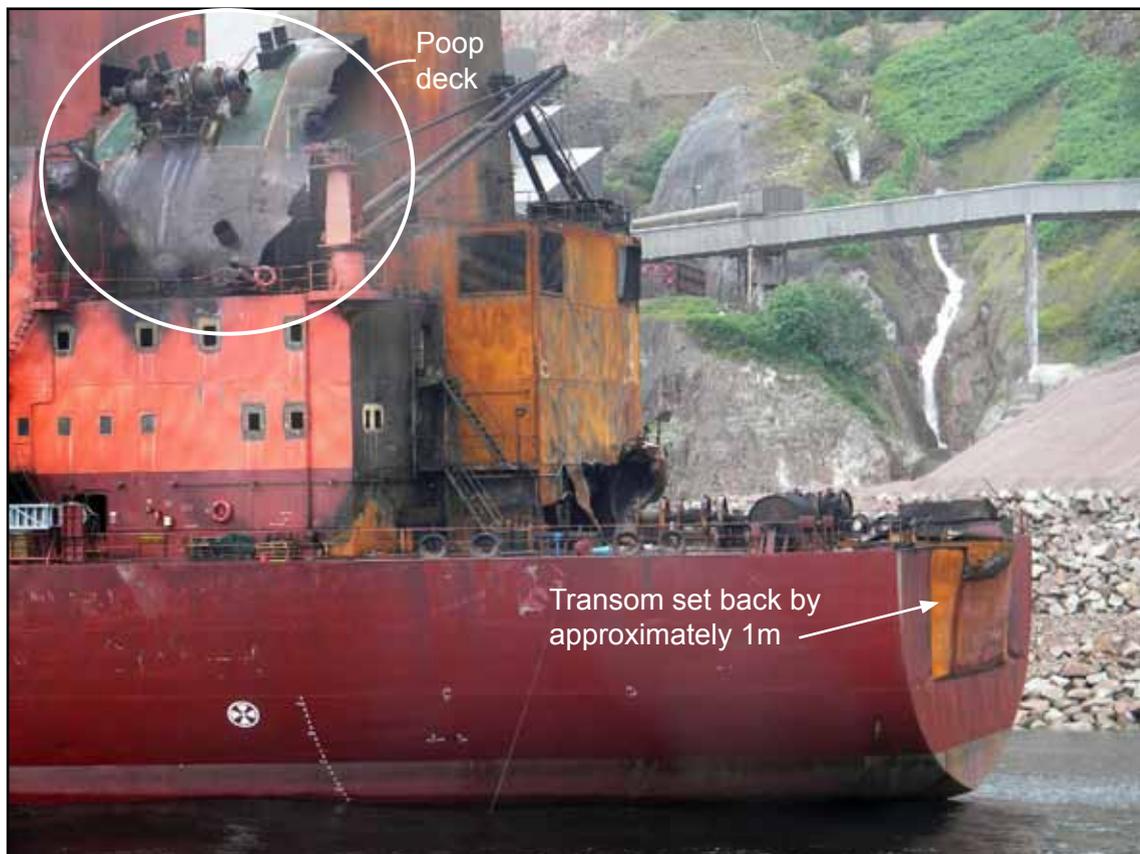
The poop deck itself had landed on the funnel deck, complete with its winches and mooring equipment (**Figure 17**).

View of poop deck relocated to the funnel deck

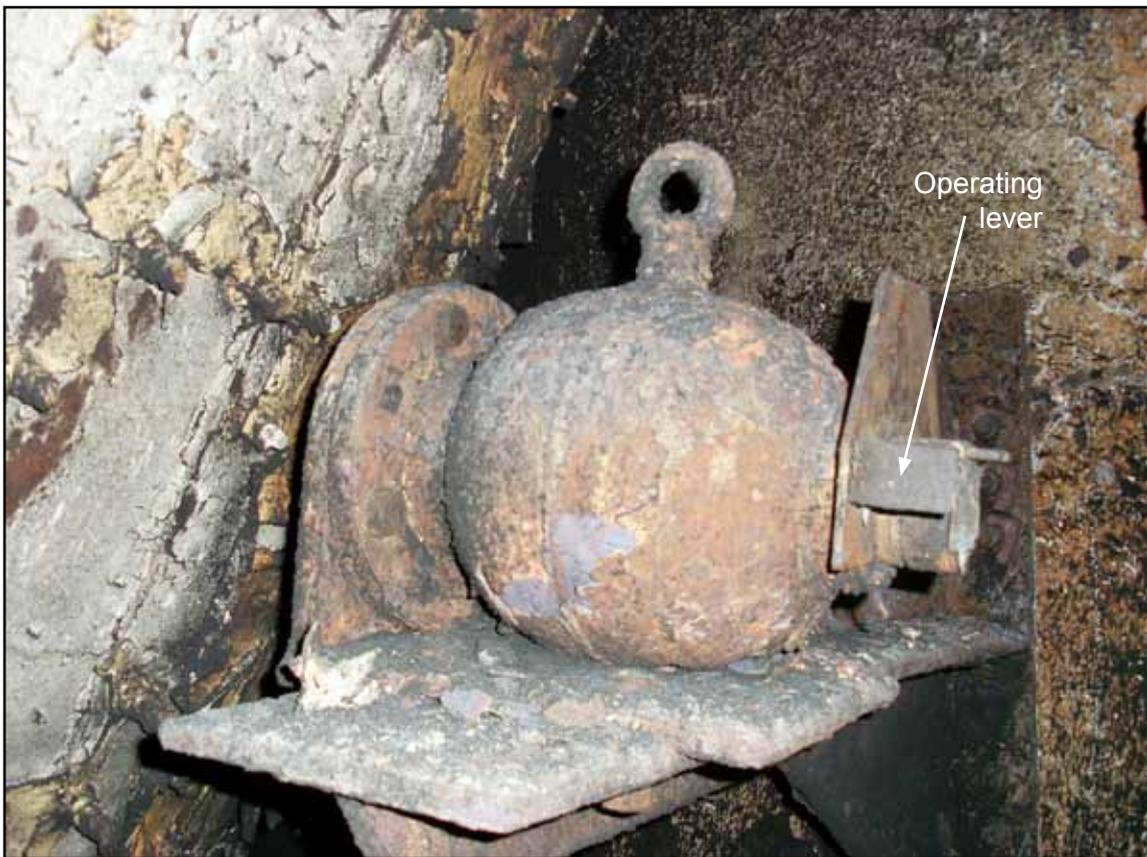
Figure 21

The access doors displayed “radioactive” warning signs, but there were none on the source containers.

Yeoman Bontrup - starboard silometer source container

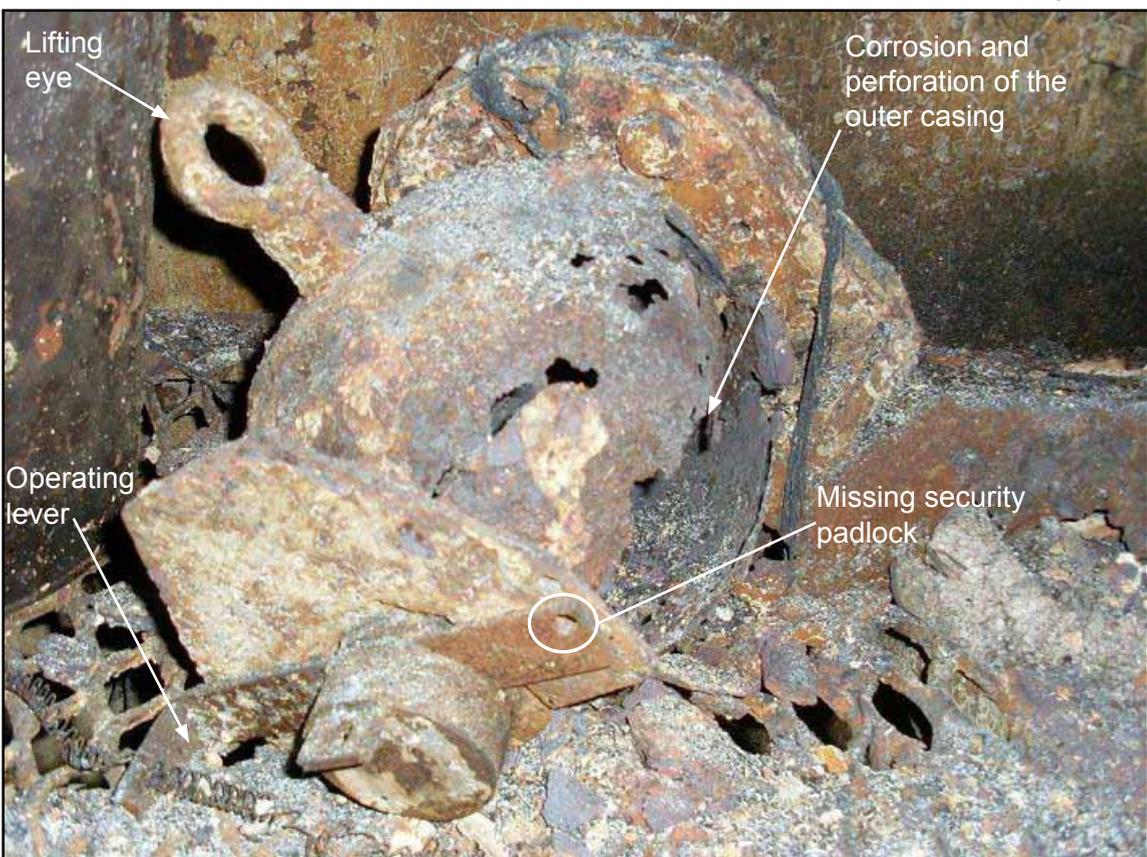
Figure 22

Yeoman Bontrup - port silometer source container

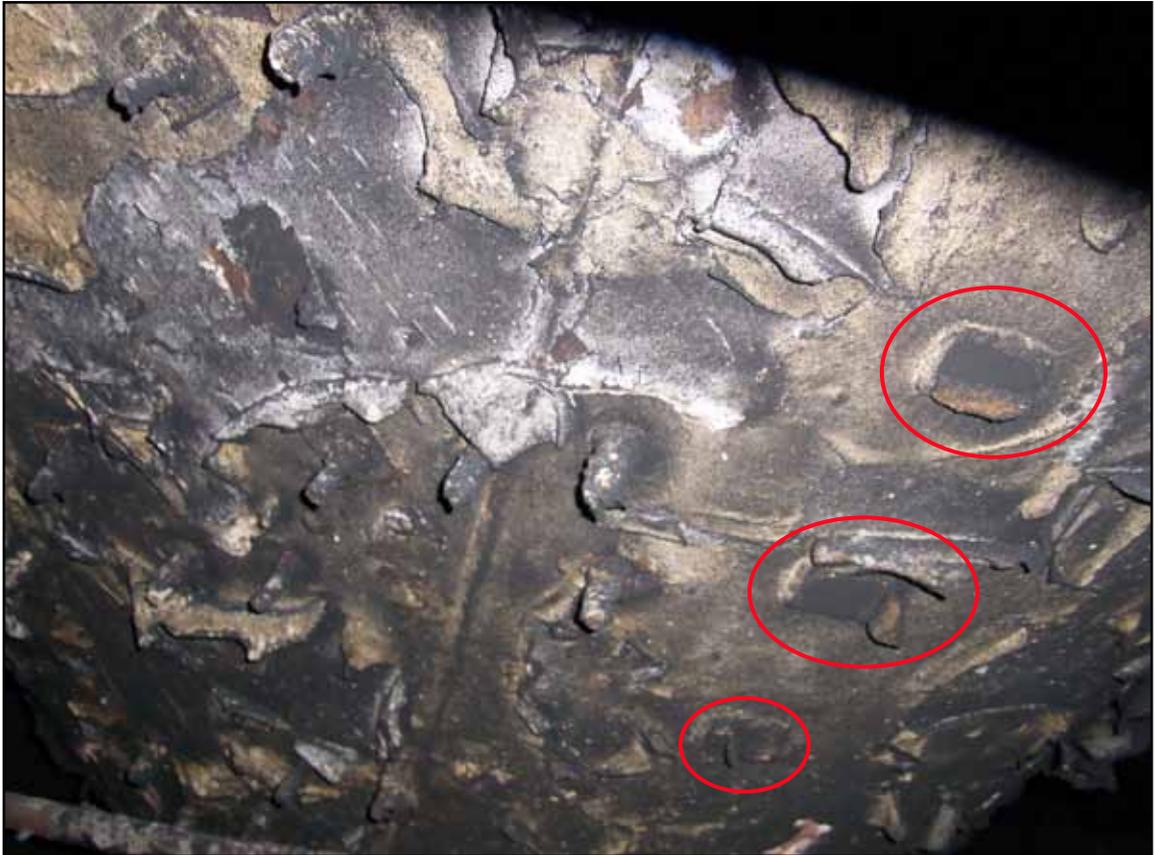
Figure 24

Doubler plates fitted to the outside of the hopper carcass

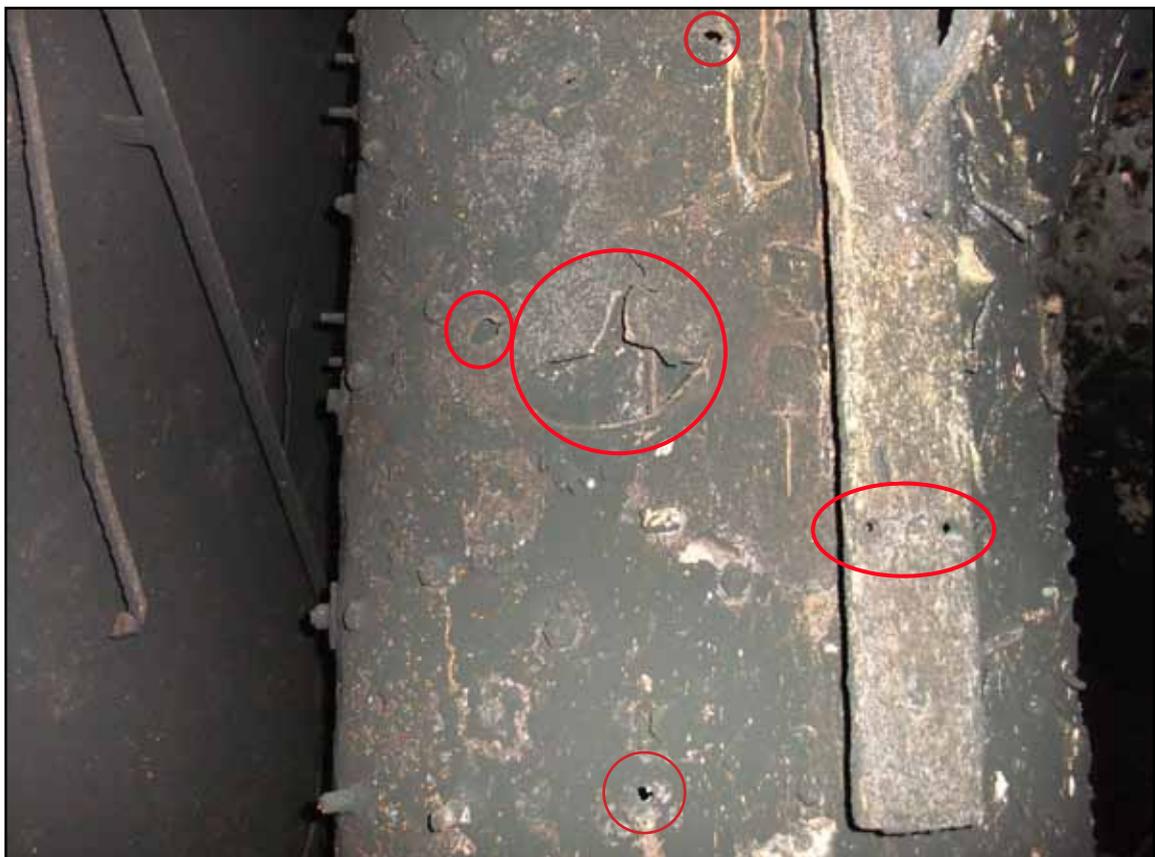
Figure 25

Hopper carcass penetrations

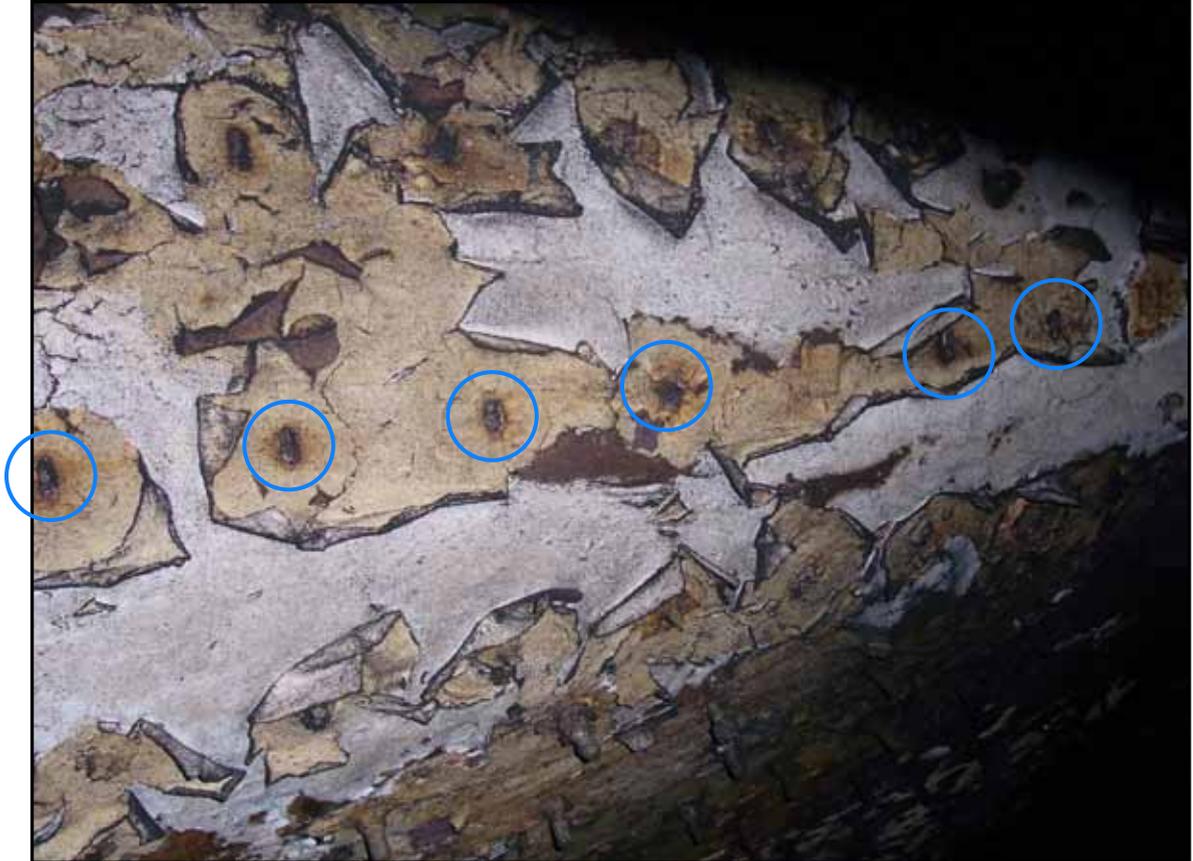
Figure 34

The repair party recognised the risk of hot debris falling onto the belt because the sloping area of the return belt was covered by a fire blanket. There is no doubt that there was a clear route for hot debris from the hopper to fall into cleats and land against the side curtain at the locus of the fire. Because of the concern over the veracity of the accounts, it is not certain whether or not oxy-acetylene equipment was used, for example to burn off “Hardox” studs, after 1400, the time at which all hopper hotwork was reportedly completed. Despite this, it was also stated that tack welding of the “Hardox” tiles took place after this time, when tack welding is clearly a form of hotwork.

Elongation of hopper carcass "Hardox" tile securing stud holes

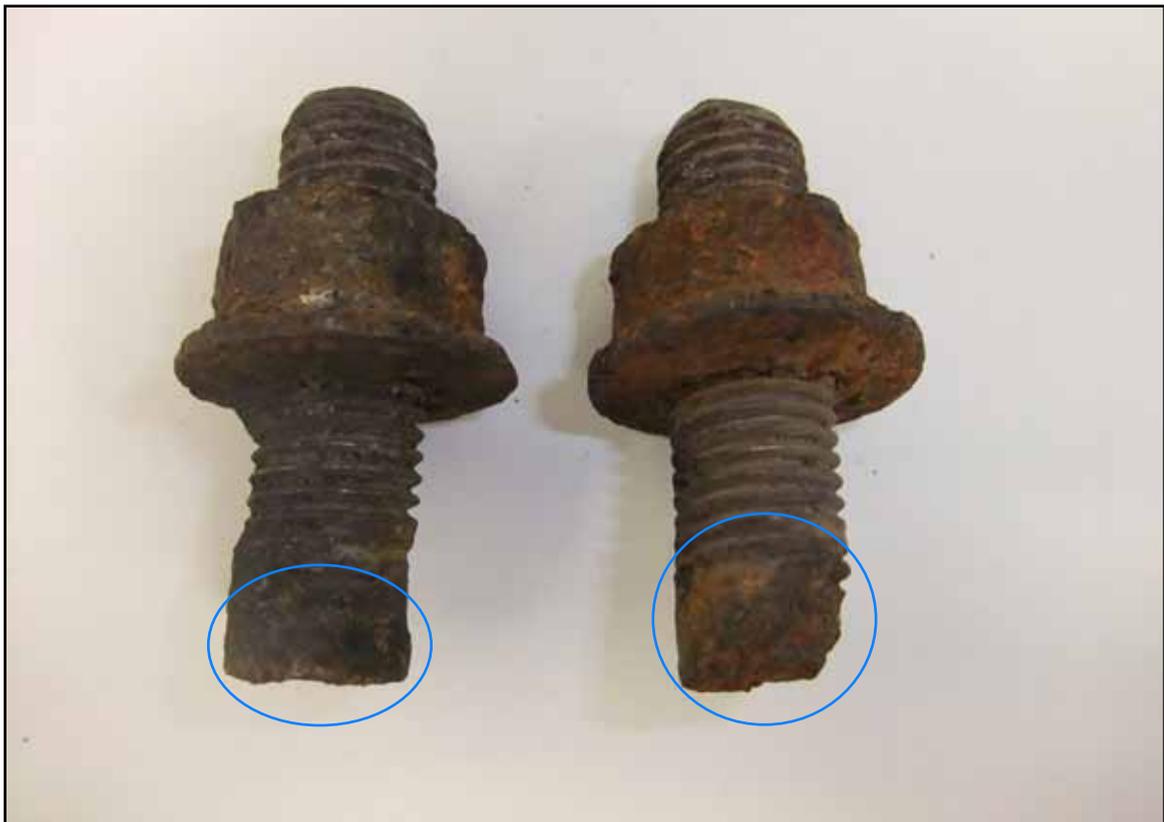
Figure 35

Flame cut bolts similar to those used to secure the "Hardox" tiles
