**The Bahamas  
Maritime Authority**

**“Grandeur of the Seas”**

**Report of the investigation into a fire at sea  
May 2013**

Date of Issue 17<sup>th</sup> January 2014  
Bahamas Maritime Authority  
120 Old Broad Street  
LONDON  
EC2N 1AR  
United Kingdom

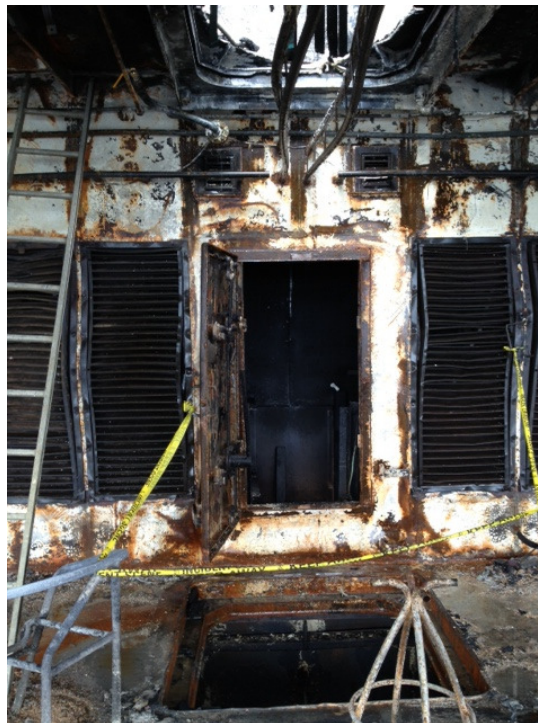
- 4.17 There were two non-insulated aluminium hatches, one on deck 4 and one on deck 5 both on the centreline. Although non-combustible, Aluminium melts at a low temperature without evidence of “red heat” and structural failure of the hatches contributed to the spread of the fire.

- 4.19 In light of these stated requirements it is clear that aluminium hatches which are not suitably insulated and have not been subjected to the required test to verify integrity and temperature rise are not compliant with SOLAS. No information has been found that the aluminium hatches had been replaced since the original construction of the vessel in 1996 and no material specification for the hatches is included on the “as-built” drawings. The conclusion is that these aluminium hatches were installed without the necessary authority during the building phase and their presence was neither detected during the new-building survey and oversight nor at any survey or inspection, whether by the Owner, by the flag State, nor by port State in the intervening period.

Aluminium hatches destroyed in fire

- 4.29 Flame and smoke sensors have been installed on the mooring deck, and improved remote and automatic release improvements have been provided for the drenching system. The aluminium deck hatches have been replaced by steel on this and one other ship in the fleet (the only other example found). Fire safety plans are to be updated to reflect current fire fighting and safety installations and arrangements.

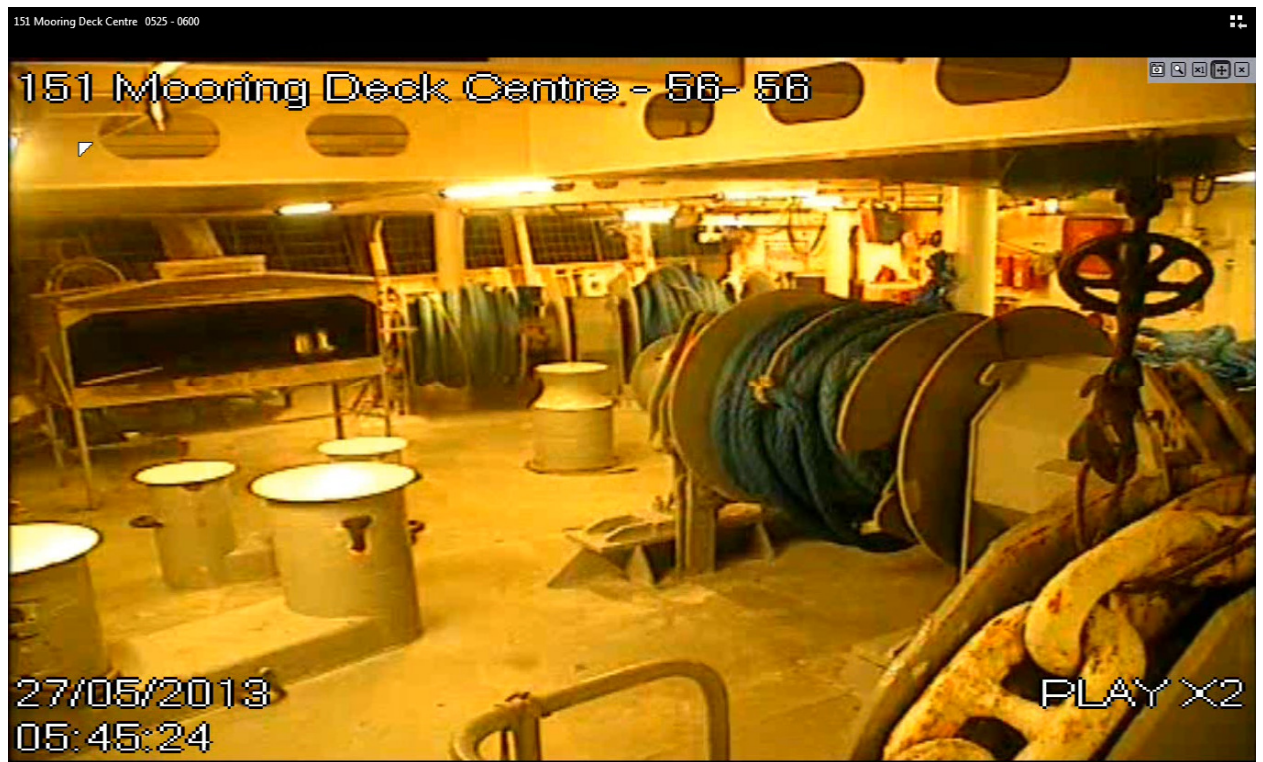
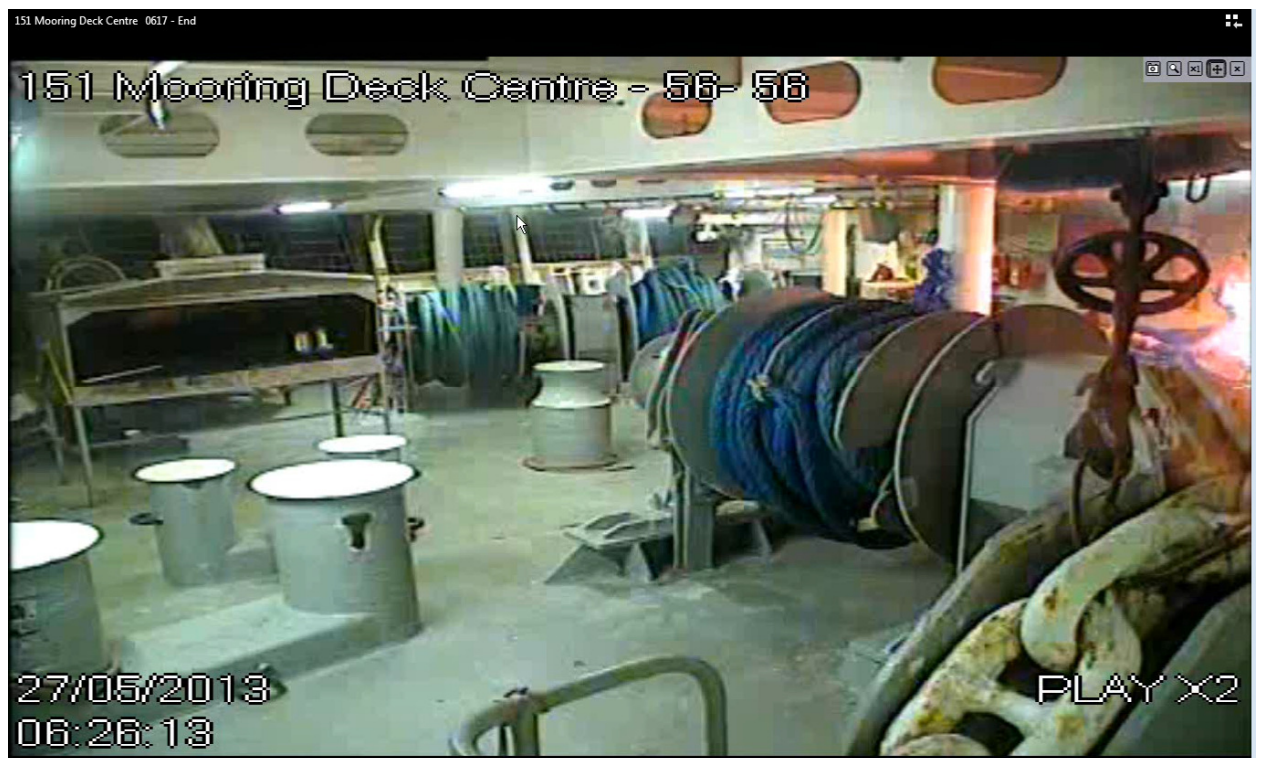
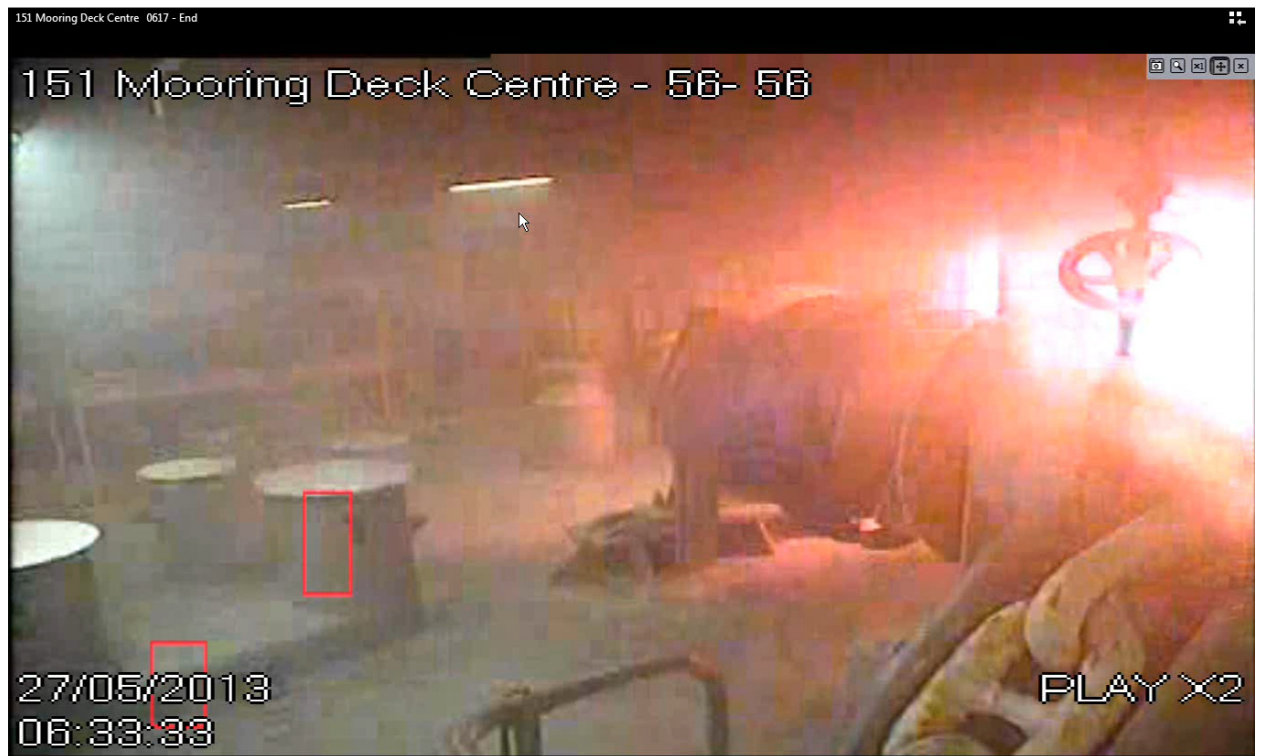
## Screenshots from CCTV

- 4.12 The actual start time of the fire is unknown and there is limited video footage available of the aft mooring deck. However, what has been viewed revealed white smoke entering into frame from the right hand side at least as early as 0133 hrs but the source is out of frame. This indicates that material smouldered for some time before flames developed.

- 4.13 The first sight of flame on the video is at 0225 hrs and thereafter the video shows the development of flames until the recording failed. See still images from the centre camera at Appendix IV.

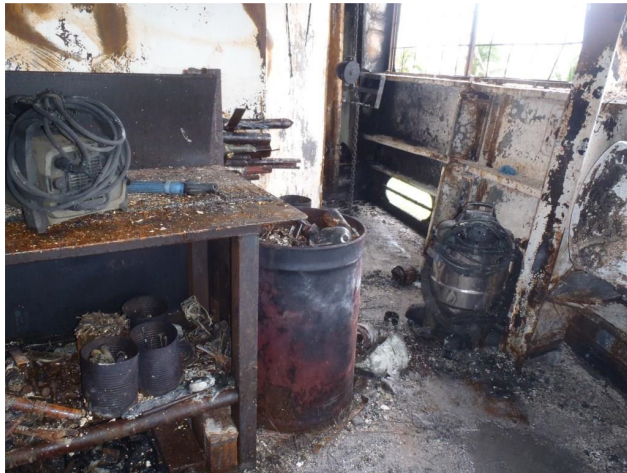
1 Starboard Side of Deck No. 3 Aft Mooring Deck

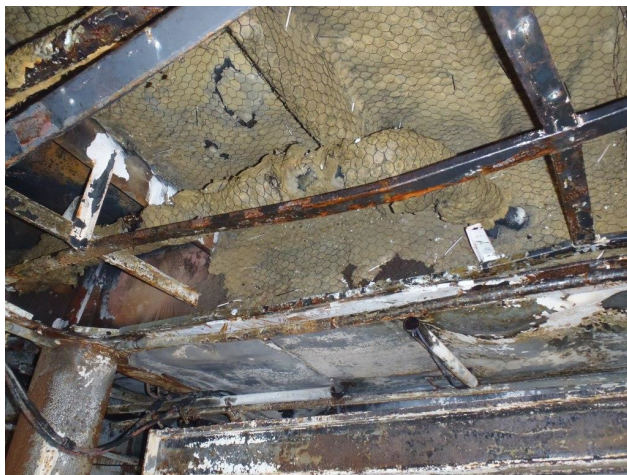
2 Starboard Side Deck Head of Deck No.3

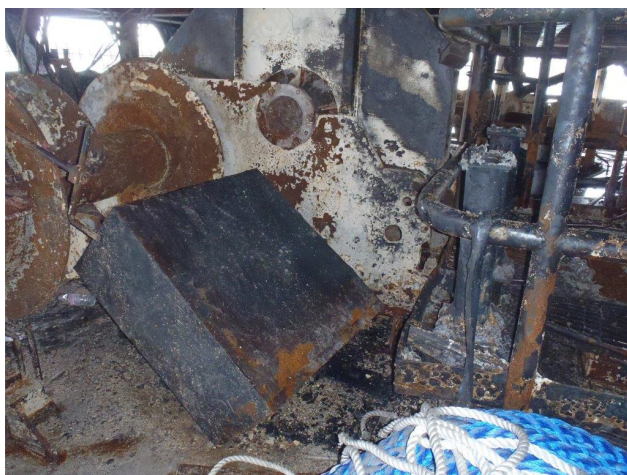
- 3.26 Checks of surrounding areas and compartments were made and boundary cooling continued to ensure that the risk of re-ignition from hotspots was minimised. The flammables locker on Deck 3 was entered and found to be intact, with no evidence of conflagration inside.

3 Deck No. 3 Aft Mooring Deck Winch Control Station and Flammables Cabinet

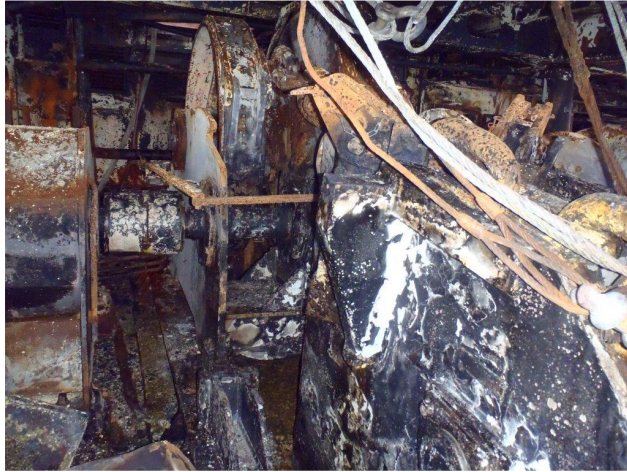
- 4.10 It is clear that a number of mooring ropes had been left openly stowed on the aft mooring deck although this is common practice when a vessel is trading with short voyage durations between ports. Additionally, mooring ropes on winch drums were also exposed on an unprotected open deck

4 Deck No. 3 Aft Mooring Deck Centre Winch

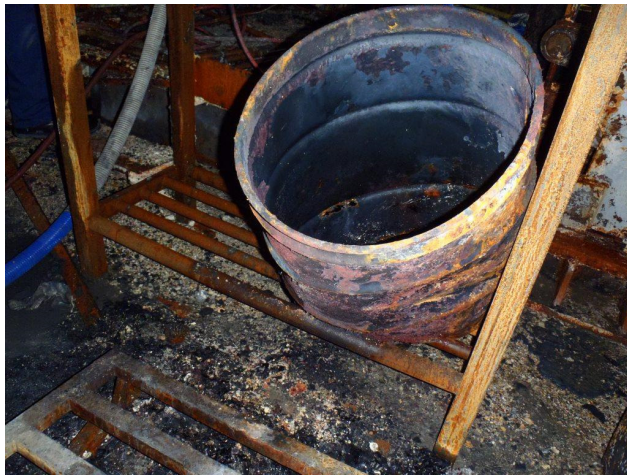
- 4.7 Whilst the original ignition point is not clear, the evidence revealed that there were two bins of rags on the aft mooring deck. The investigation found that one of these bins was utilised for dirty rags and one for clean rags.

- 4.8 It has been stated that these "clean" rags sometimes comprise of old towels used in the spa area and have been discarded and used as deck rags because they cannot be properly washed of aromatic spa oils which have soaked into them.

5 Deck No. 3 Aft Mooring Deck Rag Drum

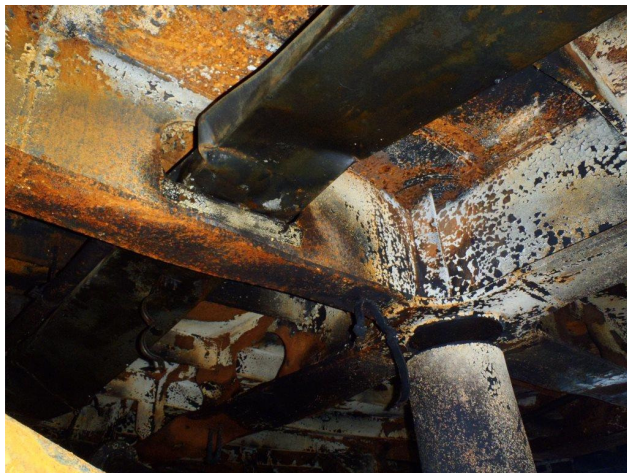
6 Deck No. 3 Aft Mooring Deck Pillar and Girder

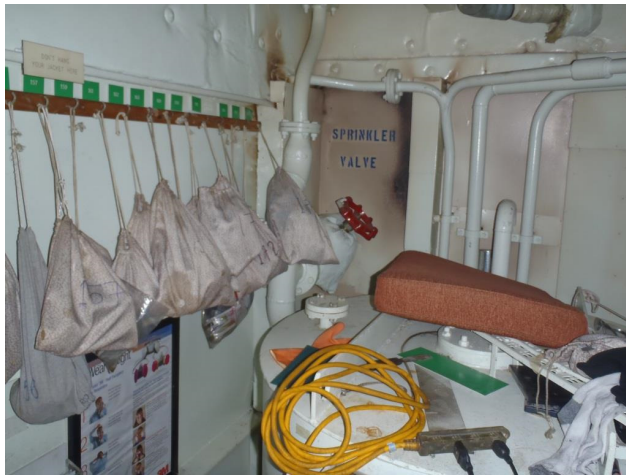
- 3.17 Of critical importance at this stage is that they were unable to reach the master control valve for the water suppression/drencher system located in the aft bosun’s store on deck 3 due to the proximity of the fire. This system did not have a remote operations system and was therefore rendered un-useable due to the close proximity of the fire.

8 General View in Bosun's Workshop on Deck No. 3 Aft  
(Note the location of the aft mooring deck fire suppression system valve)

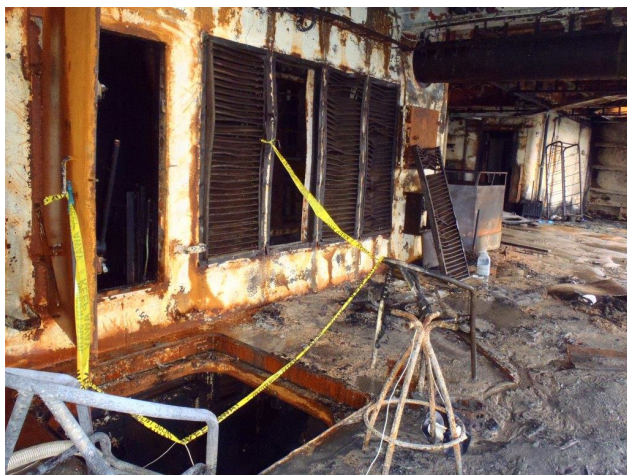
12 General View of the Crew Deck No. 4 Aft  
(Note the access hatch down to the aft mooring deck)

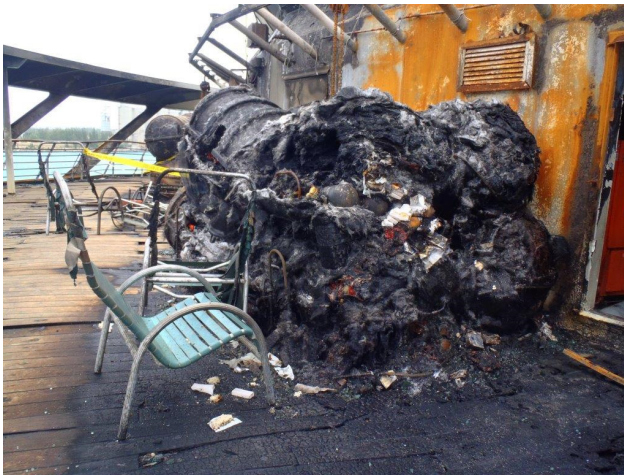
- 4.15 The stowage of life-rafts below the exterior of deck 6 provided a combustible hazard in the vent of a fire outbreak and contributed to the fire extending to the aft exterior of the deck 6 lounge.

14 General View of No. 5 Deck Aft and Spare Life Rafts

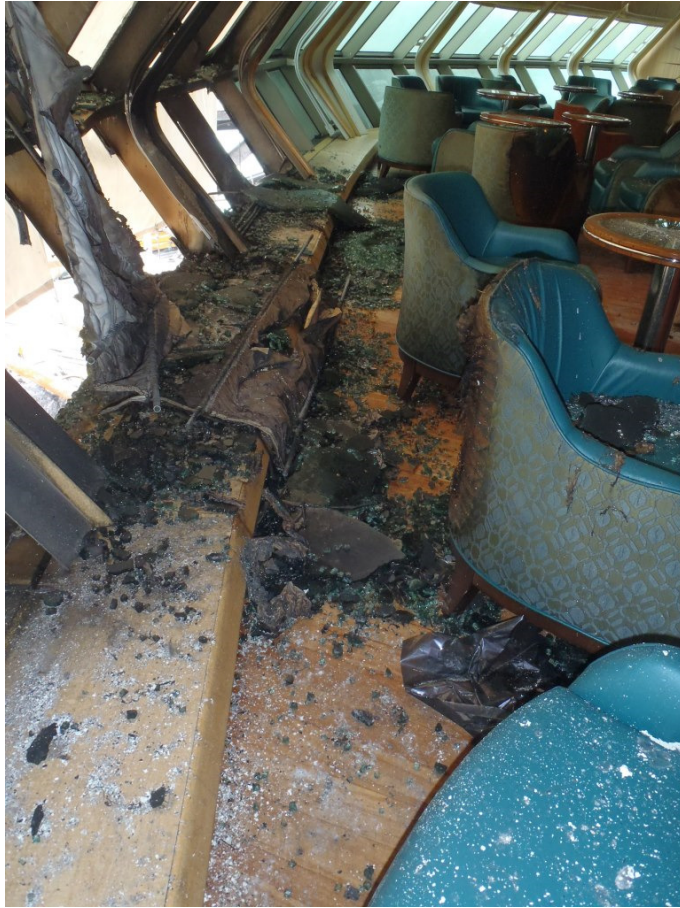
15 Fire Damage in the Deck No. 6 Aft Lounge
