**The Bahamas
Maritime Authority**

**“M.v. Black Watch”
IMO Number 7108930
Official Number 8000293**

**Report of the investigation into the Auxiliary Engine
Room fire on the 01st July 2016 approximately 260nm
off the coast of Funchal, Madeira**

Date of Issue: 19th January 2017
Bahamas Maritime Authority
120 Old Broad Street
LONDON
EC2N 1AR
United Kingdom

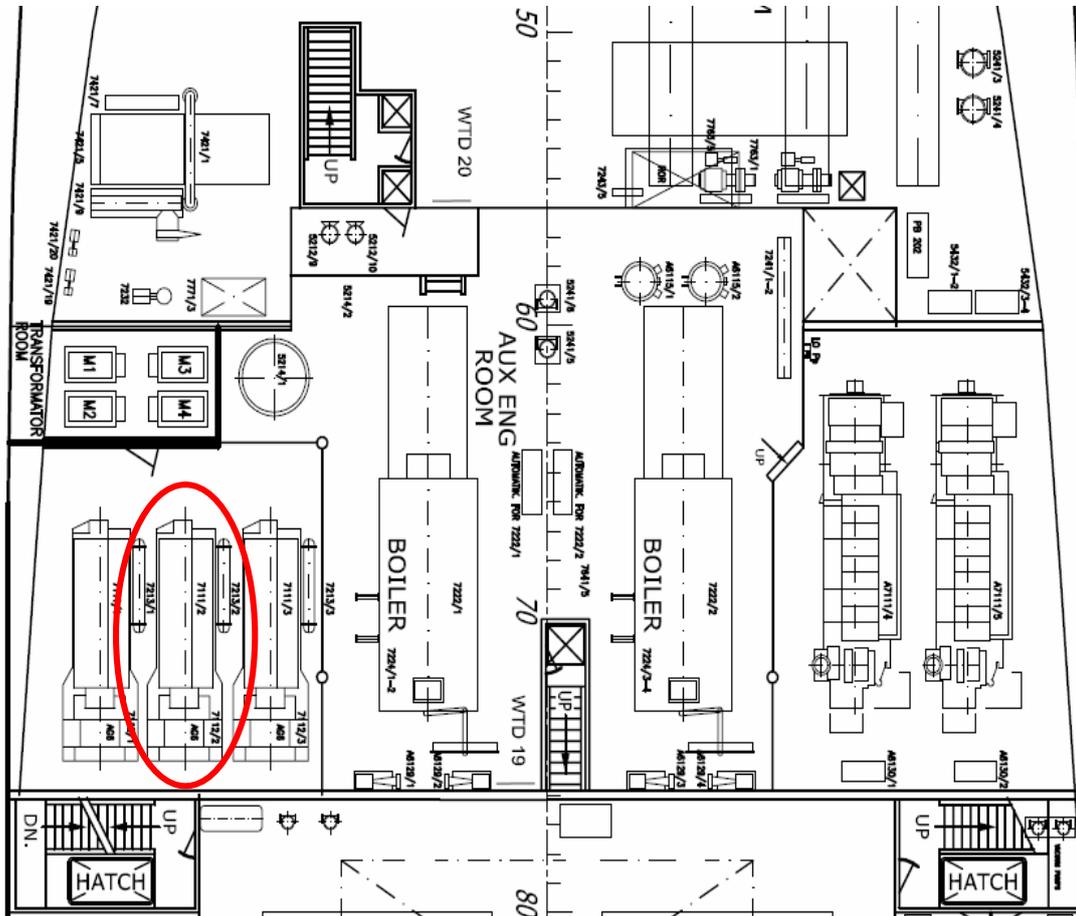
Figure 3: Auxiliary Engine Room (AE2 circled)

- 4.5 The two contractors and the 3^d Officer saw the fire engulf AE2 and immediately commenced attacking the fire by discharging one 12kg powder extinguisher. Due to the intensity of the smoke and heat all three individuals were beaten back and forced to evacuate the space through WTD 19 closing it behind them.
- 4.6 Emergency teams mustered in respective locations, the OOW requested permission to close watertight doors (WTD's) on 'A' deck in zone 4 and 5. Before approval was given the vessel lost power and blacked out as auxiliary engines 2, 4 and 5 stopped at this time. Immediately the emergency generator started and provided sufficient power to supply emergency systems. Simultaneous to this at 0842 the Master briefed all passengers and crew over the PA system of the situation and when to expect further updates. The Cruise Director assumed the responsibility of keeping the passengers

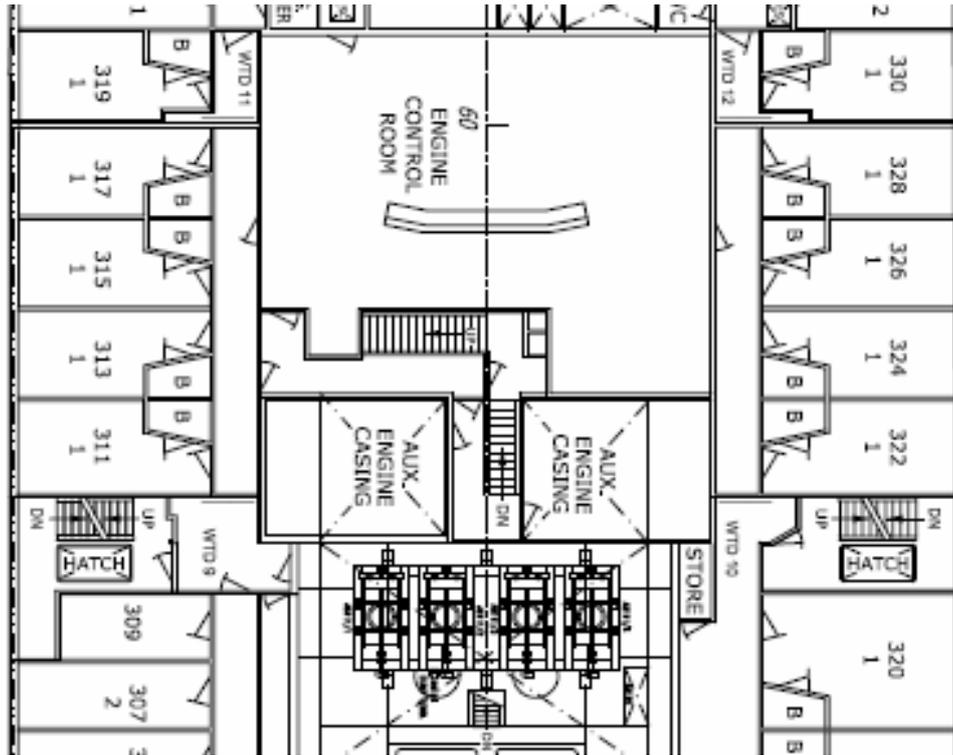
- 4.17 At 0938, exactly one hour after the fire on AE2 was reported; multiple fire alarms started to activate in cabins on deck 2, port side above the auxiliary engine room. The Command Team requested cabins 322, 324, 326 and 328 be investigated for fire and or hot spots generated by the vertical transfer of heat. The deputy on scene commander (DOSC) at Area Control was unable to investigate due to the presence of smoke. At the same time, hot spots were identified outside cabin 319 directly above the seat of the fire. The Rapid Response Team was dispatched to rig fire hoses outside cabin 319 along with a fire team in order to determine if a fire was present inside the cabin.

Figure 6: Cabins 322, 324, 326 and 328 investigated for damage

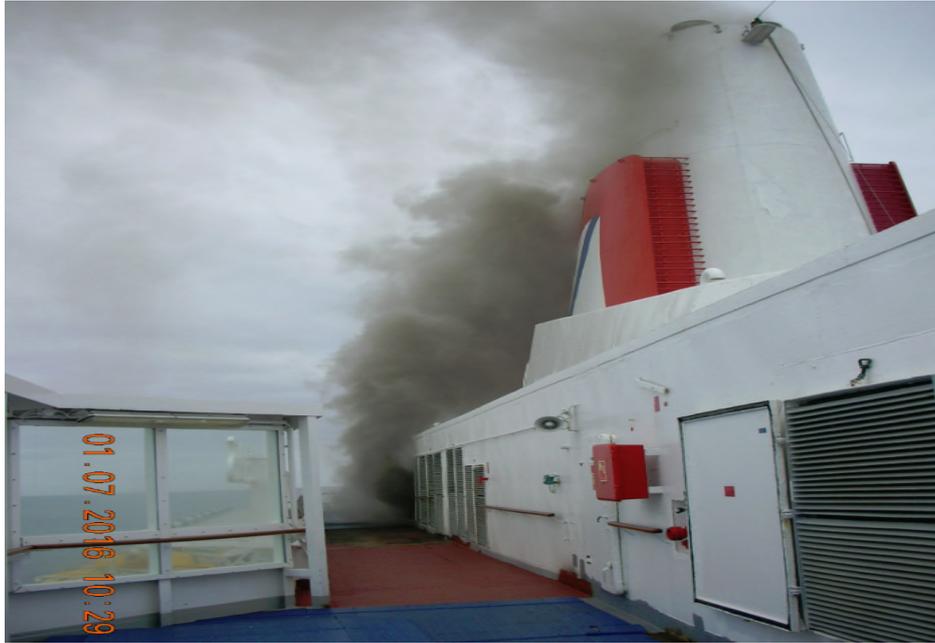
- 4.26 Smoke continued to migrate vertically within zone 4 crew staircase C; at 1027 the smoke was reported on deck 7 however at 1029 the hotel manager informed the Command Team that “*no smoke or heat, everything okay in guest areas*”, the source of this report is not known and may well be a misinterpretation of the fact that smoke was present within crew staircase C on deck 7. At this point the DOSC discussed with the Master and the Chief Officer whether to release CO₂ into the auxiliary engine room. The DOSC briefed the Master on the available firefighting equipment and confirmed that the firefighting teams had a low number of BA bottles and extinguishers left onboard. The option was taken not to release CO₂ but instead attempt to restore power by fixing the emergency generator.

Figure 7: Smoke dispersing onto deck 10 starboard side at 1029

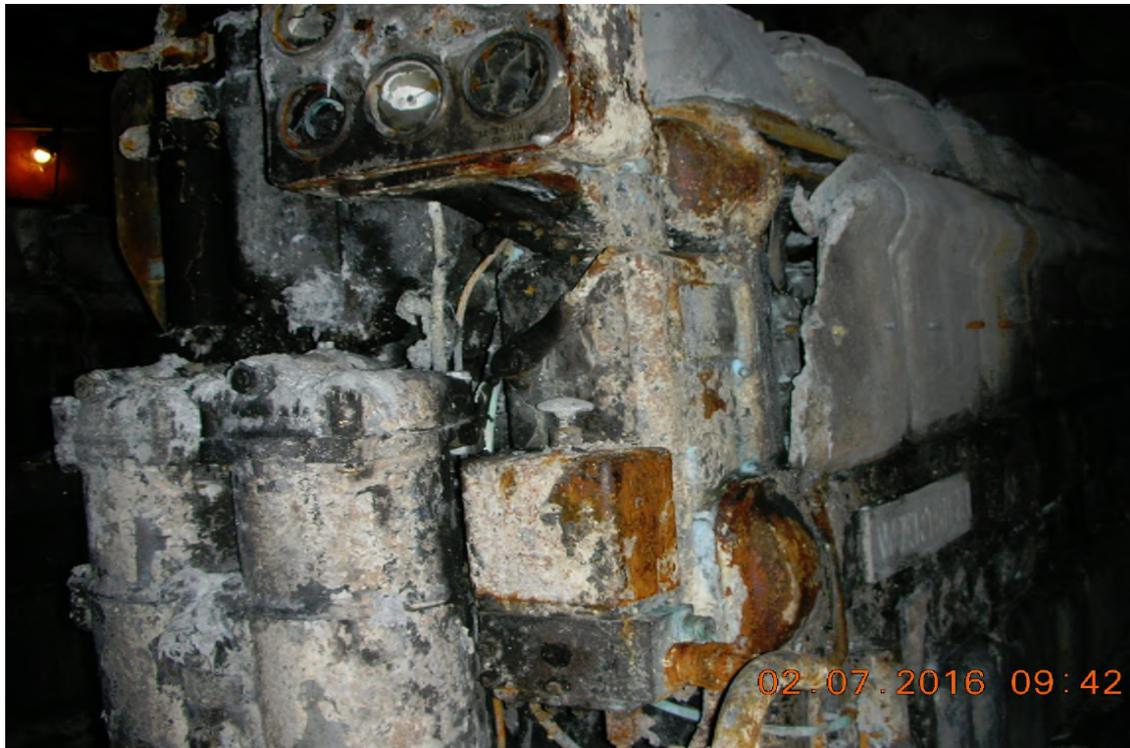
- 5.2.1 The cause of the fire cannot be fully determined due to the significant damage sustained on and around AE2. Witnesses recall seeing flames in vicinity of the upper, aft section of AE2, which from visual inspection after the fire shows a significant layer of carbon deposit in vicinity of the on-engine fuel filter. Further indication as a contributory factor was identified by a loose bolt, one of four securing the top of the filter to the base where the filter inside can be removed and exchanged. The on-engine fuel filter sits aft of the exhaust manifold which presents an unobstructed route for pressurised fuel to travel between the fuel filter and exhaust manifold. The typical operating pressure of the fuel filter is 7 bar; there is no record of the operating pressure moments prior to the fire in order to determine if a sudden drop in pressure occurred. The possible fuel leak at high pressure most probably ignited on any of the hot points on top of the engine and in vicinity of the fuel filter.

Figure 10: Auxiliary generator 2, aft end

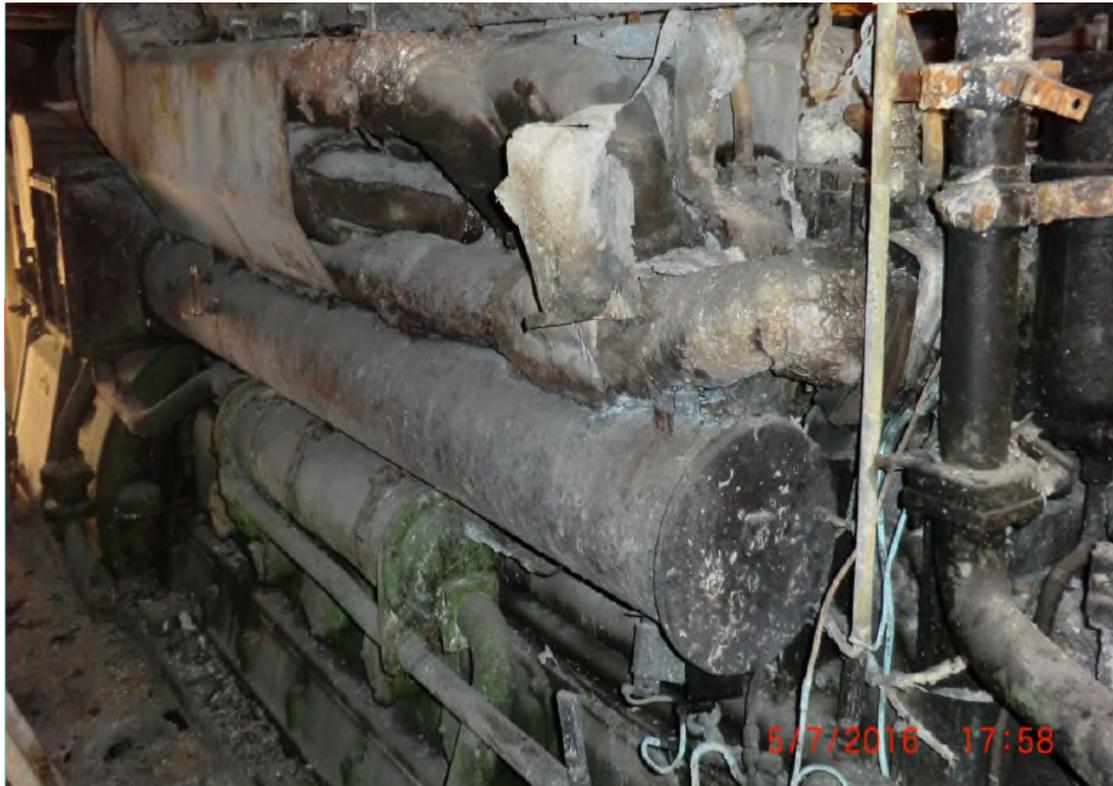
Figure 11: Inboard side of auxiliary generator 2

5.2.2 The damage to the AE2 was predominantly concentrated to the top half of the engine; however heat damage was significant in vicinity of AE1 and AE3 and to the underside of AE2. The level of damage observed to the surrounding fixtures and fittings is consistent with a fire that generated a temperature in excess of 660°C as a number of engine parts constructed in aluminium had melted.

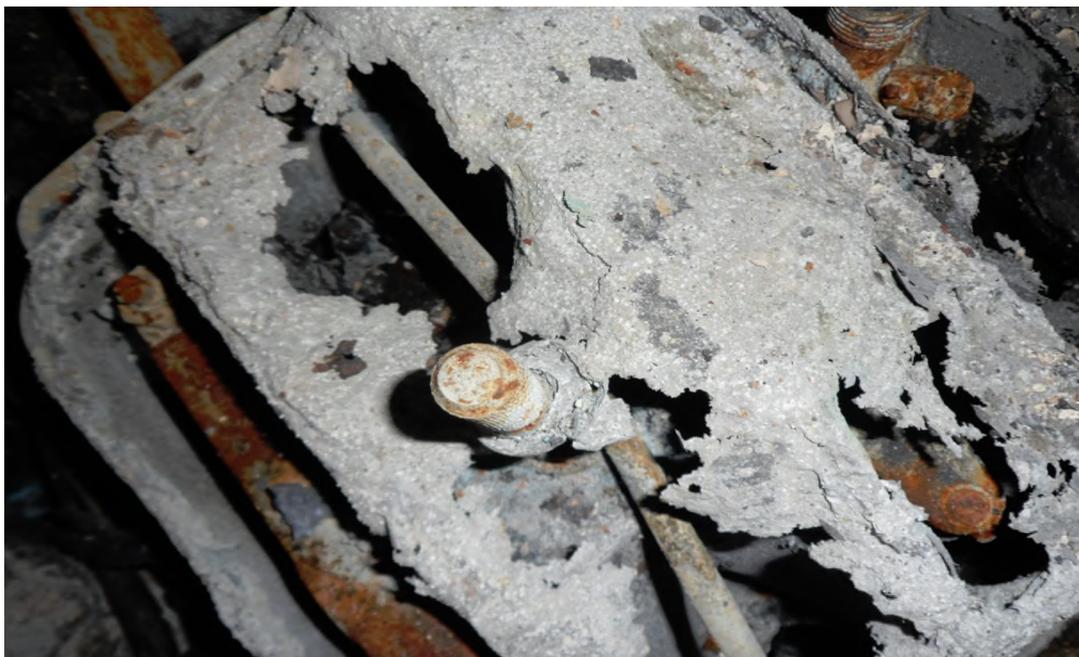
Figure 12: Aluminium rocker cover from auxiliary generator 2

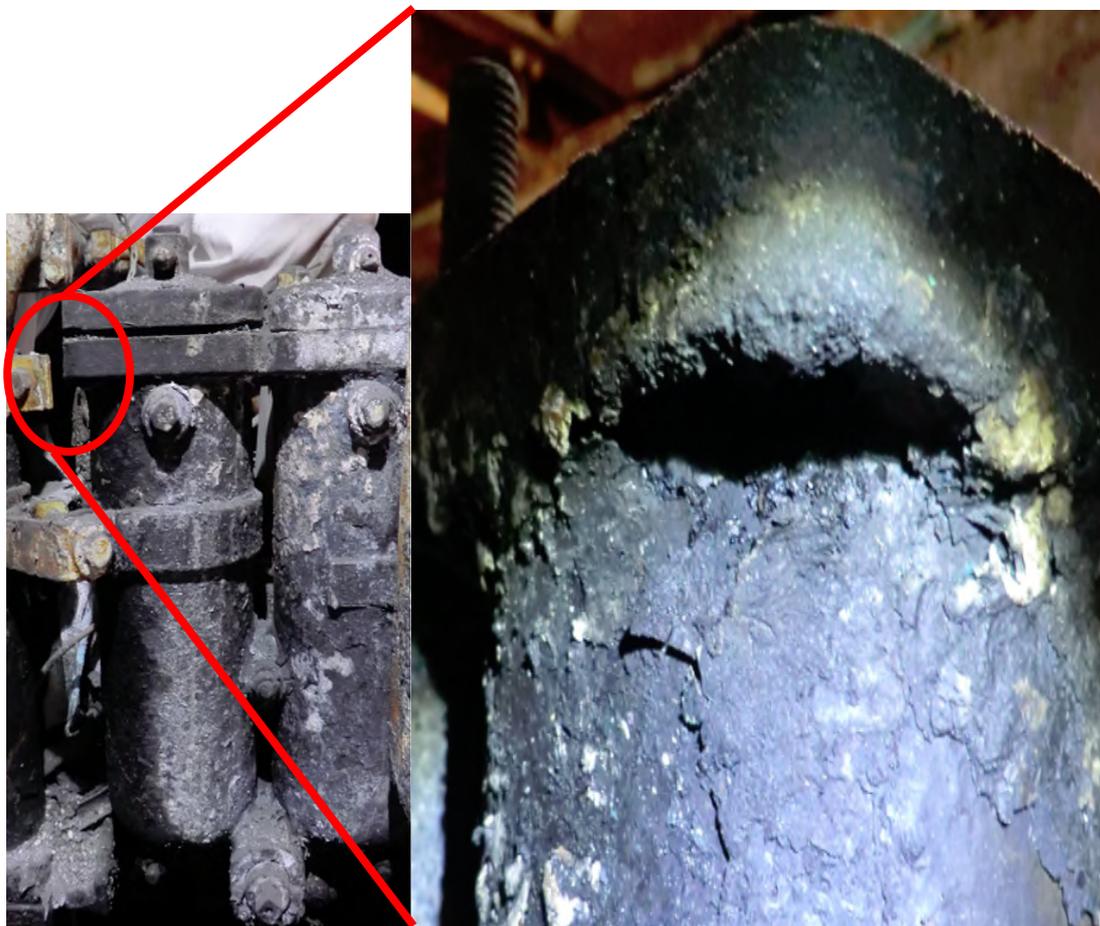
- 5.2.3 Due to the significant damage sustained on AE2, the fixtures and fittings that remained in situ for the investigator to witness were so badly damaged that a full determination of cause could not be achieved. In the moments prior to the fire it was confirmed by eyewitnesses present that no explosion or unexpected noise was heard.

Figure 13: On-engine fuel filter

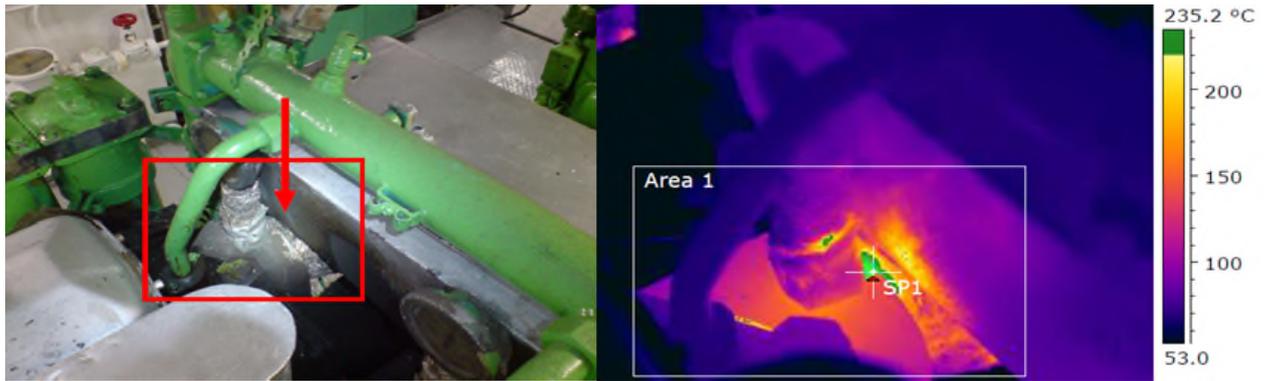
- 5.2.4 Between the 23rd and 25th September 2015 a thermal survey was conducted on all auxiliary engines by Thermo Protection Temperaturanalyse who highlighted six areas on AE2 that had a surface temperature in excess of 220°C, three of which found within the report were in the vicinity of the aft area of AE2 (see figures 14, 15 and 16), the approximate known location of the fire. The report was received in October 2015 and the Owners rectified the areas identified within the survey report, which was then verified and approved to the satisfaction of Class on the 16th November 2015 by issuance of the following statement: *“Immediate actions were taken by the engineer and the defective areas were repaired and upgraded satisfactorily”*.

Figure 14: Temperature of 402.3°C in vicinity of exhaust thermostat (highlighted left) and SP 1 (right)

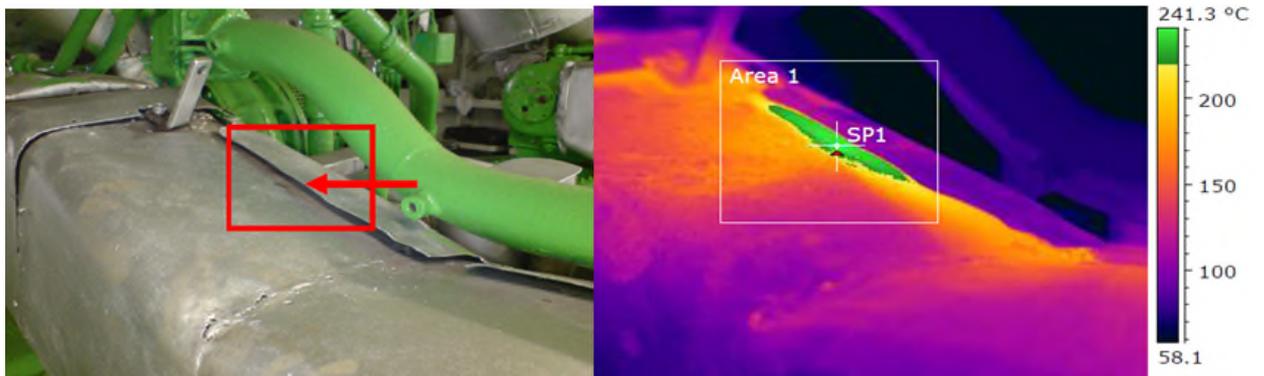
Figure 15: Temperature of 242.7°C in vicinity of exhaust manifold (highlighted left) and SP 1 (right)

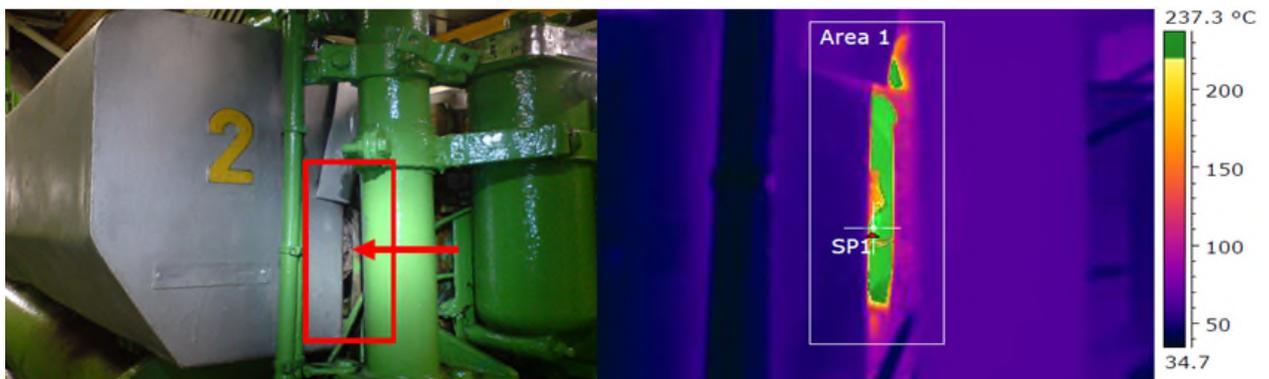
Figure 16: Temperature of 355.3°C in vicinity of exhaust manifold (highlighted left) and SP 1 (right)

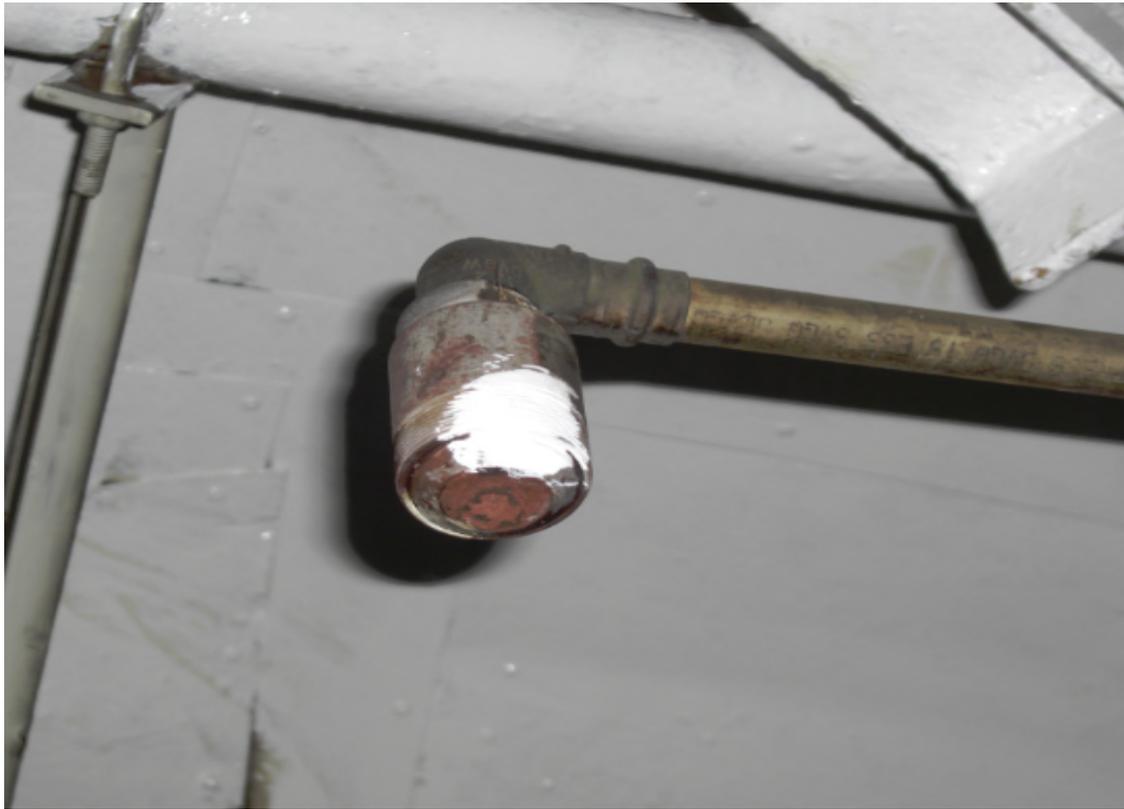
The annual inspection is required to ensure that the nozzles are maintained and working. In order to do this the system should be flushed through with either compressed air or water, neither of which occurred. Therefore the correct operation of the nozzles within the auxiliary engine room could not be ascertained. A visual inspection of the nozzles within the auxiliary engine room was conducted in lieu of water or compressed air with no deficiencies noted within the report. Figure 17 below was taken on the 17th July 2016 of a nozzle on the port side of the auxiliary engine room in vicinity of generators 4 and 5, as you can see this nozzle has been partially painted. Although there was no evidence of fresh paint in vicinity of this nozzle, it cannot be determined whether it had been painted before or after the inspection.

Figure 17: Damaged nozzle located in vicinity of auxiliary generators 4 and 5

Replaced all the broken nozzles with new ones and re-pressurized all the tested zones.

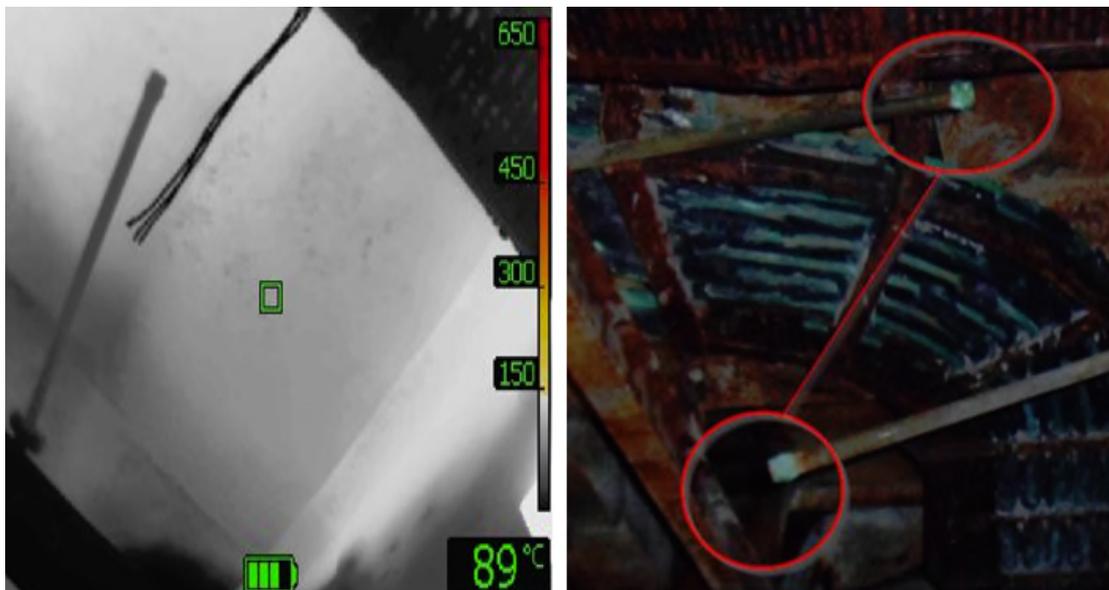
system was flushed through monthly to ensure no leaks were observed and to ensure that no debris was present which may reduce or stop the flow of water when operated. During the course of the fire, one fire team, using the thermal imaging camera captured that the flex-fog pipe above AE2 had separated at the coupling. This was further confirmed by visual inspection once the fire had been extinguished (figure 23). It cannot be determined how or why the coupling failed. The coupling was not available for inspection by the investigator and therefore it cannot be determined whether the material the coupling was made from was in accordance with the principal requirements for the system as defined within MSC/Circ.1165¹⁰ and approved to the satisfaction of the Administration. On the 17th July 2016, it was witnessed by the BMA ANI that the Owners were reinstating the flexi-fog system above the auxiliary generator using copper pipe and copper fittings (figure 24). Copper is not an approved material for use in fixed application systems as its structural integrity fails when subjected to intense heat.

Figure 23: Flex-fog coupling separated above auxiliary generator 2

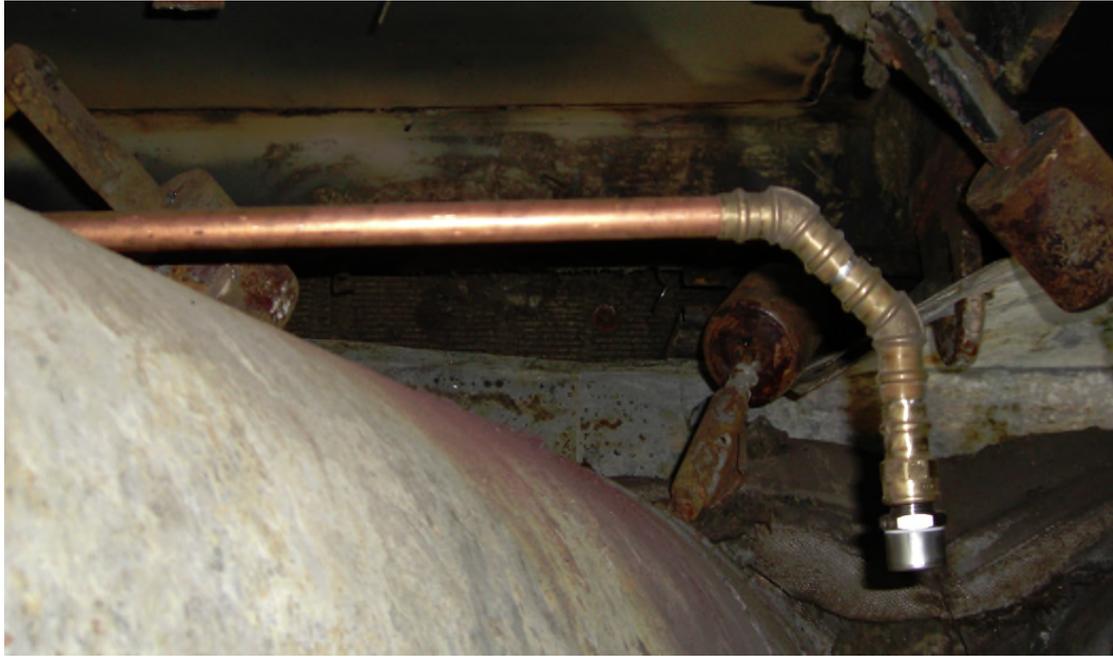
Figure 24: Copper pipe used to rectify flexi-fog piping after the fire

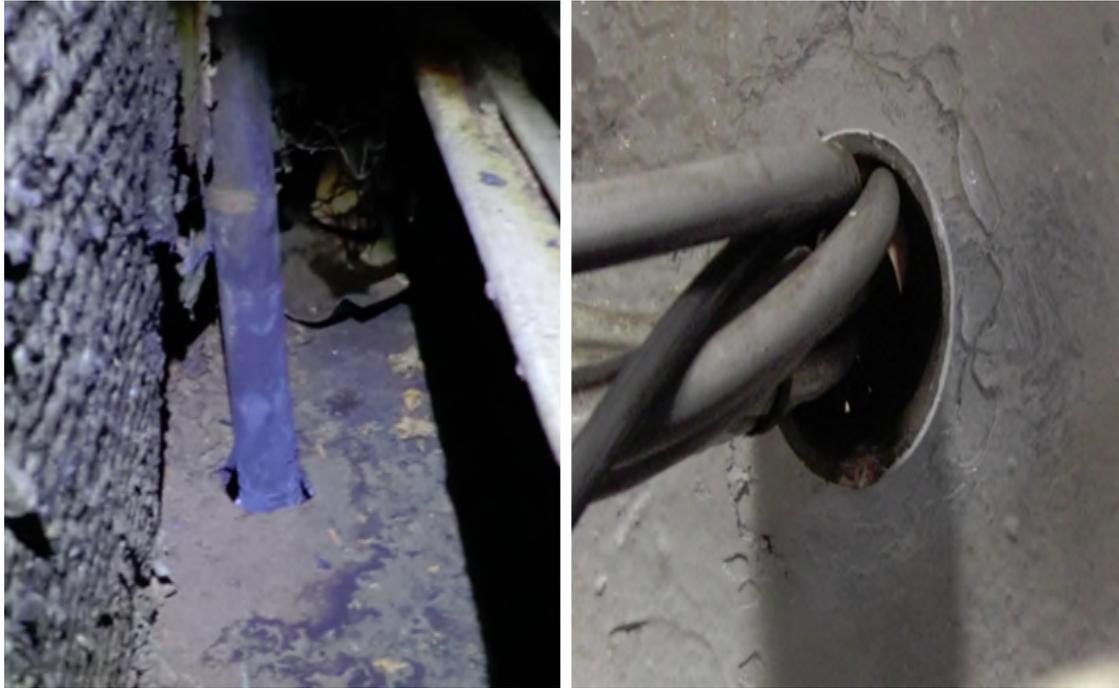
Figure 25: Condition of watertight bulkheads within auxiliary engine room

Assembly resolution A.1104(29) requires examining the collision and other watertight bulkheads required for the ship's subdivision to be conducted. Due to complications surrounding the testing of bulkheads when the vessel is in service by the hose test method, SOLAS Chapter II-1 Regulation 11.1 provides an alternative method of careful visual examination. SOLAS Chapter II-1 Regulation 13.1.1 requires *the number of openings in watertight subdivisions to be kept to a minimum compatible with the design and proper working of the ship. Where penetrations of watertight bulkheads and internal decks are necessary for access, piping, ventilation, electrical cables, etc., arrangements are to be made to maintain the watertight integrity.* The vessel records did not reveal any maintenance-taking place that may have affected the integrity of the watertight subdivision within the auxiliary engine room between November 2015 and the 17th July 2016. It can therefore be determined that both internal and external inspection routines failed in this instance to identify deficiencies effecting the integrity of watertight subdivision.

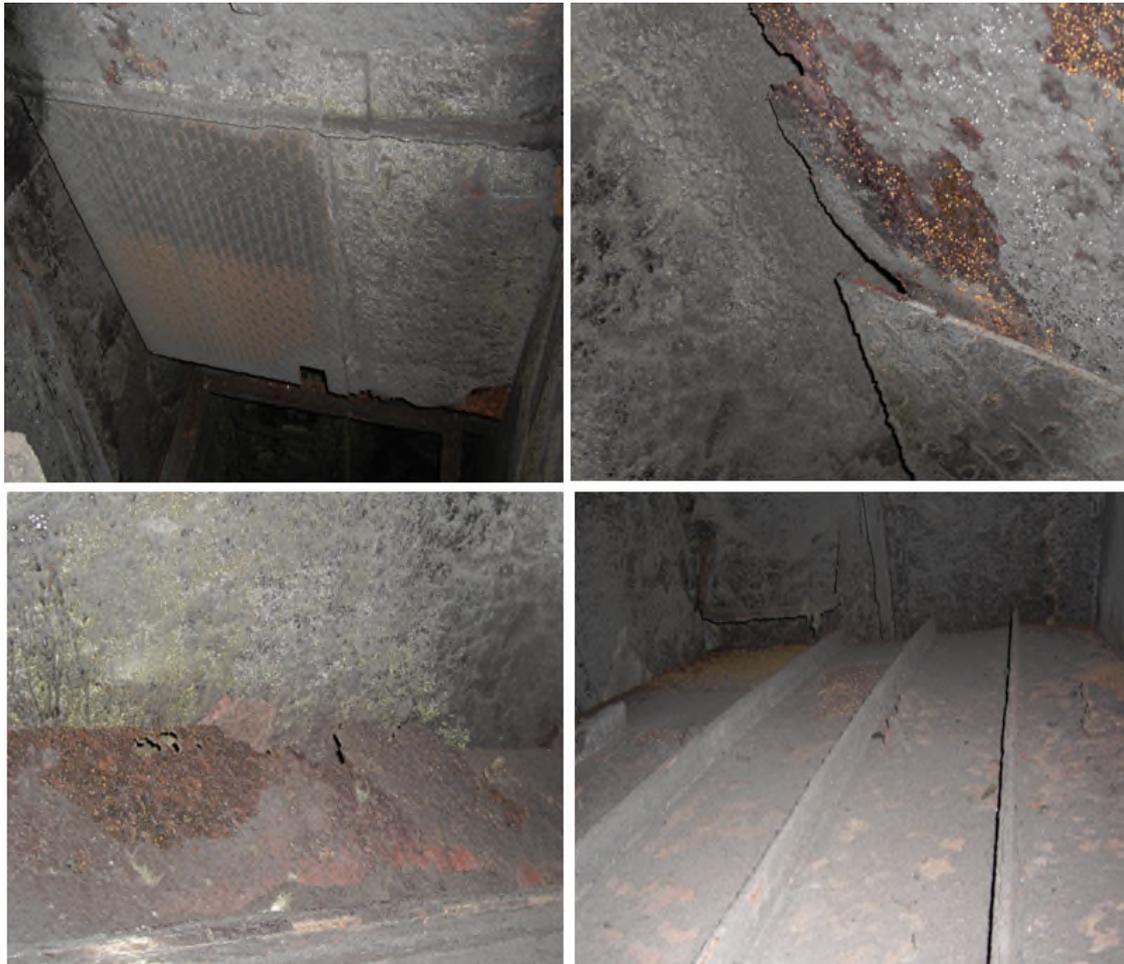
On the 17th July 2016 the condition of the fire dampers in ventilation ducts supplying the auxiliary engine room was also verified. Figure 26 below is provided to demonstrate the condition of the fire dampers during the visual inspection. It can be seen that the physical condition of the fire dampers inspected are degraded to such an extent that the Owners were required to replace prior to sailing.

Figure 26: Auxiliary engine room fire dampers

It can be determined with a certain degree of certainty that the degraded condition of the fire dampers shown in figure 26 was not a result of fire damage from the auxiliary engine room fire on the 1st July 2016. Further it can also be determined with a degree of certainty that the condition of fire dampers did not deteriorate to such an extent that the Owners or PSC inspections would not have had sufficient opportunity to potentially identify their condition.

The Owners are ultimately responsible for the condition and operation of fire dampers. Regular on board inspections should be conducted to ensure the fire dampers structural integrity is not compromised by verifying their condition and operation to ensure in the event of a fire the engine space can be contained.

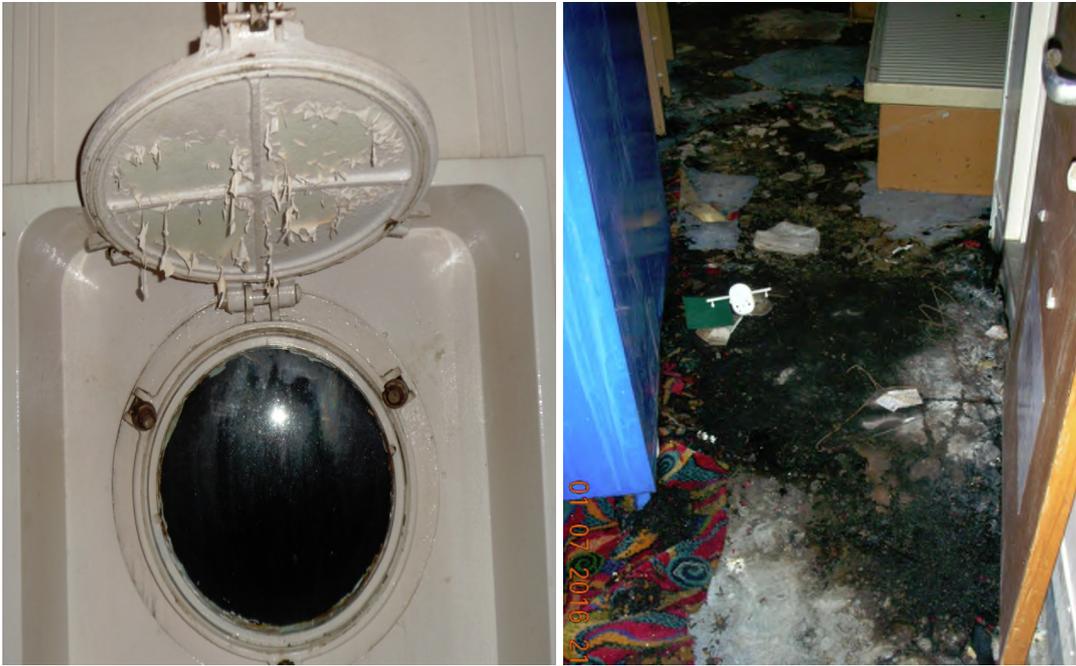
- 5.4.3 The 'A' class insulation on the deck head of the auxiliary engine room provided adequate structural fire protection sufficient to contain the heat from transferring for approximately 60 minutes. As the fire continued to burn in excess of one hour the fire protection insulation degraded allowing the transfer of heat to adjacent compartments, this resulted in secondary fires to establish themselves in the crew cabins located above the seat of the fire. Damage sustained to these compartments can be seen within figure 27 below.

boundary cooling had been initiated immediately, in accordance with onboard firefighting procedures, the transfer of heat would have been reduced and the likelihood of such damage occurring may have been significantly lower.

Figure 27: Heat damage sustained in cabin 311 above the seat of the fire

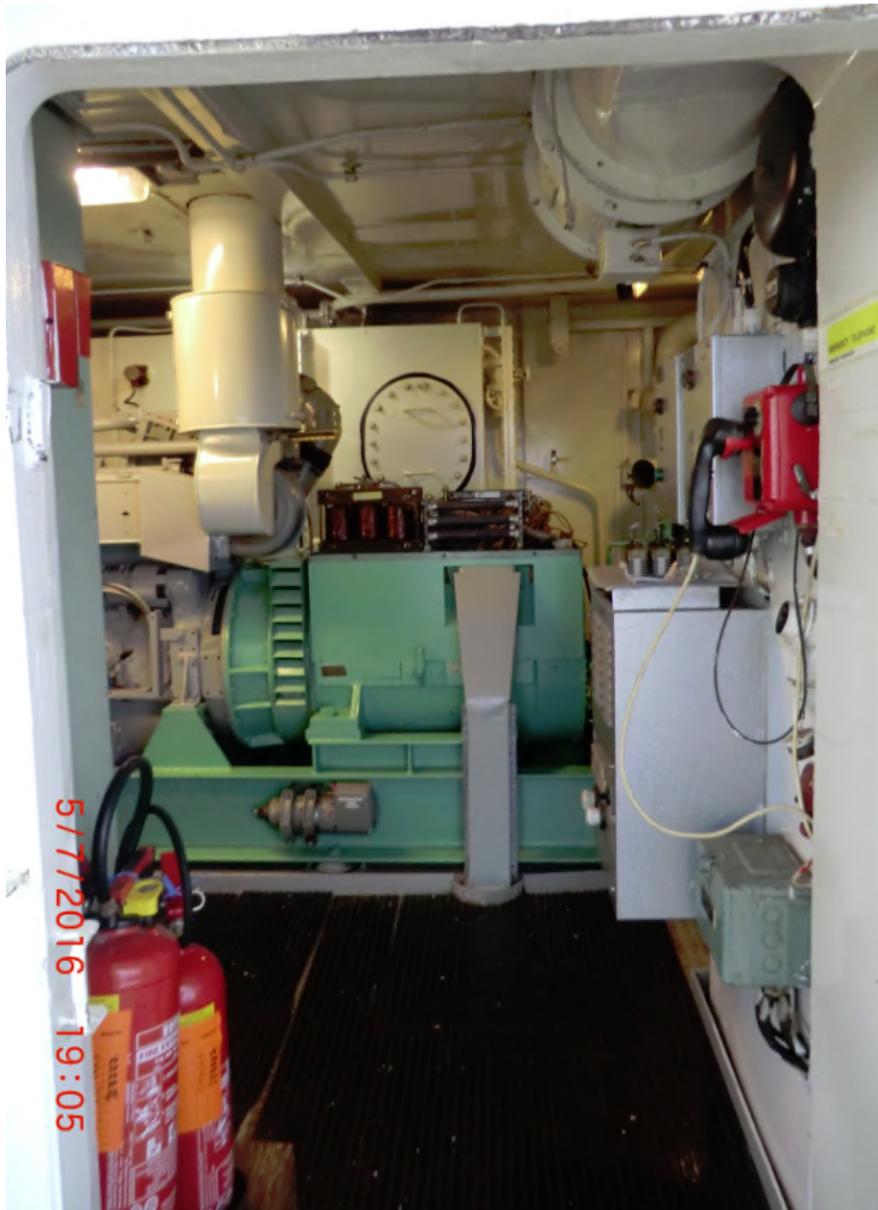
Figure 28: Emergency generator

- 5.6.4 The vessel maintenance record for the emergency generator indicates that the generator was tested weekly for one hour. The PMS work order does not stipulate what load the generator should be under when tested. Therefore it can be determined that prior to the incident the generator had not been operated in a condition in which it was expected to fulfil in the event of an emergency.

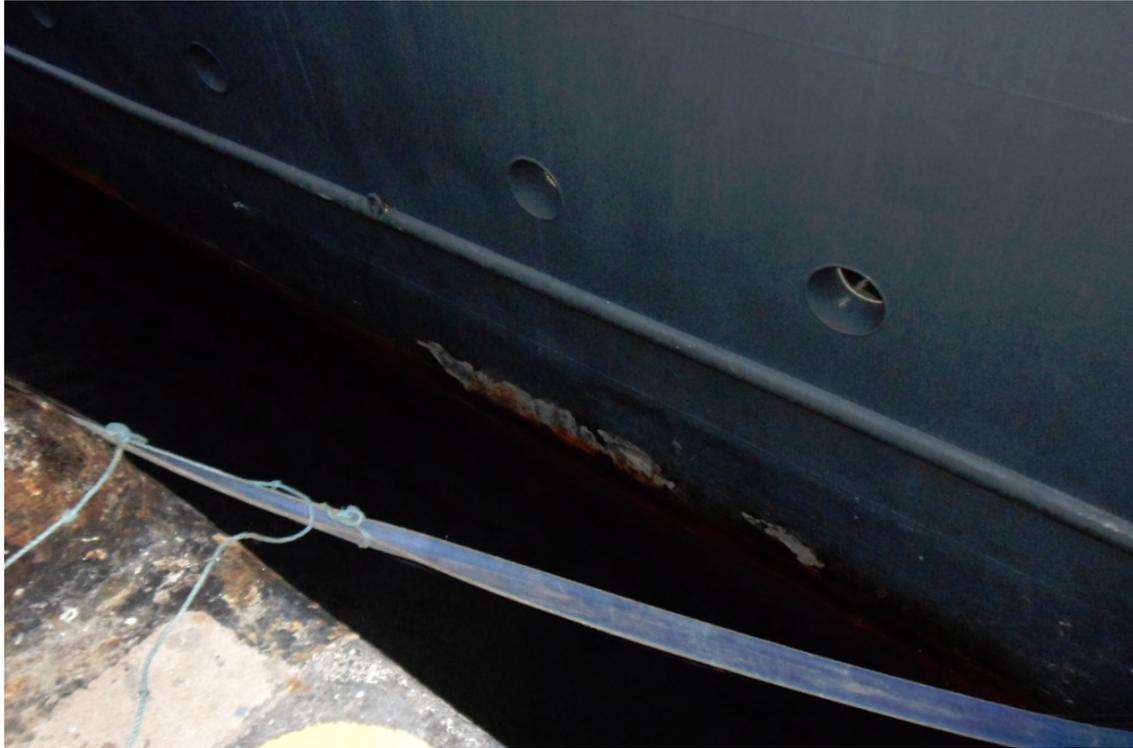
Figure 32: Starboard Side shell plating in vicinity of Auxiliary Engine Room

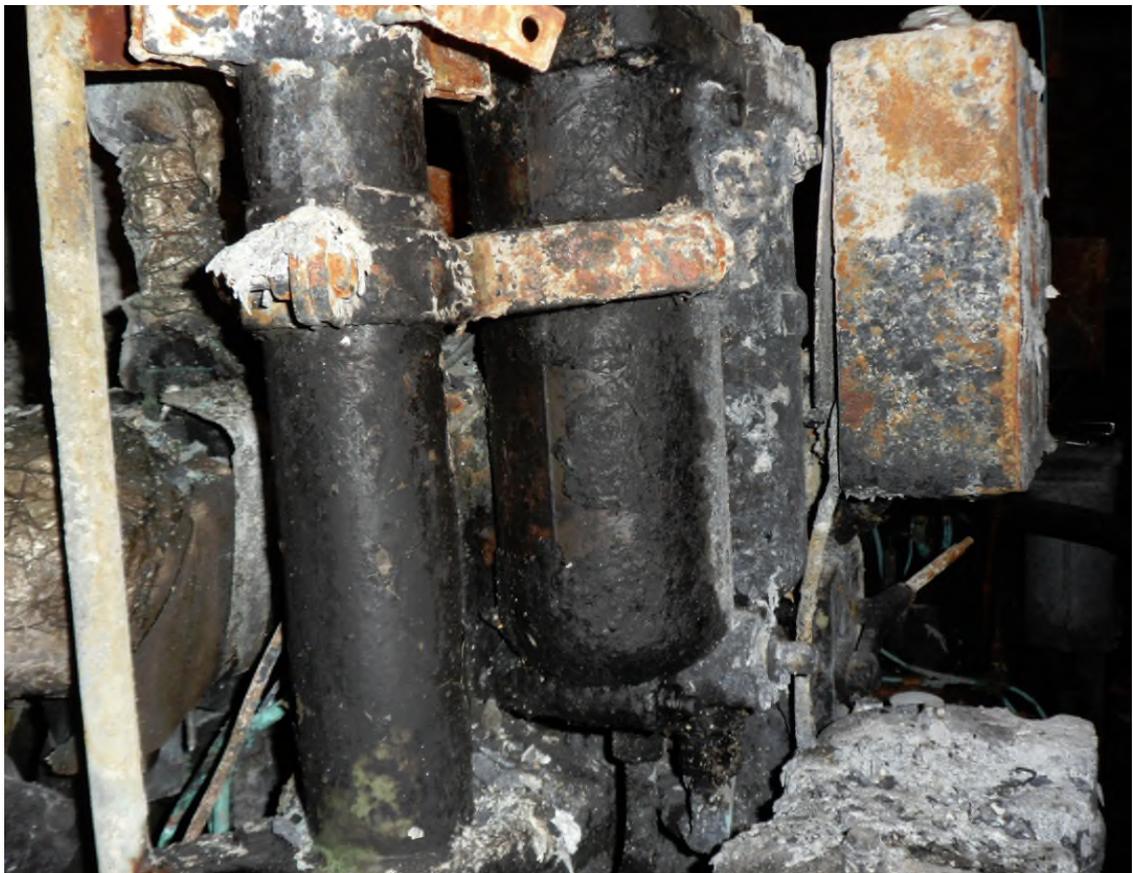
Figure 33: On-engine fuel filter

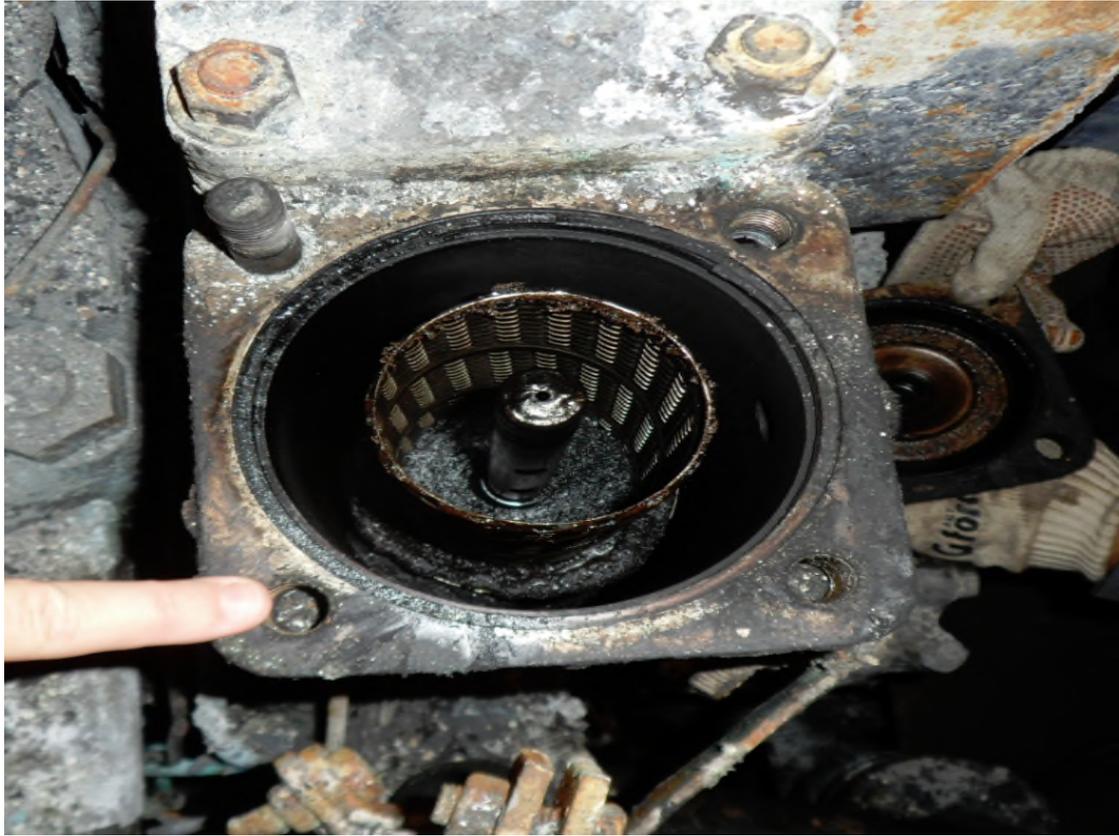
Figure 34: On-engine fuel filter with lid removed, identifying location of loose bolt

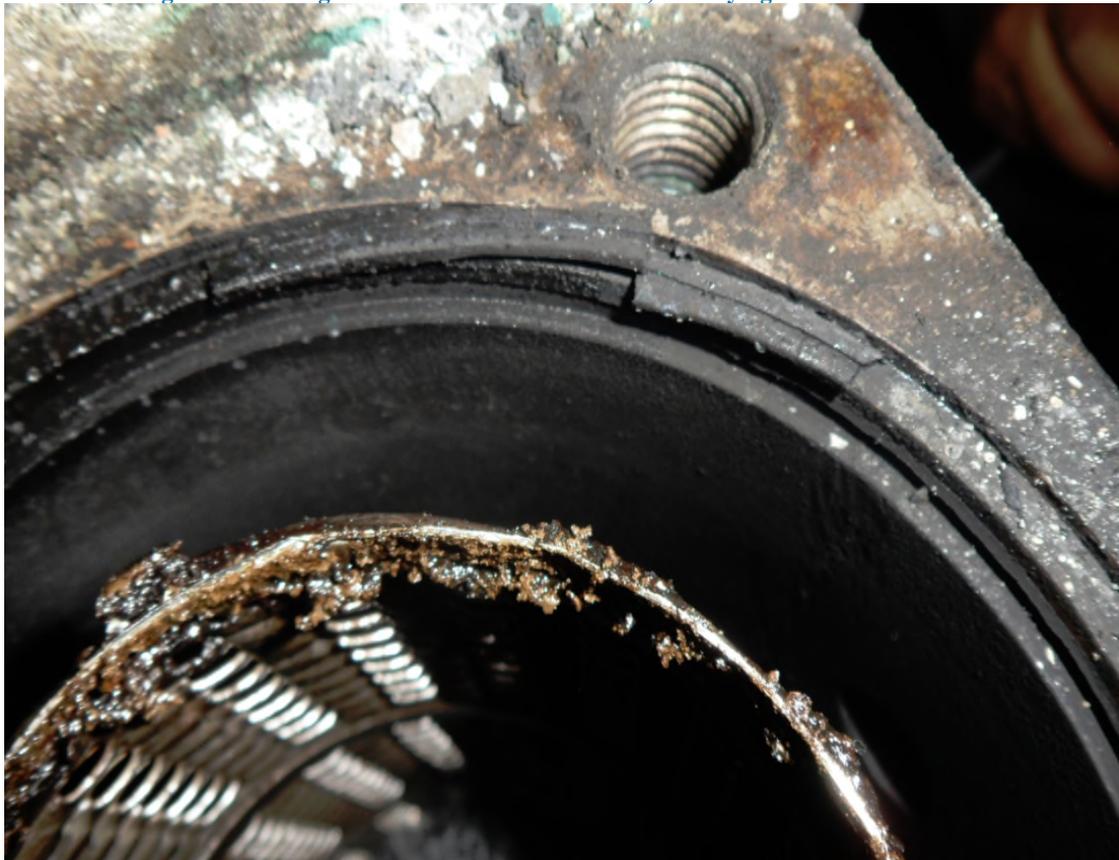
Figure 35: On-engine fuel filter damaged seal with lid removed
