**The Bahamas
Maritime Authority**

**M.v. BOUDICCA
IMO Number 7218395
Official Number 8001101**

**Report of the investigation into an
Auxiliary Engine Room Fire on the
25th January 2015**

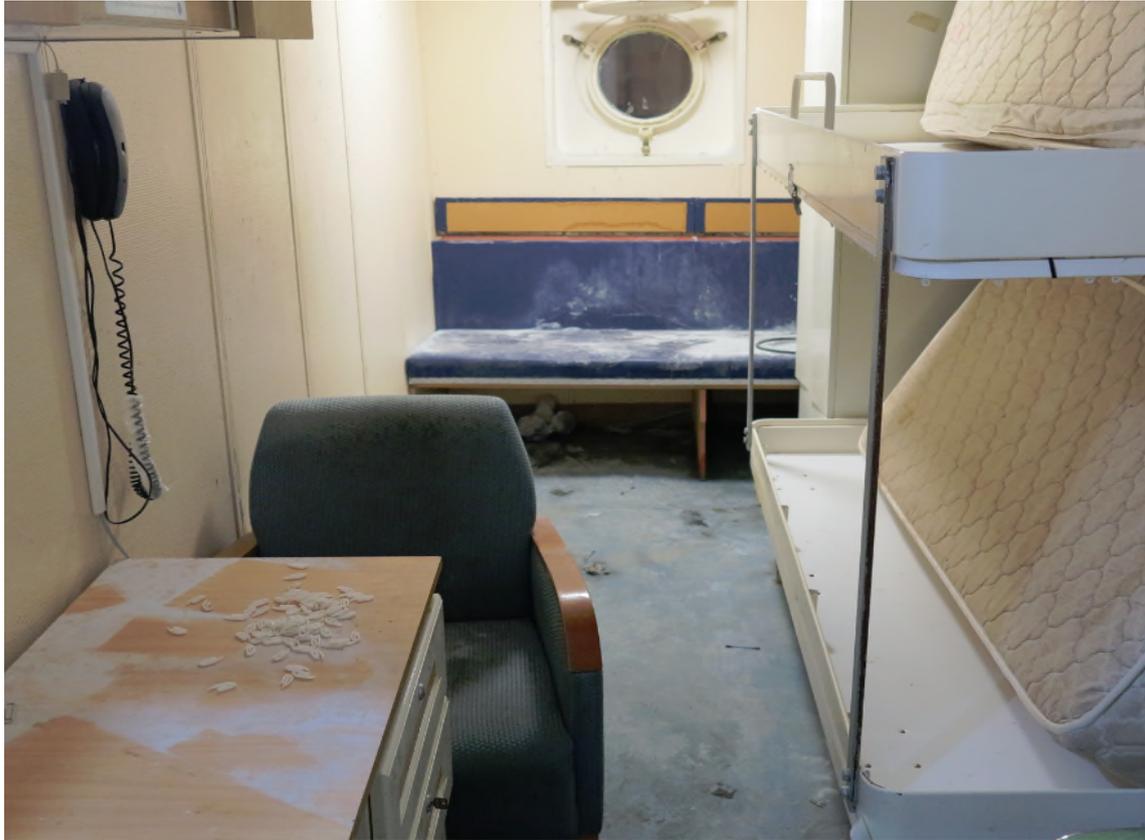
- 3.6.1 At 0358 hotspots were found on deck 2 in cabin 2101 (see figures 10 and 11), the location of which was immediately above the source of the fire in the auxiliary engine room. The rapid response team conducted boundary cooling containing the situation and preventing the vertical spread of the fire.

Figure 10: Cabin 2101 post boundary cooling efforts

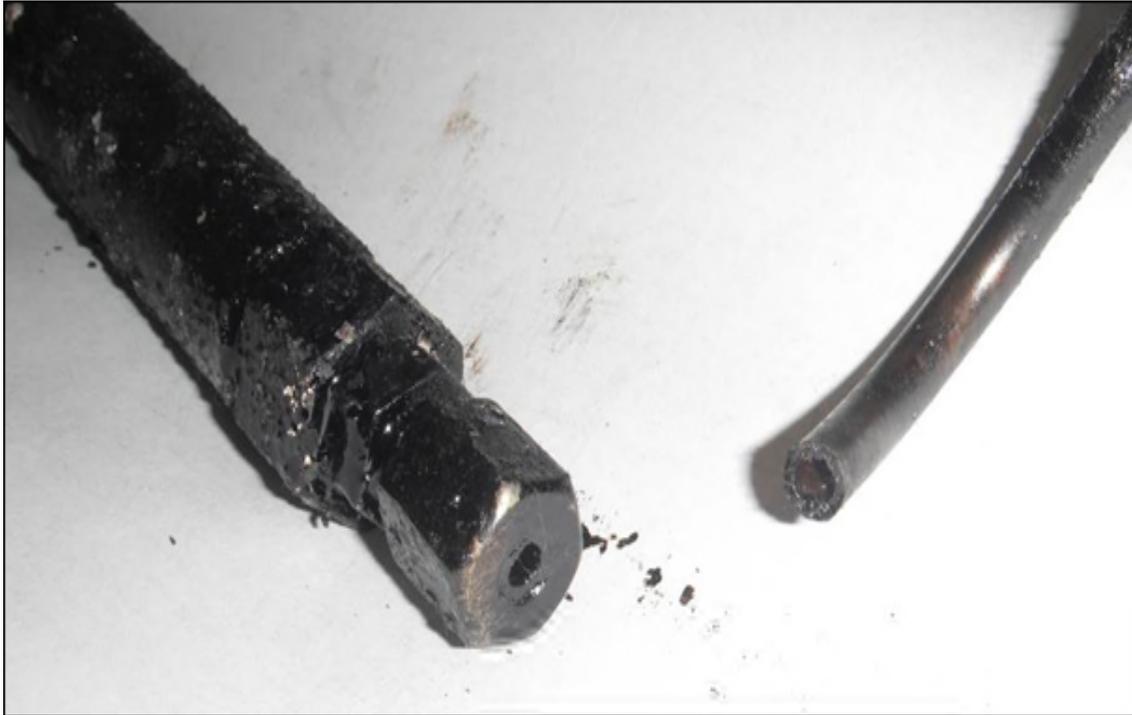
4.2.1 The initial cause of the fire is known to have originated from a fracture in the fuel oil pressure gauge supply line on AE1. The supply line fitted, fractured at the point of connection to a hex nut (see figure 12). The line is physically connected to a compensation device which is fitted to the supply line connected to the manometer gauge.

Figure 11: Point of fracture in the fuel oil pressure gauge supply line

- 6.2 The fuel oil supply lines fitted to the auxiliary engines should meet the manufactures recommended arrangement and only be constructed using the appropriate and approved material and/or components.

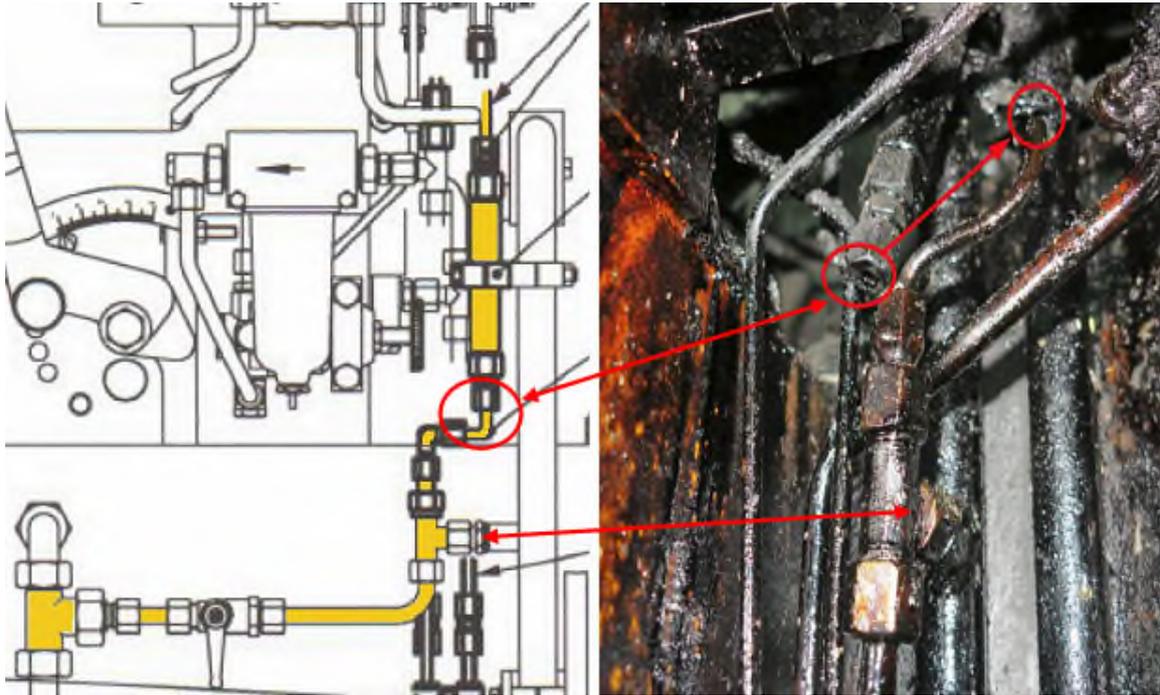
- 4.2.2 The fuel supply line is situated on the forward end of AE1 behind the panel holding the manometer pressure gauges. The fuel oil pressure gauge supply line measures the fuel oil supply to the generator by feeding the manometer gauge, the approximate pressure of the fuel within the line is 5 bar. The steel line is inverted 'Z' shape, 6mm wide and 120mm in length, situated (see figure 13) approximately 500mm below the top of the engine and 800mm beneath the turbo charger. At the point of the fracture the pressurized fuel, occupied the atmosphere surrounding the engine. The exact source of ignition cannot be determined, however, there are various components that have a surface temperature sufficient to auto-ignite hot fuel in vapour and liquid form within the immediate vicinity of the fracture. Due to the proximity of the turbo charger to the fuel oil supply line at the front of the engine, it can be concluded with a high degree of probability that the source of ignition was provided by the turbo charger.

Figure 12: Fractured fuel oil pressure gauge supply line schematic and photograph post fire

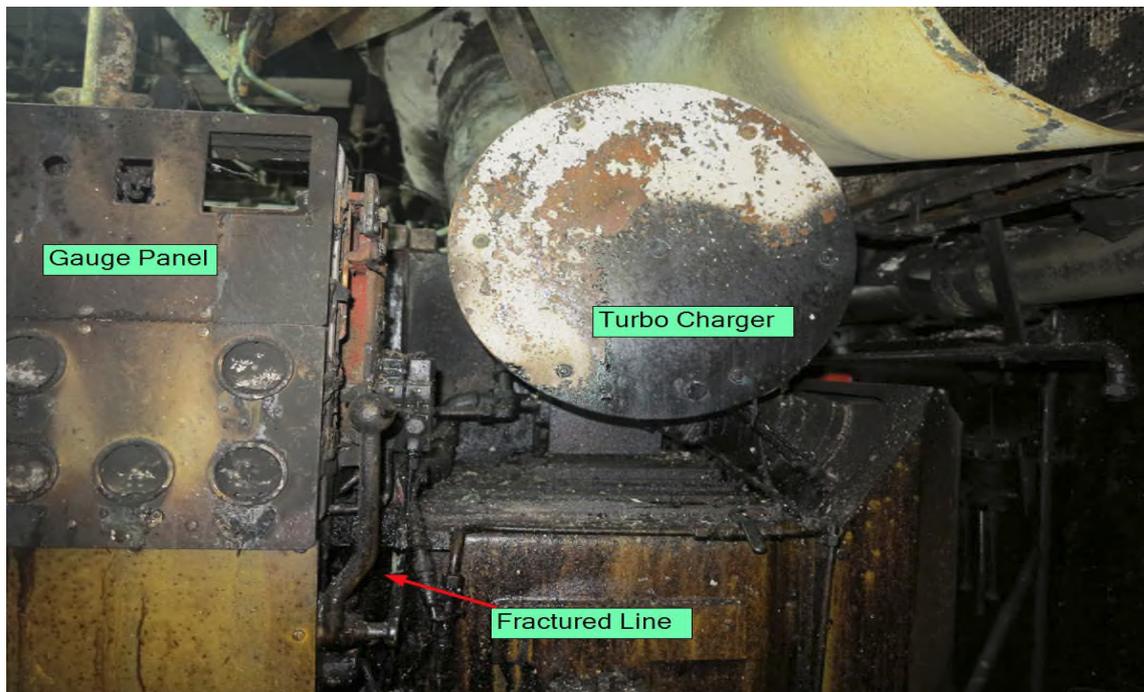
4.2.3 The fire engulfed the entire front end of AE1 and spread out and above the point of ignition, moving aft, fuelled by combustible material in the surrounding area. On examination of the scene post fire, significant damage had been caused to cable trays, wiring looms, AE1, AE2, damage to ancillary equipment supplying AE3, insulation, fixtures and fittings throughout the Auxiliary Engine Room.

Figure 13: Post incident damage to forward end of AE1

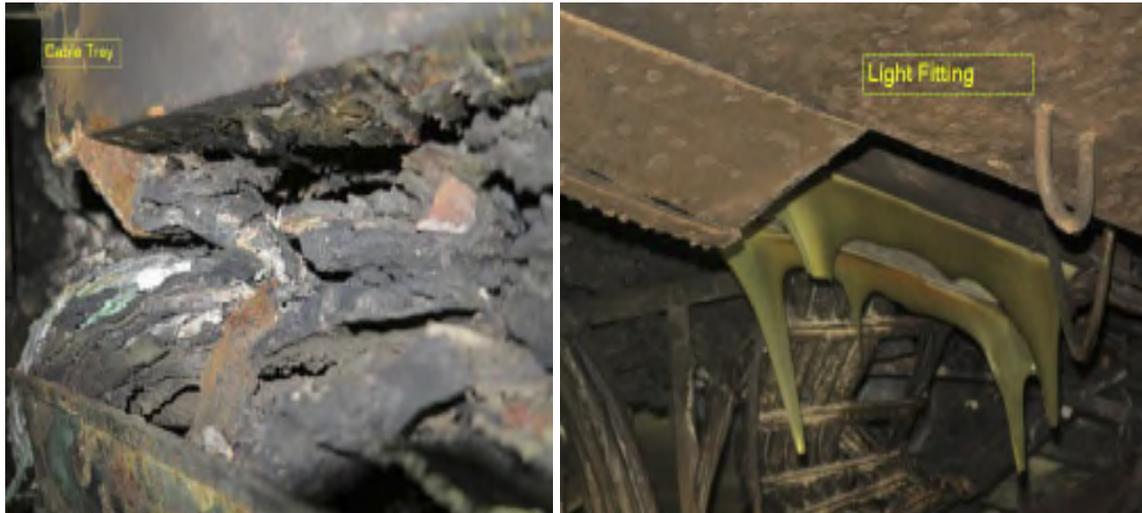
Figure 14: Collateral damage to cable tray (left) and light fixture in vicinity of AE1 (right)

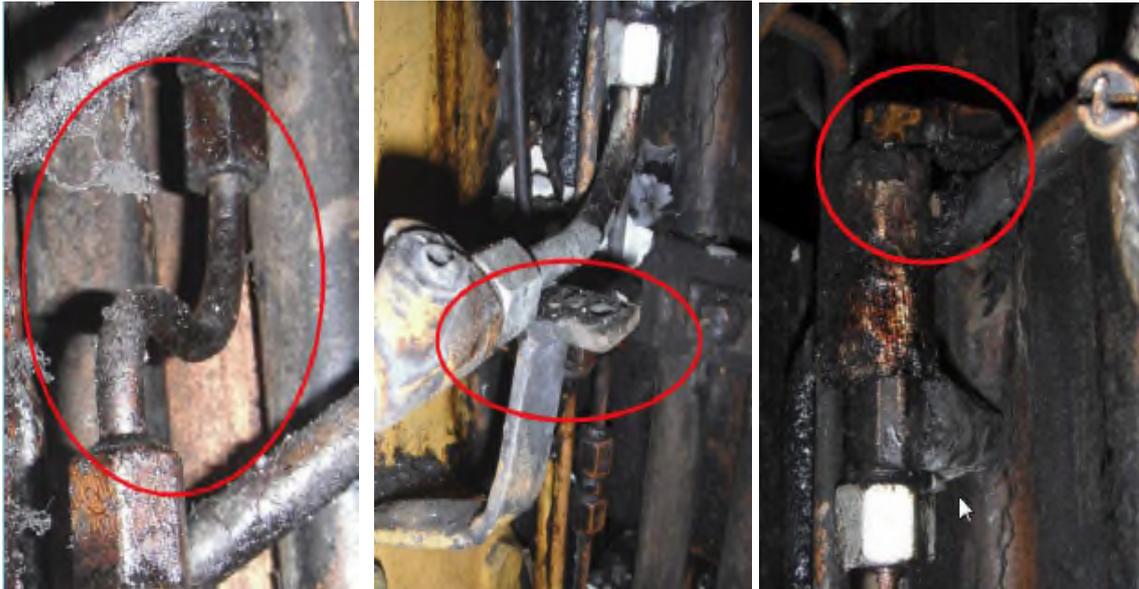
- 4.2.4 Within the manufacturers' manual, a schematic of the layout of the fuel supply line is provided. On reviewing three of the Auxiliary Engine's fuel oil pressure supply lines, discrepancies exist in the construction and materials used of these supply lines. AE1 and AE2 are configured using different materials compared with that of AE3. AE3 fuel oil pressure gauge supply line is constructed with 90° compression fittings whereas AE1 and AE2 has in a place a steel fabricated line with compression fittings on either end as per the manufacturer's schematic (see figure 12). In addition AE3 has a bracket situated beneath the fuel supply line but does not come into contact with said fuel supply line, therefore providing no support.

Figure 15: Fuel oil pressure gauge supply lines discrepancies (left to right AE2, AE3 and AE3)

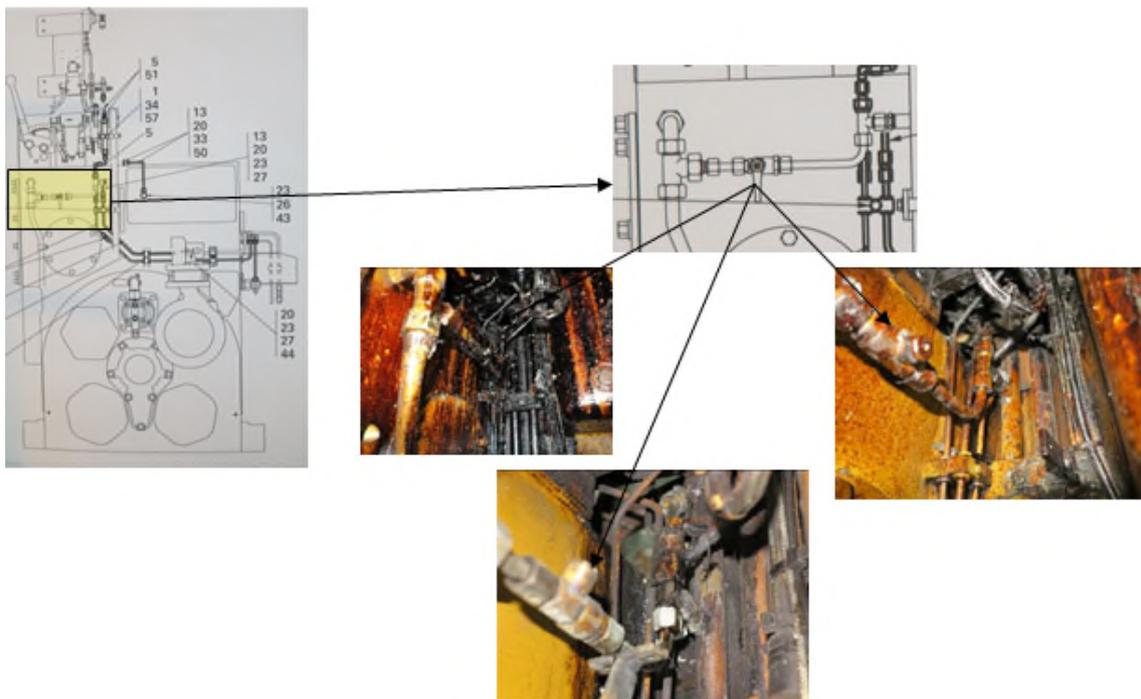
- 4.2.5 Further, the manufacturer's manual includes a valve with valve handle on the schematic. Although the valve is present the handle used to control the supply of fuel to the pressure gauge is missing on all three auxiliary engines. These discrepancies do not appear to have had any measurable impact on the performance of the fuel oil pressure gauge supply line prior to the incident.

Figure 16: Fuel oil pressure gauge supply lines on AE1, 2 and 3 indicating missing valve handle

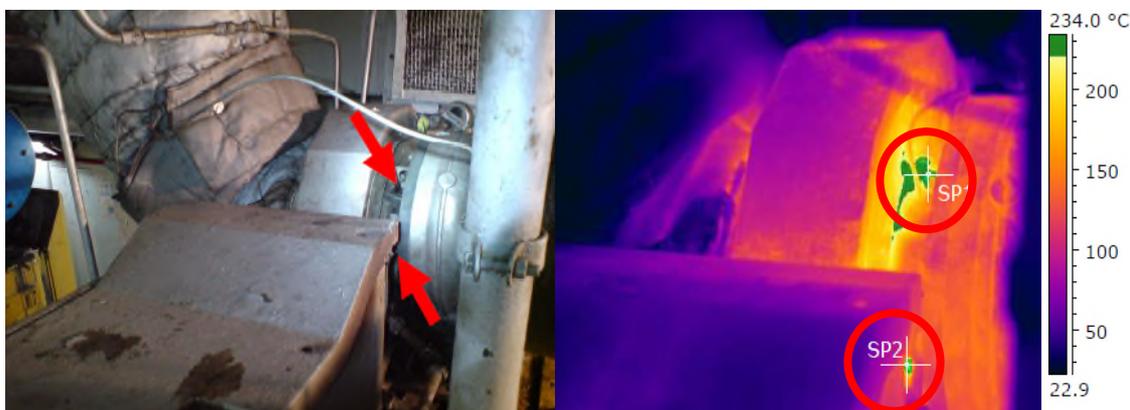
- 4.2.7 The thermal survey concluded that AE1 in vicinity of the fuel oil pressure gauge supply line and turbo charger located towards the rear of the engine had five areas identified via thermal imagery as having a high temperature in excess of 220°C⁶.
- 4.2.8 At the time of ignition AE1 was using heavy oil fuel, which has a typical flashpoint range of between 65~80°C and a typical minimum auto-ignition point of 400°C. Figure 18 identifies the precise surface temperature of the turbo charger whilst under load. As seen on the thermal image the surface temperature recorded ranges from 22.9°C to 234°C. The two areas, SP1 and SP2 highlighted by a red circle have a recorded temperature of 404.8°C and 401.5°C respectively.

Figure 17: Photo (left) of AE1 turbo charger in vicinity of fuel oil pressure gauge supply line and thermal image (right)

- 6.1 Consider fabricating insulation protection for those areas identified within the Thermo Protection Temperaturanalyse report. In addition, it is recommended that thermal surveys be conducted at regular intervals and on completion of any maintenance or repair of equipment that has been carried out, to ensure that the insulation material has been properly reinstalled or replaced.

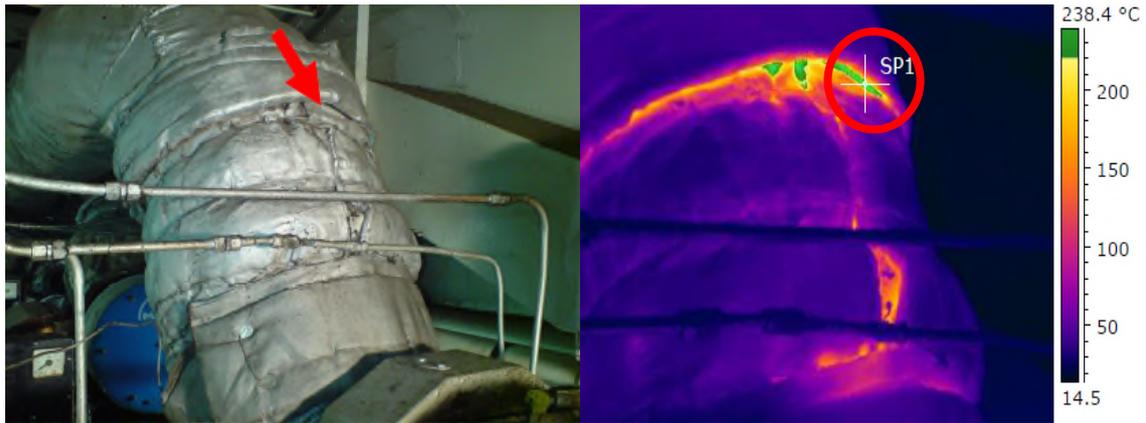
- 4.2.9 The insulation surrounding the exhaust gas turbo charger identified in figure 19 appears visually adequate⁷, however when compared to the thermal image, it clearly detects gaps within the insulation potentially exposing the high temperature surface of the exhaust to the atmosphere.

Figure 18: Photo (left) of AE1 turbo charger exhaust in vicinity of fuel oil pressure gauge supply line and thermal image (right)

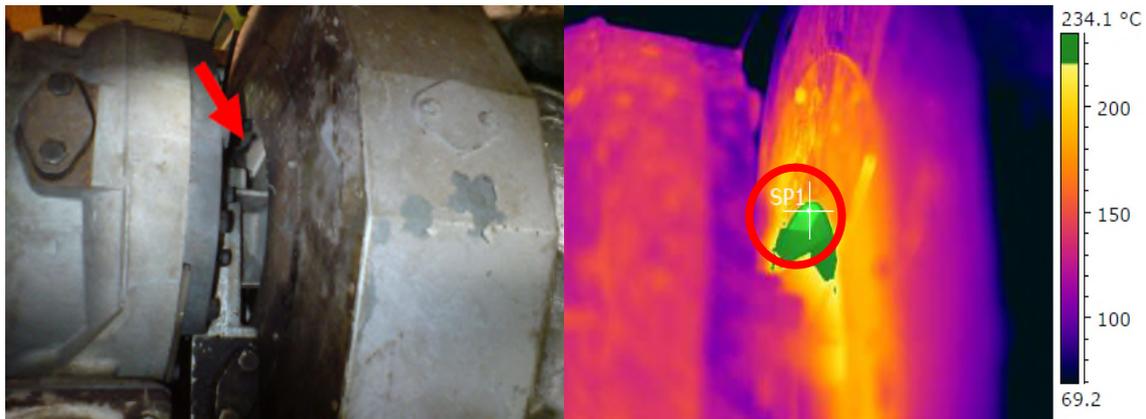
4.2.10 The thermal image of the bearing housing of the AE1 turbo charger had a maximum-recorded temperature of 445.3°C. The surface of the turbo charger had no insulation or spray shields to prevent flammable oil coming into direct contact with high temperature surfaces.

Figure 19: Photo (left) of AE1 turbo charger bearing housing in vicinity of fuel oil pressure gauge supply line and thermal image (right)

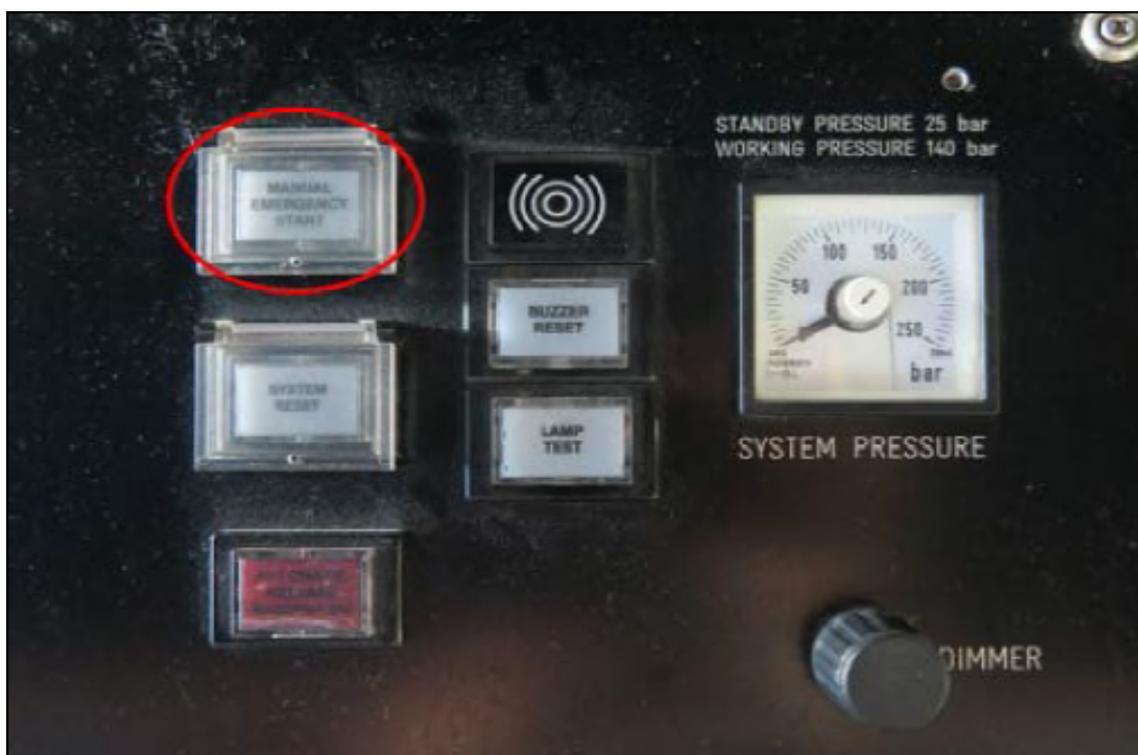
- 4.3.6 A Marioff technician, instructed to determine the cause of the system not operating as required, found that at some point during the incident the manual emergency start button had been activated on the bridge panel which starts all high pressure pumps, feed water pumps and overrides the pump units technical tanks high level switch. This resulted in the technical tanks to overflow despite

- 4.3.7 It may have been apparent to the operator on the bridge if the lamp, indicating the switch was activated had not been faulty, resulting in a delay in switching off the breakers to the system to stop the Hi-Fog system from operating.
- 4.3.8 Once acknowledged as being the root cause of the 5^o list to port, the remaining water was pumped from the bilge restoring the upright condition of the vessel via the onboard emergency bilge pumps.

Figure 21: Bridge – Emergency Start Button

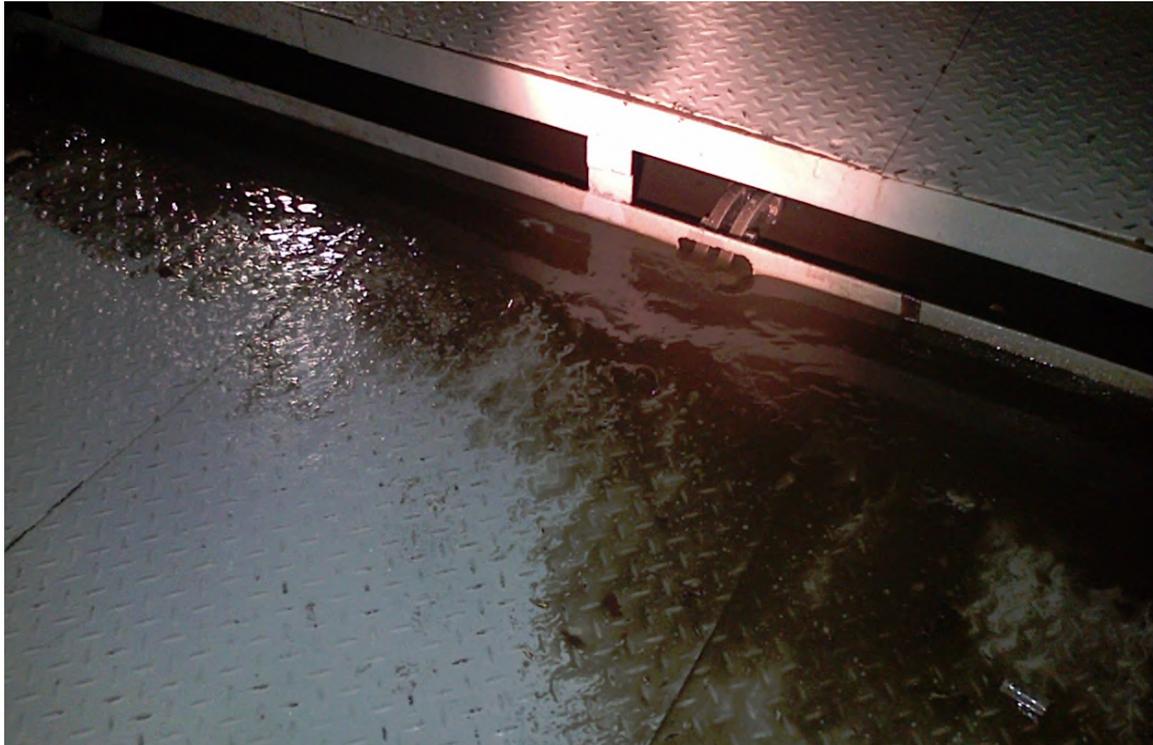
- 4.3.5 Due to the developing list, which was the first indication the vessel had not restored all systems, it was determined that the Hi-Fog system had continued to operate for 1 hour 14 minutes after the point at which it was assumed it had been stopped. The estimated water discharged into the space during the course of the systems operation was in the region of 80m³, which was collected in the bilge of the chilling plant and water generation room, aft of the auxiliary engine room that subsequently drained into the tunnel room (tank top).

Figure 25: Mid tunnel tank top flooding (Frame 40-60)

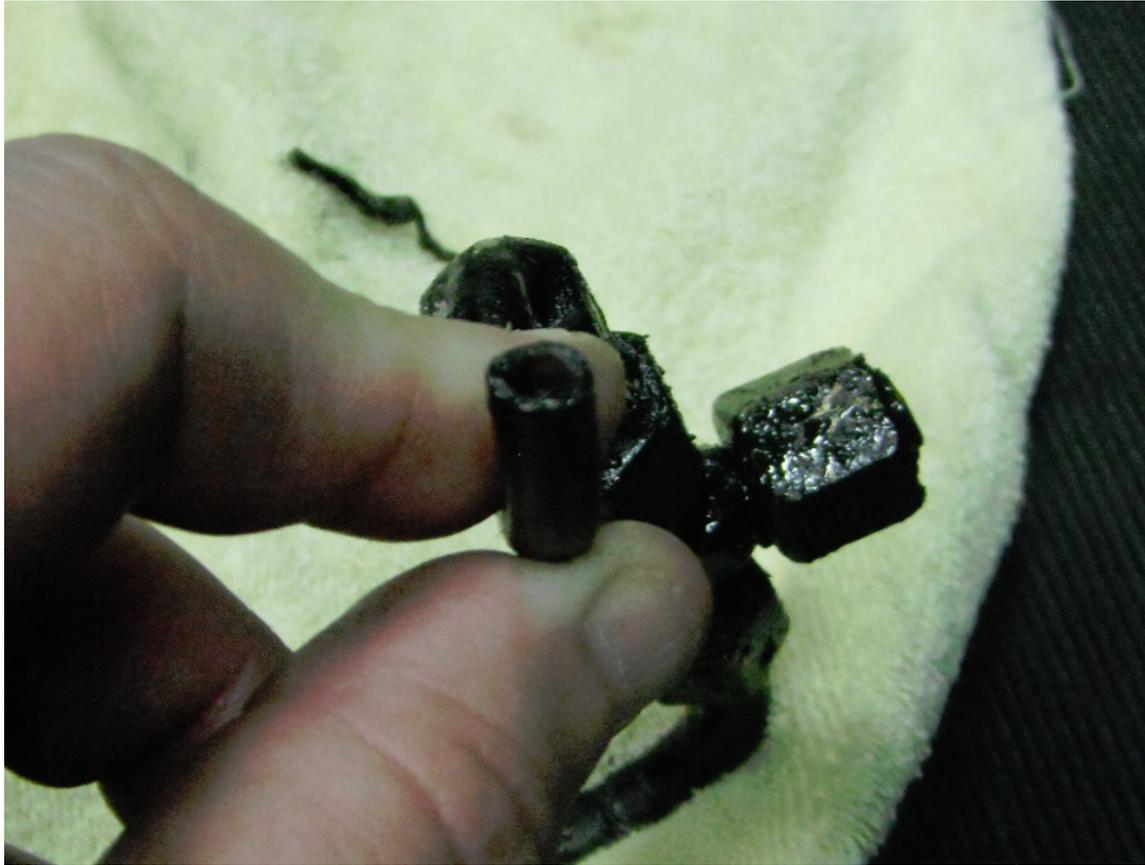
Figure 27: Fractured fuel oil pressure gauge supply line
