“CARNIVAL TRIUMPH”

**IMO Number 9138850
Official Number 732044**

**Joint report of the investigation
into an engine room fire
on February 10th, 2013**

Date of Issue: 12th September 2014

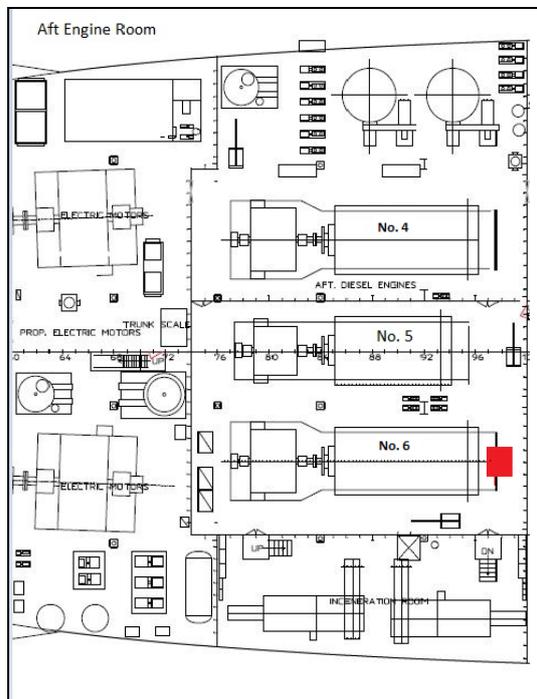
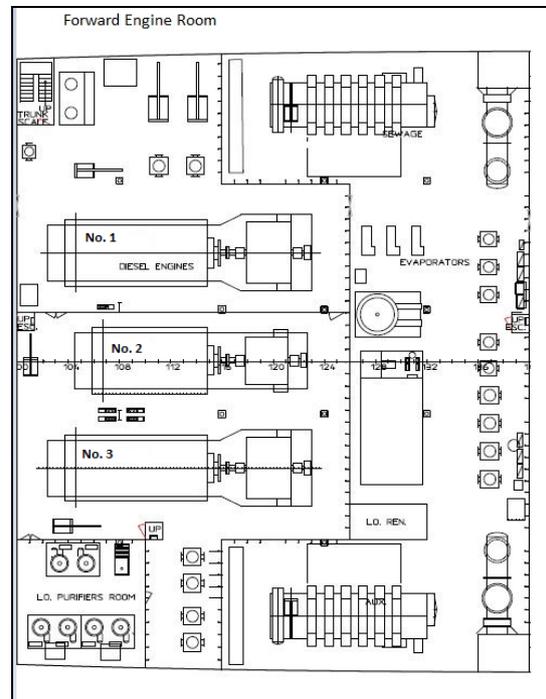
- 2.5 The Forward and Aft Engine Rooms contain a total of six diesel engines, two of which are twelve (12) cylinder engines mounted along the vessels centreline: Engine No.2 in the forward engine room and No.5 in the Aft Engine Room. The remaining four are sixteen (16) cylinder engines. These are mounted one each to port and starboard of the centreline engines and are designated as Engines No.1 and No.3 (in the Forward Engine Room), and Engines No.4 and No.6 (in the Aft Engine Room). Electrical generators are directly coupled to these engines. Each of the six generator engine assemblies are skid mounted on resilient mounts for the isolation and suppression of the effects of vibration from the hull and fixed structures. Each diesel generator's ventilation trunk is supported from the vessel's structure by resilient fixtures; this also limits the transfer of vibration.

■ Source of Fire

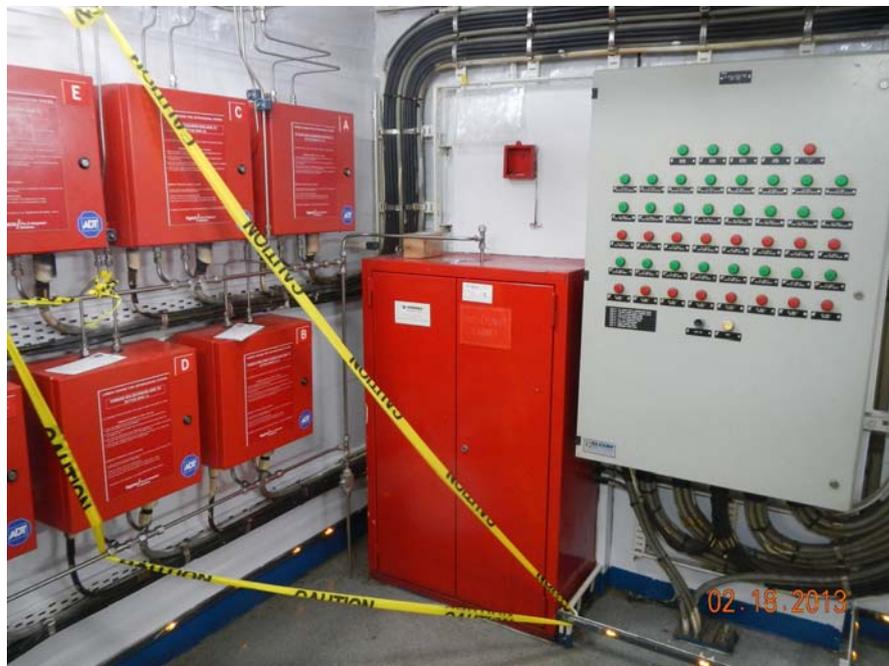
CO₂ system remote release station.

- 3.29 Once the CE was certain that the CO₂ release alarm was sounding and that the auto close for the fire doors and dampers had time to operate, due to the failure at the local station to activate the CO₂ system at the Aft Engine Room, the CE proceeded from Deck 0 to Deck No.11, via the stairways, to access the CO₂ room. In the event the failure was due to a fault to the distribution valve in the CO₂ Room. En route, he noted that the vessel's lights were flickering.

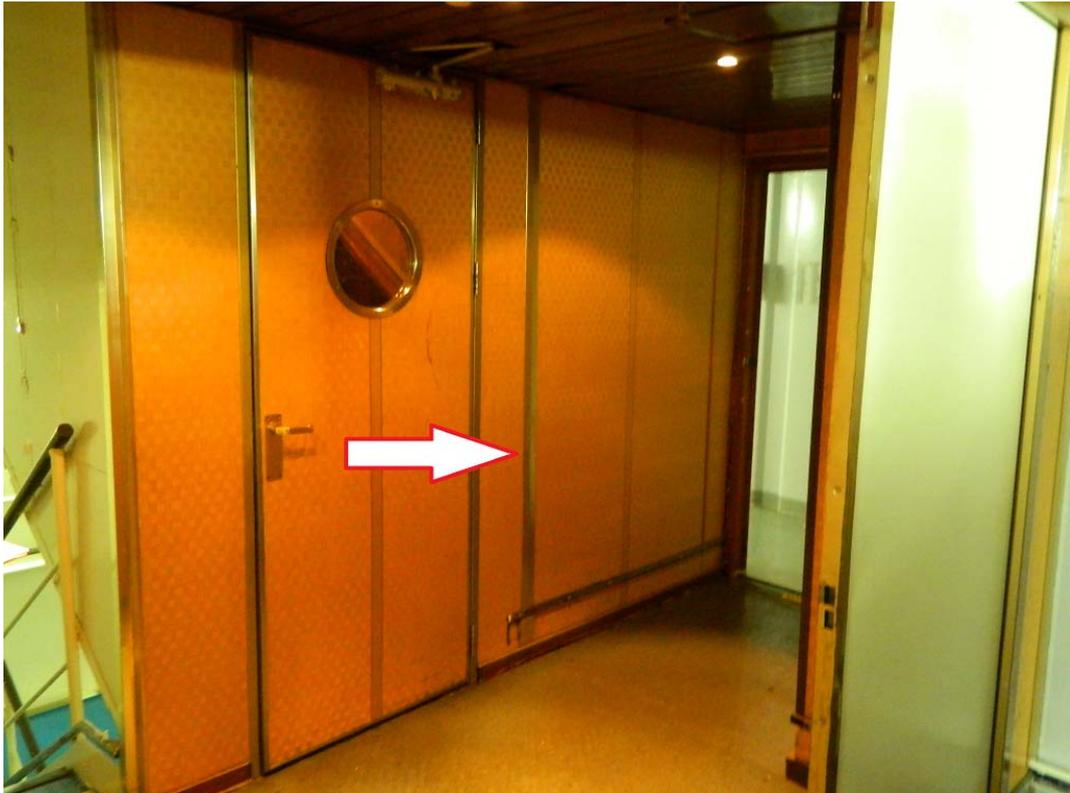
- 3.35 The Safety Officer and the Captain discussed whether to open the internal doors between Deck 0 and the aft mooring station, to vent smoke from the marshalling area and the Engine Control Room. During interviews with passengers, it was determined that the stairwell door stayed open and smoke entered the passenger deck No.1 aft.

Access door from crew to passenger decks with defective closing device.

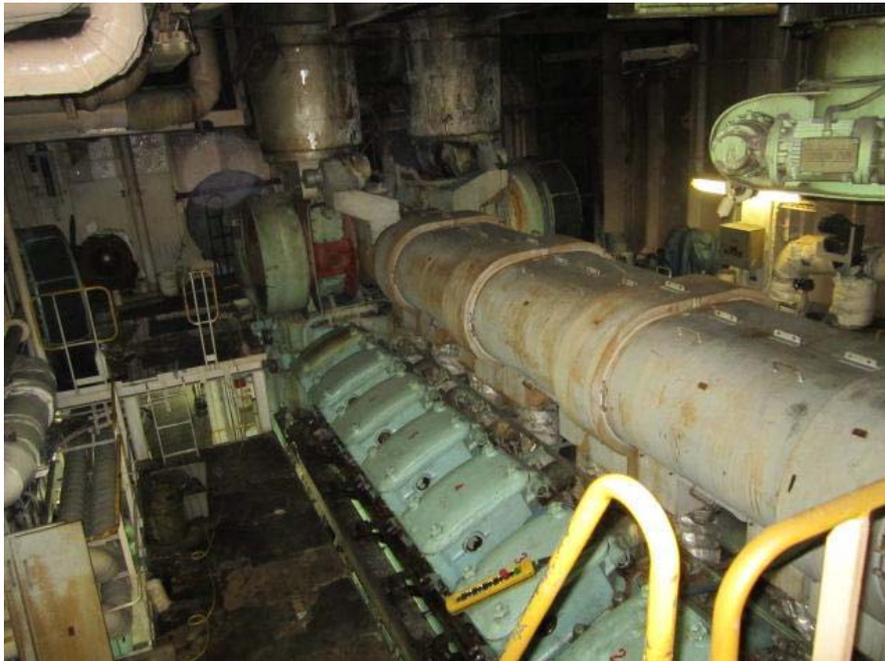
Upper part of diesel generator No.4 – looking aft.

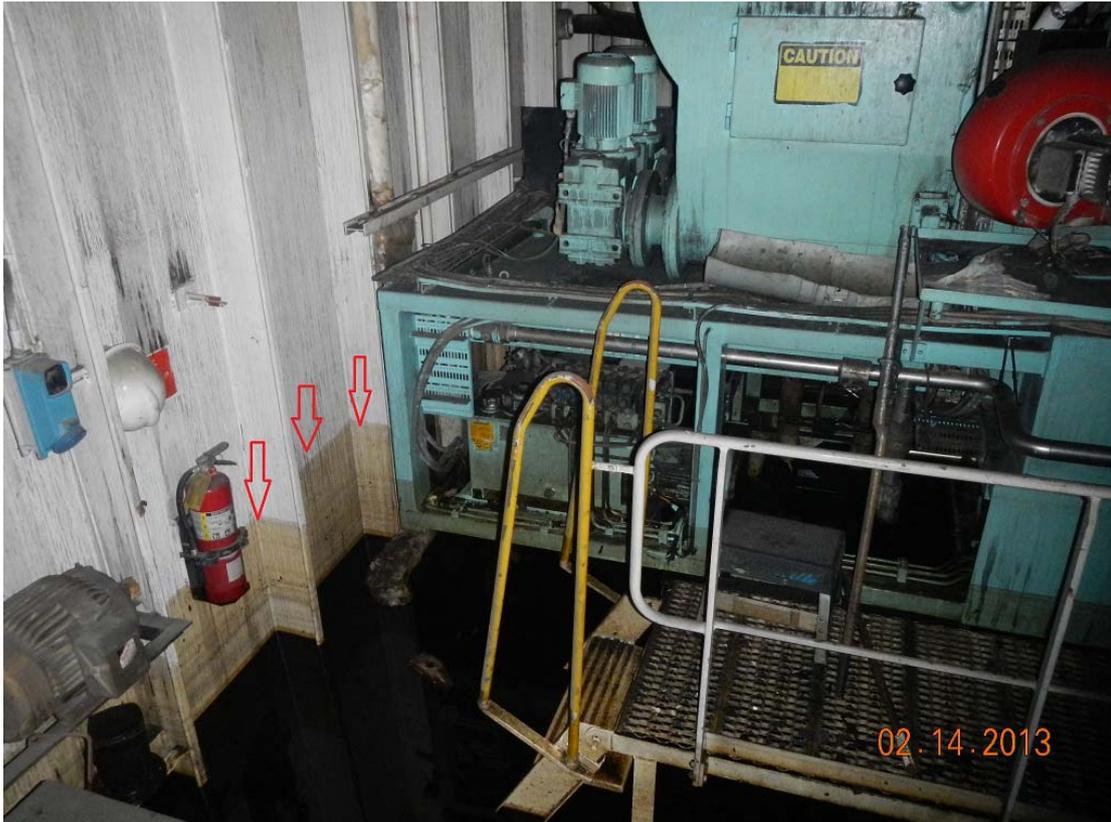
- 4.4 On the starboard side of the partition the incinerators were found to have paint systems intact and a limited amount of soot accumulation, heat damage was noted in way of cable trays running along the outboard side of the starboard partition bulkhead.

Flooding in the Incinerator Room (note tidemark ↓)

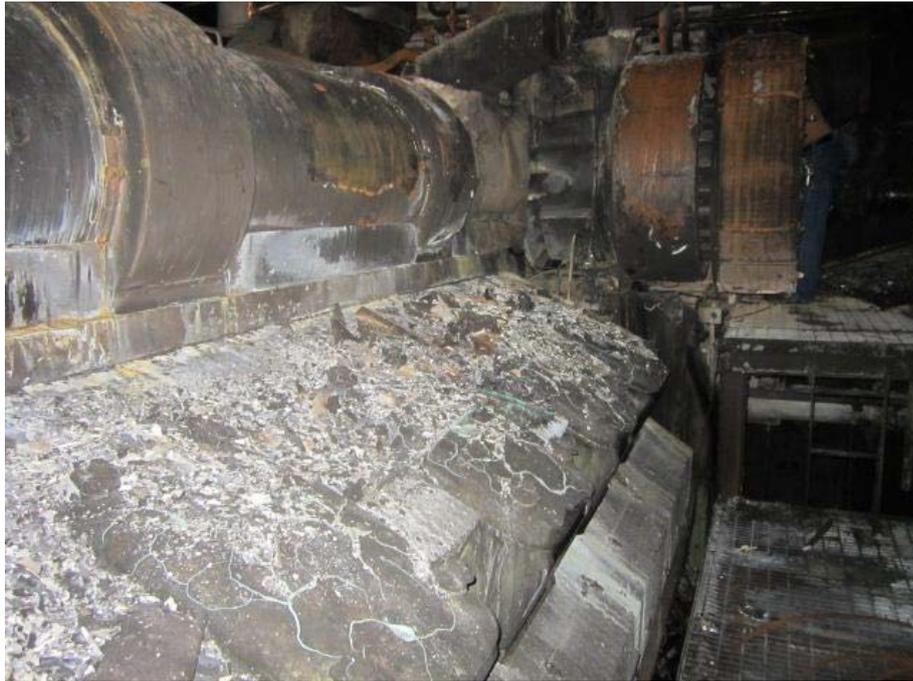
- 4.7 Deformation of fittings, including lights, loudspeakers, alarm panels, fire activation points and fire fighting equipment indicate that the heat from the fire was concentrated forward of engine No.6, and between that engine and along the starboard partition bulkhead to the aft bulkhead at frame 74.

Inboard side of upper part of diesel generator No.6 – looking aft

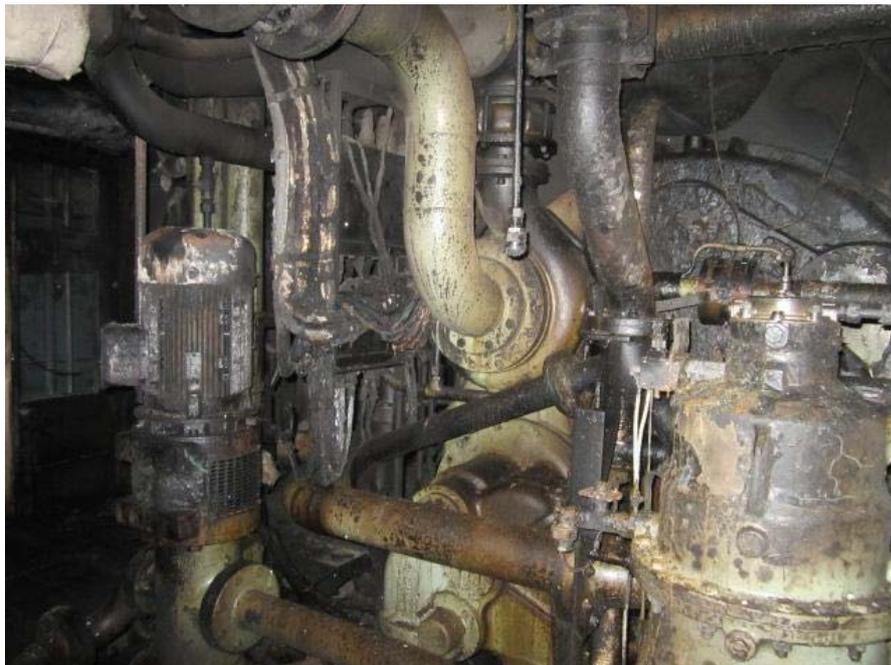
Forward end of diesel generator No.5 below Turbo Chargers

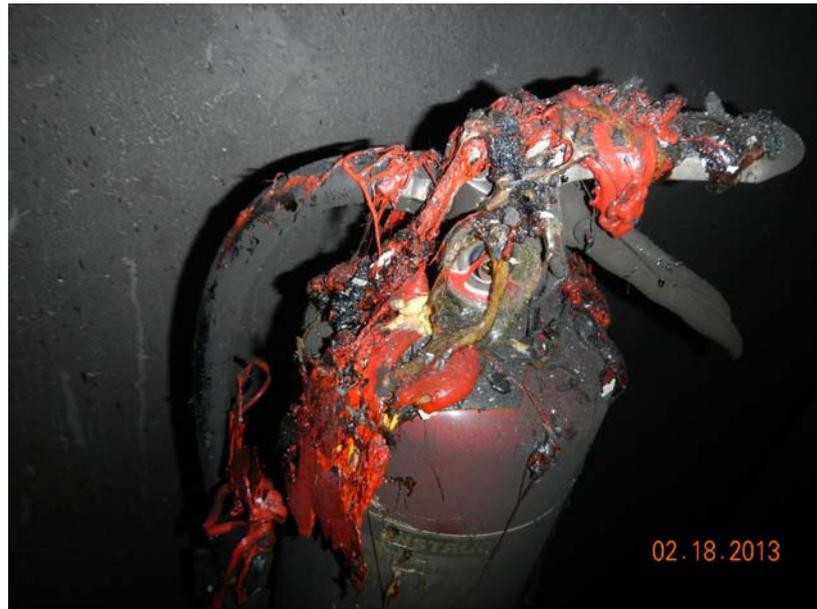
Fire alarm activation point melted onto fire extinguisher

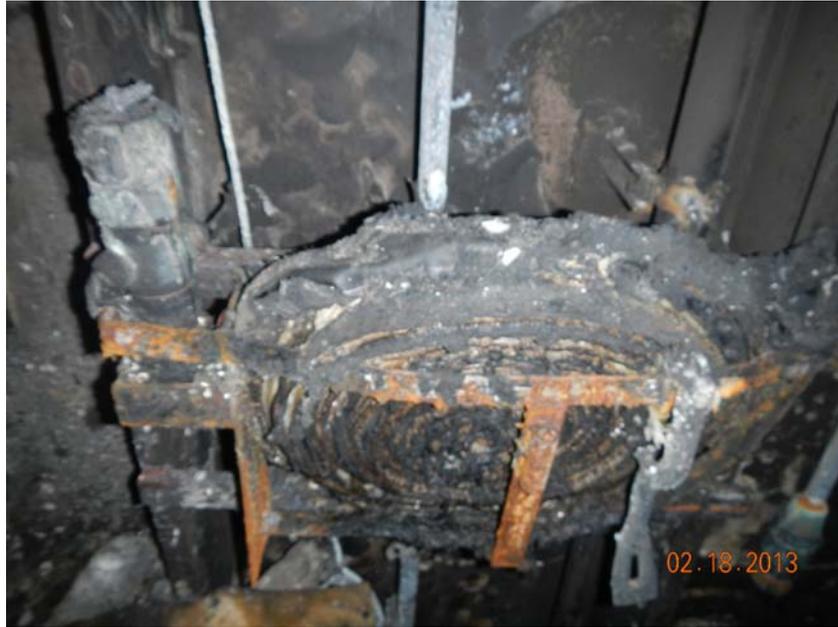
- 4.8 The fire hydrant valve at the fire station, located forward, and to the starboard, of diesel generator No.6, was noted to be newly installed and free of fire damage. It was reported that this valve had been replaced after the fire. Inspection of the original hydrant revealed that the diaphragm failed during the fire. As a result, the fire main continuously discharged water into the space, flooding the bilges.

Fire hose adjacent to Engine No.6

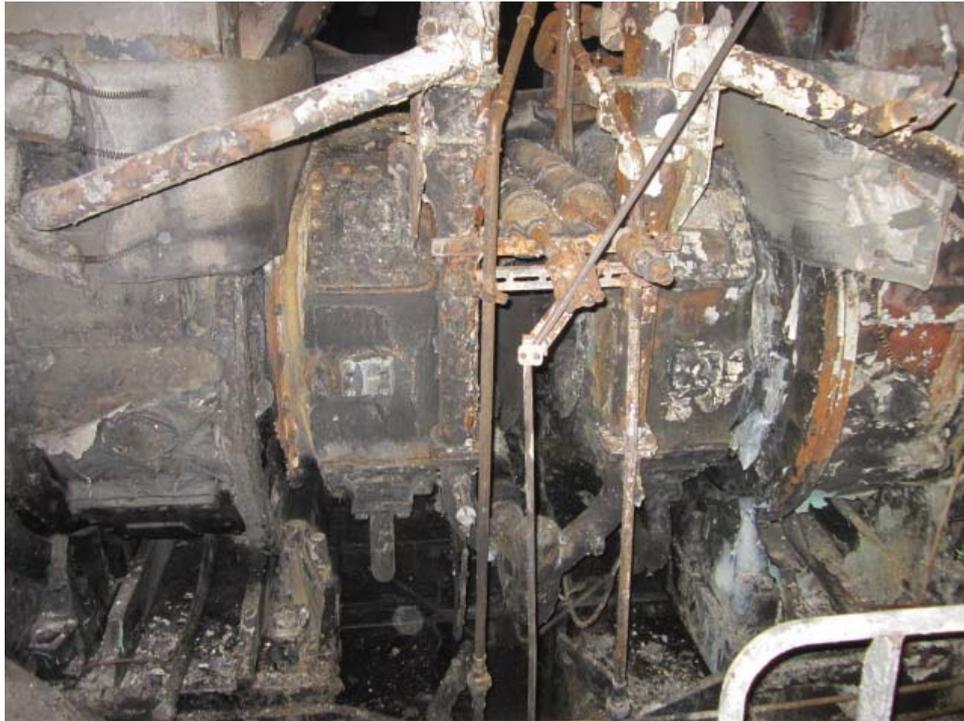
- 4.9 The forward end of diesel generator No.6, its turbochargers and exhaust manifold were examined for a source of ignition. Thermal insulating blankets were found saturated with an oily residue. These were carefully removed from between the two turbochargers, revealing the heat shield where the exhaust manifold splits to enter the inboard and outboard turbocharger. In the lower outboard corner of the heat shield, an area of approximately 250 mm² was found free of soot. This represented the hottest and closest area to the failed section of flexible pipe where the heat was sufficient to consume all combustible material and thus was considered the point of ignition.

Forward end of diesel generator No.6 between turbo chargers

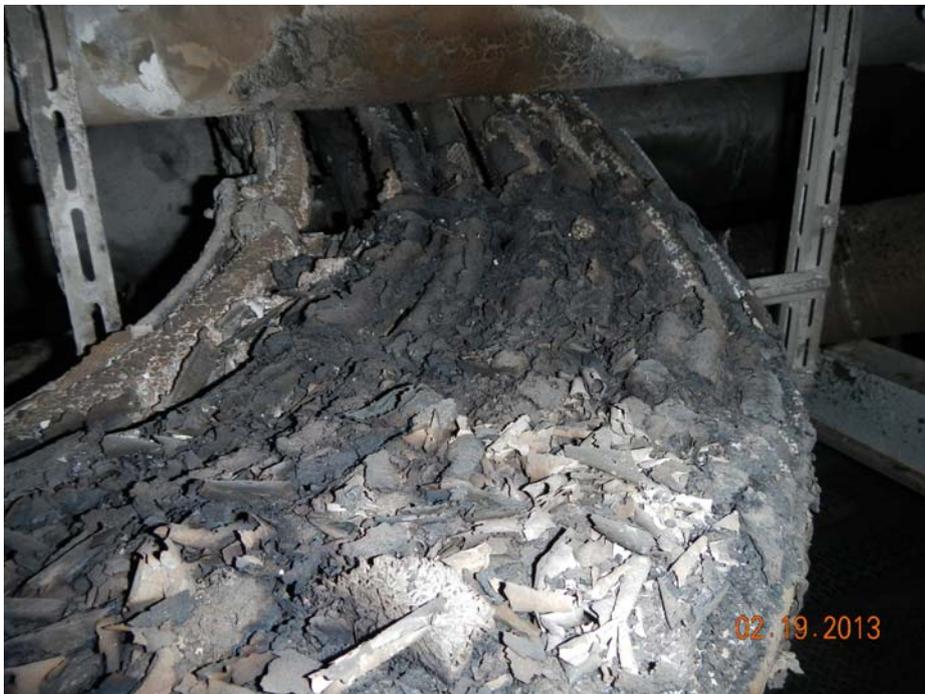
- 4.10 Equipment surrounding diesel generator No.6 was found with heat damage and a heavy accumulation of soot. The insulation for electrical cables in trays forward of the engine, along the starboard partition bulkhead, and above the turbochargers, was found with severe heat damage.

View of heat damaged electrical cables above diesel generator No.5 & No.6

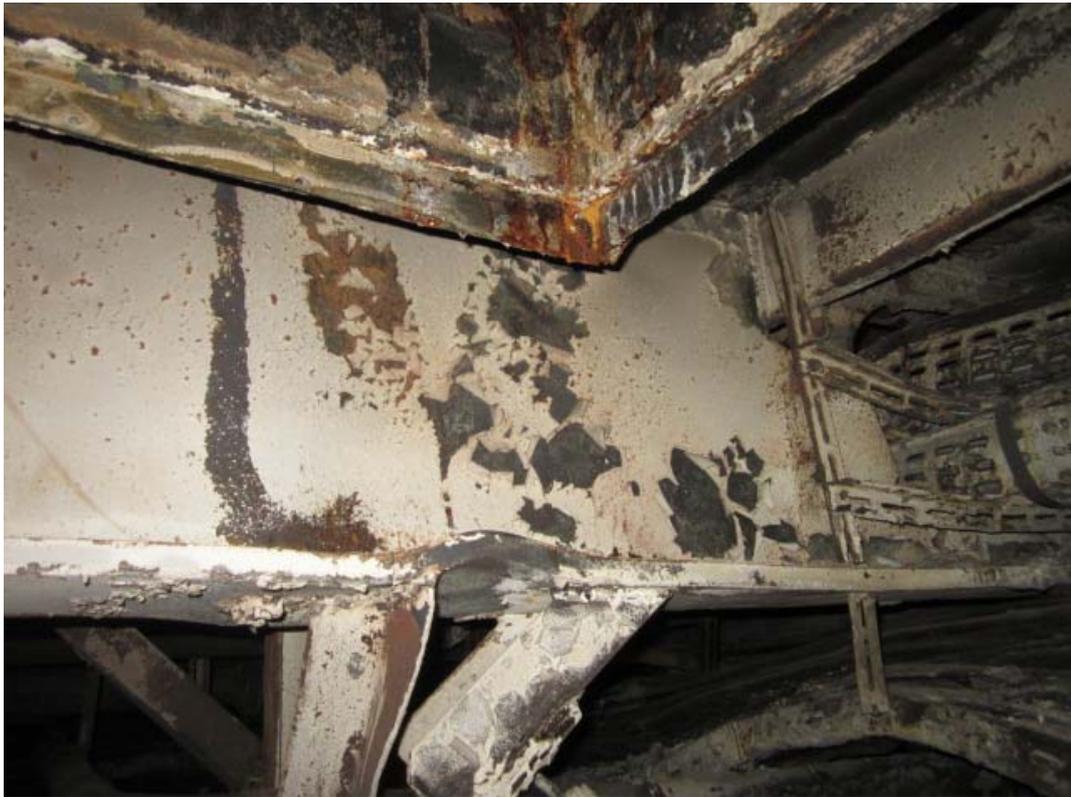
- 4.11 The overhead was examined and sections of the transverse under deck support beam at Frame 96 were found distorted 0-75mm at two (2) locations. Each of the areas found distorted were in way of the fixed points for the resilient fixtures, which supported the inboard and outboard ventilation trunks. In addition, the ventilation register immediately above the turbochargers for engine No.6 was found with the automatic fire dampers closed. Close examination revealed that some of the individual damper panels for this register appeared to have been bent and distorted from extreme heat.

Heat damaged overhead transverse beam in Aft Engine Room

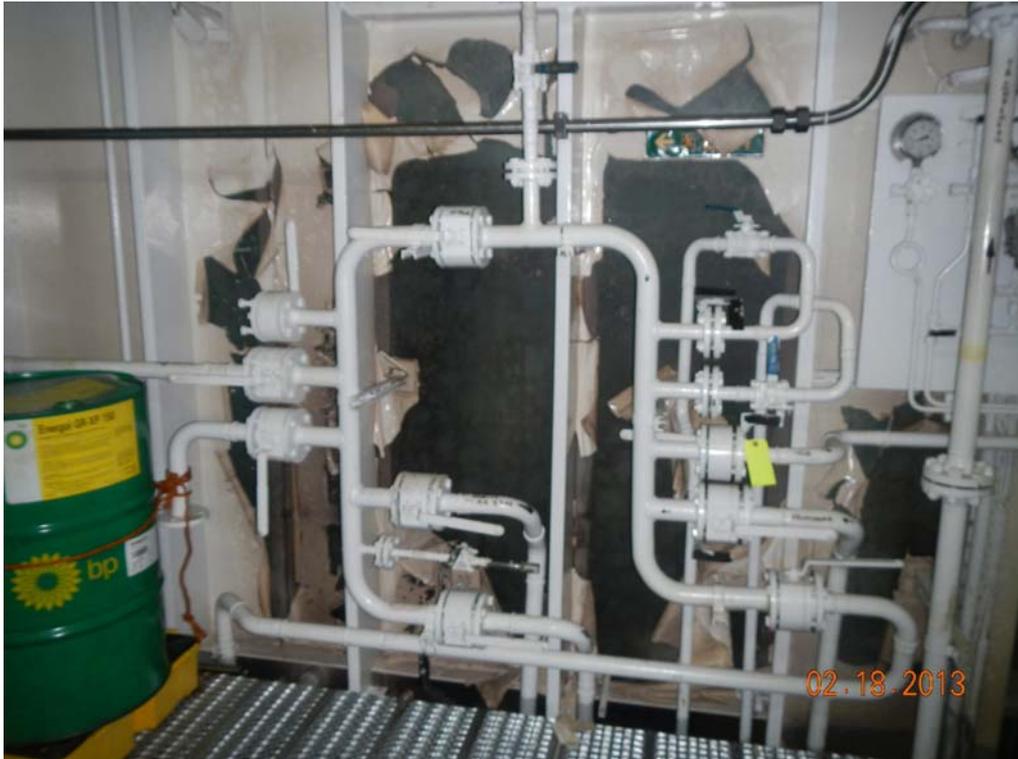
- 4.12 The spaces bordering the Aft Engine Room were examined. The bulkhead between the Forward and Aft Engine Rooms, Frame 100, has thermal insulating blankets installed. There was no evident heat damage to those blankets. The aft bulkhead of the Aft Engine Room borders the propulsion room at Frame 73. Heat damage resulted in the peeling of paint over a 9 m² area, approximately 16 metres off the centreline to starboard.

Heat damage to the forward bulkhead in the Propulsion Room

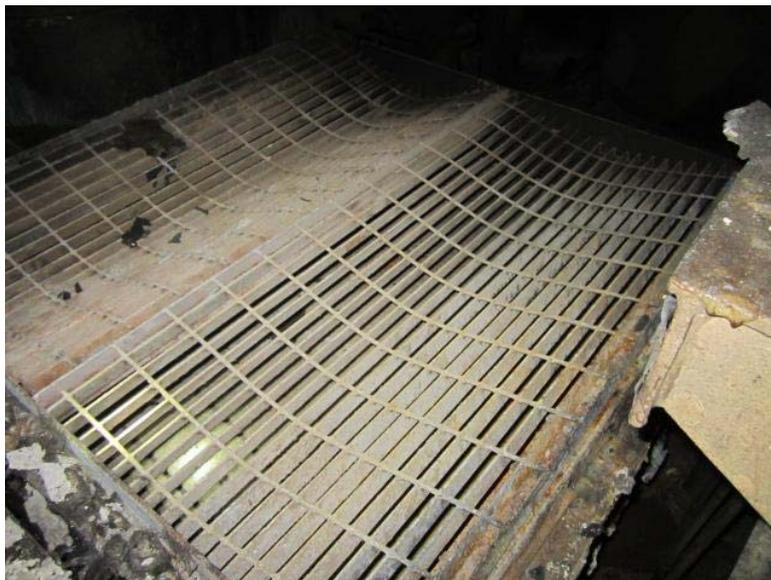
- 4.16 The sides of the ventilation register box, located between Frames 96 & 100, approximately 16 meters to starboard of the centreline was found severely distorted. Some of the individual panels of the fire dampers were also found bent and distorted. The actuators for fire dampers were distorted and the linkage was found detached. The bar grate cover was found set down and sagging between framed supports.
- 4.17 On Deck 0, there are two vertical trunks near Frame 100. These were found bent and distorted, with an inspection cover found lying on the deck. The cover was apparently blown off the trunk. An inspection of the trunking between decks 0 and 11 revealed that the two trunks were bent and distorted throughout. The segment flanges were found to be bent, and distorted. Flanges were separated at numerous locations throughout.

View of sagged grating covers

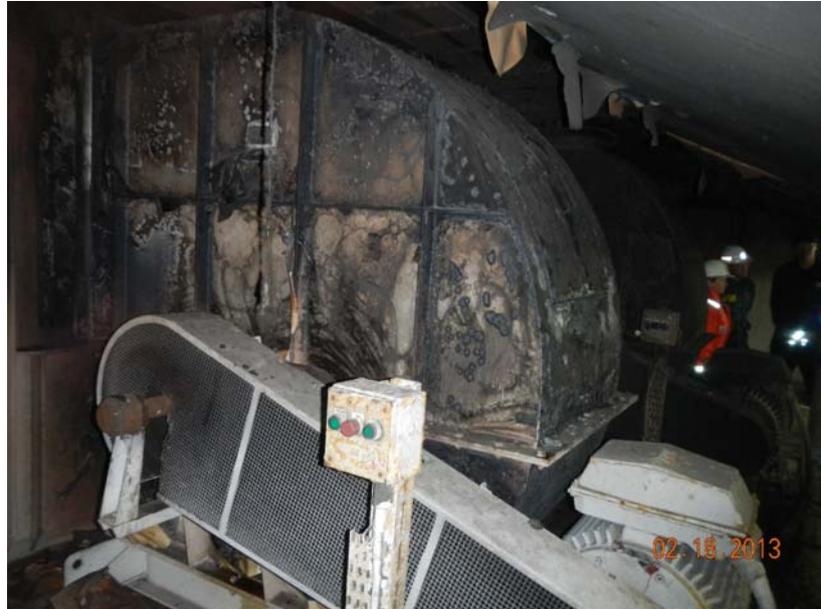
- 4.18 Within the Engine Casing, cables in trays, plastic light fixtures, phone stations, alarm indicating panels, fire detection head covers, and the Exhaust Gas Boiler control station on Deck 3 were found with heat damage. The heaviest soot accumulation was noted at Deck 5.

Heat damage to deck 11 ventilation fan

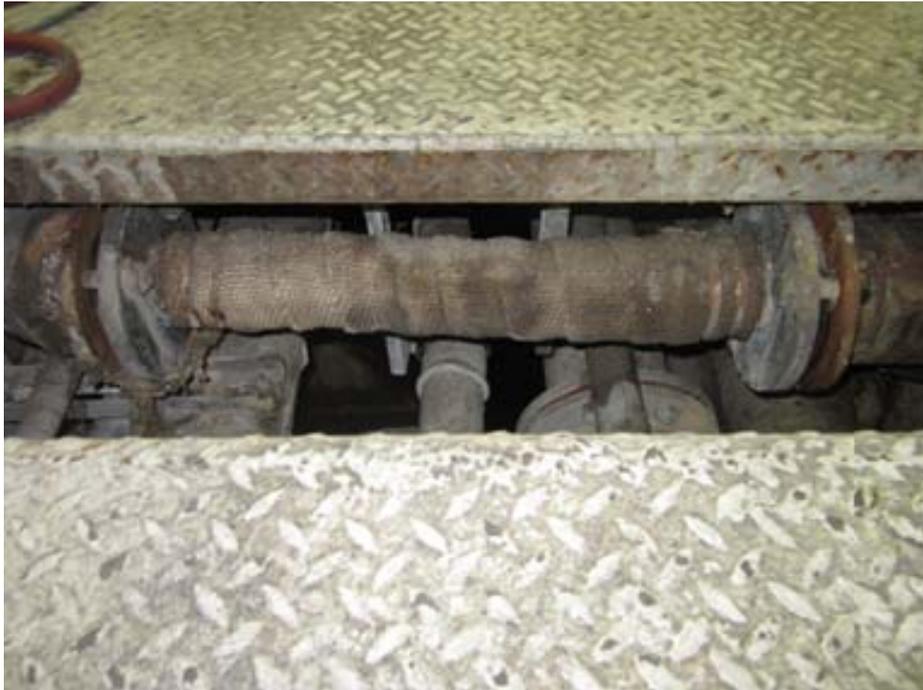
- diesel generator No.6 was found without a line guard on the return line. This section of pipe was found positioned under the deck plates.

View of the diesel generator No.4 fuel oil return line flexible pipe in position, located beneath engine room floor

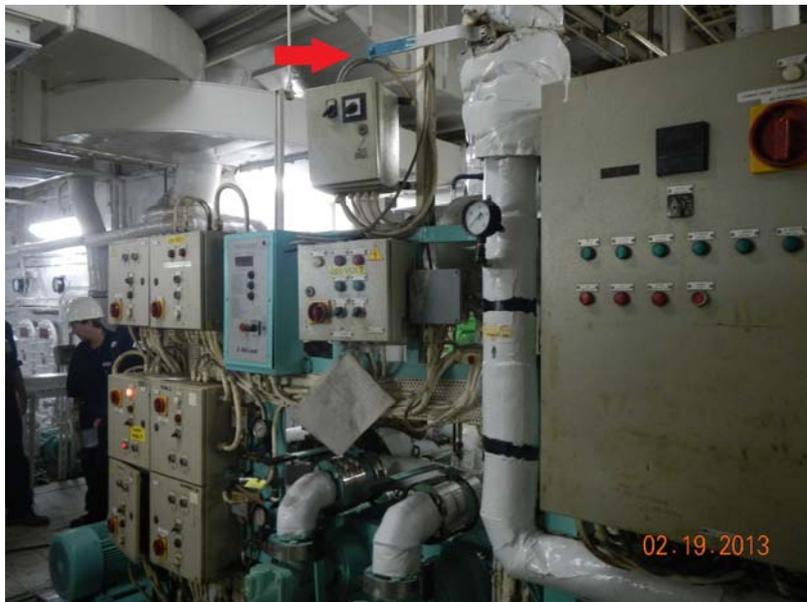
- 4.25 In the Fuel Oil Purifier Room the aft Viscochief fuel oil module discharge valve was found to have been manually closed. This would have stopped the flow of fuel oil to diesel generators Nos.4, 5 and 6.

View of the Viscochief unit for the Aft Engine Room showing the isolating valve (blue handle) closed.

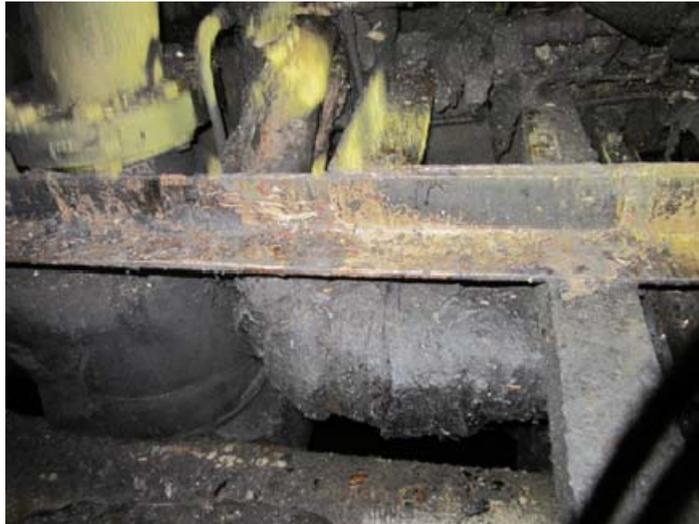
- 5.11 Inspections of flexible fuel pipes are scheduled at 6 month intervals and following change of policy, the flexible pipes are now replaced at 18 month intervals. The pipe which failed in this case was inspected at Mobile, Alabama post-casualty. The engine room floor plates were removed and the return line exposed. The pipe was found wrapped with thermal insulation which was removed to uncover the pipe.

Diesel generator No.6 fuel return line flexible pipe in-situ beneath floor plates, thermal insulation shown in place. The floor plates have been removed to afford access.

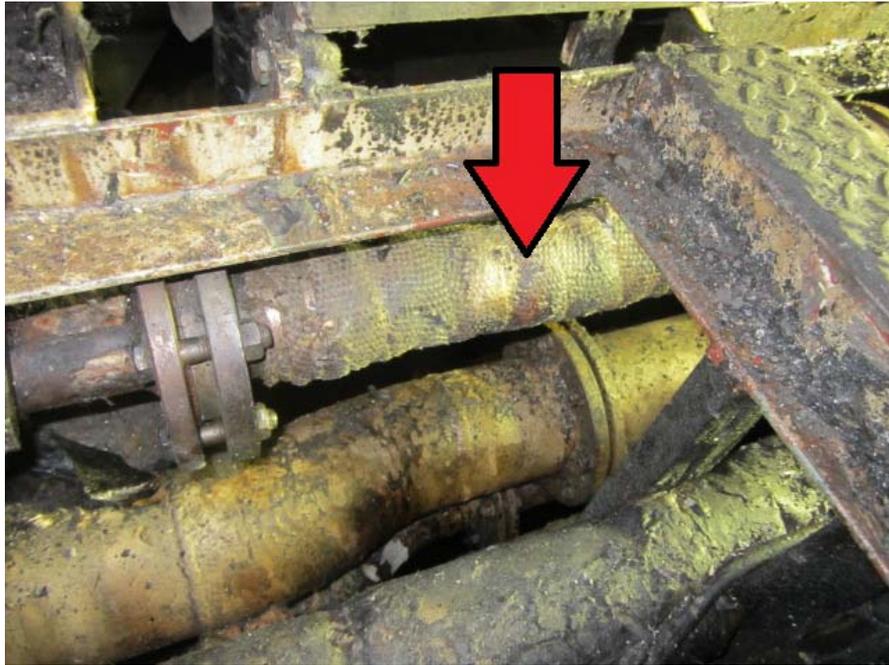
- 5.14 The pipe clamps and insulated cloth jacket were removed and the braided pipe was found to have a 25 mm diameter bubble extending out from the surface of the pipe approximately 15 mm. Viewed from either end flange into the pipe, light was clearly visible entering at the site of the bubble. Gaskets at both flanged connections to fixed piping were examined and found intact and in satisfactory condition.

Diesel generator No.6 fuel return line flexible pipe (uppermost in this photograph ↓) shown with the thermal insulation removed prior to disconnection.

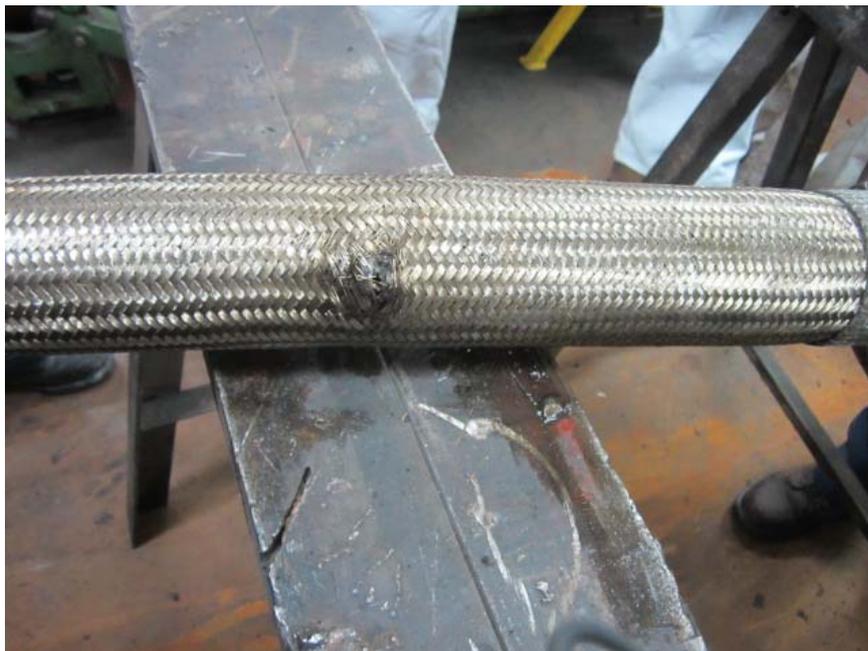
Diesel generator No.6 fuel oil return line flexible pipe shown with Jacket insulation removed to expose the pipe and apparent rupture.

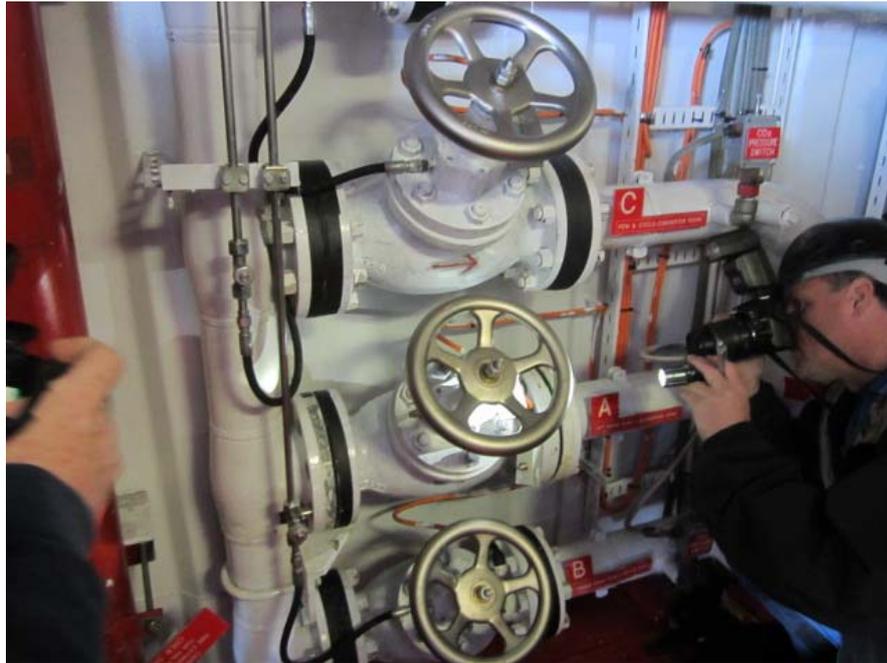
Main distribution manifold at the CO₂ room

- 5.28 Valve A, the distribution valve that would permit the flow of carbon dioxide from bottle banks 3, 4 and 5 to the Aft Engine Room is pictured above. This valve failed to open when the Chief Engineer operated the system from the remote station.
- 5.29 The indication from analysis of this valve is that the actuator had been pressed down onto a gasket inside the valve and there was insufficient clearance between actuator and gasket for the pilot cylinder nitrogen pressure to operate the actuator. An inspection of the valve by the manufacturers, DAB Engineering, indicated the root cause to be internal damage caused by an external force.

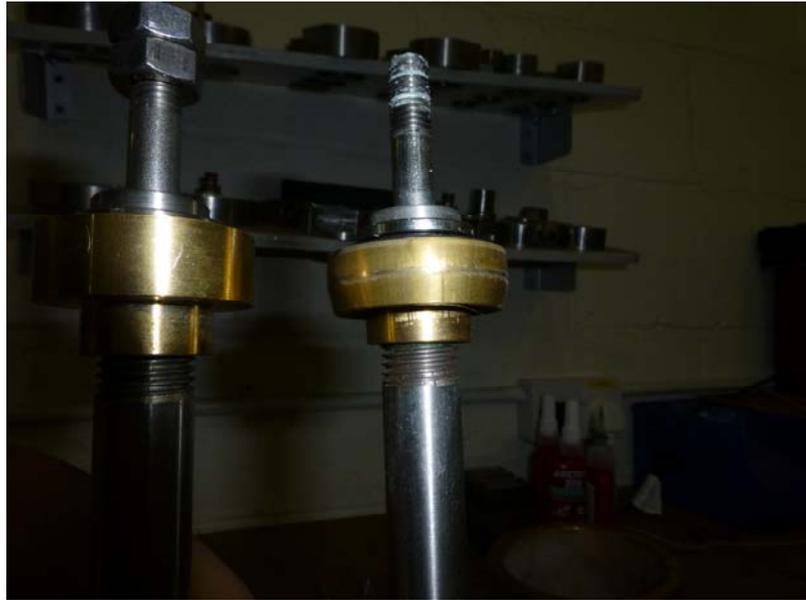
Pilot seat retainer from Carnival Triumph (right) in comparison with new (left). Note longitudinal compression and “barrelling”

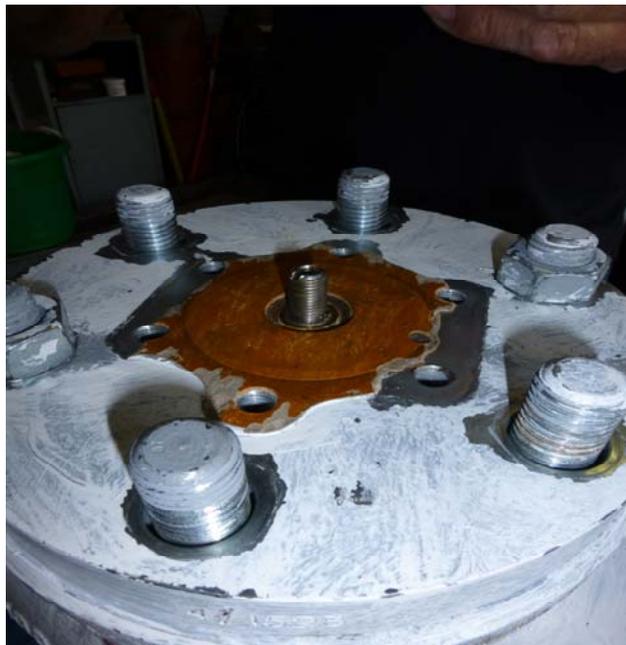
Gasket between pilot valve housing and valve body cover. Absent the damage found in the valve removed from Carnival Triumph a small clearance exists between the surfaces of the gasket and pilot valve.

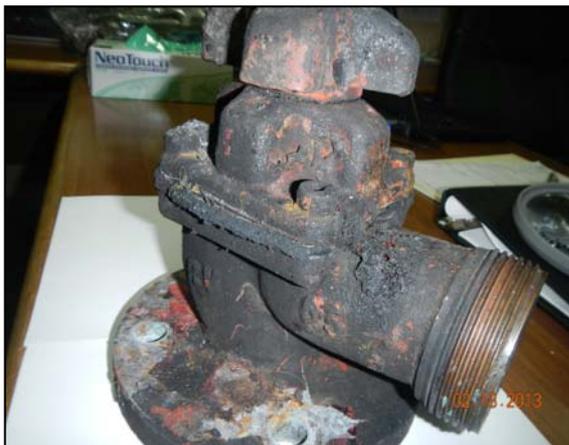
- 5.32 The forward starboard hydrant on the fire main in the Aft Engine Room centre section, adjacent to the forward end of engine No.6 failed during the fire.
- 5.33 The hydrant was subsequently disassembled at Lucius Pitkin laboratory in New York where the internal diaphragm was found to have failed during the fire.

Fire hydrant removed from Aft Engine Room, found leaking post fire.

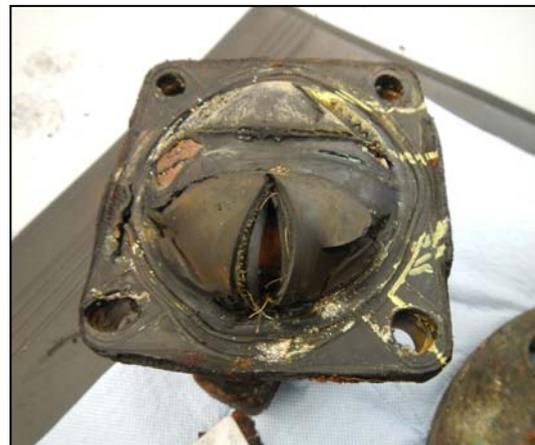
Fire hydrant diaphragm removed for investigation
