**Report of the investigation into
the engine room fire
onboard the *MV. Laurentian*
at sea on
11 October 2001**

Date of Issue : 23 April 2002

Bahamas Maritime Authority
Latham House
16 Minories
LONDON
EC3N 1EH
United Kingdom

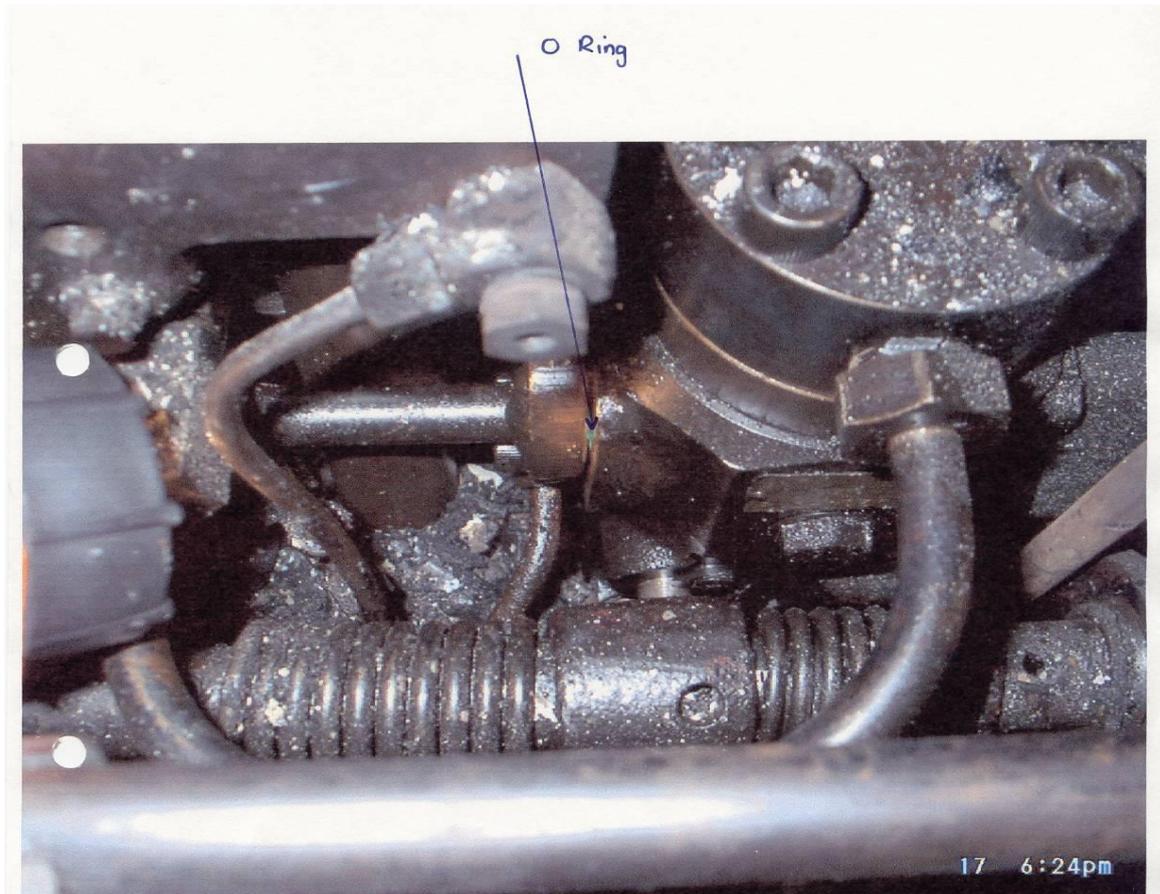
Photo 1 No 8 Cylinder fuel pump

- 5.2 The primary fire was caused by the fuel leakage due to the failure of the 'O' ring on No 8 high pressure fuel pump suction flange which allowed fuel at 8 bar pressure to spray out below the fuel pump cover and impinge on the exhaust manifold in way of the turbo charger. The 'O' ring failed due to the top retaining "Allan" screw vibrating loose which eased the pressure on the flange allowing 'O' ring to blow out.

- 5.3 Although the fire was knocked down, fuel to the engine could not be isolated due to the intense heat in the location of the shut off valve. This allowed the leakage at No.8 fuel pump to continue. The fuel return line was isolated, but the fuel supply line isolating valve could not be shut. Therefore fuel leakage continued, re-igniting and causing a secondary fire. The secondary fire was fuelled with further oxygen from the main air receiver relief valve which resulted in the fire ball.

- 6.1 Replace fuel line retaining “Allan” screws in way of HP fuel pump suctions on all 4 main engines
- 6.2 Fit fuel pump covers with sealing strips in way of the cylinder head cover landing face.
- 6.3 Fit independent remote shut off valves to each main engine to allow individual engine remote fuel isolation.
- 6.4 Investigate the cause of vibration in No.1 main engine fuel system and rectify.
- 6.5 Review and apply the requirements of SOLAS 2001 Chapter II-2 Regulation 15. 2.7 – 2.12.
- 6.6 Fit a sheet steel guard between No. 8 cylinder and the turbo charger of each engine.

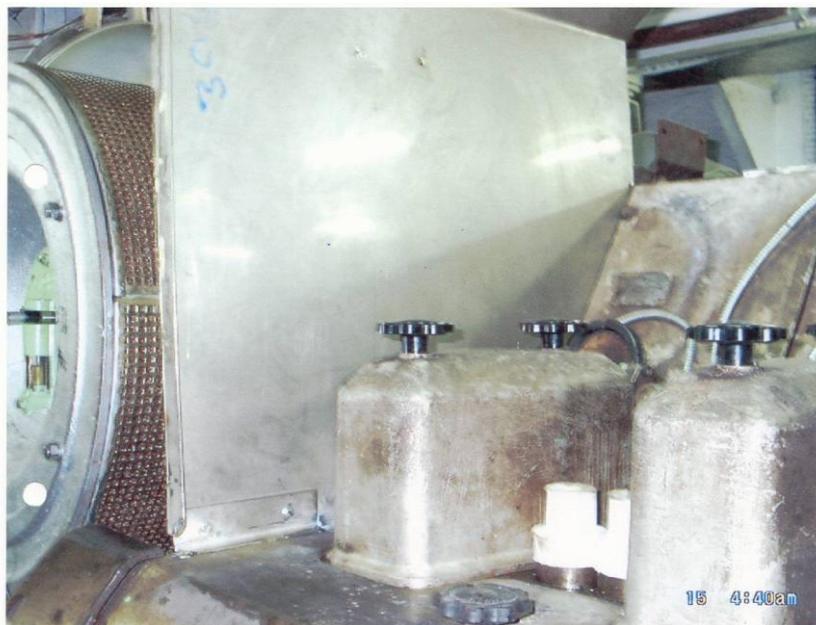
Photo 2 Guard retro fitted between No. 8 cylinder and turbo charger on each engine

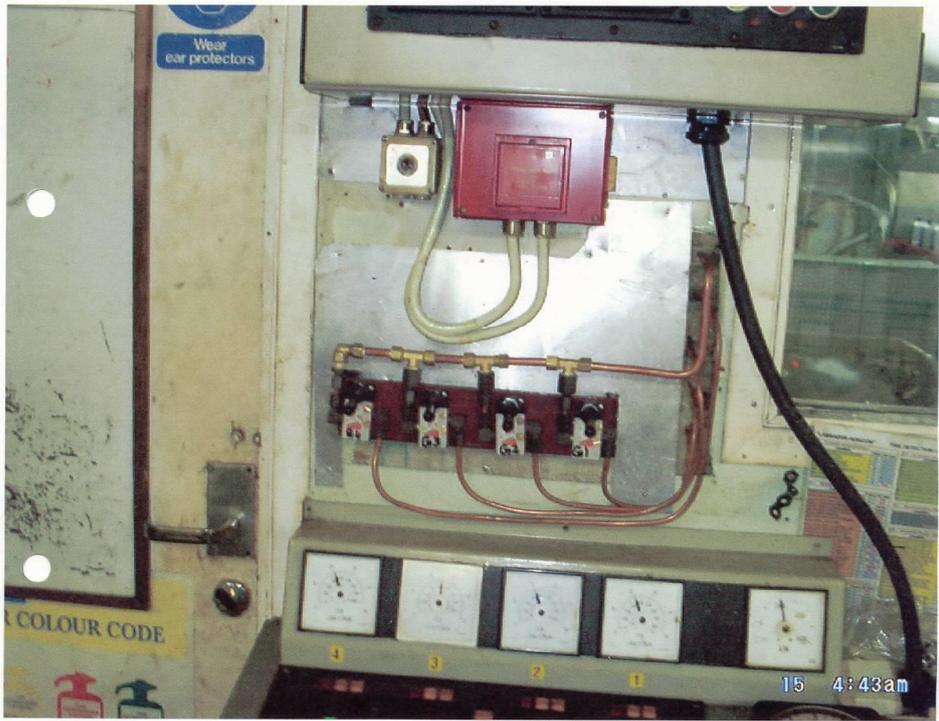
Photo 3. Quick closing valve operating station in MCR

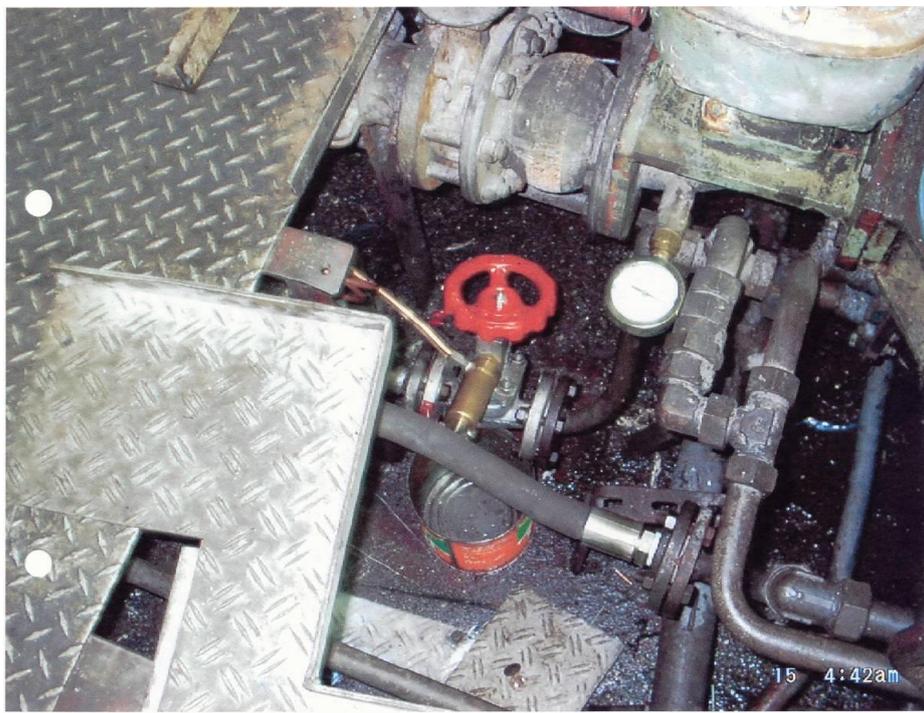
Photo 4. New fuel oil quick closing valves fitted on each main engine
