**Report of the investigation into  
the engine room  
fire onboard the *M.V. Nariva*  
at sea on  
14 August 2001**

Date of Issue : 14 January 2002

Bahamas Maritime Authority  
Latham House  
16 Minories  
LONDON  
EC3N 1EH  
United Kingdom

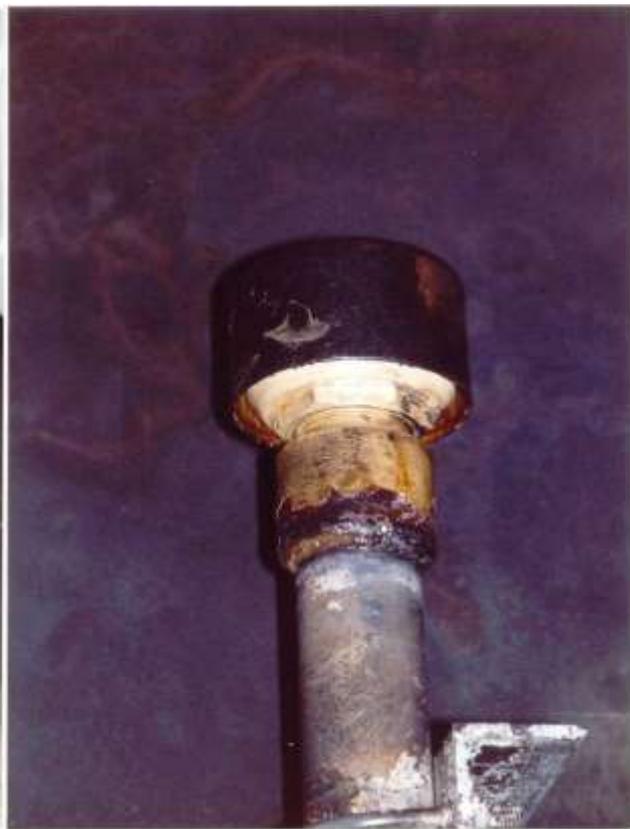
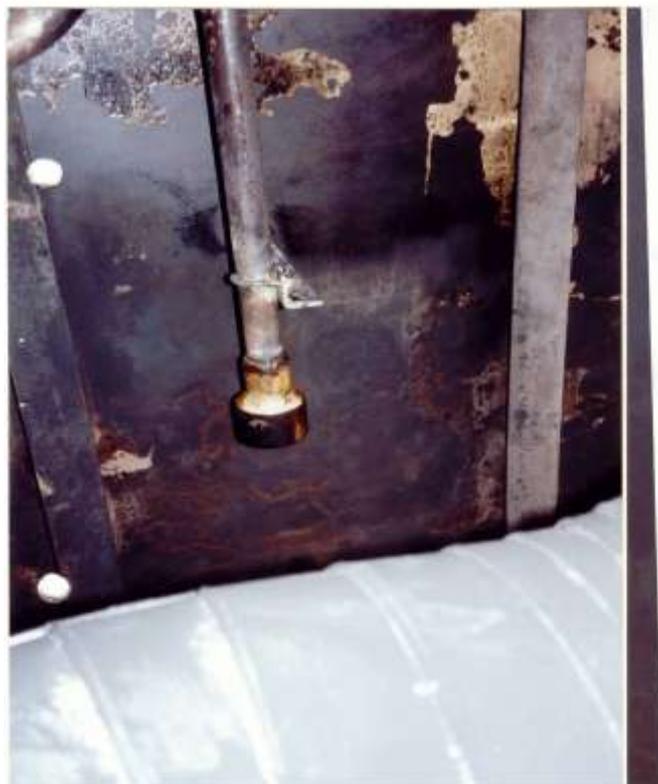
- 4.2 Whilst draining the deck line the reservoir/expansion tank drain valve was open to the engine room storage tank and oil was also returning through the overflow pipe to the storage tank. The reservoir/expansion tank vent pipe ran from the storage tank at the bottom of the engine room to an open ended pipe with a vent breather at the top of the engine room just below the funnel deck level and above the main engine exhaust in way of the turbo charger.

- 4.4 Due to the top of the vent pipe being lower than the forward part of the deck line due to the stern trim and the vent pipe being of a larger diameter than both the drain and overflow lines, it would appear that the oil returning from the deck was forced up the vent pipe. The location of the vent, above the main engine exhaust turbo charger, directed any overflow to fall directly on to it where it ignited.

- 5.3 The fact that the vent pipe was positioned too low was a design fault which did not take account of the stern trim of the vessel allowing the vent pipe to become lower than the forward sections of the hydraulic pipe.

Photos 1 & 2. Deck hydraulic system reservoir tank vent pipe in upper part of engine room

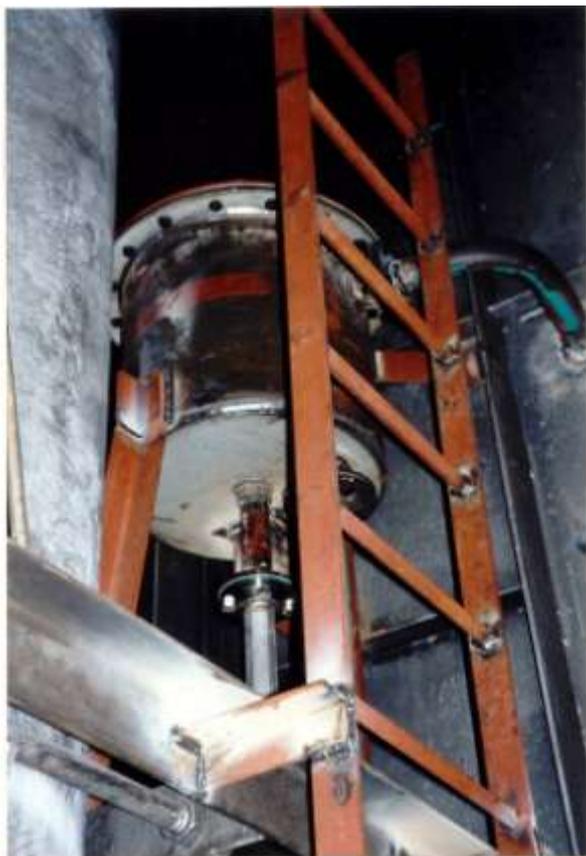
Photo. 3 New collection tank for deck hydraulic system reservoir tank vent pipe.

6.1 The position of the vent pipe should be routed up into the starboard side of the funnel and fitted with a collection tank. A drain pipe of greater diameter than the vent pipe should be led from this tank to the engine room oily bilge. In addition a vent from the top of the collection tank should lead straight out through the side of the funnel so in the unlikely event of the collection tank becoming full oil would not flow into the top of the engine room.

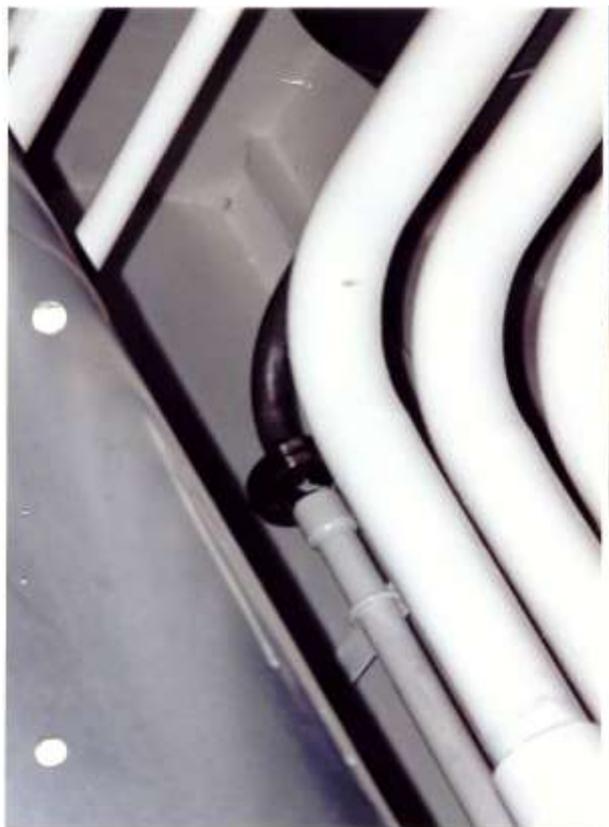
Photo. 4 Deck hydraulic system reservoir tank vent pipe extended up into funnel.

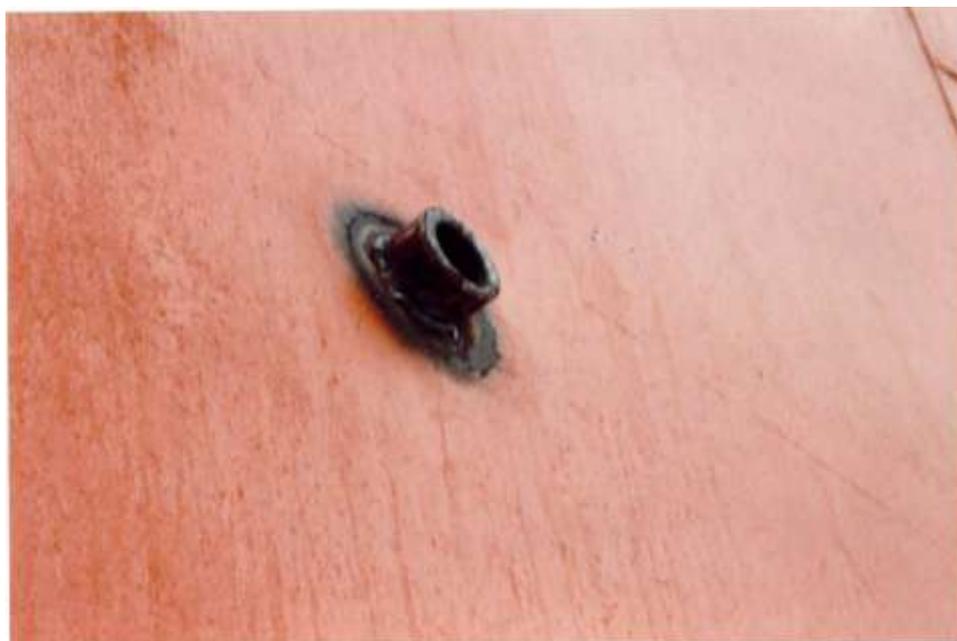
Photo.5 Deck hydraulic reservoir tank vent pipe collection tank vent through side of funnel.
