Bahamas Maritime Authority

Report of the investigation into the constructive total loss of the Bahamas registered chemical tanker "Panam Serena" at the port of Porto Torres in Sardinia, Italy on 01 January 2004

Date of Issue: April 2006

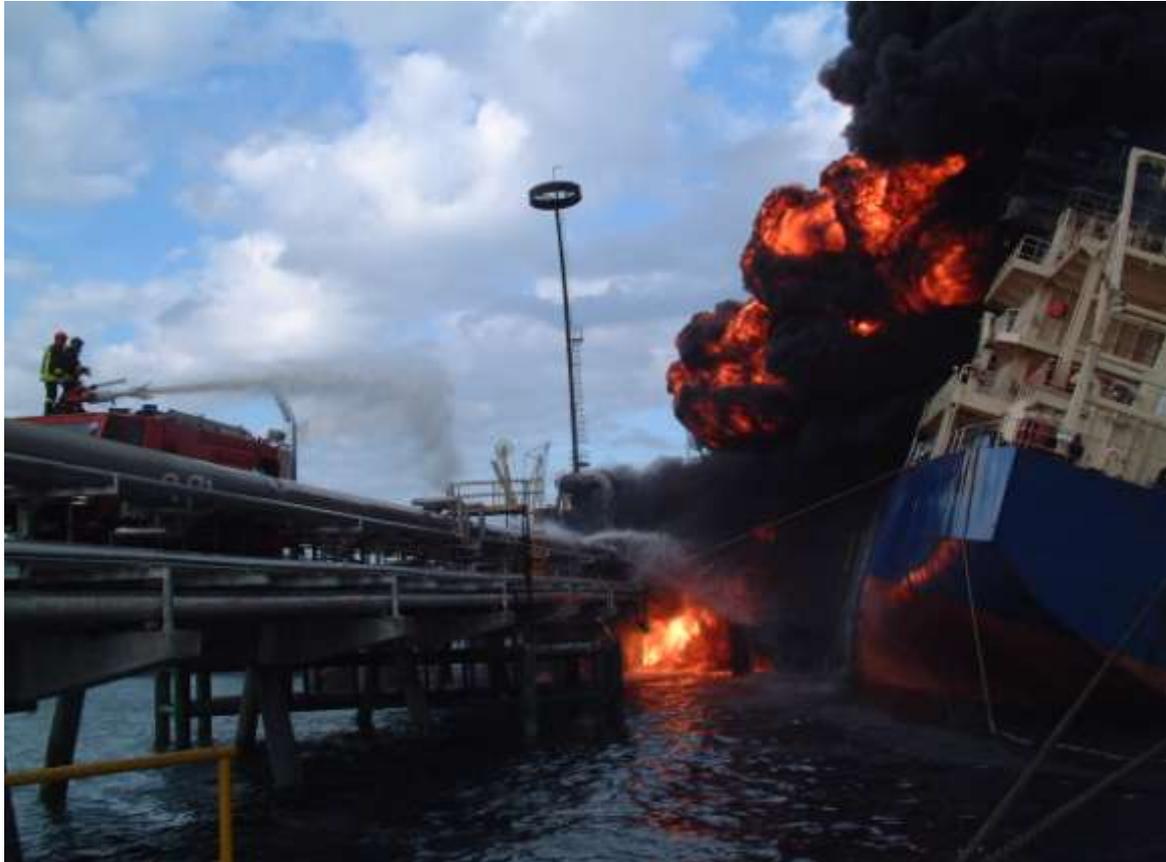
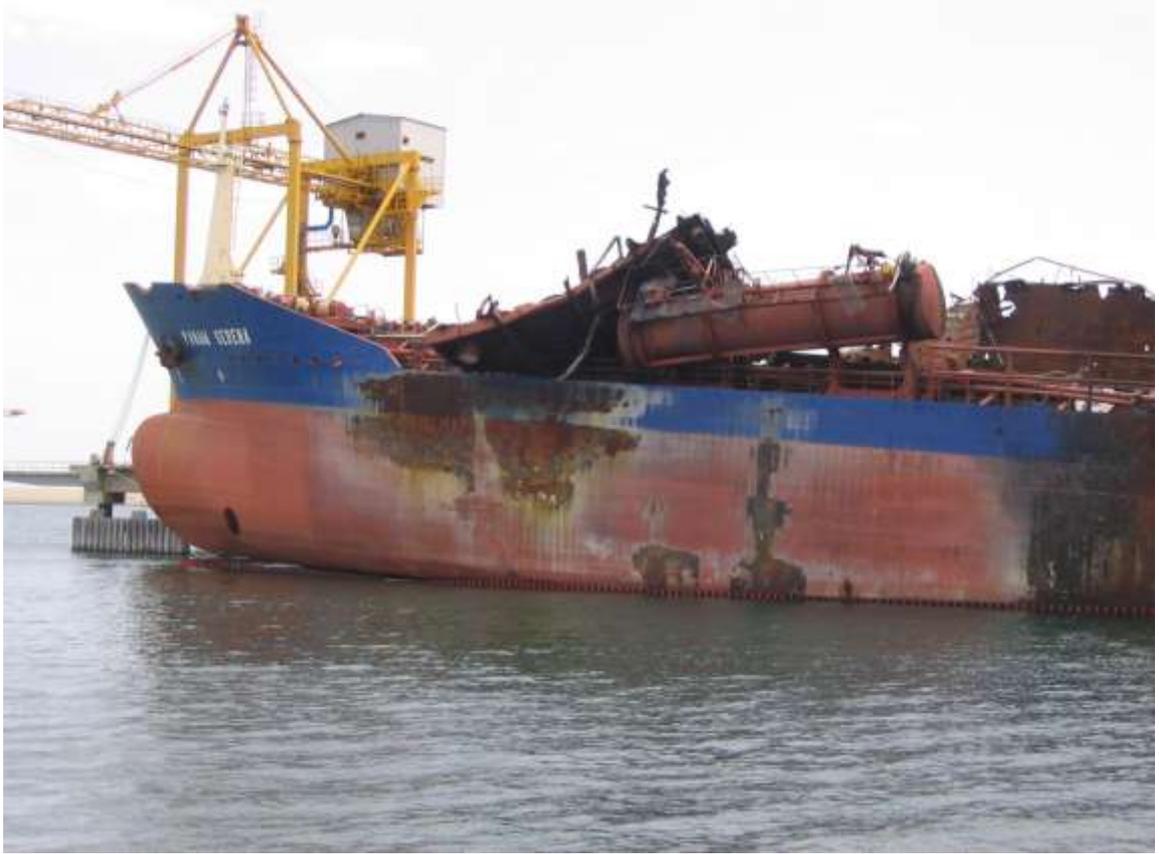
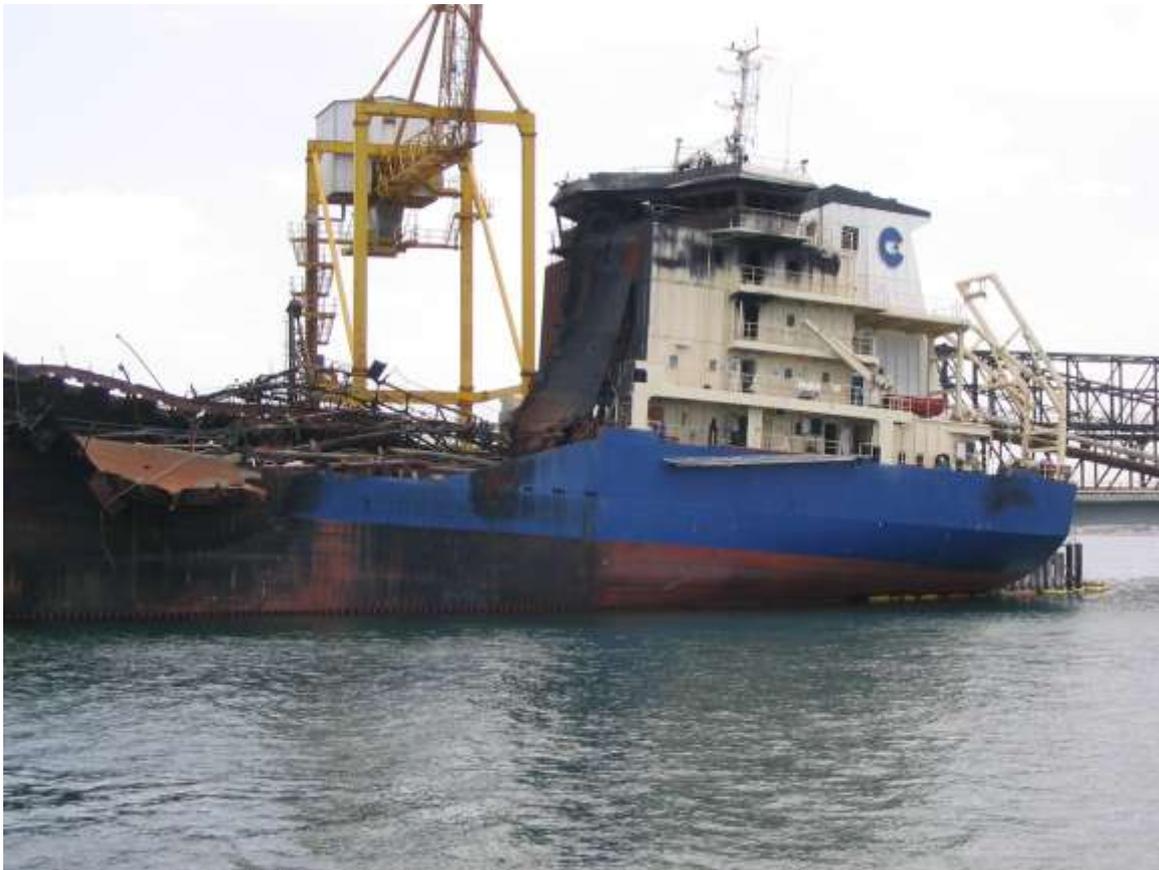
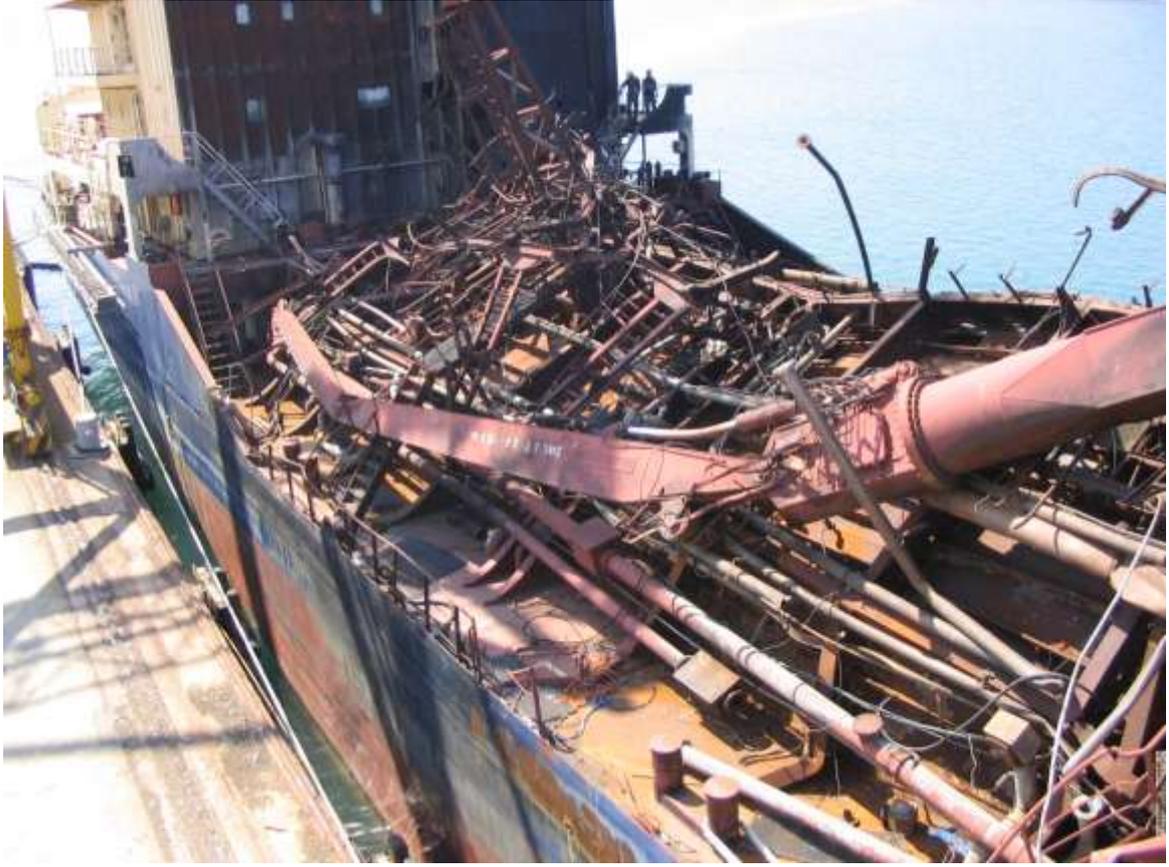
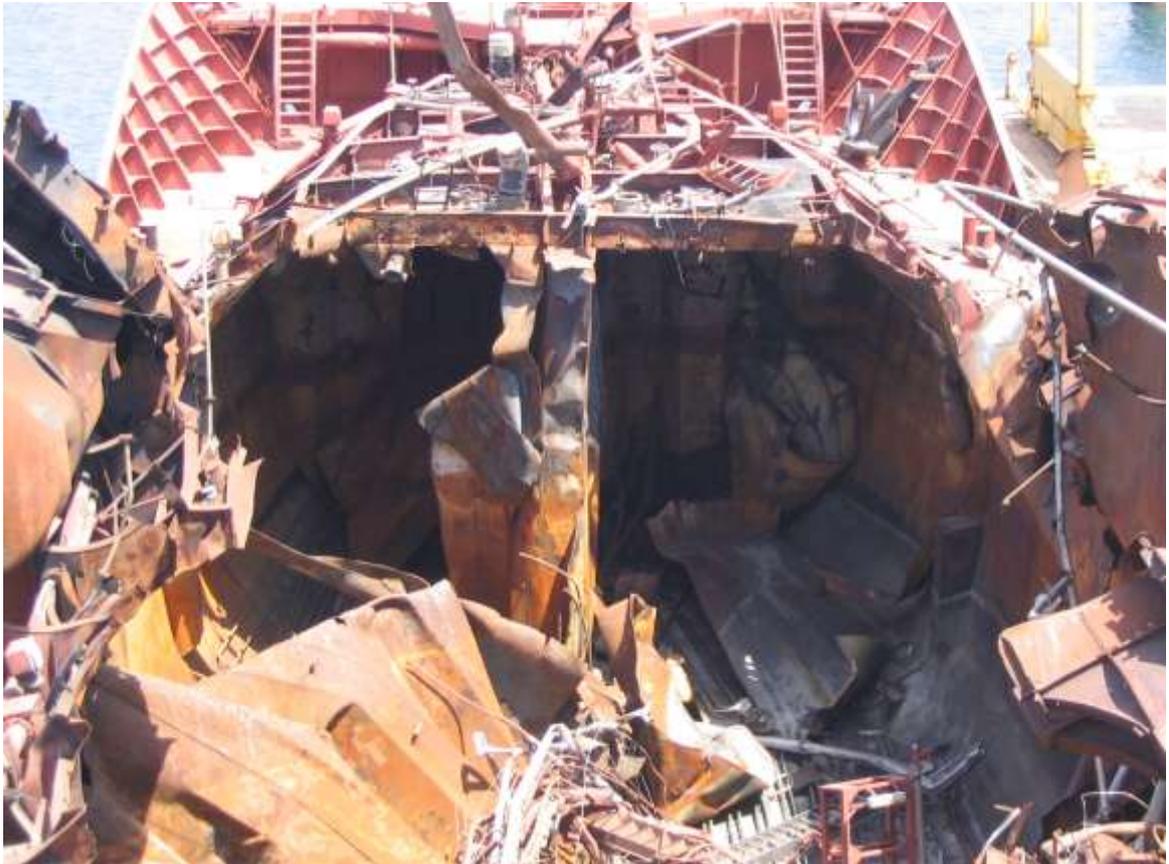
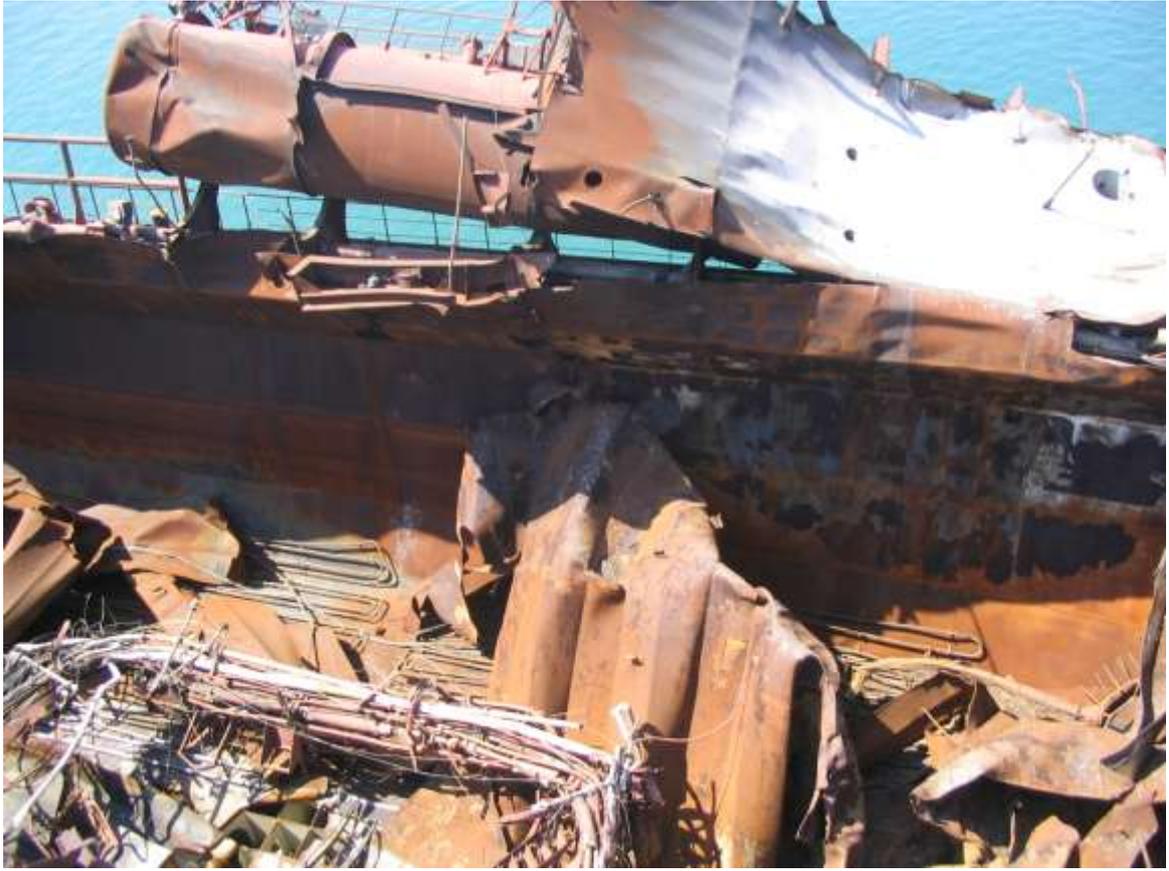
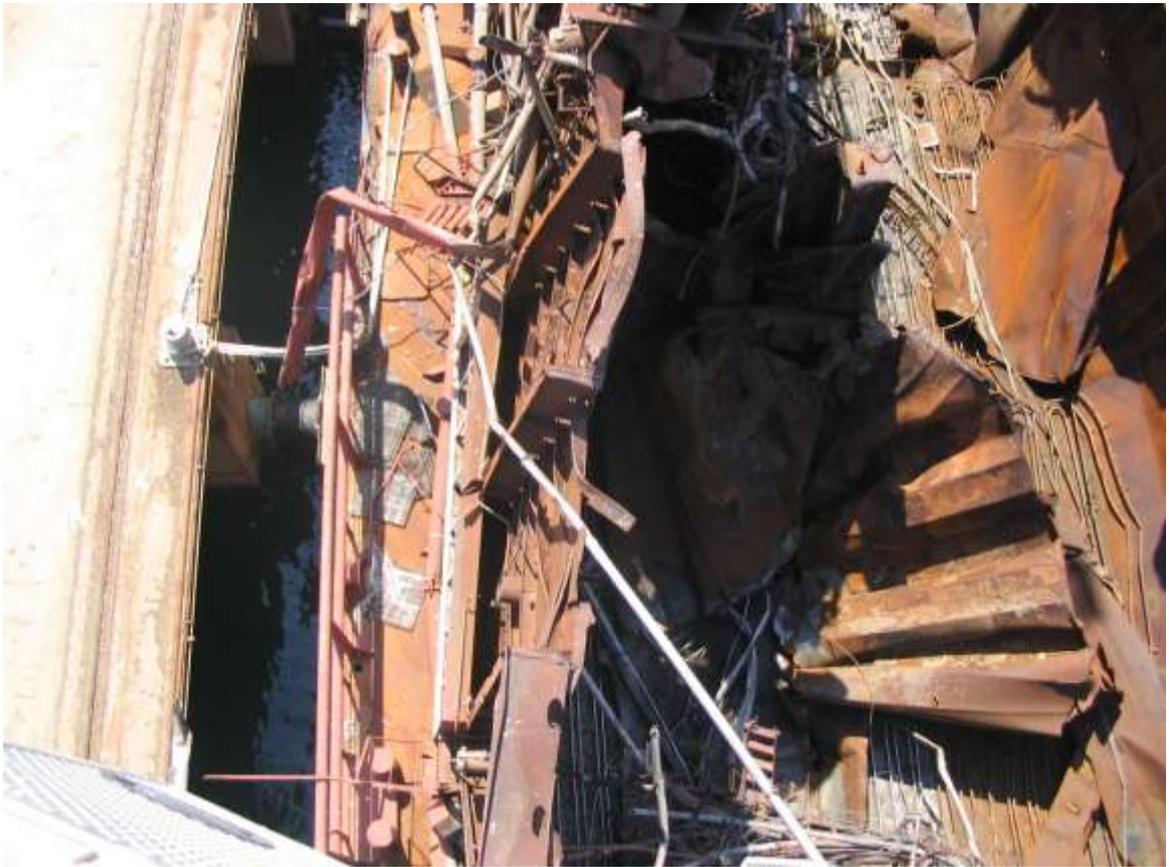
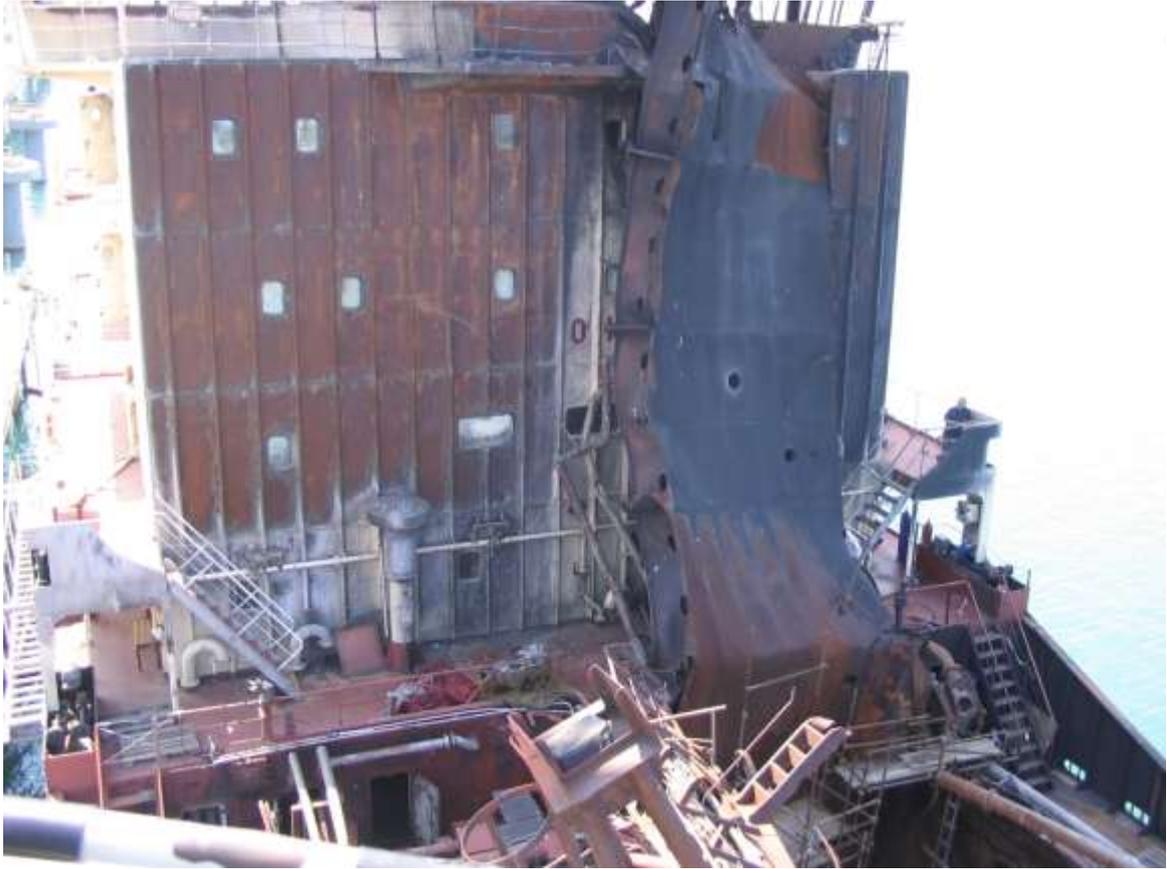
- 3.22 The damage;** caused on board the "Panam Serena" by the explosions and subsequent fire, particularly within the main deck and cargo tank area of the ship was catastrophic. The selection of photographs attached to this report demonstrates the difficulties which have hampered investigators trying to determine the initial cause and location of the first explosion.

4.12 The analysis of the damage; the series of photographs attached to the report are a selection of the many available and only indicative of the massive damage caused to the vessel following the series of violent explosions. From the damaged caused it has been determined that a series of explosions took place inside the cargo tanks. It has not been possible to determine the *exact* source of the initial explosion.

Photographs of the "Panam Serena" on fire following the series of explosions on the 01 January 2004 and the subsequent, catastrophic damage to the vessel:-

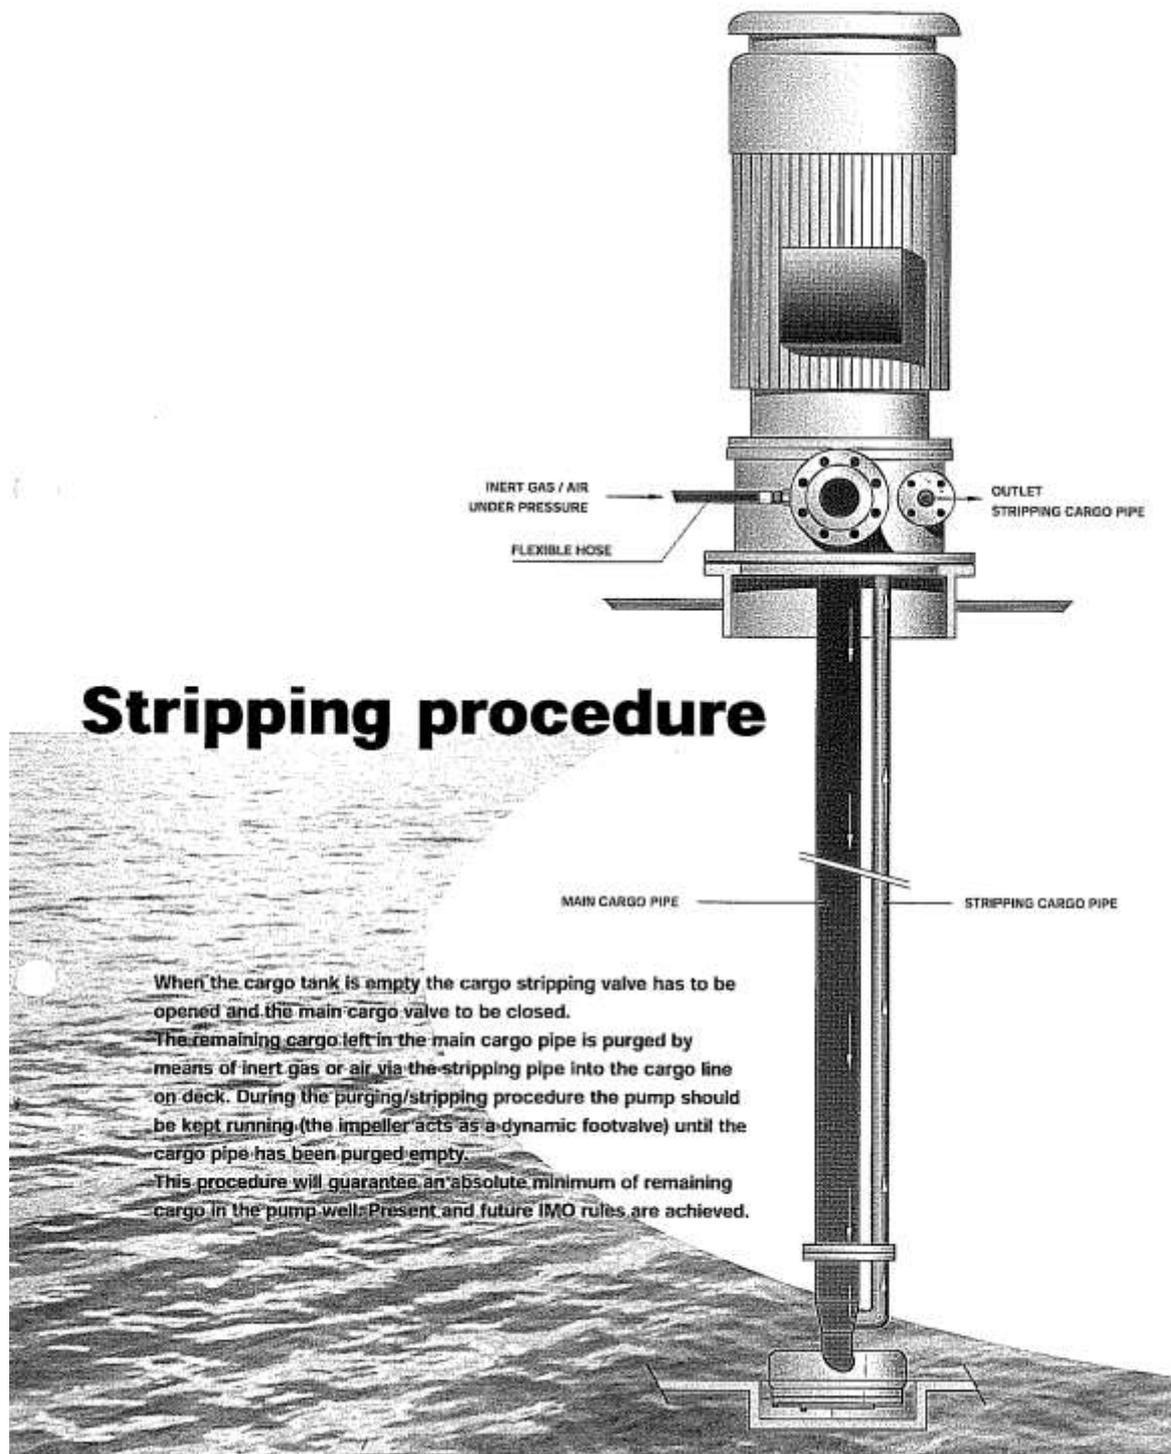
MarFlex deep-well pump diagram:-

- 4.13 Further investigative work** is still required to establish if there was a problem with one of the deepwell cargo pumps. There was some evidence to suggest that this may have been the case, however the overwhelming evidence within the witness statements, with respect to the location of the initial explosion and fire is not consistent with the theory that a cargo pump problem caused the initial explosion.
