Bahamas Maritime Authority

**Report of the investigation into
fire in the generator room of the
Bahamian registered passenger
vessel "Seven Seas Navigator
on 17 January 2005**

Date of Issue : 12 February 2007

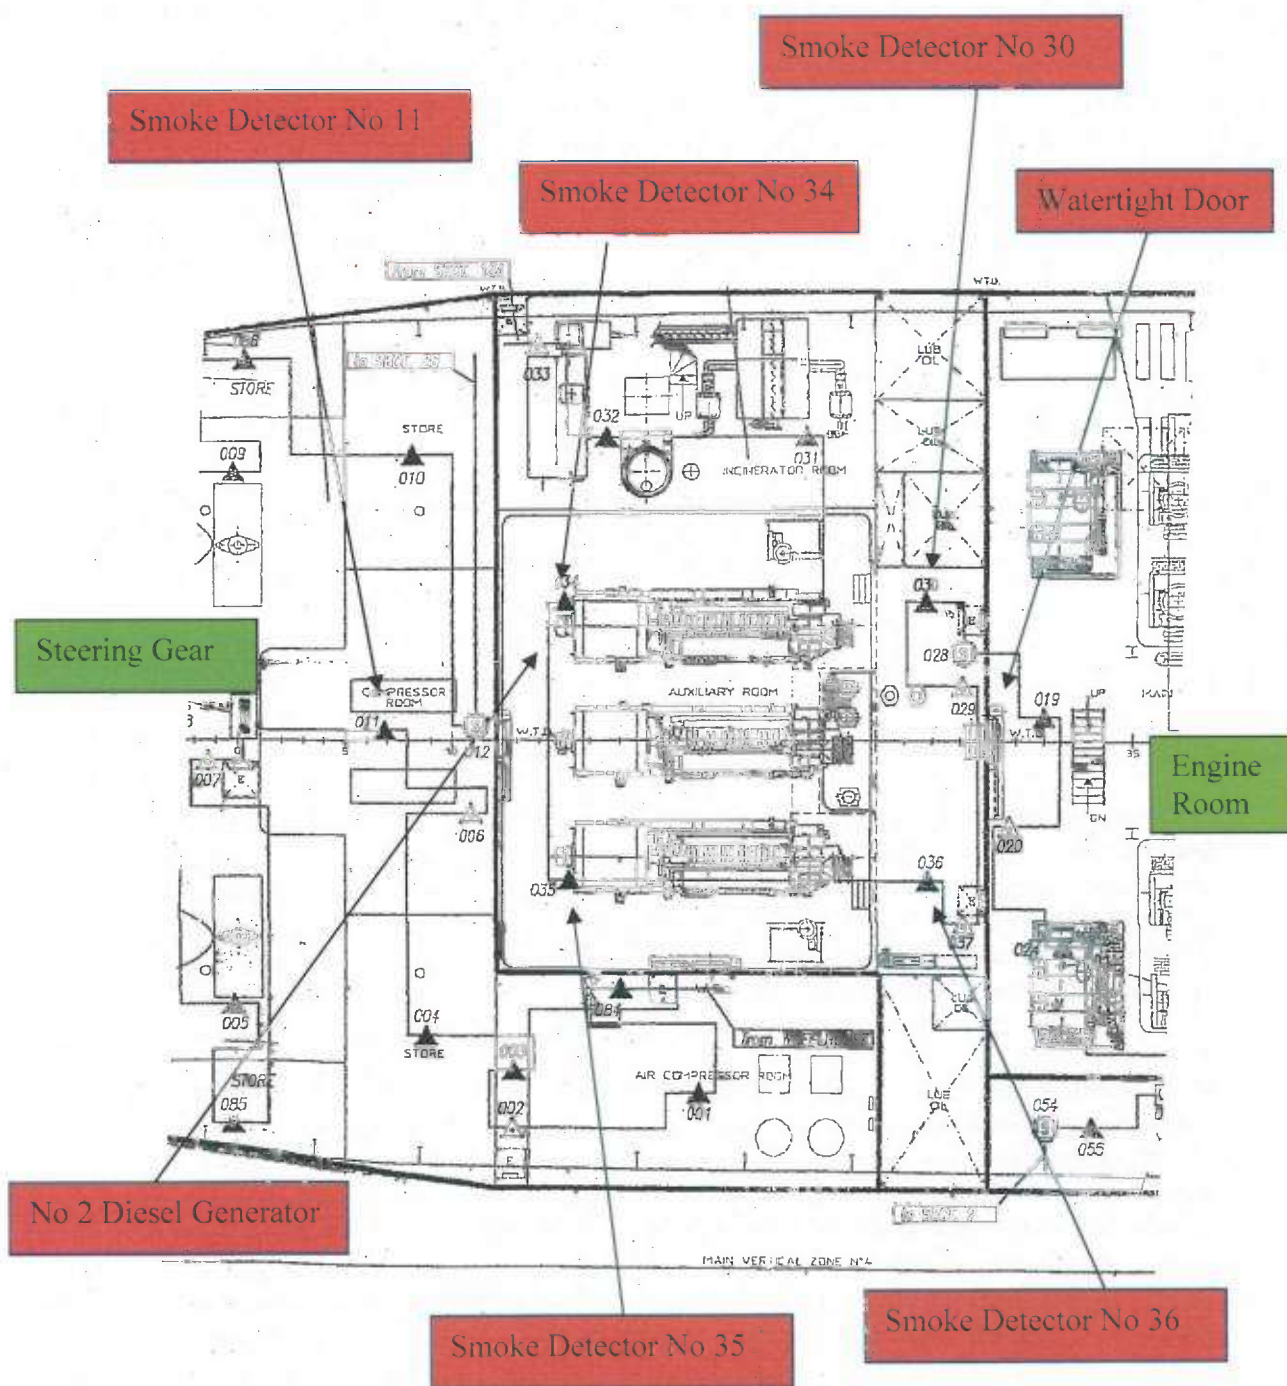
Fig 1 Plan of Diesel Generator Room showing location of fire detectors and watertight door

Table 1 Smoke Detector Activation		
Smoke Detector Number	Time of activation	Location
30	05h 58m 52	Diesel Generator Port Side Forward
34	05h 59m 04s	Diesel Generator Port Side Aft
36	05h 59m 34s	Diesel Generator Starboard Side Forward
35	06h 00m 45s	Diesel Generator Starboard Side Aft
11	06h 00m 50s	Compressor Room Midships
9	06h 01m 22s	Steering Gear Port Side
8	06h 02m 37s	Steering Gear Midships
5	06h 02m 41s	Steering Gear Starboard Side

The location of the smoke detectors is shown in Fig 1.

- 4.4 The arrangement of the mechanical ventilation in the Diesel Generator compartment caused a flow diagonally across the space from starboard forward to port aft, and similarly in the Compressor Room and Steering Gear compartments immediately astern. As smoke would be carried in the ventilation flow, it would be expected that No 34 Smoke Detector would have been activated before No 30. The smoke detectors in the Compressor Room and Steering Gear compartment were activated in accordance with a flow of smoke from starboard forward to port aft.

- 4.5 During the investigation all of these smoke detectors were tested and found to be functioning normally. The sensitivity of detector No 34 was however lower than the others. This is considered to have resulted from a build up of desensitizing oily and carbonaceous deposits emitted from the diesel generator engines during normal operation, with a higher deposit on detector No 34 arising from the natural ventilation flow across the space. The order in which the smoke detectors were activated is therefore consistent with the fire originating in or above No 2 Generator, as indicated by the pattern of damage in the compartment, and further suggests that the fire was well established before smoke detector No 30 was activated.

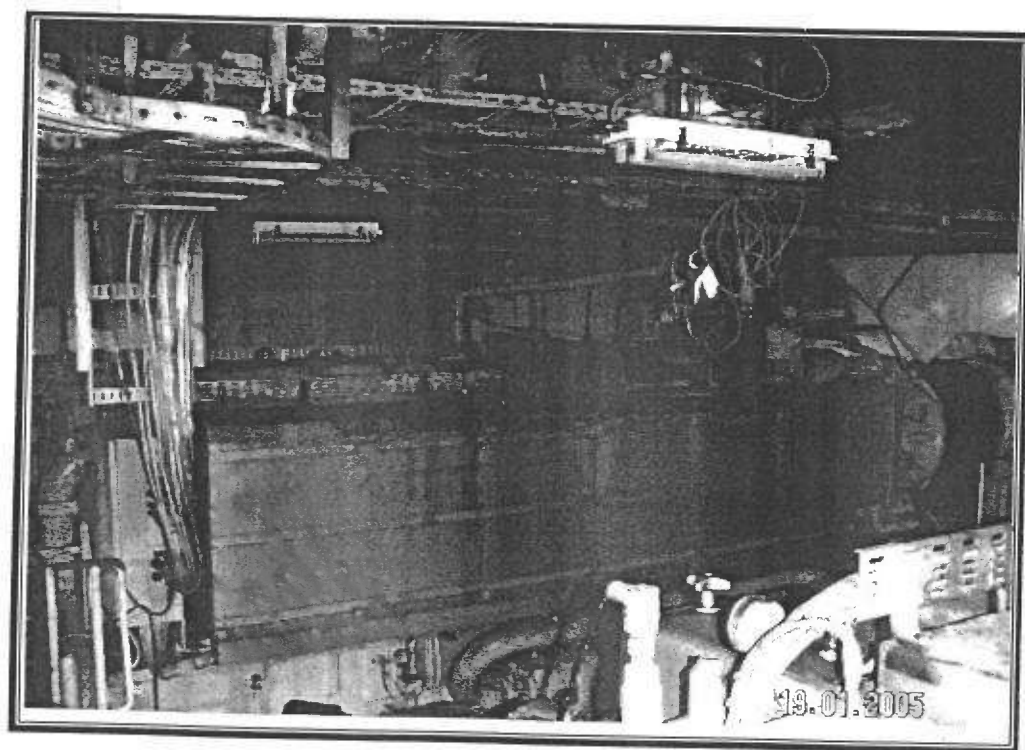
2. Diesel Generator Room showing No 2 Generator in foreground

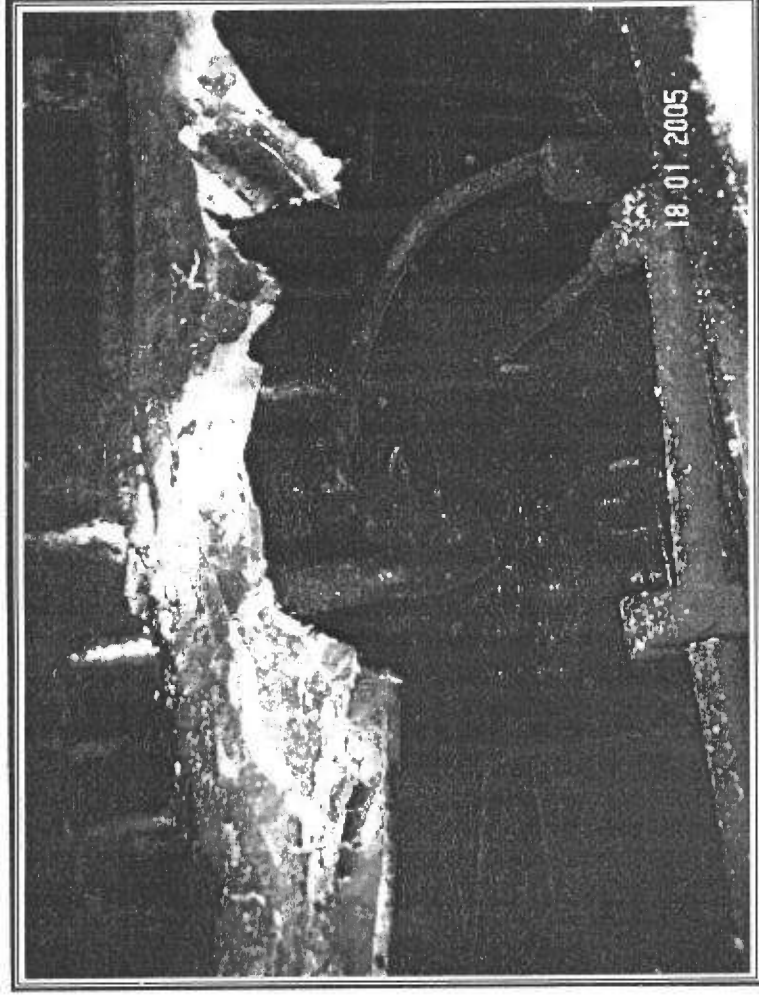
- (b) No 2 Generator: fire damage to main power cables, control cables, lighting cables, power sockets, fluorescent light fittings, public address system speaker and visual alarm indicator, cylinder covers and fuel pump covers, and turbocharger air inlet filter.

3. No 2 Diesel Generator Fuel Pump No 2

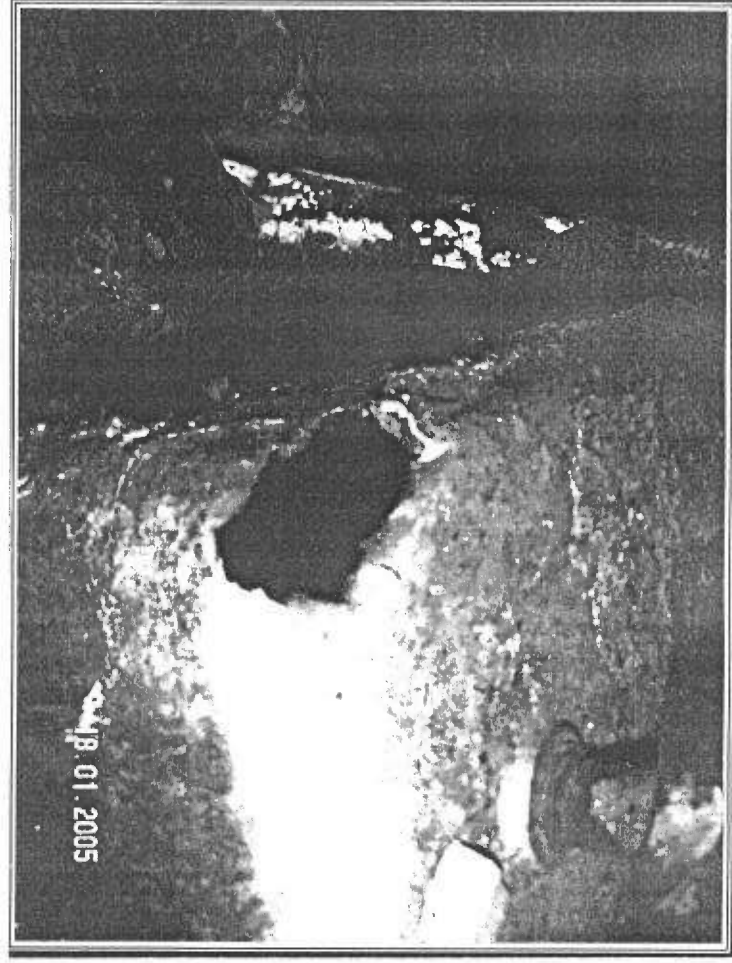
- 4.11 The displacement of the air start valve while the engine was running is considered to have been insufficient to have permitted the passage of flame, but would have been permitted the escape of hot exhaust gas. This view is supported by a build up of products of incomplete combustion depositing on the inside of the cylinder cover (Photograph No 15). If the build up of vaporised lubricating oil inside the cover ignited, the resulting flame would have impinged on the cylinder cover. This would account for the holes found in the covers of No 1 and 3 cylinders.(Photograph No 4).

4. No 2 Diesel Generator No 1 Cylinder Cover

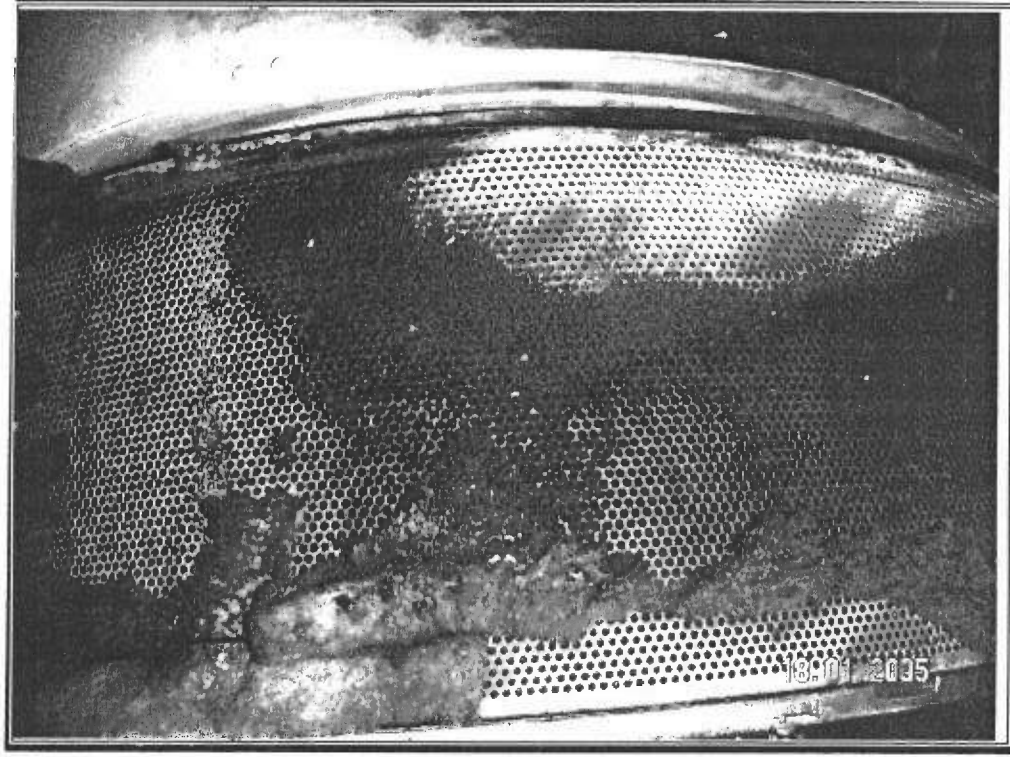
5. No 2 Diesel Generator Turbocharger Inlet Filter Casing

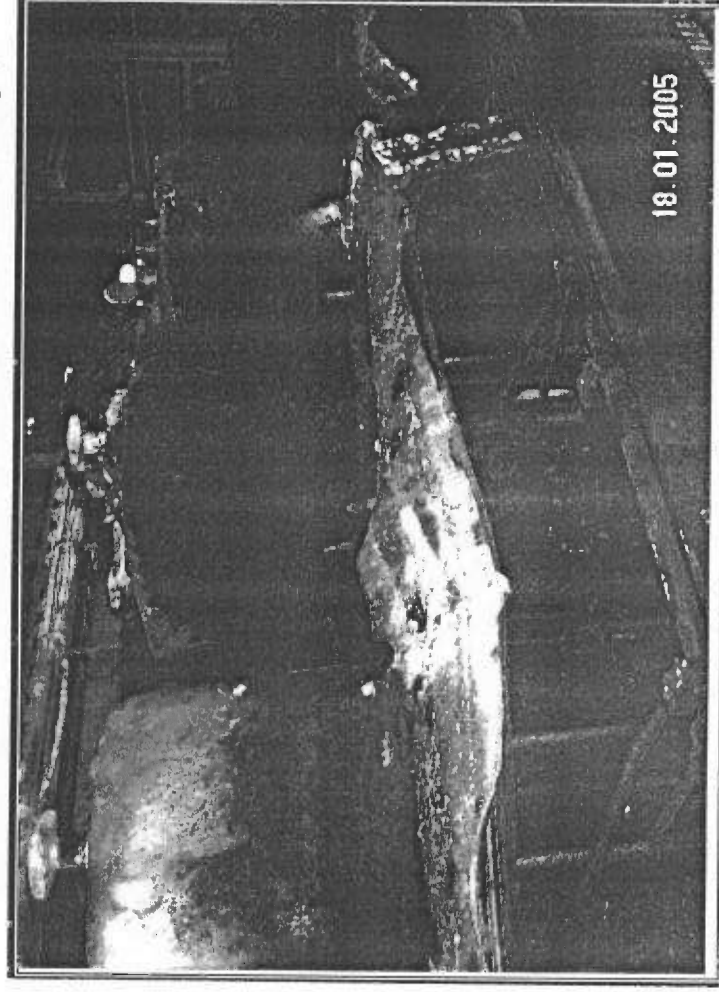
6. No 2 Diesel Generator Aft Fuel Pump Casing

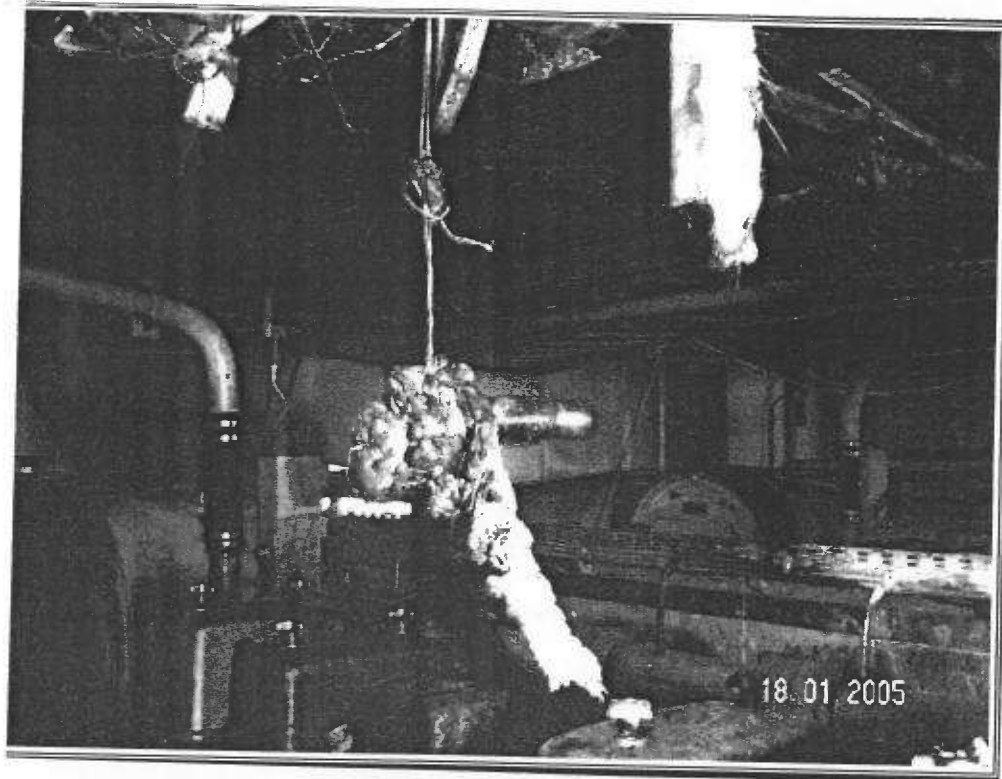
7. Remains of rotating alarm light

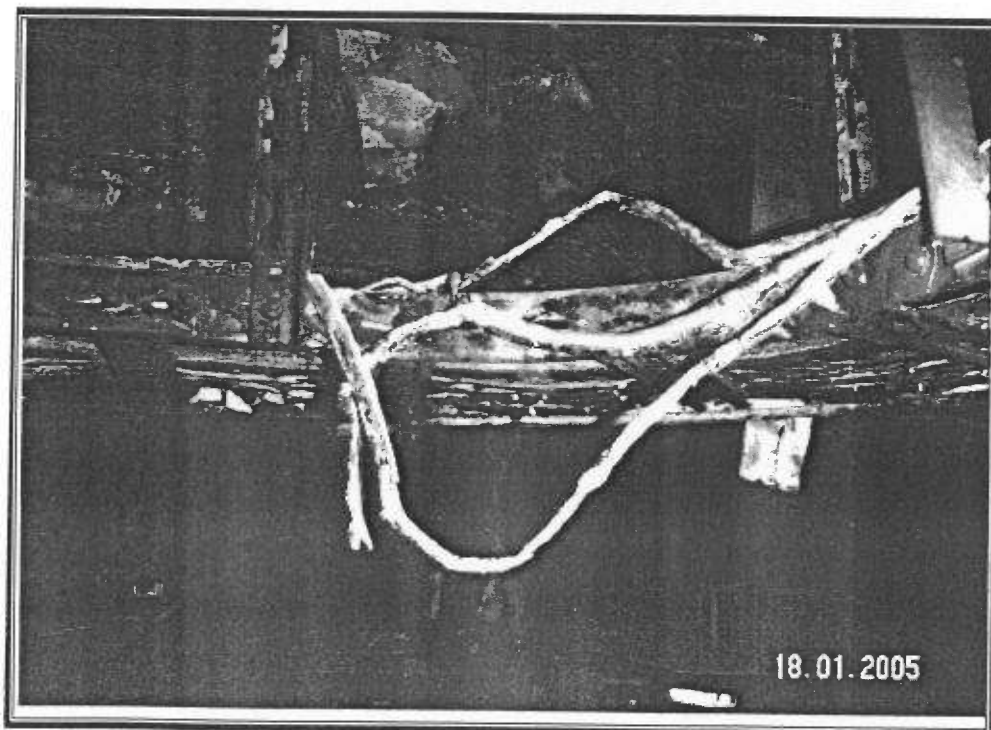
- 4.18 The control cables for all three generators were mounted on cable grids close to the deckhead. As a result, all were vulnerable to damage from a common source (Photograph Nos 8 and 11). In this incident, only one generator could be operated after the fire, and this was only possible following temporary repairs to the damaged cables. The risk of losing all generating capacity in similar circumstances could be reduced by running the control cables separately.

8. No 2 Diesel Generator Control Cables

- 6.1 In view of the vulnerability of the total power generation to fire damage, and the resultant disablement of the vessel, it is recommended that the cabling serving each of the three diesel generators be separated and protected with some degree of insulation.

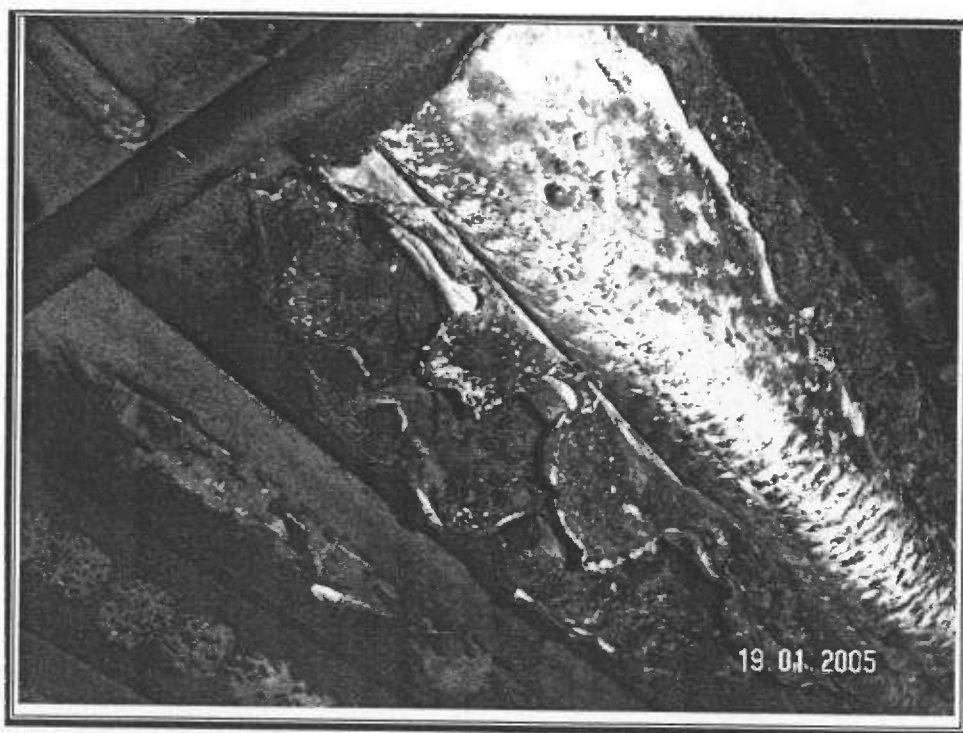
9. Damaged No 1 Diesel Generator Power cables above No 2 Diesel Generator

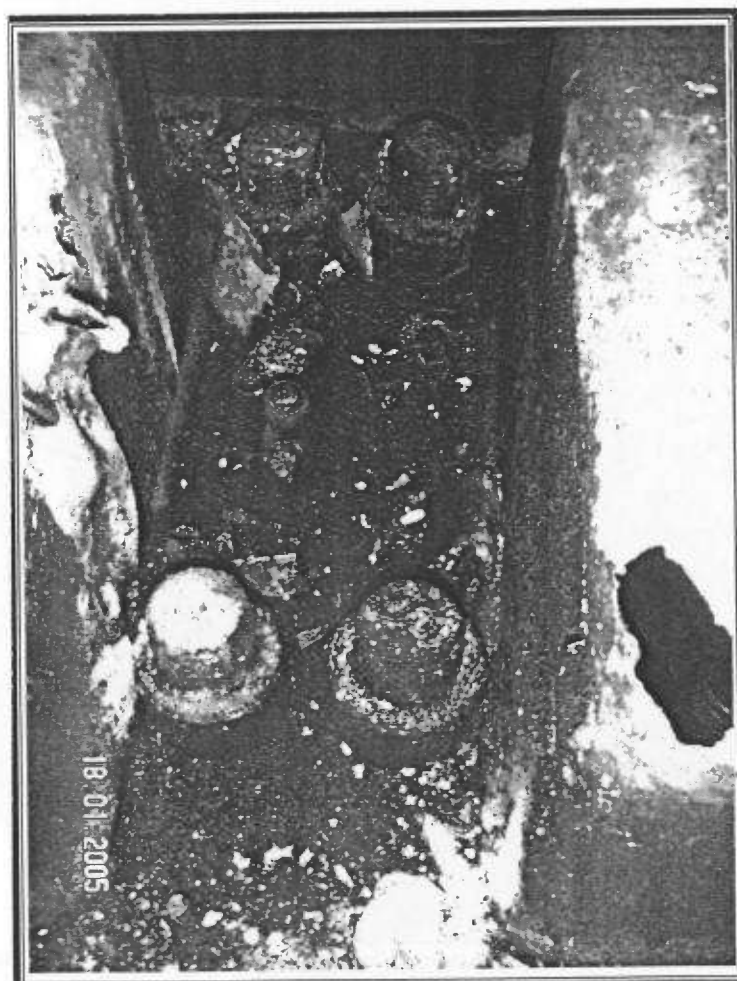
10. View between No 1 and 2 Units on No 2 Diesel Generator

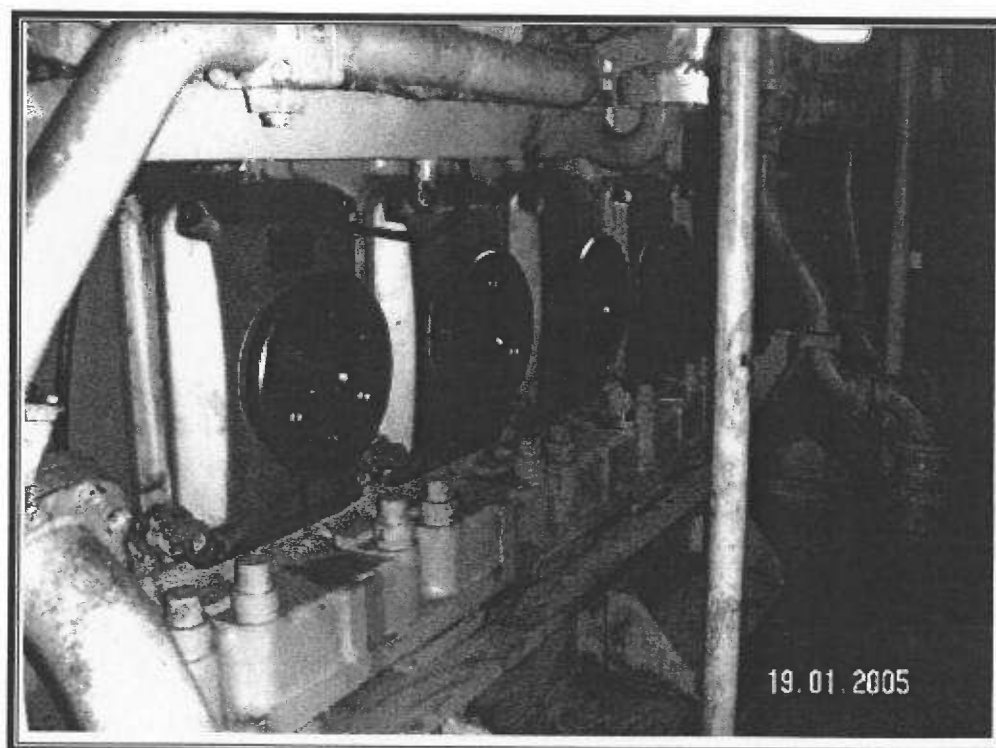
- 4.7 The evidence of the engine room rating who first approached the fire and that of the fire party which followed indicates that the fire originated either at the top of No 2 Diesel Generator motor or on the deckhead above. This is confirmed by the survey of the damage conducted on arrival of the vessel at Port Everglades. Photograph No 2 in Appendix 1 taken during the damage survey show damage to the top of No 2 diesel generator and to the deckhead immediately above, while the lower part of the engine is unaffected by the fire or smoke (Photograph No 12)..

12. No 2 Diesel Generator Crankcase Doors

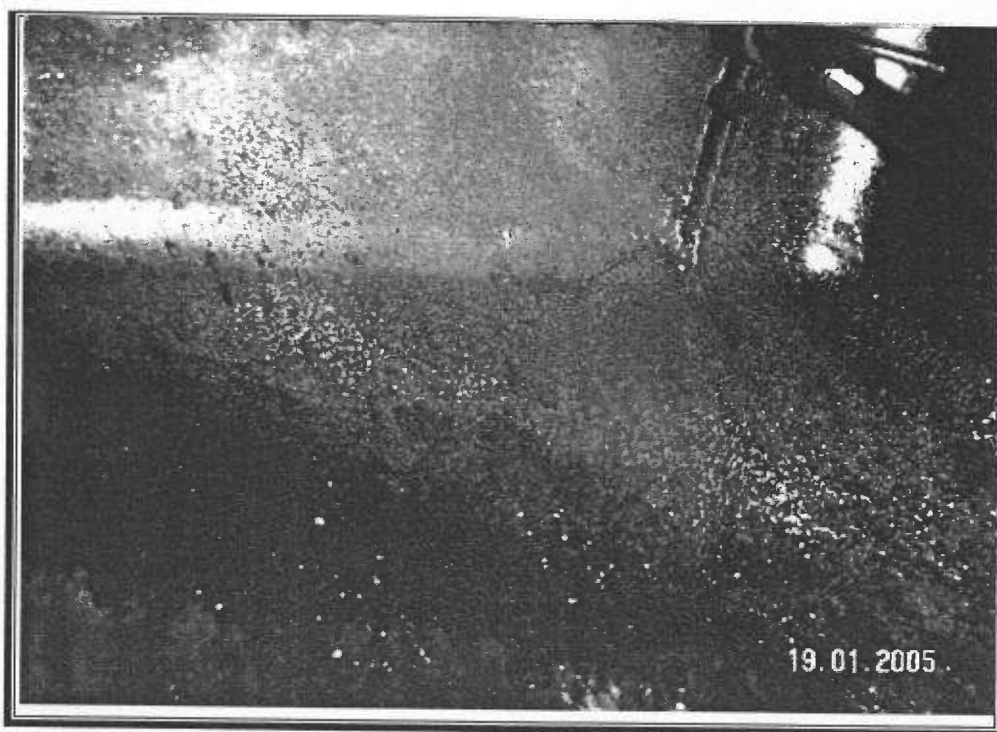
15. Build up of carbon inside No 2 Cylinder Cover of No 2 diesel Generator

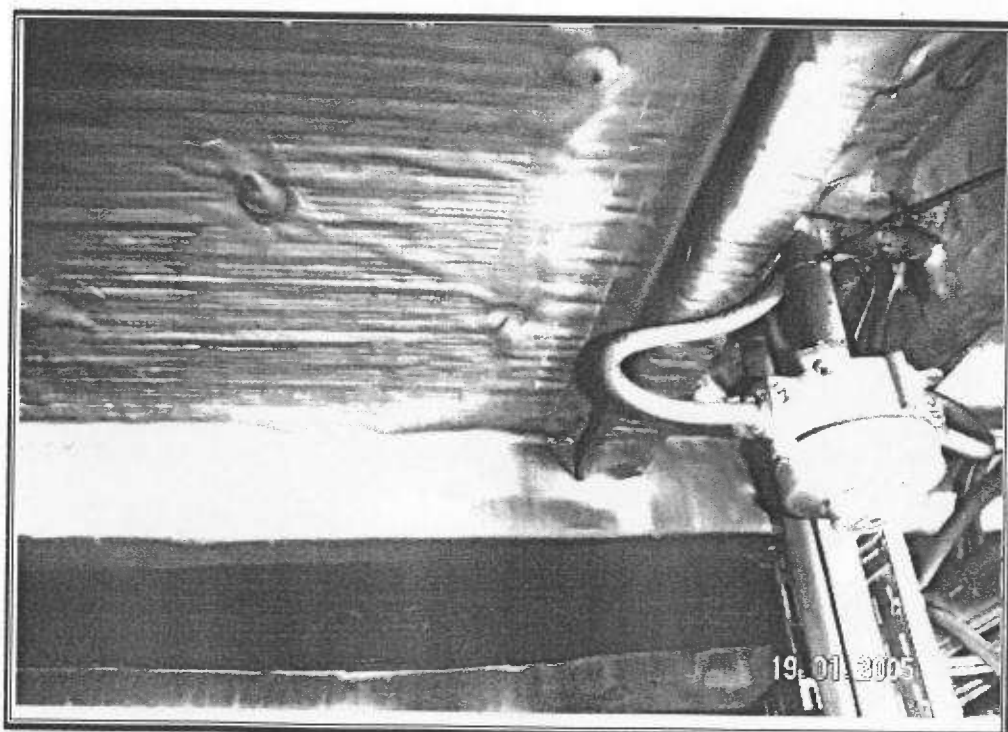
- 4.13 A section of the deckhead insulation unaffected by the fire was removed and tested for flammability. The sample was found to ignite readily on application of a cigarette lighter flame and emit black smoke. This is possibly due to absorption of oil vapour to the extent that it became flammable, or alternatively the flame retardant material was not as effective as required for such locations.

16 Undamaged deckhead insulation on starboard side of Diesel Generator Room

- 6.2 As the fire appeared to spread rapidly, in part due to the flammability of the deckhead insulation covering, it is recommended that the insulation be improved and finished with a smooth surface for ease of cleaning where practicable to avoid the accumulation of oil mist over time.

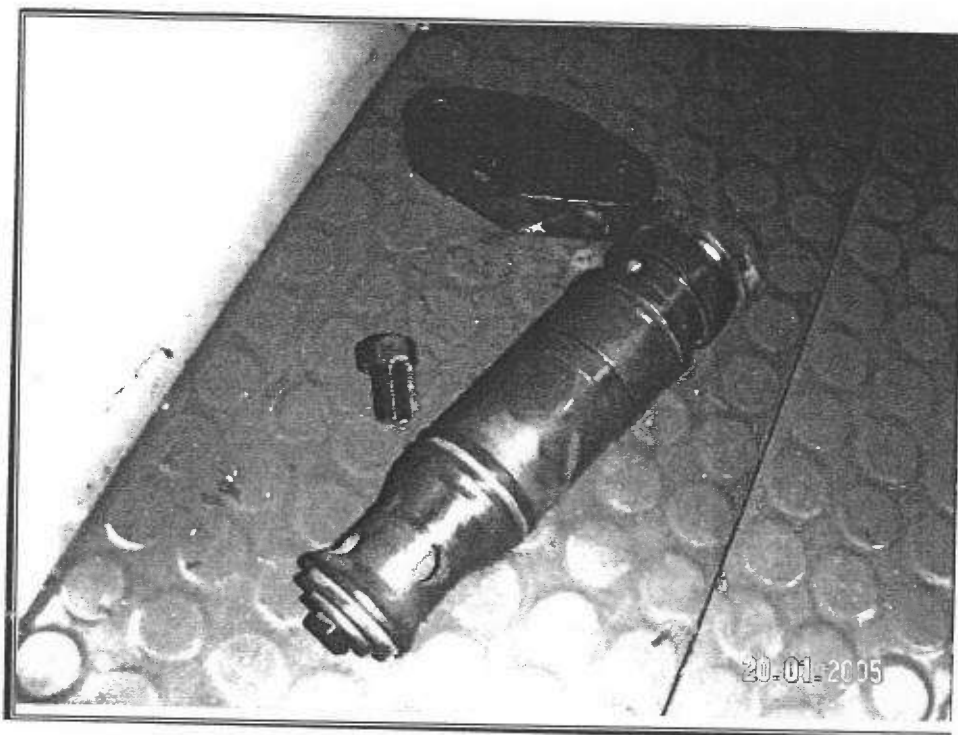
17. No 2 Diesel Generator No 2 Air Start Valve

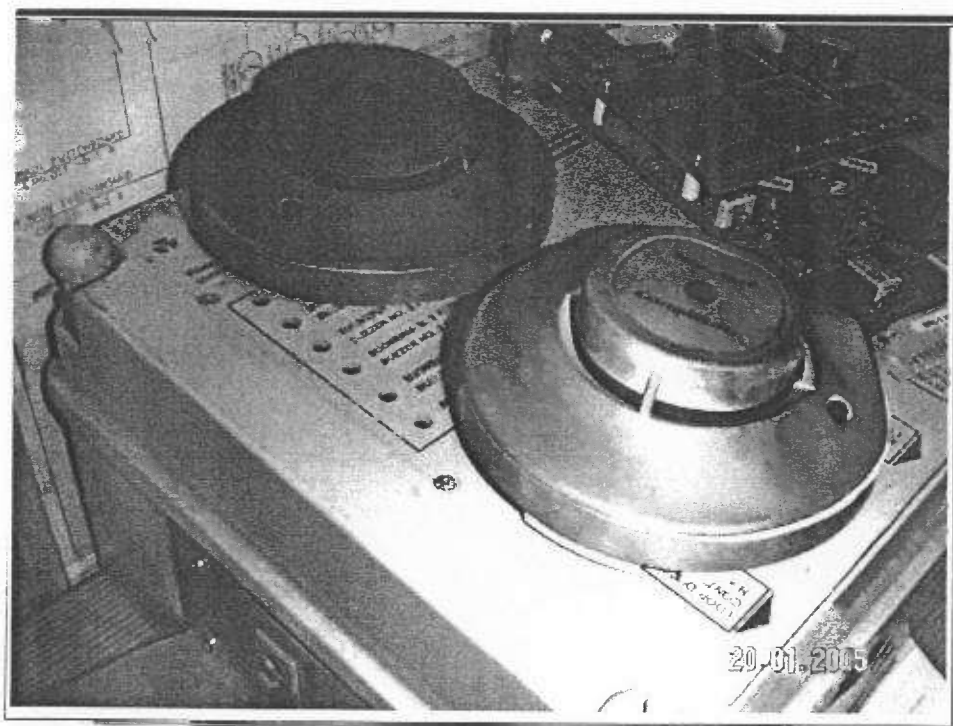
18. Diesel Generator Room Smoke Detectors
