**The Bahamas  
Maritime Authority**

**M. v. Sherice M**  
**Official Number: 724986**

**Report of the marine safety investigation into a  
fire on a General Cargo vessel on 16 June 2018**

Date of Issue: 31 August 2018  
Bahamas Maritime Authority  
120 Old Broad Street  
LONDON  
EC2N 1AR  
United Kingdom

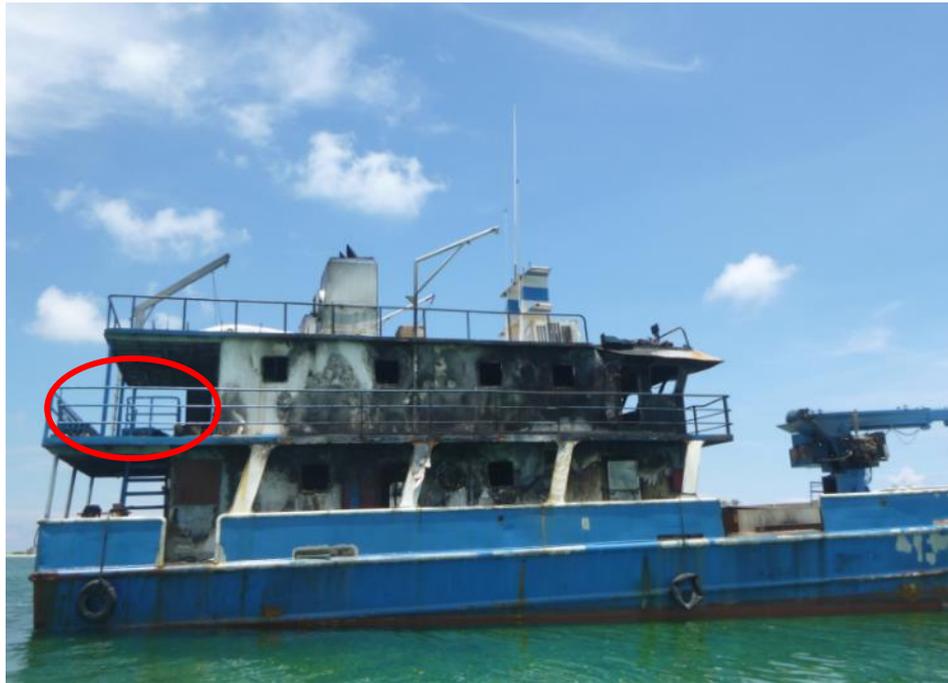
Figure 5: Location of firefighting equipment

5.2.3 The Master was the fire marshal of the vessel and was unable to reach the firebox (refer figure 5), due to the spread of the fire. No crew member including the Bosun tried to access the firebox, before the Master’s arrival at the scene. The crew members were busy fighting the fire using the fire pump and made no attempt to wear the fireman outfit located in the firebox to extinguish the fire.

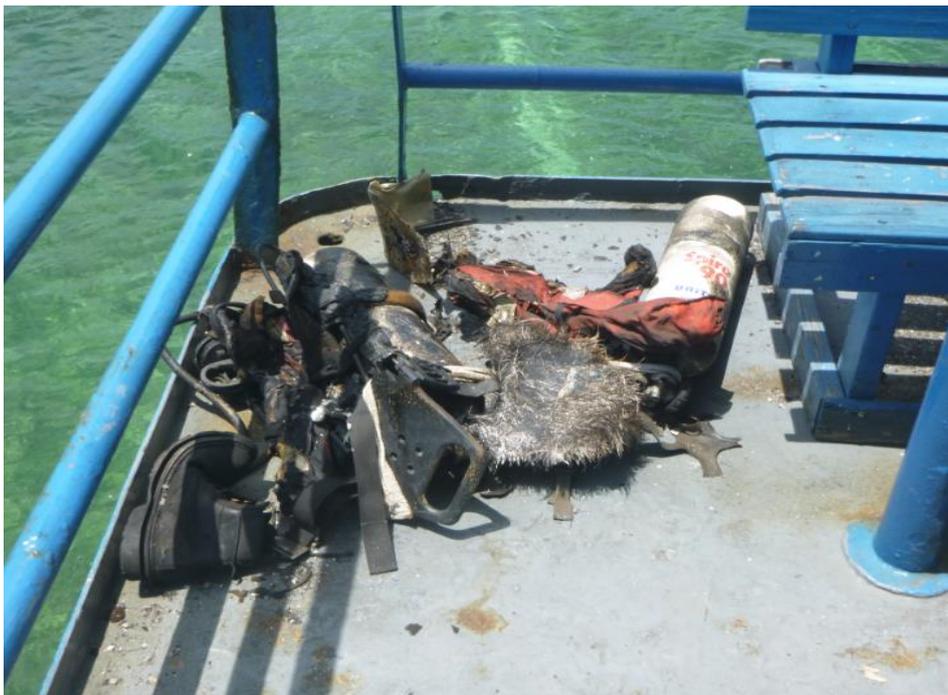
Figure 6: Unused firefighting equipment after fire

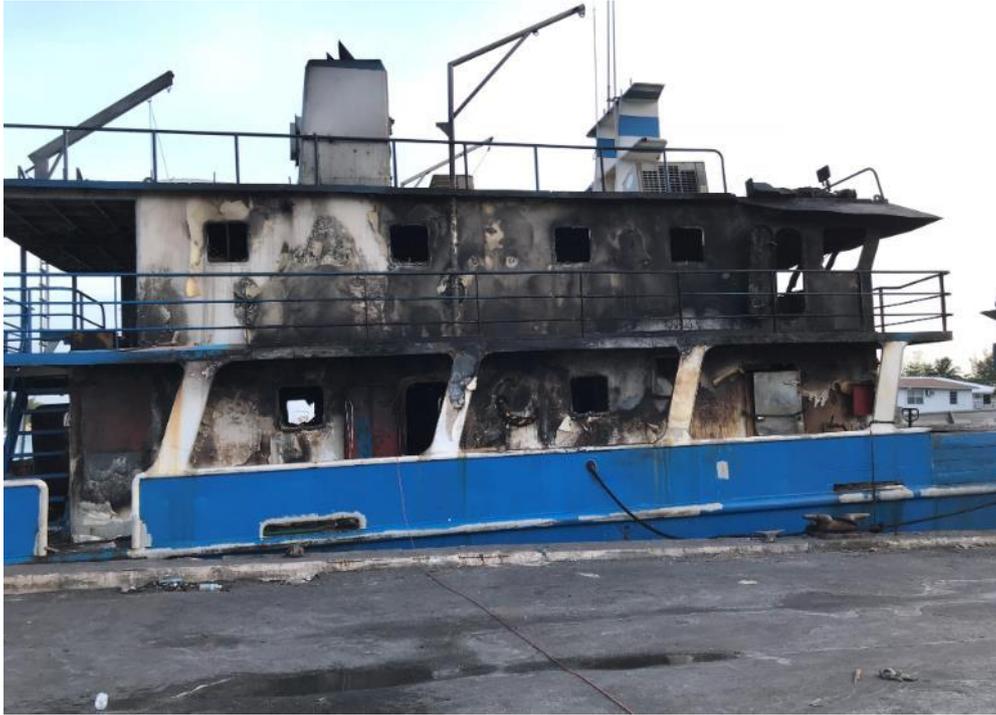
Figure 7: Vessel condition after fire was extinguished (Source: RBPF)

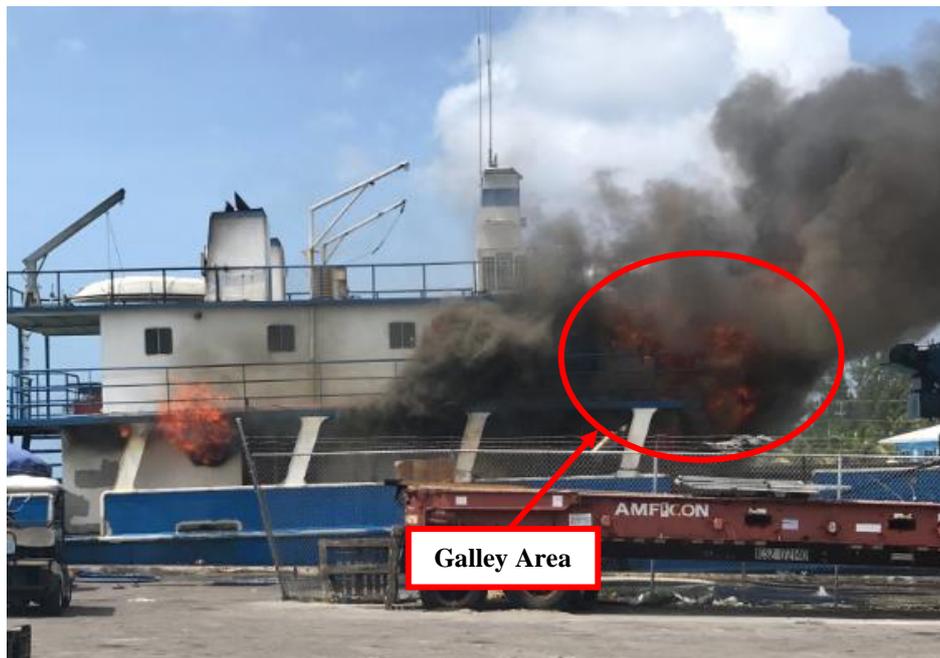
- 5.1.3 The Bosun and other deck hands were on the dock alongside the ship loading the cargo to the vessel. At 1110 hours the Agent was talking to the Bosun and they were standing by the bow of the vessel when the Agent observed the fire around the galley area with heavy smoke and flame coming out from the galley window. The Agent quickly informed the Bosun about the fire.

Figure 8: Fire location (Source: RBPF)

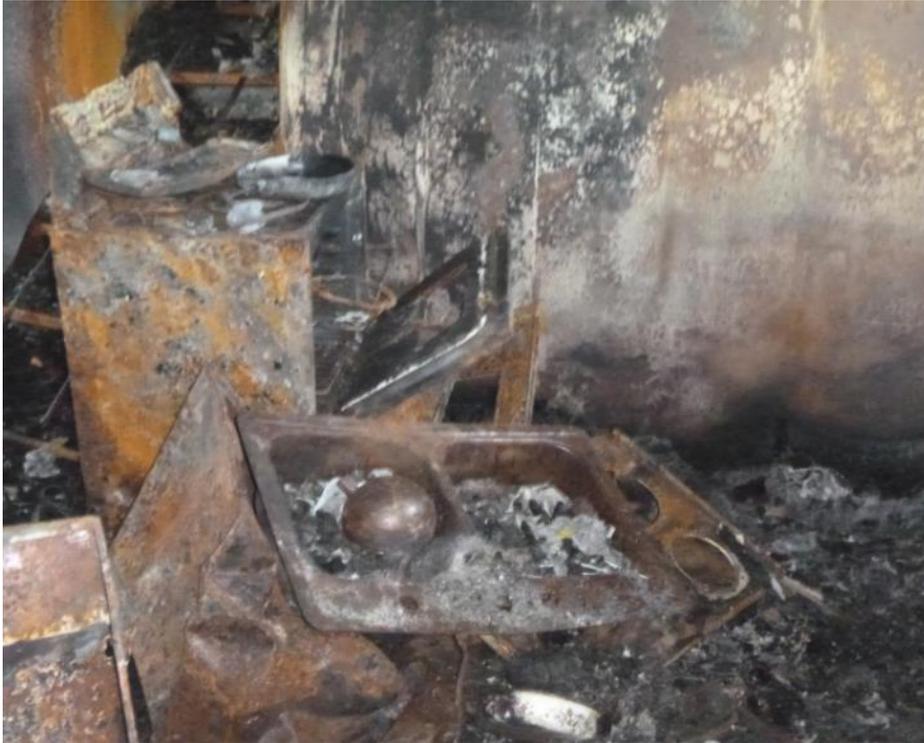
- 5.1.4 The Bosun tried to enter the galley, but he was unable to do so due to the heavy smoke and fire in the area. He observed large flames above the stove area.
- 5.1.5 The knobs and metal that held the knobs of the stove were completely disintegrated due to the fire. Therefore, the Cook's testimony could not be

confirmed as to the position of the knobs, to determine whether the stove was in an ‘on’ or ‘off’ condition.

Figure 9: Picture of the stove after the fire was extinguished

5.1.6 From the RBPF fire investigator’s report it was concluded that heavy damages were observed on the starboard side of accommodation area and a distortion of the metal in the galley area indicated that the galley area was burning for a longer period. The most probable origin of the fire was the stove, which most likely was left on and after some time, overheated the vent, spreading the heat to wooden cabinets in the immediate vicinity, which then initiated the fire due to heat conduction.

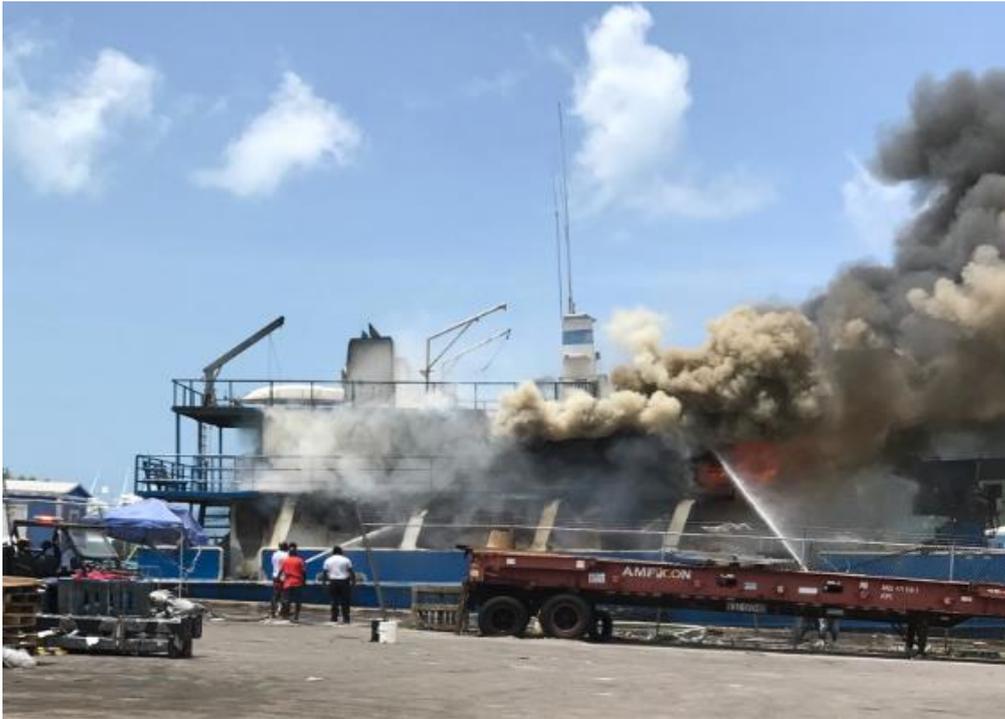
Figure 10: Firefighting efforts by resort world fire team (Source: RBPF)

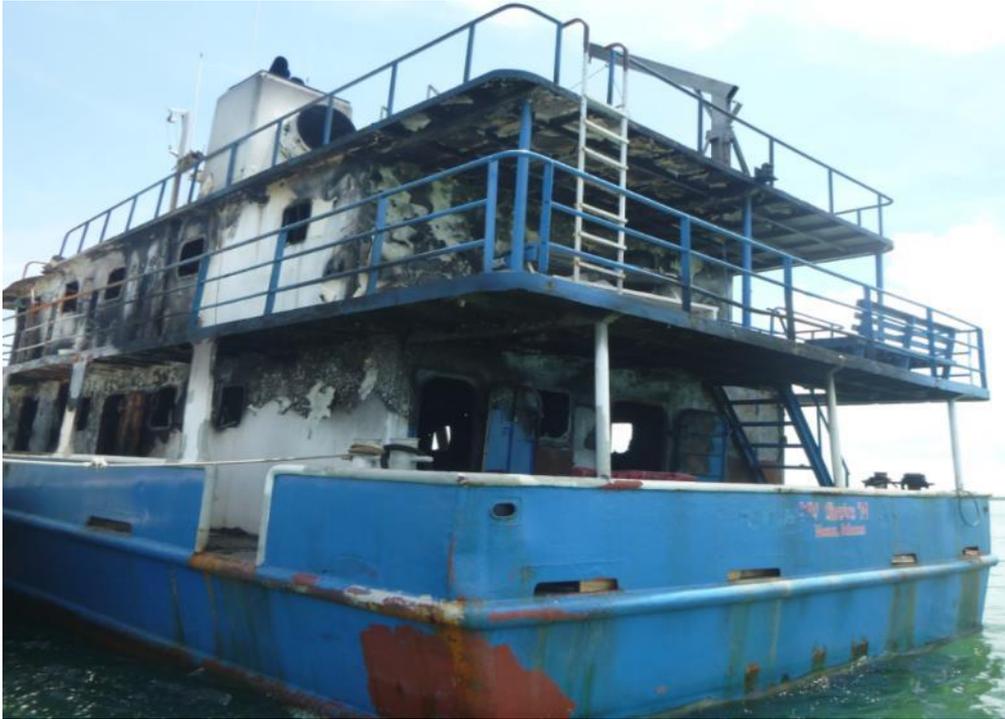
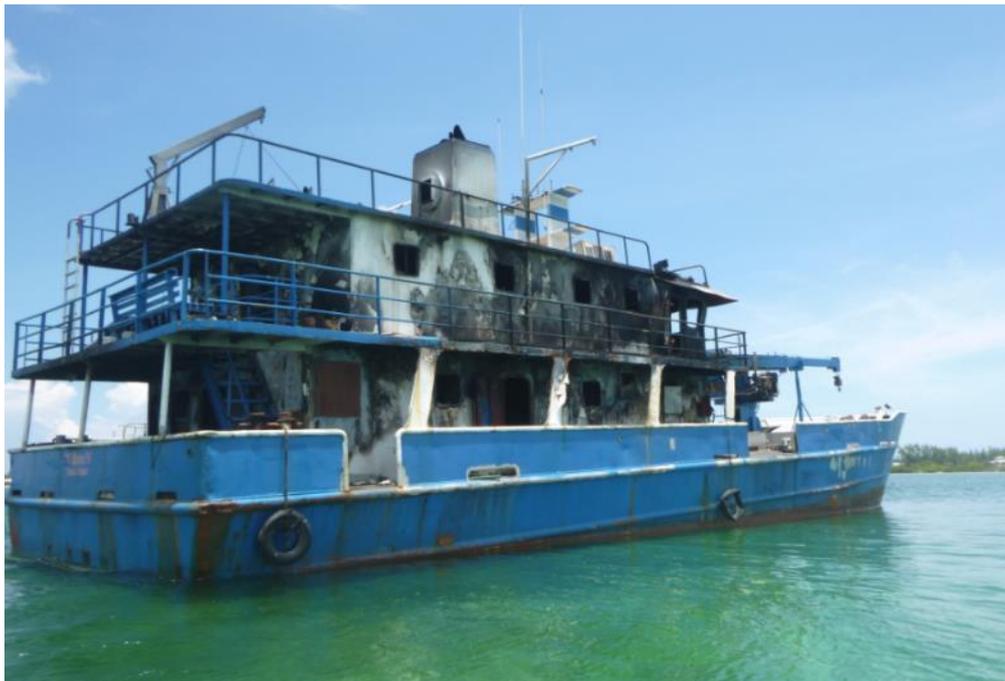
- 5.3.1 The fire potentially started in the galley area and rapidly spread throughout the whole superstructure.
- 5.3.2 The CCSS code chapter 3, section 3.16 outlines the requirement of the material used to build the vessel's bulkheads, decks, doors and stairways, as such: '*the fire safety requirements of bulkheads, decks, doors and stairways should, as far as practicable and reasonable in the opinion of the Administration, comply with the applicable requirements of the 1974 SOLAS Convention for such bulkheads, doors and stairways.*' Considering the swift spread of fire and the heavy damage caused by the fire, it is highly likely that the wooden fixtures, infrastructure and fittings which provided a ready source of fuel were not constructed in accordance with the Code and ultimately aided the spread of the fire.

Figure 11: Superstructure after the fire

Figure 12: Superstructure after the fire

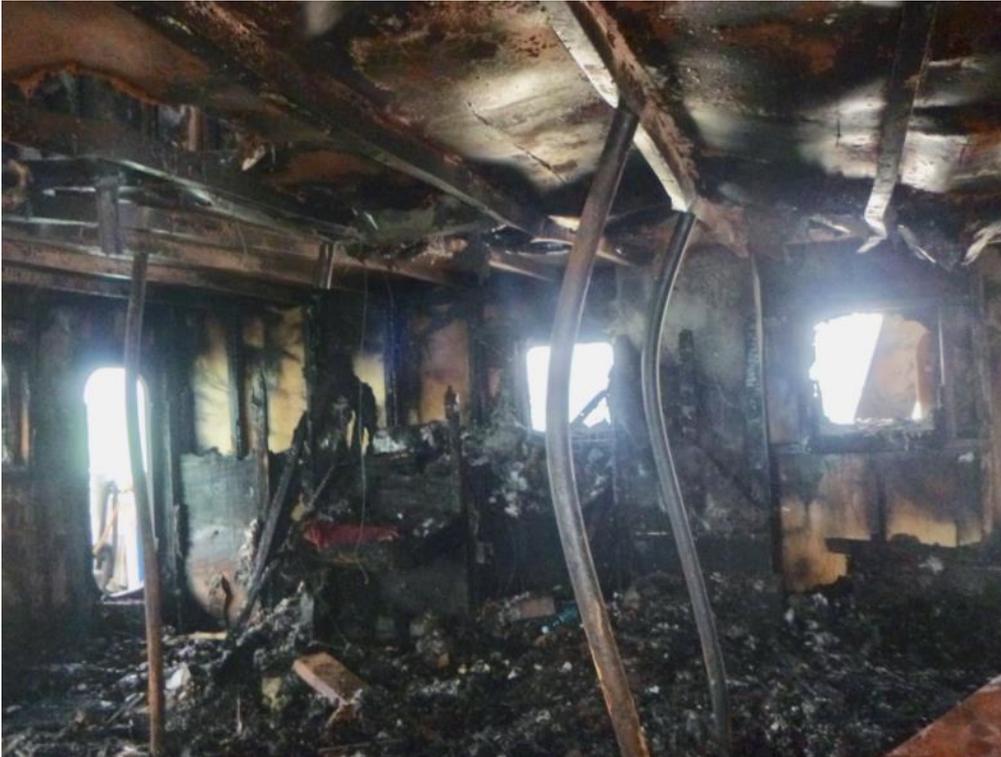
Figure 13: Cabin and accommodation area after the fire

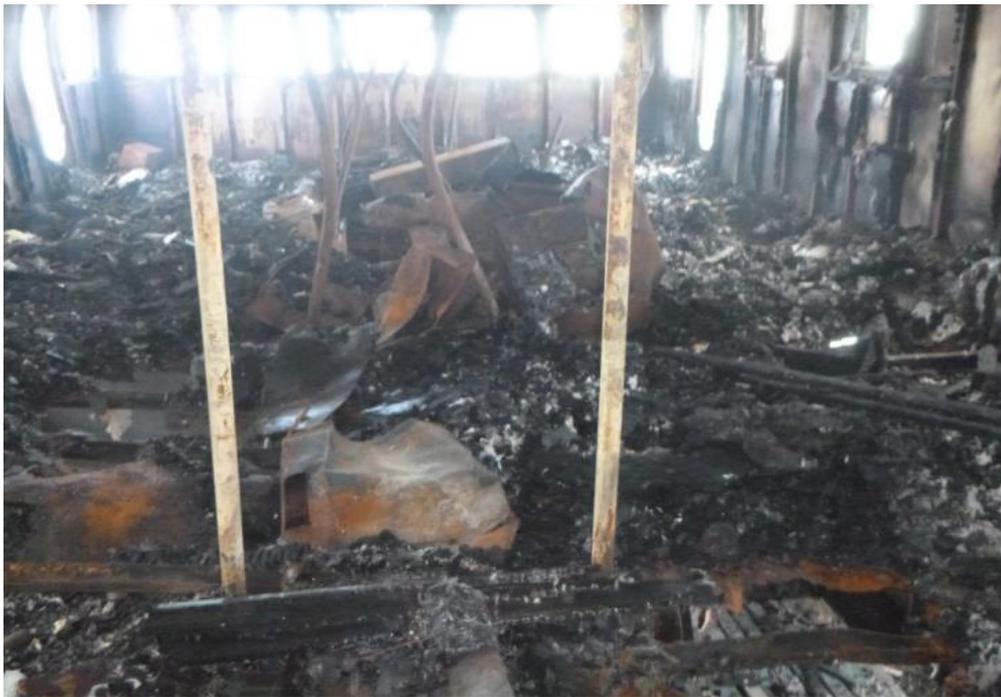
Figure 14: Bridge and Master's cabin area after the fire

- 6.5 The firefighting efforts took 6 hours to extinguish the fire and the accommodation area including the bridge area and Master's cabin was severely damaged due to the spread of the fire.
