**The Bahamas
Maritime Authority**

TAI SHAN

IMO Number 8513560

**Report of the investigation into
Fire damage to
Tai Shan
on
2nd July, 2014**

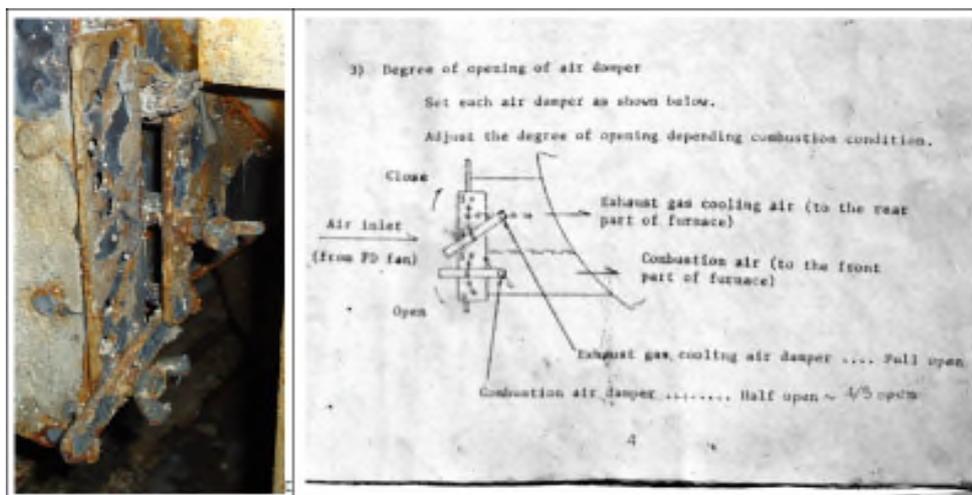
Fig. 07 Air Damper Control & Fire damaged damper

- 3.12 The incinerator forced draft fan duct, between the fan and the casing, was split into two paths. The upper path was for providing cooling air to the exhaust and outside of the furnace on the exhaust side of the incinerator. The lower path was for combustion air, ducted to the burner section. The manual on board provided default settings for the 5-step flap control. The advised setting was 100 % open for the exhaust flap and 50 - 80% open for the combustion flap. The exhaust cooling flap was found completely out of the graduated plate provided for setting, but the flap position would have been approximately 50% open. The combustion air flap was 80% open.

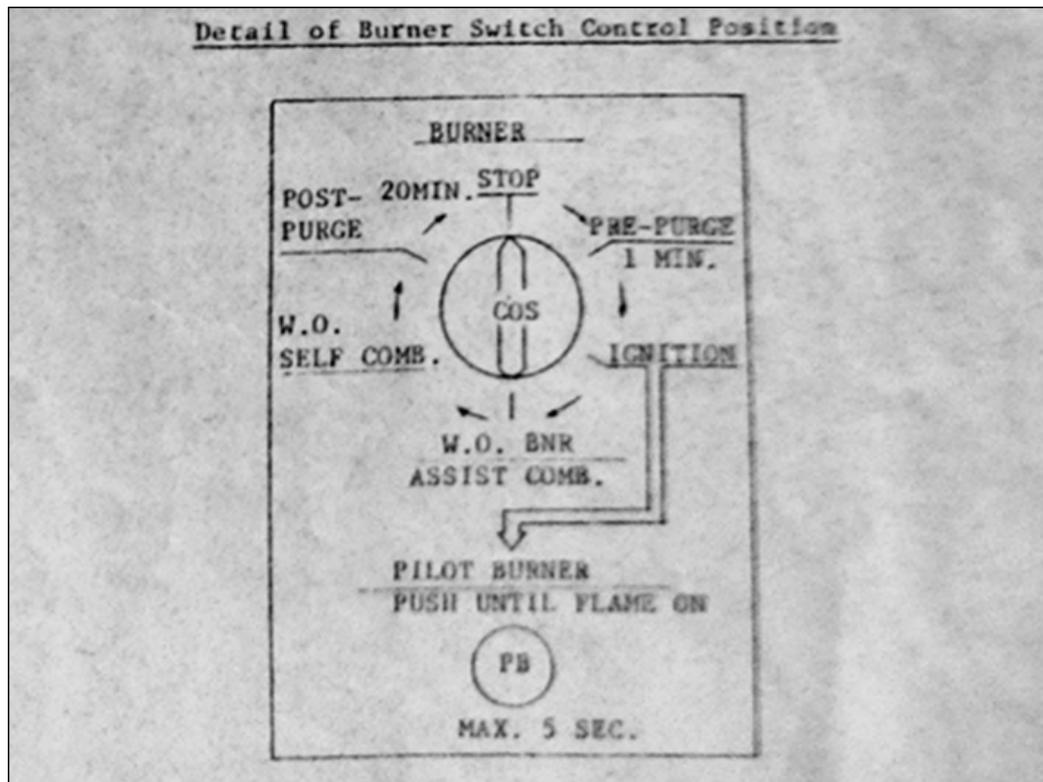
Fig. 08 Burner Switch Control Position

- 3.13 The 4/E, finding the incinerator had stopped, due to the low Waste Oil tank level alarm having activated, went straight from the engine control room to the incinerator room, which would have taken approximately a minute. He then shut down the incinerator and continued with his duties and to investigate the incinerator abnormality later.
- 3.14 He reported that he had switched the control selector from the “Waste Oil Self” mode, to “*post purge*” for 20 seconds” and then switched it off. The manual indicates that the post purge should be operated for 20 minutes. The 4/E noted at the time the exhaust temperature was approximately 200° Celsius.

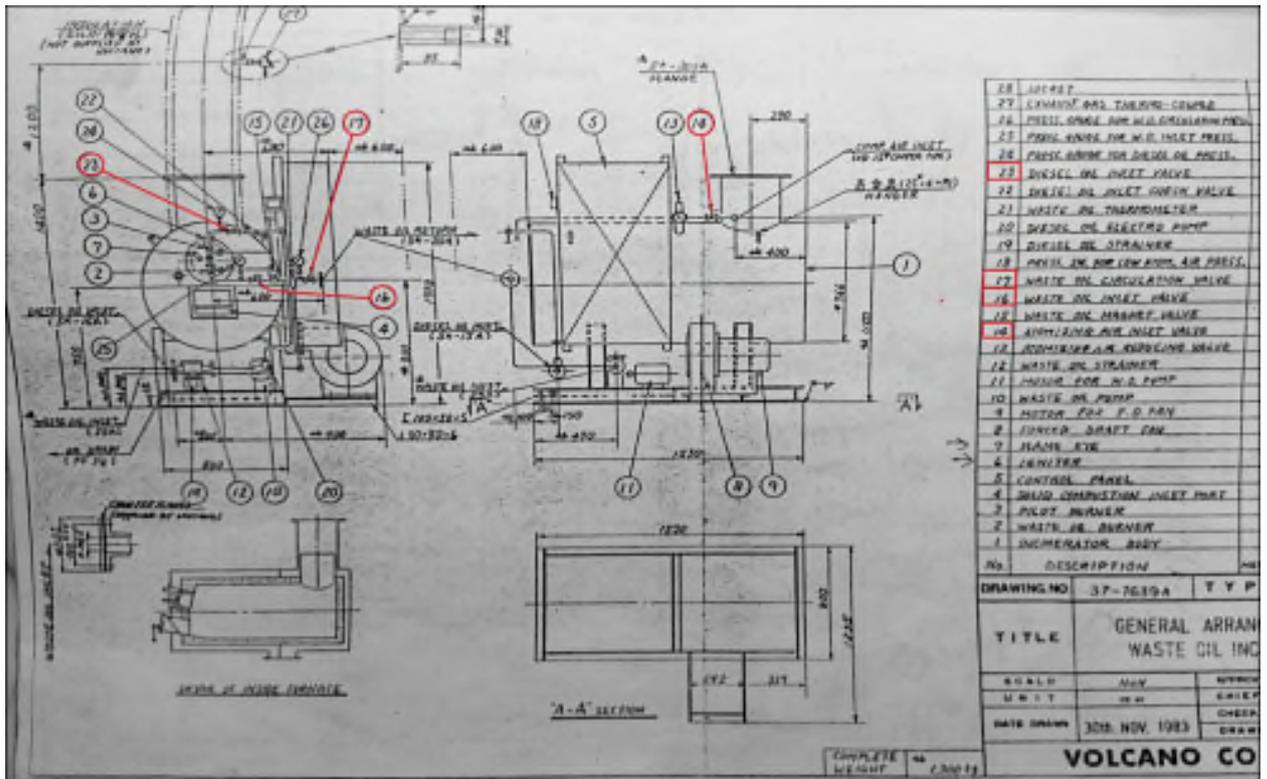
Fig. 10 General Arrangement – Waste Oil Incinerator

- 3.15 Thereafter the 4/E closed the following valves, as per drawing (Fig 10) Waste oil filter valve, atomising air inlet valve (14), Waste oil circulation valve / Return to tank (17), diesel to pilot burner (23) and diesel to waste oil burner (16). Notably, the diesel valve on the diesel tank and the main diesel valve before the filter and pump were not closed.

3.16 It is estimated that the incinerator may have been switched off, less than a minute after it stopped burning sludge, far less than the recommended 20 minutes.

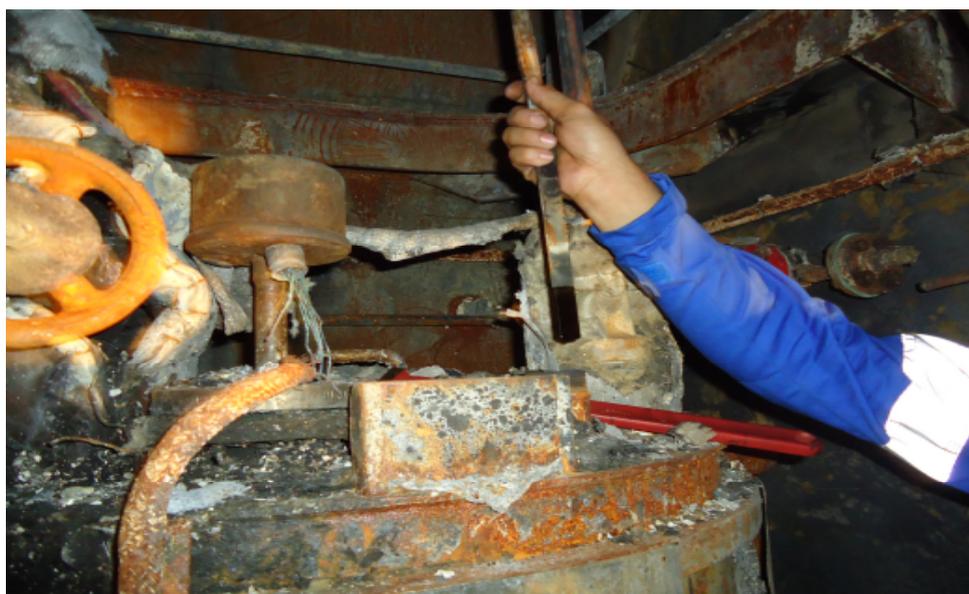
Fig. 11 Waste Oil Tank sounding rod

3.17 The waste oil tank sounding rod was used to check the remaining contents in the tank. The result was a level approximately equivalent to 10% of the depth, which would be roughly 50 litres.

- 4.12 During the investigation, the Waste Oil tank was found empty, or at least as far as the dipstick sounding arrangement could reach, which appeared to be at about 10 % level.

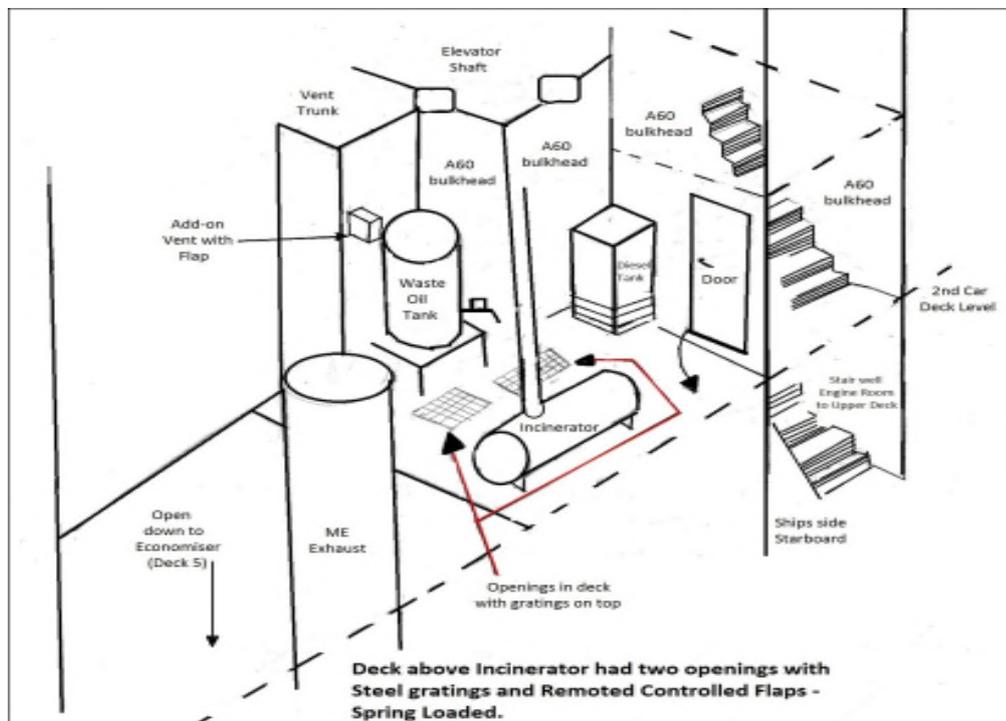
Fig. 14 Incinerator Room

- 3.20 The primary source of the fire was found to be centred in the incinerator room, which was fed by the pilot burner and diesel fuel tank, the content leaking fuel from the burnt pipes and melted alloy fuel filters under the incinerator. The diesel tank and the waste oil tank were both found empty.
- 3.21 Prior to the fire the diesel tank was stated to have been “*about half full*”, which would indicate that it had contained approximately 300 litres of diesel.
- 3.22 A large amount of insulation in the stairwell had allowed a secondary fire to develop, which spread to No. 2 Car Deck. The spread of the fire was caused by the opened Incinerator room door. The insulation had been removed in places, down to the bare metal. Where insulation did remain, it was evident that the cladding had been coated with paint.

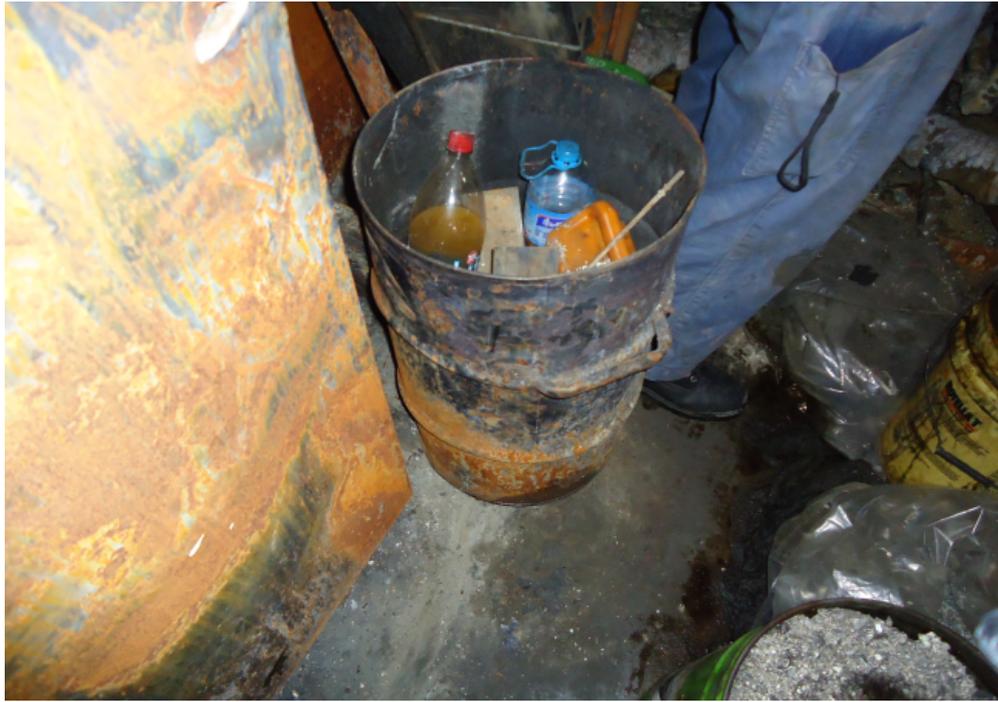
Fig. 15 Drum propping open door

- 3.26 The incinerator was positioned on a platform (not enclosed), level with the 2nd car deck within the engine casing and adjacent to the stairwell leading from the engine room level to the upper deck. No drawings, which could adequately illustrate the actual situation, were found and the sketch above was drawn up to assist (Fig. 14).
- 3.27 The 4/E and firefighters arriving at the scene of the fire, concurred that the door from the incinerator room was propped open with a drum, used to hold rags and other garbage. The rags were those used to wipe up diesel which had leaked under the incinerator. The empty drum shown was the one used to prop open the door. Following the incident unburned garbage was placed in the drum.

- 4.13 It had become a regular practice on board for the incinerator door to the stairwell to be kept opened with the drum, used to collect the oily rags used to wipe up the oil leaking from the incinerator, .

- 4.19 It was reported that the cabling in the stairwell was burning less than an hour after the fire was detected. The door from the incinerator room, to the stairwell had been held open by a drum would have resulted in breaching of the A60 division. This would have caused a secondary fire to develop, which spread to cargo space.

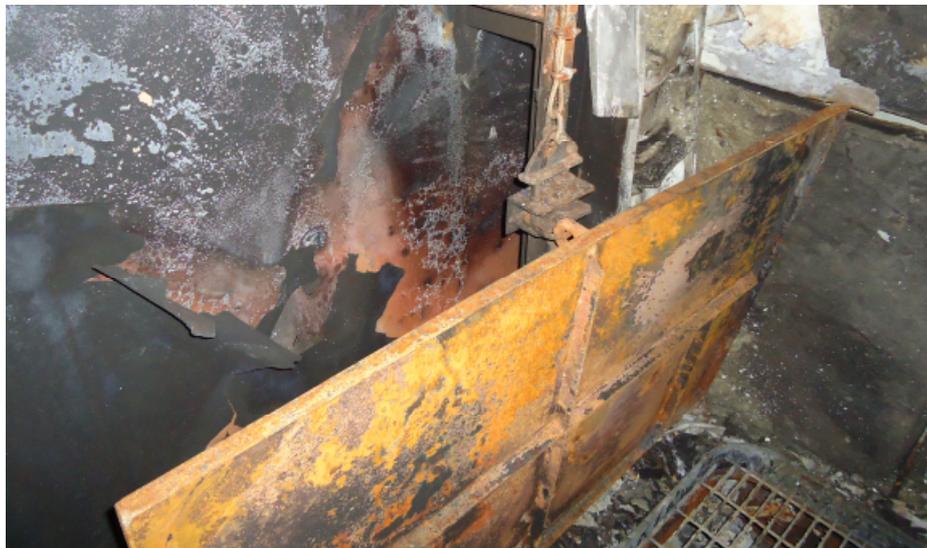
Fig. 16 Flaps in the funnel casing deck at upper deck level

- 3.28 The flaps in the deckhead above the incinerator were open, which would allow pressurised air from the engine room into the upper funnel casing and out of the louvered vents.
- 3.29 It could not be confirmed if the flap had been closed at any stage during the fire. The flaps had a manual release facility as well as a remote (pneumatic) facility. The Electrician stated that he had closed the flaps by pulling the trip wire outside the engine room casing. However (Fig.16) shows flaps in the funnel casing deck still open, following the fire.

- 3.30 With the flaps open the updraft, caused by air flow from the engine room air supply fans exhausted out of the funnel casing louvres and the open stairwell door on the upper deck.
- 3.31 The relative sizes of the openings (partially open incinerator room door and open funnel casing flaps), were estimated to be slightly larger through the funnel casing louvres.

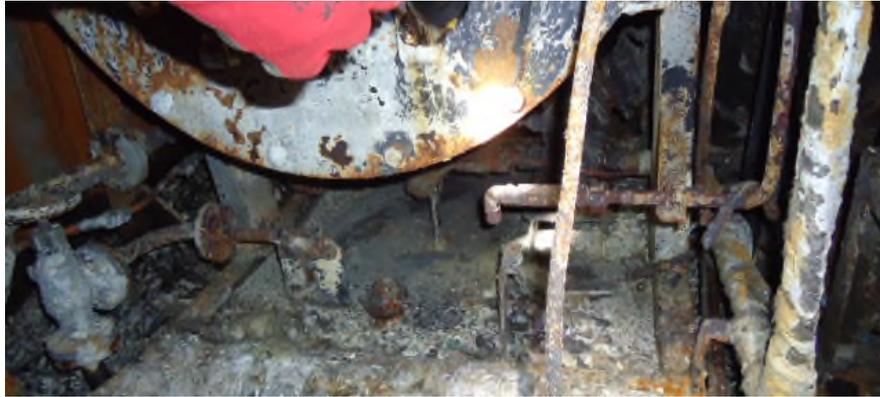
Fig. 17 Melted alloy under the Incinerator

- 3.32 The fire, starting in the incinerator room, would be propelled into the stairwell and also upward into the upper part of the funnel casing into the cargo space. If the flaps in the division deck were closed, the fire would all be pushed through into the stairwell and out through the open door to the upper deck, until the upper deck door was closed.
- 3.33 The heat generated by the fire, fuelled by diesel leaking via fittings on the incinerator, resulted in temperatures in excess of the melting point of Brass (approximately 900°C). The alloy filter, originally fitted under the incinerator, had melted completely.

- 3.42 The fire was subsequently found to have been fed by the pilot burner diesel fuel tank contents, leaking from burnt pipes onto a hot surface and melted alloy fuel filters under the incinerator.

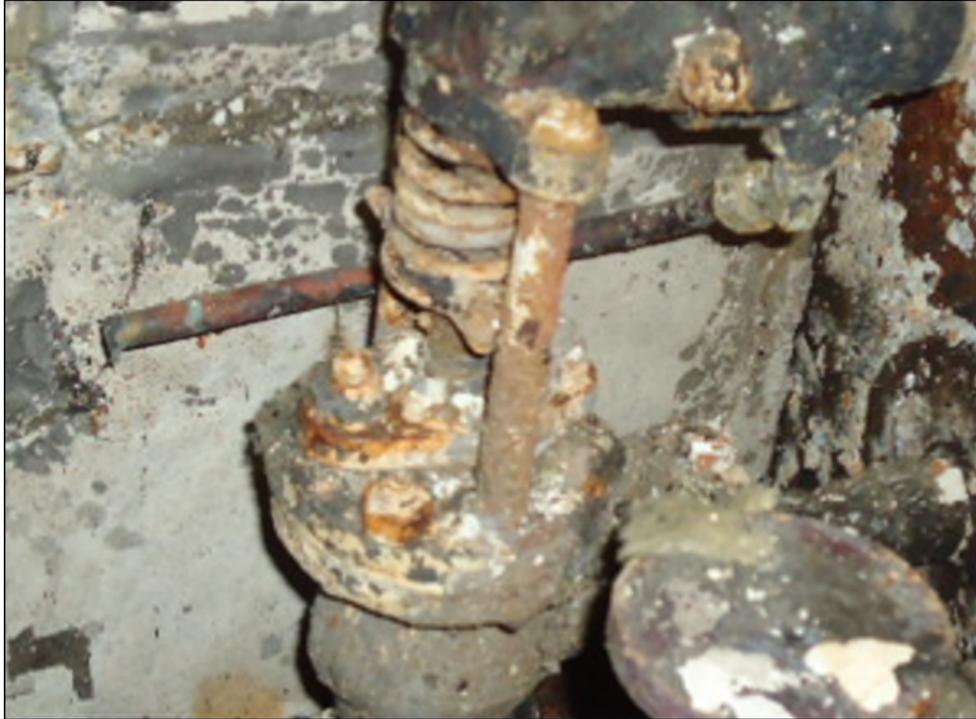
Fig. 19 Quick closing valve – diesel tank

- 3.50 The operation of the quick closing valves for the outlet valves for the diesel and incinerator waste oil tanks had not been activated. It was noted that the valves were included in the "one shot" system for all quick closing valves. If operated, all other fuel supply quick closing valves, which may have been needed, would have had to be manually reset. After the vessel

blackened out, this would have not been of significance, and only the emergency diesel generator supply valve would have required manual re-opening. The quick closing valve on the diesel tank for the incinerator was found stuck in the open position.

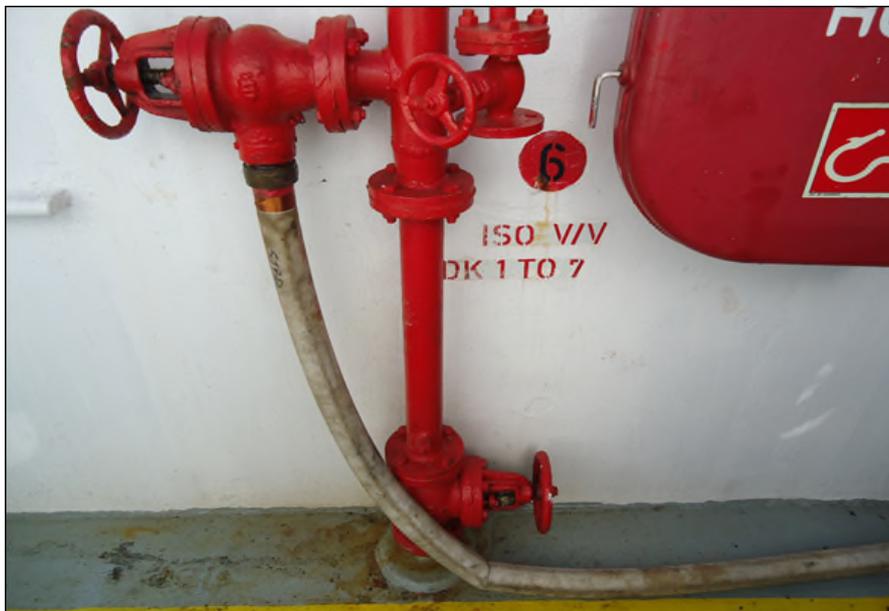
Fig. 20 Isolation valve for car decks 1 to 7

- 3.51 Fighting the fire from the car decks access to the stairway was the most effective route. It was established that access to the stairway was delayed due to lack of effective water pressure, which later found to be due to fire main isolation valves for the car decks (and engine room) being shut.

- 4.18 It appeared that the ship staff believed that the fire isolation valves to car decks (and apparently the engine room), should be closed and only opened as required. This is a dangerous practice and undoubtedly caused delays in actively fighting the fire.

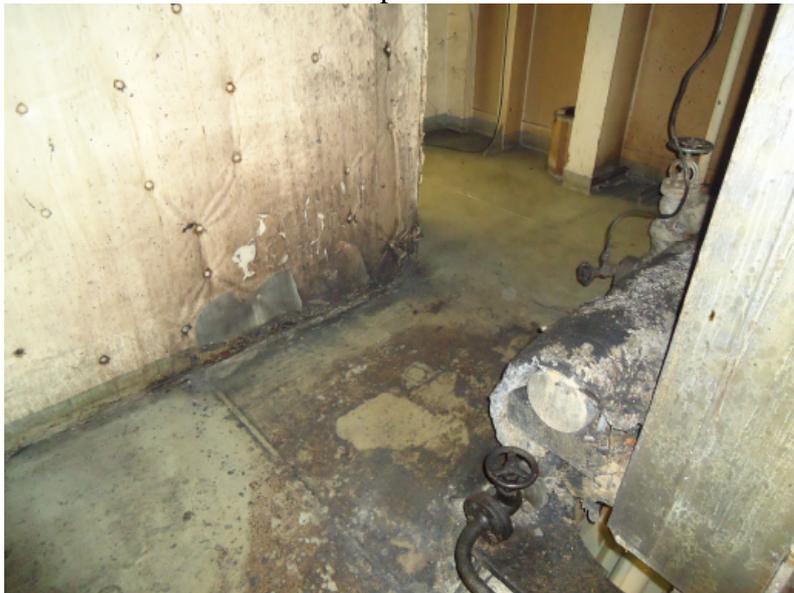
Area where initial fire was reported - debris had fallen from incinerator above.

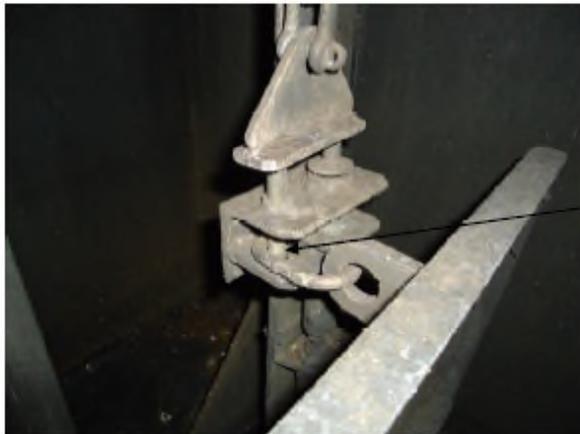
Mechanism for releasing the fire flaps in the deck above the incinerator. The shackle at the top, was connected to the cable pull fitting on the outside of the funnel. The unit below, was a pneumatic operated cylinder, which was also designed to release the spring loaded flap, by withdrawing the pin from the link.

It was apparent that the pneumatic system was not considered operational and that manual operation was the means used.

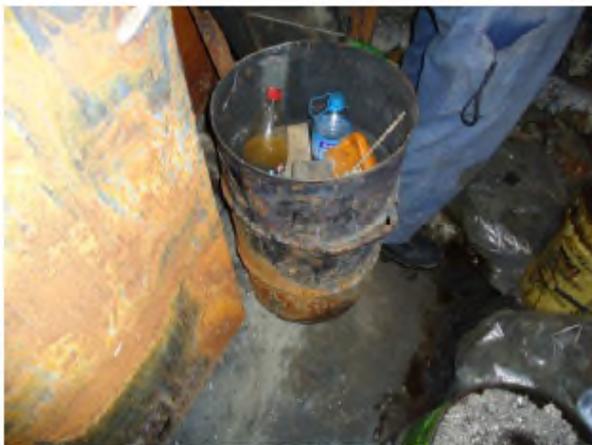
The drum viewed, was reportedly used to hold open the door at the time prior to the fire starting. It was stated that it was approximately half full with oily rags at the time and was placed in the door opening, keeping the door approximately 1/3 open.

The plastic and other debris in the drum at the time of the first attendance, had been deposited, during cleaning up operations, after the area had cooled down and before the operator informed the ship staff to preserve the scene, which had subsequently been cordoned off until arrival at Durban.

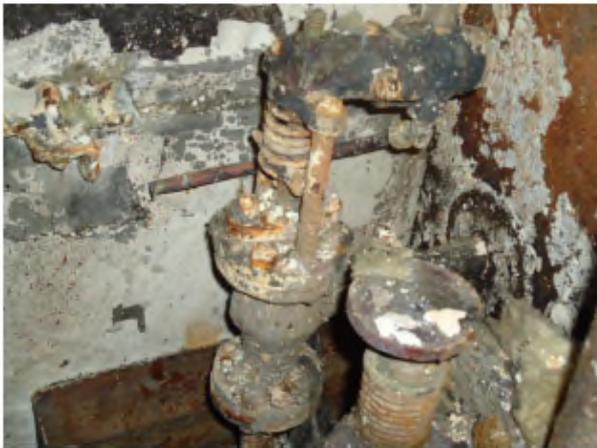
Quick closing valve for diesel tank, noted to be in the open position. (Closing spring still compressed).

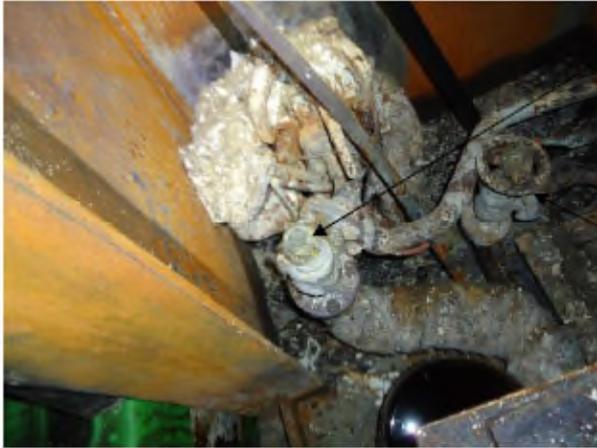
Valve from the waste oil tank to the waste oil filter. The valve was partially melted and appeared to be open.

Valve from the diesel tank, prior to the diesel filter. This valve was confirmed to have been left open.

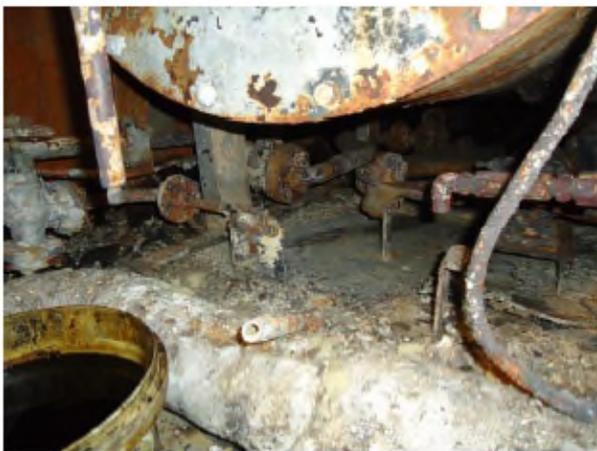
The diesel filter and pump were completely melted / disintegrated. In conjunction with the open diesel valve mentioned above and also viewed on the left, all of the diesel in the tank, was able to run into the saveall under the incinerator and feed the fire

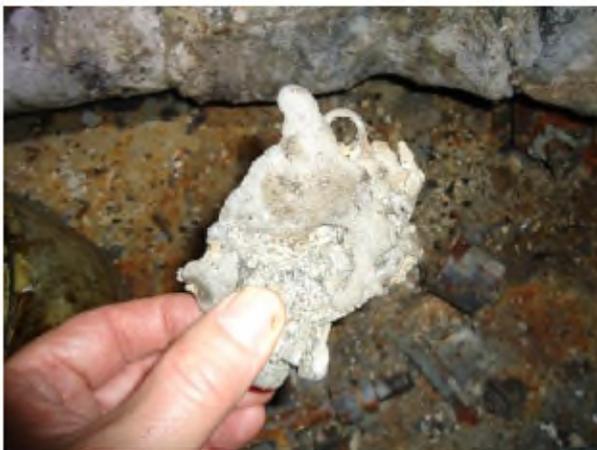
Molten alloy, found under the incinerator, which was presumed to be from the diesel filter.

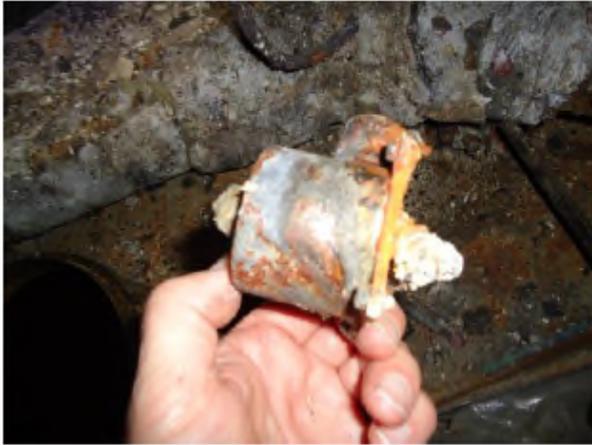
Motor for the diesel supply pump. The pump casing was completely melted / disintegrated.

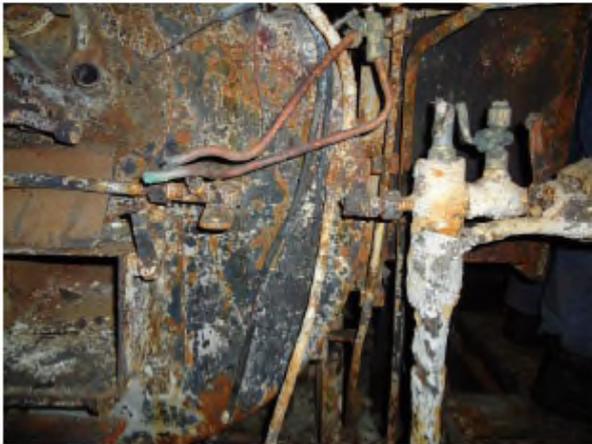
Evidence of non-ferrous piping, including fuel and waste oil piping, having melted.

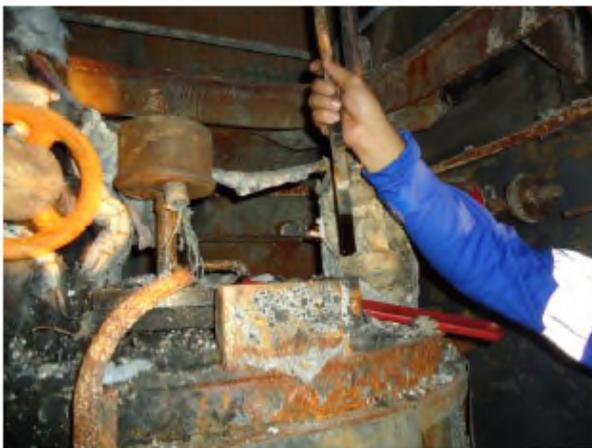
Dipstick level measurement of waste oil tank, indicating less than 50 litres.

Although it is possible that the contents of the tank could have boiled, it is considered more likely that the tank was at approximately this level at the time of the fire commencement, than at the 450 litre level, that was presumed by the 4/E.

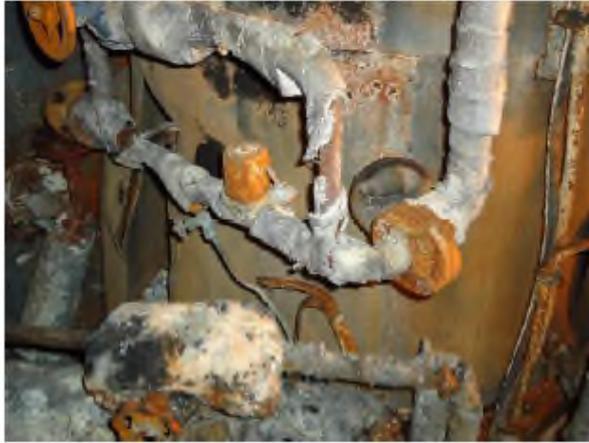
The waste oil tank was fitted with a steam temperature control system, which was reportedly not used. Steam valves were controlled manually, to maintain the temperature at approximately 85 Deg C. Noted that if the tank was at 50 litres overnight, and not the presumed 450 litres, then the temperature may have been higher. However, the absolute maximum temperature achievable by the steam, would be approximately 175 Deg C and the combustion temperature of sludge would be well over 250 Deg C

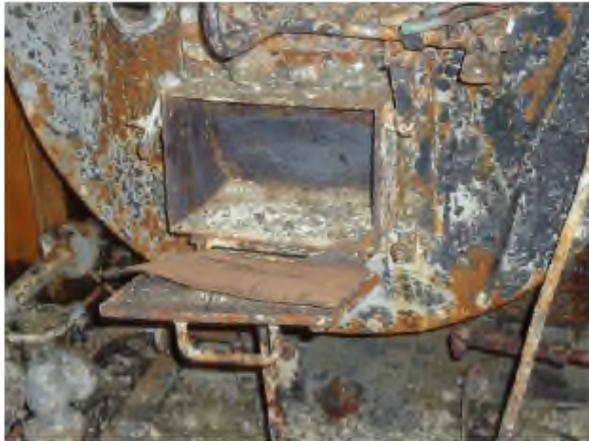
The incinerator was opened initially in the inspectors presence and the state of the locking devices, indicated that it had not been opened since the fire.

The outer door was slightly buckled, however, a flame gauze was in place and the inner flap was effectively closing the opening.

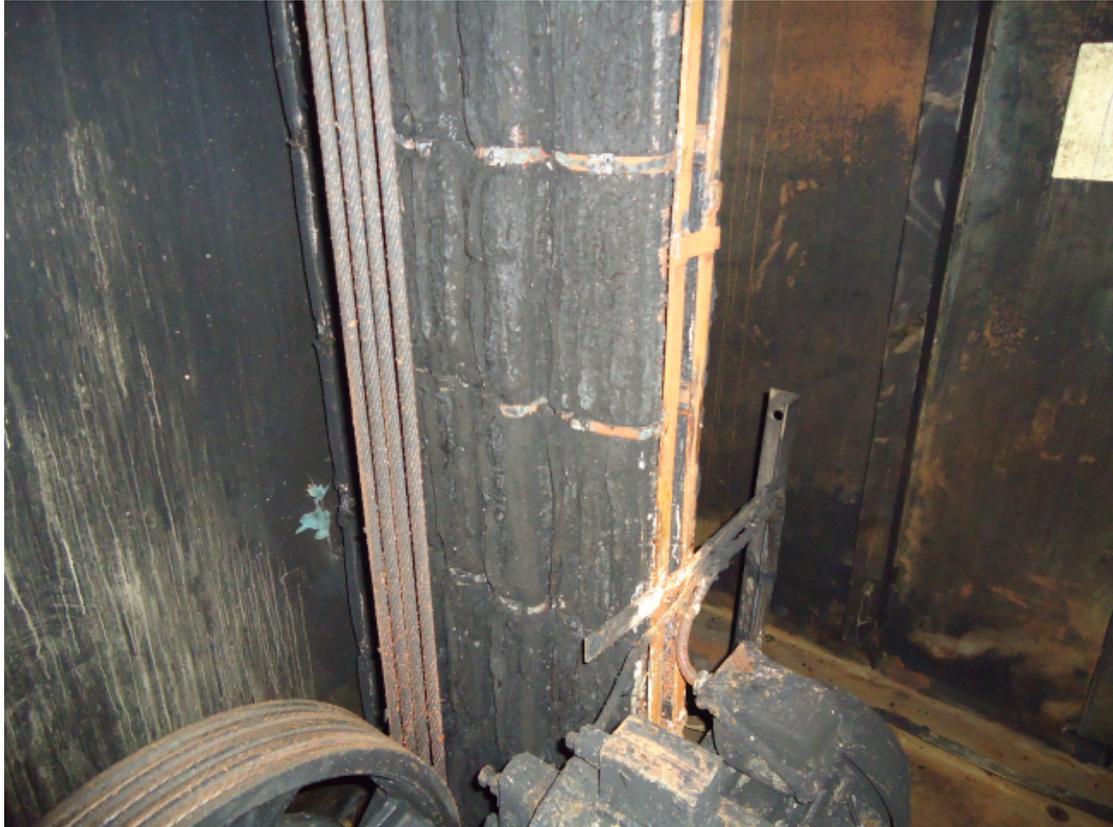
Fire damage electrical cable – adjacent elevator motor.
