# The Bahamas Maritime Authority

### M.V CALEDONIAN SKY

**Report of the marine safety investigation into a grounding  
within Raja Ampat Marine Conservation Area to the  
south of Pulau Gam, Indonesia on 04 March 2017**

Date of Issue: 06 March 2019  
Bahamas Maritime Authority  
120 Old Broad Street  
LONDON  
EC2N 1AR  
United Kingdom

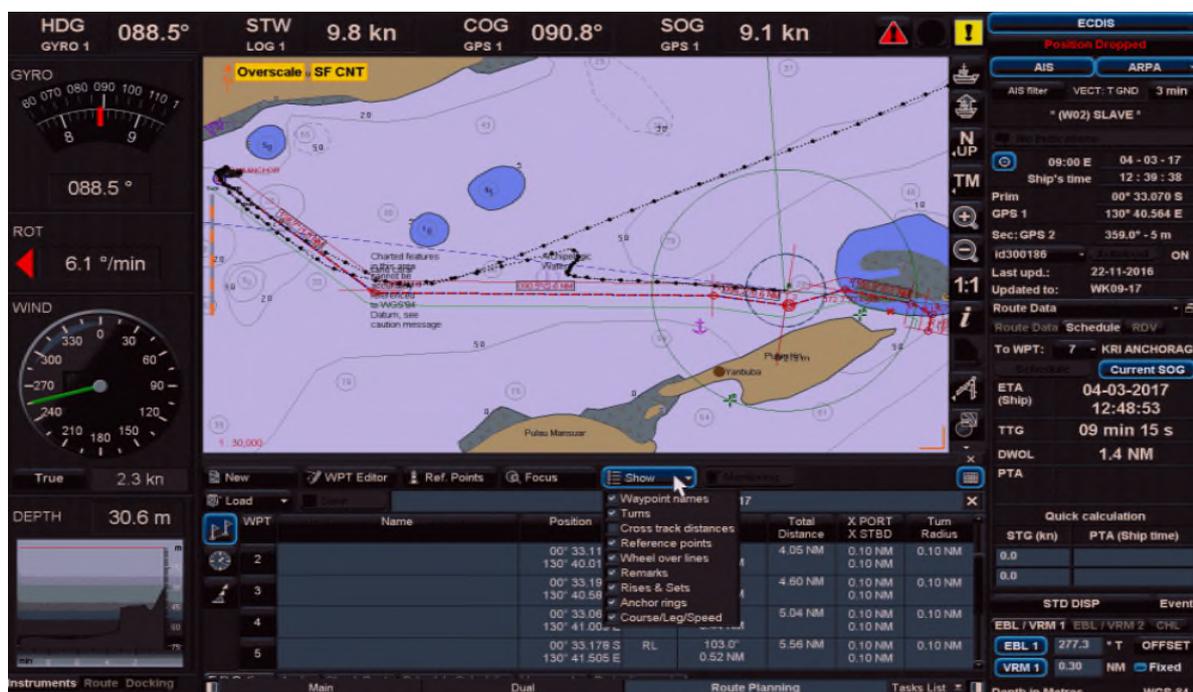
Figure 4: ECDIS screenshot taken moments prior to the grounding at 1239

- 4.14 At 1239 the ECDIS display was zoomed out to display the entire route from waypoint 1 to waypoint 8 (see figure 4).

- 4.15 At 1239:53 the Master was asked by the expedition leader “do you want to come and have a look at this”, referring to shallow water observed visually from the bridge ahead and either side of the vessel. The depth was acknowledged by the Master as 16.1m while the vessel’s speed was steady at 8.8kts on a course of 091°. At this point, the Master ordered port 20°, followed by an acknowledgement that the depth had reduced further to 10m.

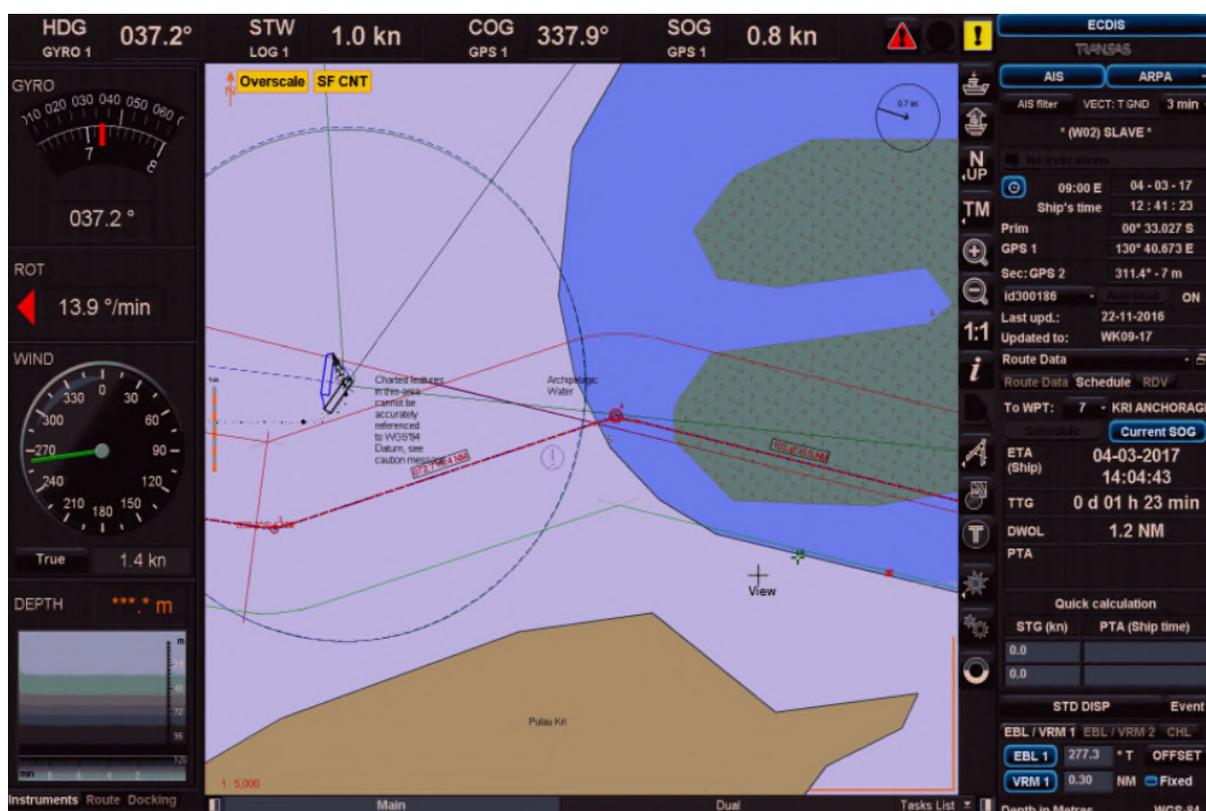
Figure 5: ECDIS screenshot of vessel aground, taken at 1241

- 4.17 Some 23 seconds later, while the vessel’s speed log read 1.4kts, the Master requested ‘all stop’ on the engine control levers. At 1241:08 the Master acknowledges the fact that the vessel was aground in position 00° 33.02S 130° 40.67E, 280yds port of the planned navigation track and approximately 80yds outside the northern most cross-track corridor.

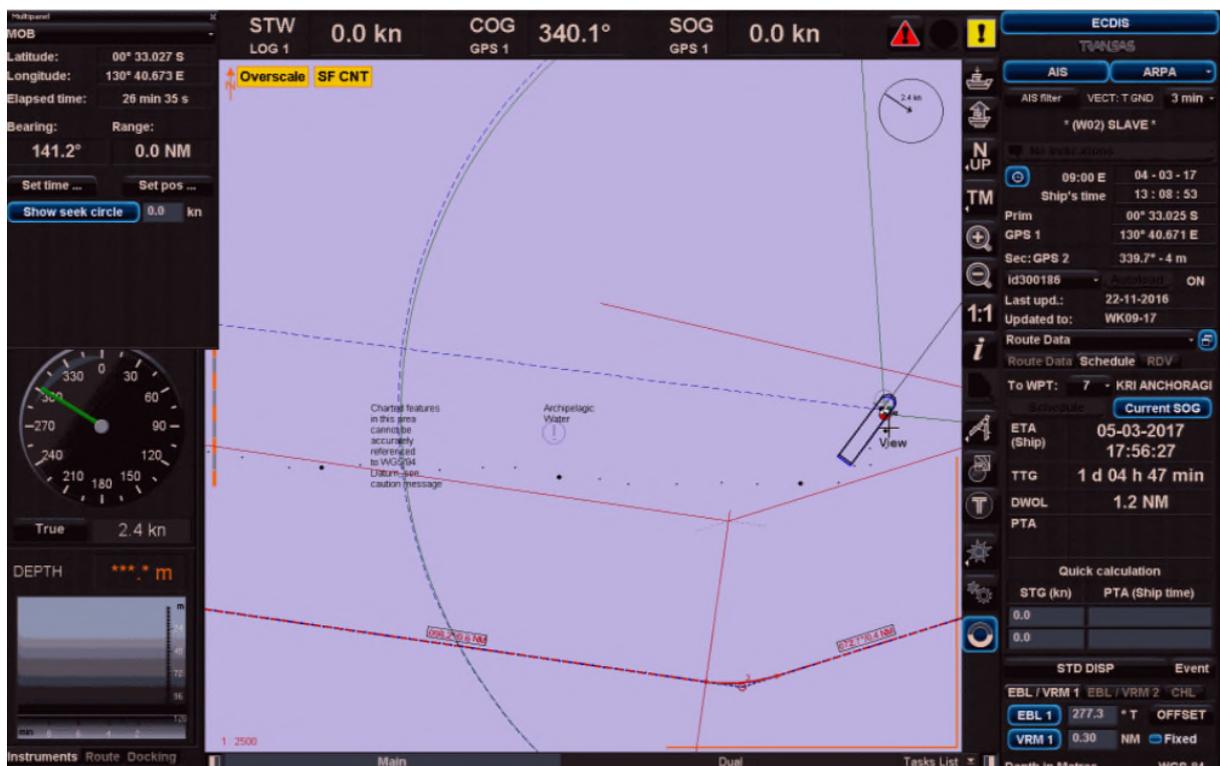
Figure 6: ECDIS screenshot at 1308, at the point where the vessel is hard aground. Note the route taken by the visual markers displayed by small black dots astern of the vessel

- 4.25 At 1306 the expedition leader offered to take a closer look under the vessel using a snorkel which was initially agreed to by the Master. The Master then denied the request due to lifeboats being lowered and engine clutched-in. At 1307, the Master attempted to manoeuvre the vessel again but to no avail.

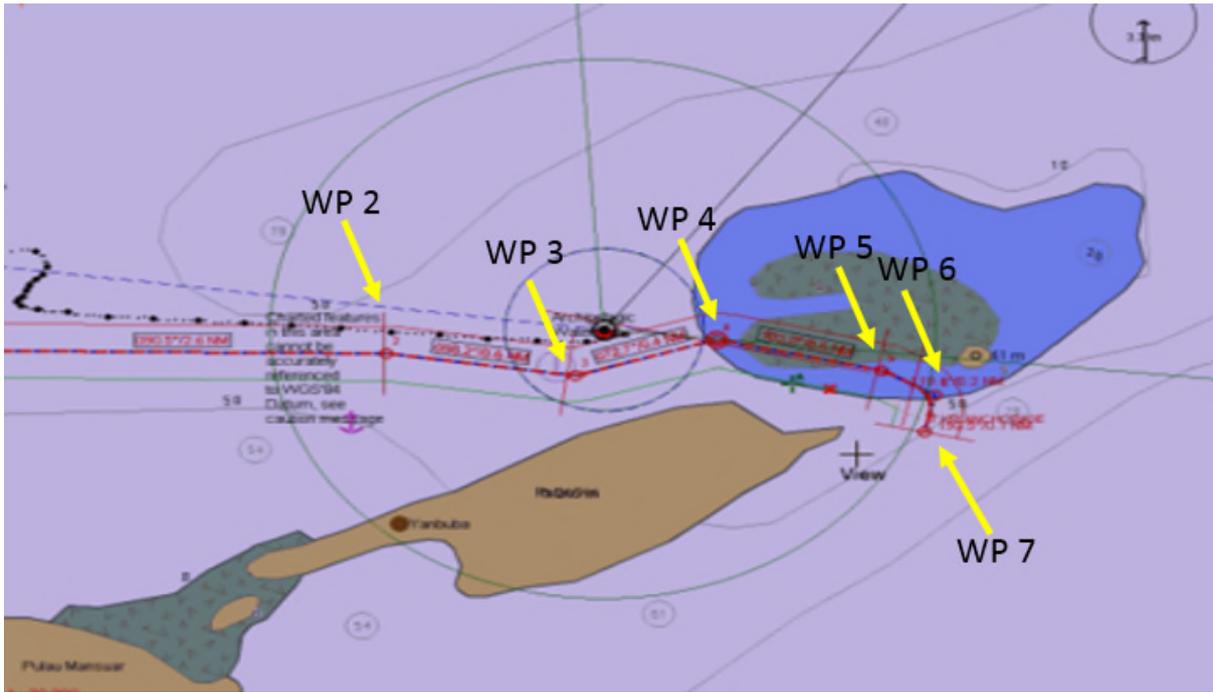
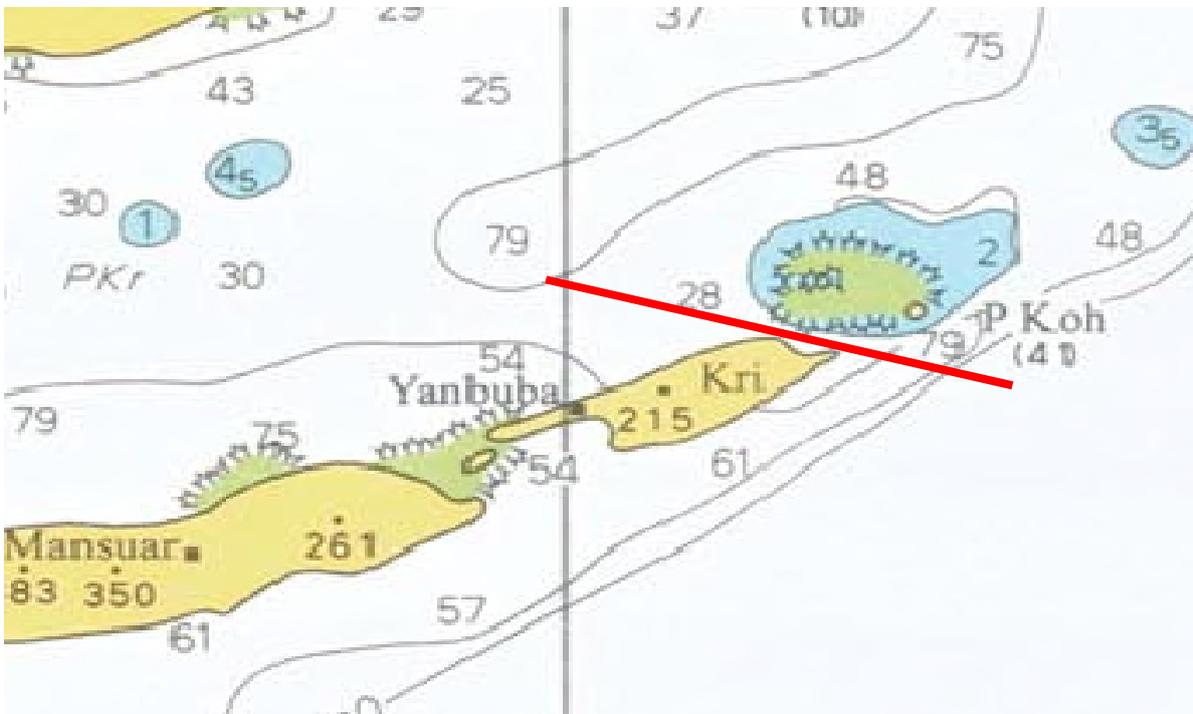
Figure 8: ENC 300186 as displayed on the ECDIS

5.3.4 The paper version of chart 300186 is shown below and although the chart was not present on board, a copy of the area is shown below within figure 9 demonstrating the equivalence of the same chart in a different format.

Figure 9: Local Indonesian paper chart 186 and for illustration purposes, the safe water between the eastern most reef and Pulau Kri

- 6.3 The charted information contained on the charts held on board within the chart folio, and those charts produced but not held on board, fail to identify the reef in which the vessel grounded. Although the extended drying height and in general deficient charted detail on all charts for the precise region, demonstrates the overall lack of confidence of the charted area, there is no way of knowing the exact location of the reef which the vessel struck, based solely on charted data.

- 7.5 It is highly recommended that a hydrographic survey of the region is conducted in order to update the nautical charts in order to inform mariners of the precise location of underwater hazards so as to improve navigational safety and efficiency in the region.

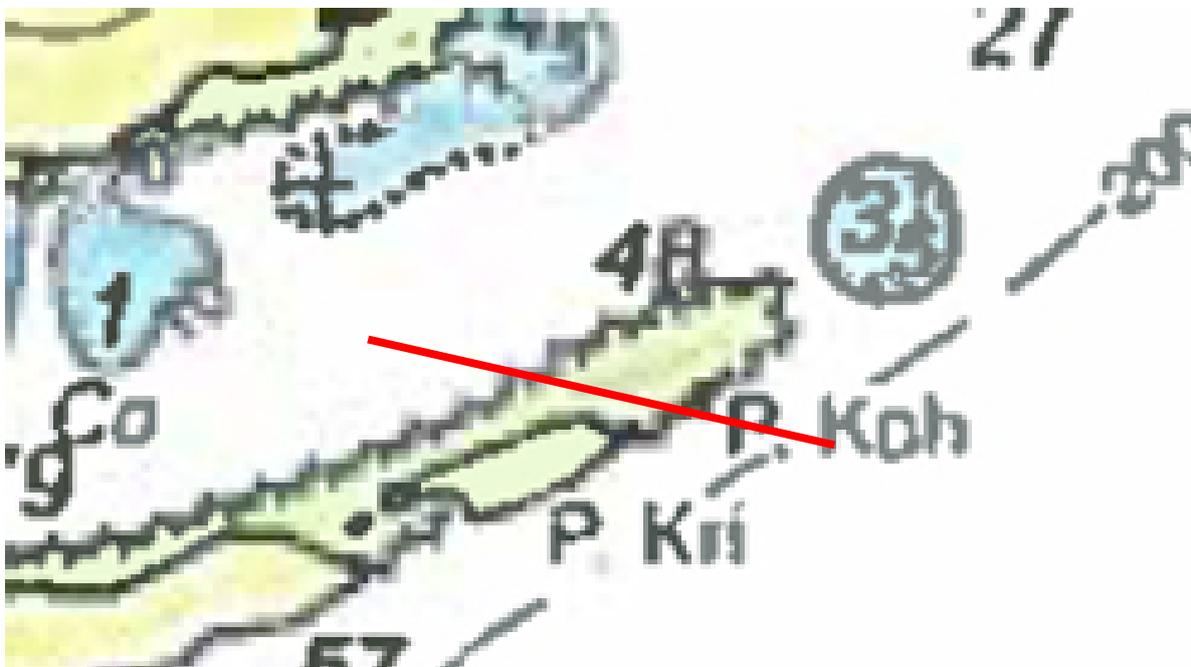
Figure 10: Chart 3923 illustrating drying height at the eastern end of Pulau Kri

- 5.3.6 It is advisable and common practice to use all available means when planning a navigational passage. This is discussed within the International Chamber of Shipping Bridge Procedures Guide section 2.4 which states: *‘that during the planning stage of a passage, the appraisal of all charts, nautical publications and additional information should be used to prepare a passage plan’*. A cross-reference of the two charts would have identified a significant discrepancy. As seen within figure 10, the drying height surrounding Pulau Kri is significantly larger than that shown on chart no. 186. This drying height extends the length of the island and does not show the narrow channel between the eastern most shoal.

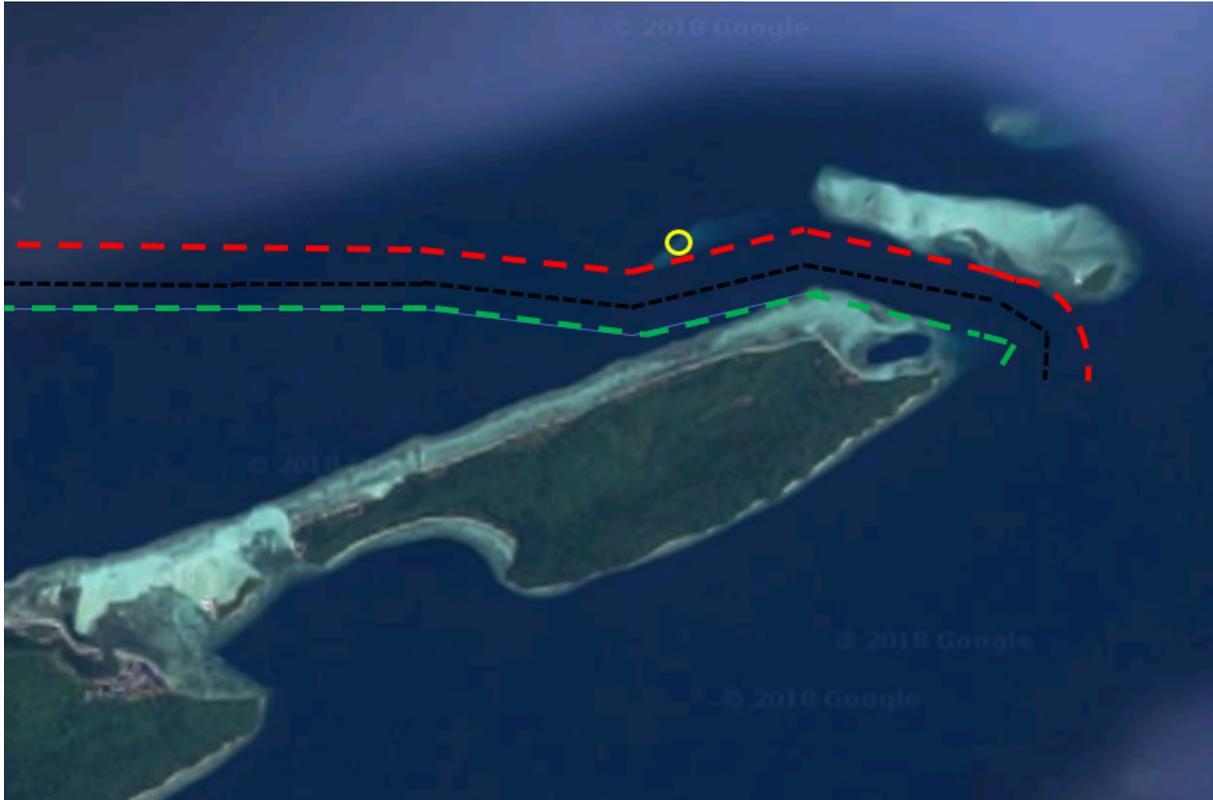
Figure 11: Satellite imagery of Pulau Kri and adjacent drying heights and location of the grounding as indicated by the yellow circle (Source: Google Maps 2018)

- 5.3.7 A satellite image of Pulau Kri shows a number of reefs and the available water to the east in which the vessel intended to sail. An overlay of the vessel’s intended track and cross-track corridor has been placed on top of the satellite image. As shown, the intended track, if followed would have resulted in the vessel’s safe passage to the intended anchorage south of Pulau Kri.

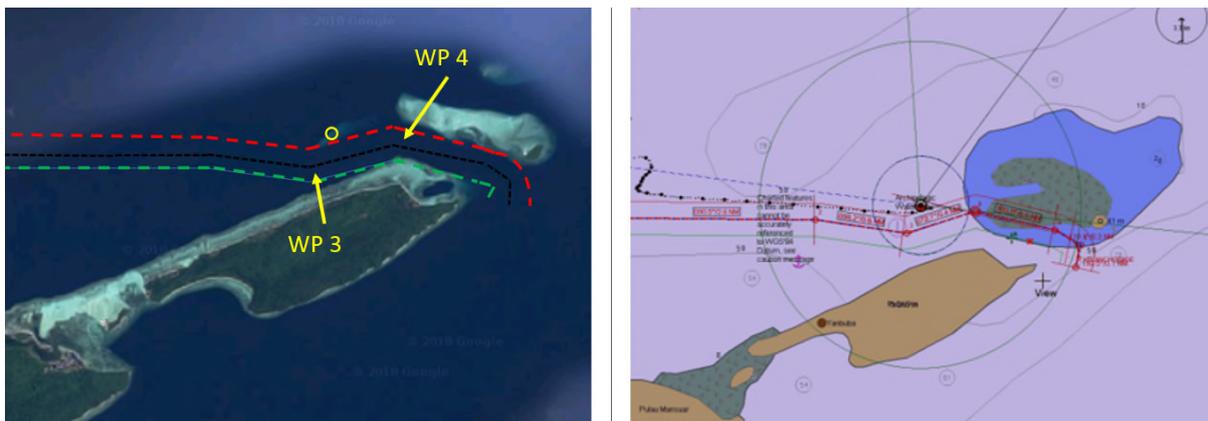
Figure 12: Comparison between satellite imagery and nautical chart 300186 used for navigation against the vessel’s track

5.4.2 The primary objective of the passage plan<sup>13</sup> is to determine if the route is safe and achievable. If the passage is deemed unsafe the Master has ample time to adjust the passage to ensure the risk is as low as reasonably practicable. This particular route was chosen based on scanty information. The route was previously undertaken in November 2016 by a different Master but with the same Navigator. Aside from the track, no further details were provided from one Master to another. This was a significant contributory factor in the grounding of the vessel. The Master relied heavily on the Navigator for this passage as he had experience having completed this route some four months prior. The single danger was identified as passing between the eastern edge of Pulau Kri and the adjacent shoal patch. At no stage was it considered that the chart data in the region was poor and therefore this route should be avoided in its entirety or the previous track should be followed meticulously due to the lack of accurate chart data.

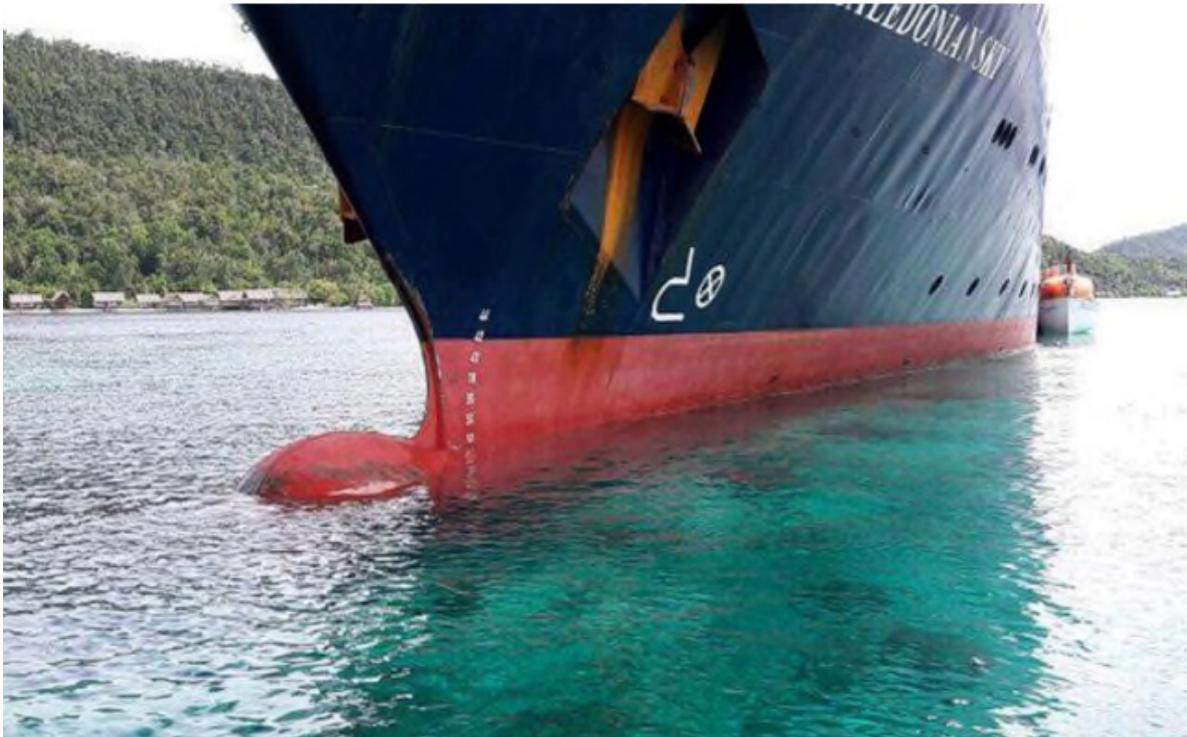
- 5.6.2 The vessel was considered to be bodily aground in that the majority of the hull was in contact with seabed and the vessel was sat in an even keel condition. An occasional survey of the hull was conducted by the vessel’s classification society to determine and obtain a damage assessment of the hull. The evidence provided by the Class approved independent dive company, Yusen Navtec, consisted of photographs and a written report describing the damage sustained. The Class report stated the following *“Not found any serious damage affected to Class Rule”*.

- 5.6.3 As depicted in figure 14, the vessel came to rest on the seabed between frames 10 and 100. The remainder of the hull appeared to have no signs of damage.

**Figure 14: Caledonian Sky aground on the reef with lifeboats in the water**

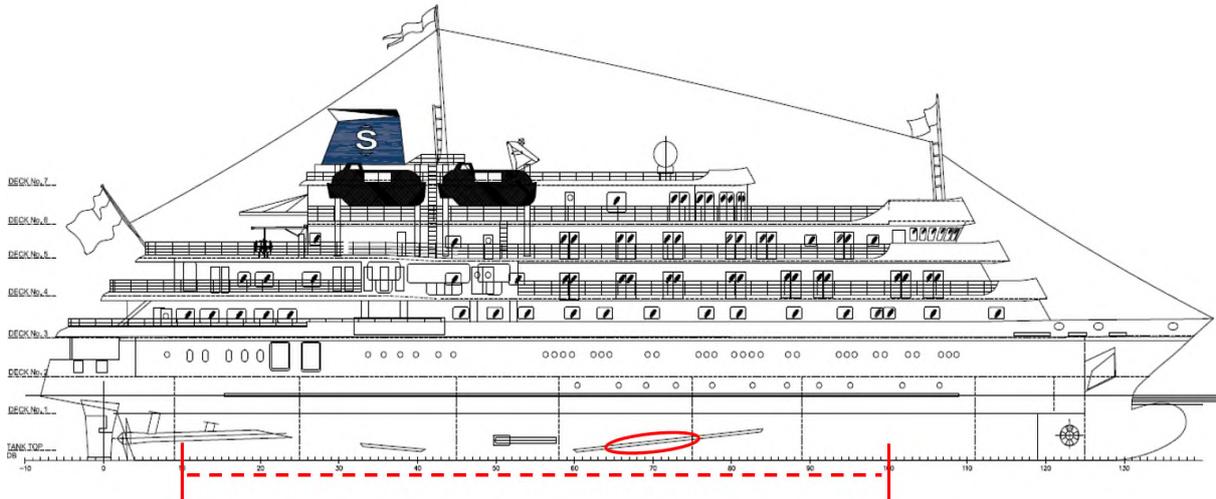
- 5.6.1 The reef had the following seabed characteristics which consisted of rock, sand and coral. As a consequence of the grounding, the vessel sustained damage to the hull in the form of intermittent compression, minor damage to bilge fin and removal of anti-foul paint between frames 10 to 100. At no point was the hull punctured or water tight integrity compromised.

Figure 15: Damage sustained to beneath the waterline

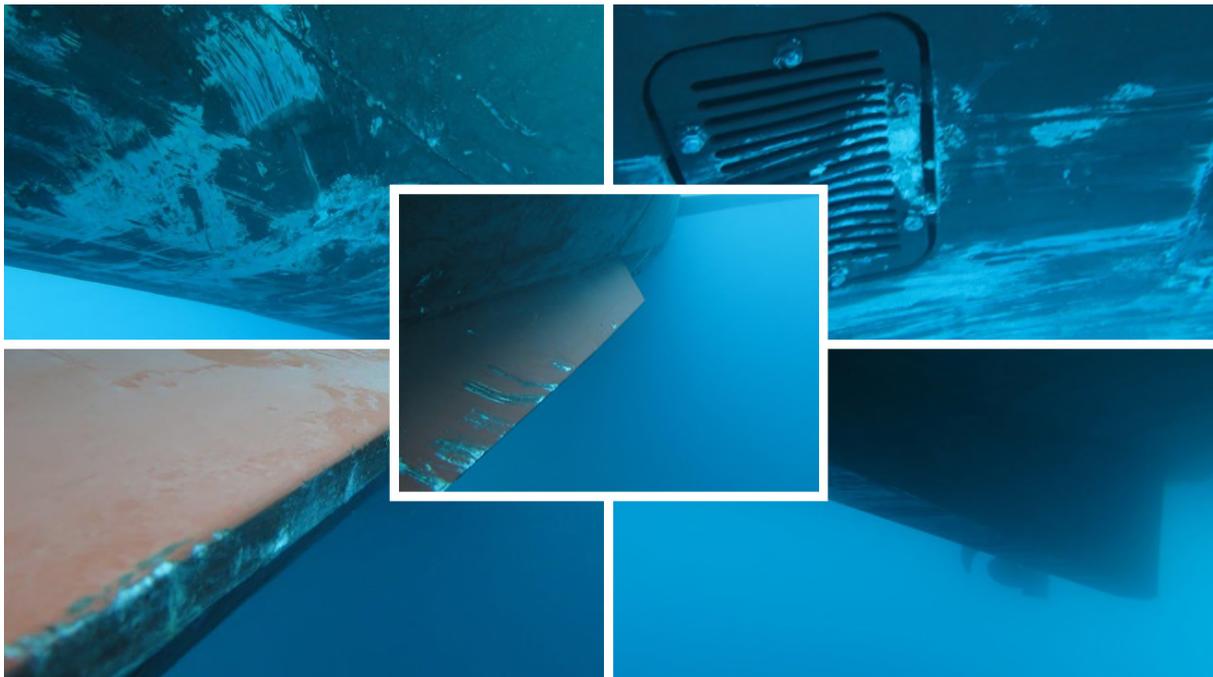
Figure 16: Hull damage

5.6.4 The pictures of the hull shown within figure 16 indicates the type of damage sustained to the hull and bilge fin. Scratches can be seen along the majority of the hull between frames 10 and 100 and intermittent compression against the aft longitudinal rib in vicinity of frame 70.

- 6.9 The seabed characteristics combined with the shallow angle of approach of the hull against the reef at the point of initial impact, resulted in only minor damage being sustained. This is evident by the fact that the hull was not penetrated and therefore no pollution was expelled from the vessel. Significant damage to the reef was reported
