M.V CELTICA HAV

**Report of the marine safety investigation into a grounding
in the approaches to the River Neath, Wales on 27 March
2018**

Grounding of general cargo vessel *Celtica Hav* in the approaches to the River Neath, Wales 27 March 2018

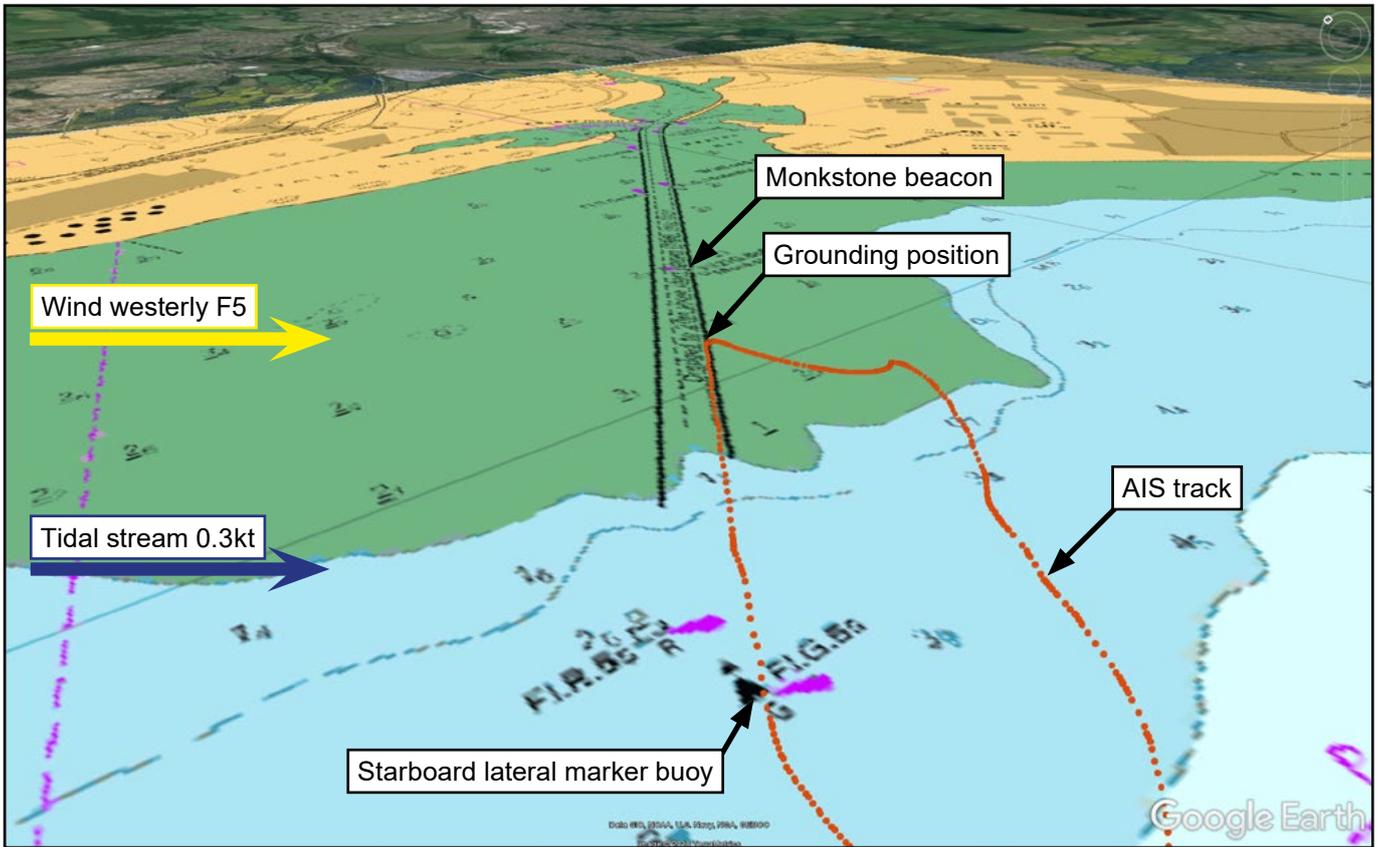
Figure 2: Track of *Celtica Hav*

At 1438, the ship left the dredged channel and grounded on the training wall (**Figure 2**). The vessel scraped along the top of the training wall for about 200m before coming to a stop in a position about 600m from the Monkstone light beacon (**Figure 3**). The master stopped the vessel's engine and ordered the crew to conduct a damage assessment. Due to the rising tide potentially causing the ship to scrape further along the wall resulting in more damage, the decision was made to refloat the vessel immediately.

It was also evident from *Celtica Hav*'s Automatic Identification System (AIS) track that the pilot made his turn into the approach channel close to the starboard fairway buoy. As a result, a significant course correction was required to turn the vessel onto the centreline of the dredged channel, which was not made. The pilot's previous inbound solo act of pilotage was undertaken on 26 December 2017 on board the general cargo vessel *Eems Spirit*, which was a similar size to *Celtica Hav*. On that occasion the pilot passed close to the starboard fairway buoy and manoeuvred the vessel into the centre of the approach channel before it reached the seaward end of the training walls.

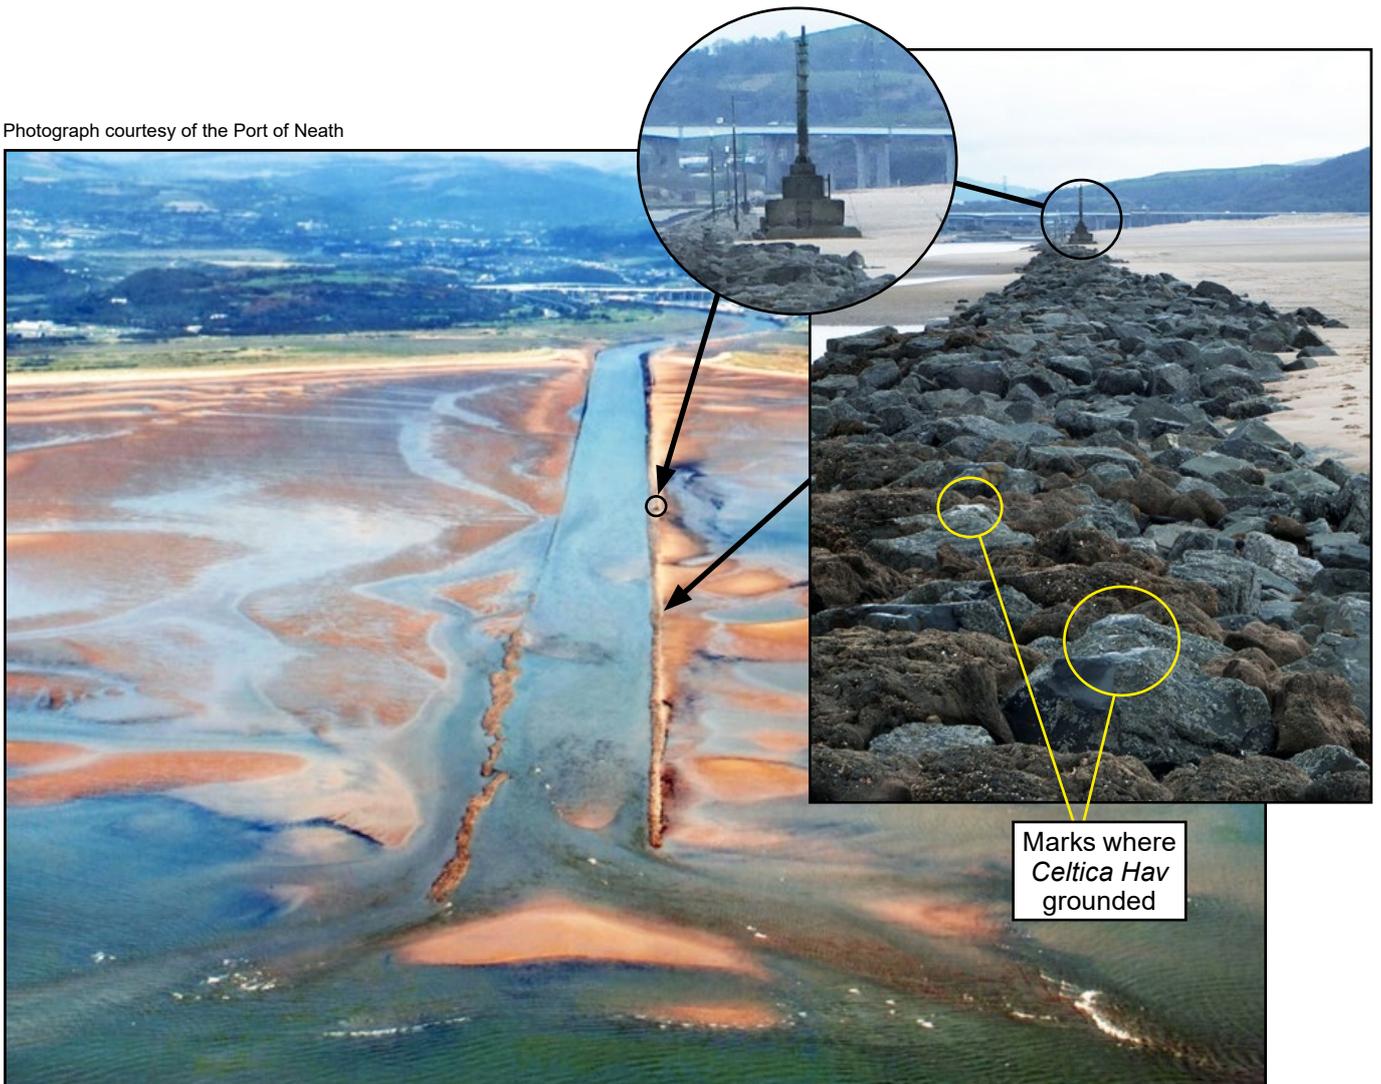
Figure 3: Approach channel to River Neath (insets showing the training wall and Monkstone beacon)

The River Neath approach channel training walls were constructed of granite blocks. They were about 1.8 miles long; the distance between them was about 75m; and they gradually increased in height towards the shore end. The training wall on the east side of the channel, where *Celtica Hav* grounded, protruded between 1m and 1.5m above the seabed.

Each training wall was marked by three steel beacons and 14 intermediate posts. The beacons and posts were painted green on the eastern training wall (inbound, starboard) and red on the western training wall. The beacons exhibited flashing green lights on the eastern wall and flashing red lights on the western wall. The intermediate posts were unlit, but each was fitted with a radar reflector. The walls were submerged at high water but exposed at low spring tide along their whole length. They were regularly inspected by the harbourmaster and pilots. The beacons and posts were routinely painted every 5 years, and this was last done in 2014.

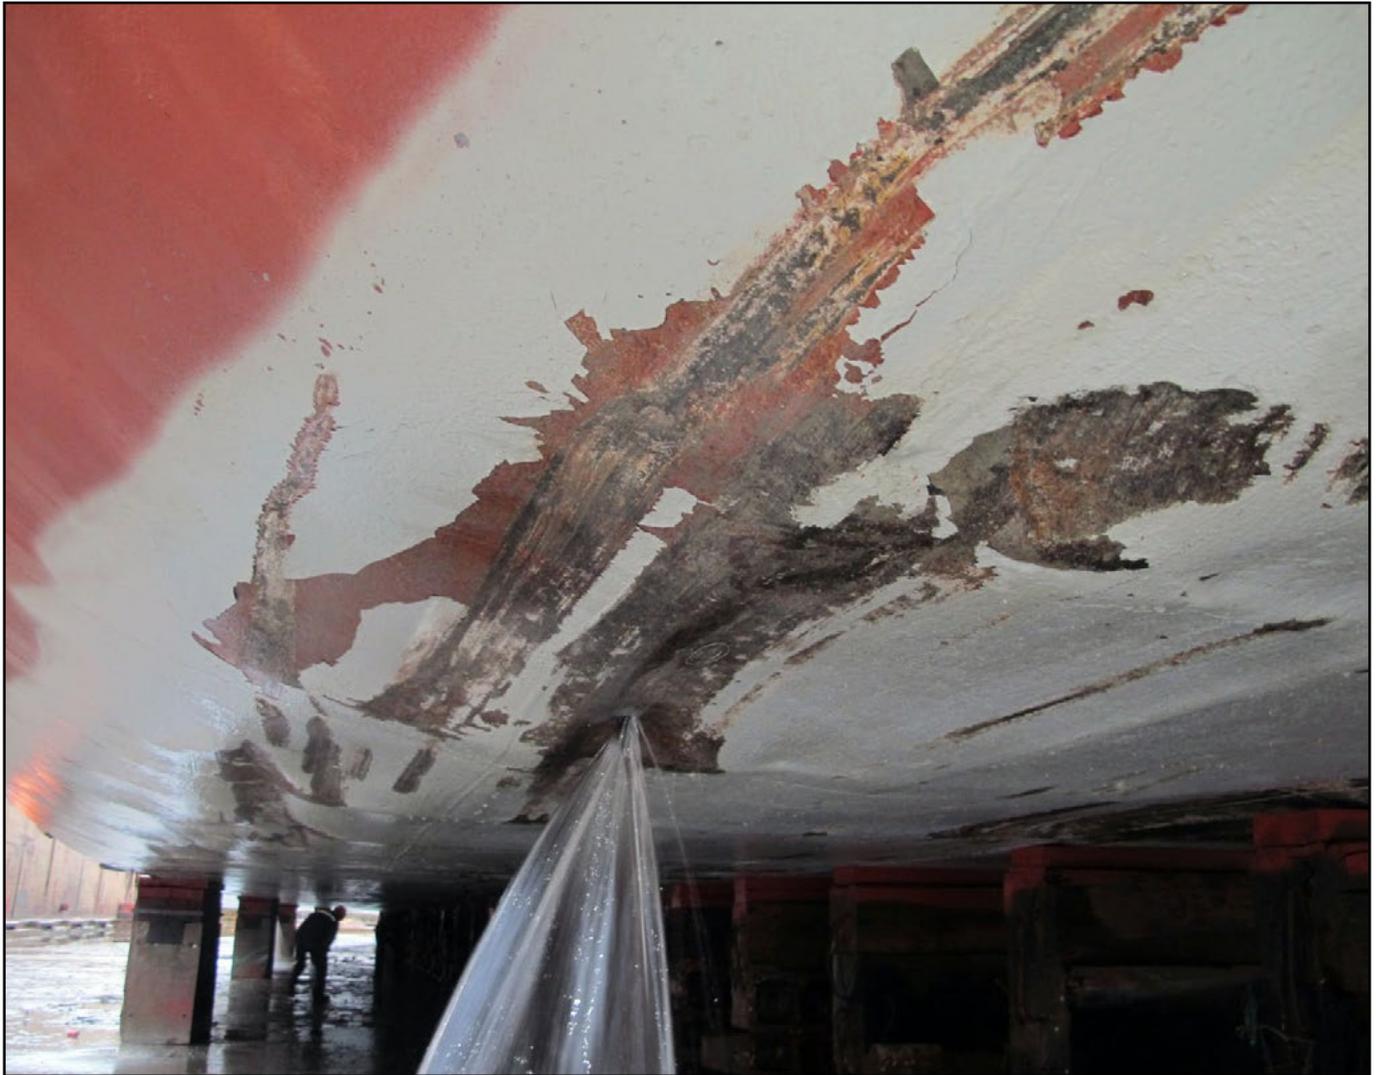
Figure 4: *Celtica Hav* hull damage

The crew's initial damage assessment identified that the hull had been breached in several locations and water was flooding into the vessel's starboard ballast tanks and engine room (Figure 4). As the breached ballast tanks began to fill *Celtica Hav* started to list to starboard. Following discussions with his chief engineer, the master decided to allow the tanks to fill, and to use the vessel's bilge and ballast pumps and two portable salvage pumps to control the level of floodwater in the engine room.

Due to the location and size of the hull breach in the engine room, the master considered it too dangerous for the crew to attempt to stem the inflow of water and decided to monitor the level instead. With the aid of an additional five submersible pumps provided from ashore by the harbourmaster, the level of water to the engine space began to drop and *Celtica Hav's* list steadied at 6°.

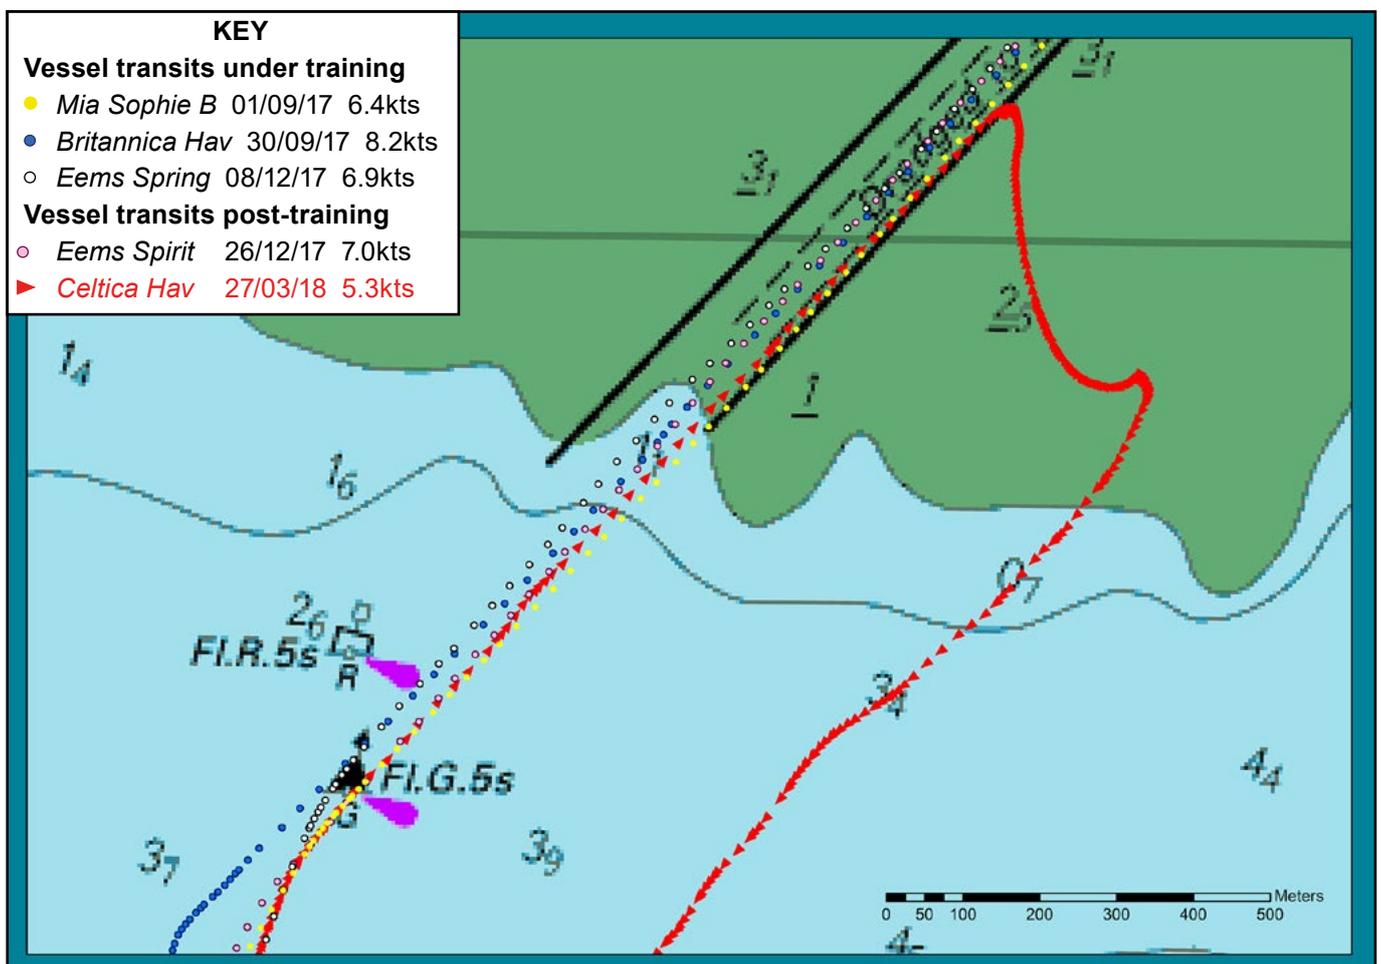
Figure 5: Tracks of inbound vessels

A review of the inbound acts of pilotage conducted by the pilot, under the supervision of the senior pilot, during his accelerated training programme, showed that vessels were frequently piloted close to the starboard fairway buoy (**Figure 5**). On 1 September 2017, the general cargo vessel *Mia Sophie B* was navigated outside the starboard limits of the dredged channel and along the top of the submerged training wall (**Figure 5**). Fortunately, on that occasion the vessel was brought back into the channel just before it reached *Celtica Hav*'s grounding position.

Because the height of the training walls above chart datum was not known, at no time was it safe to allow a ship to pass over them. As there is plenty of sea room to the south-west of the approach channel, it would be prudent to line vessels up further to seaward before making an entry. This would avoid the need to make substantial course alterations around the starboard fairway buoy, and therefore reduce the risk of similar groundings. This approach was demonstrated during the pilot's training on board *Celtica Hav*'s sister vessel *Britannica Hav* (**Figure 5**).
