## Bahamas Maritime Authority

**Report of the investigation into  
the grounding of  
HEDLO  
on Urter Island, Norway,  
25 December 1999**

Date of Issue : 16 February 2001

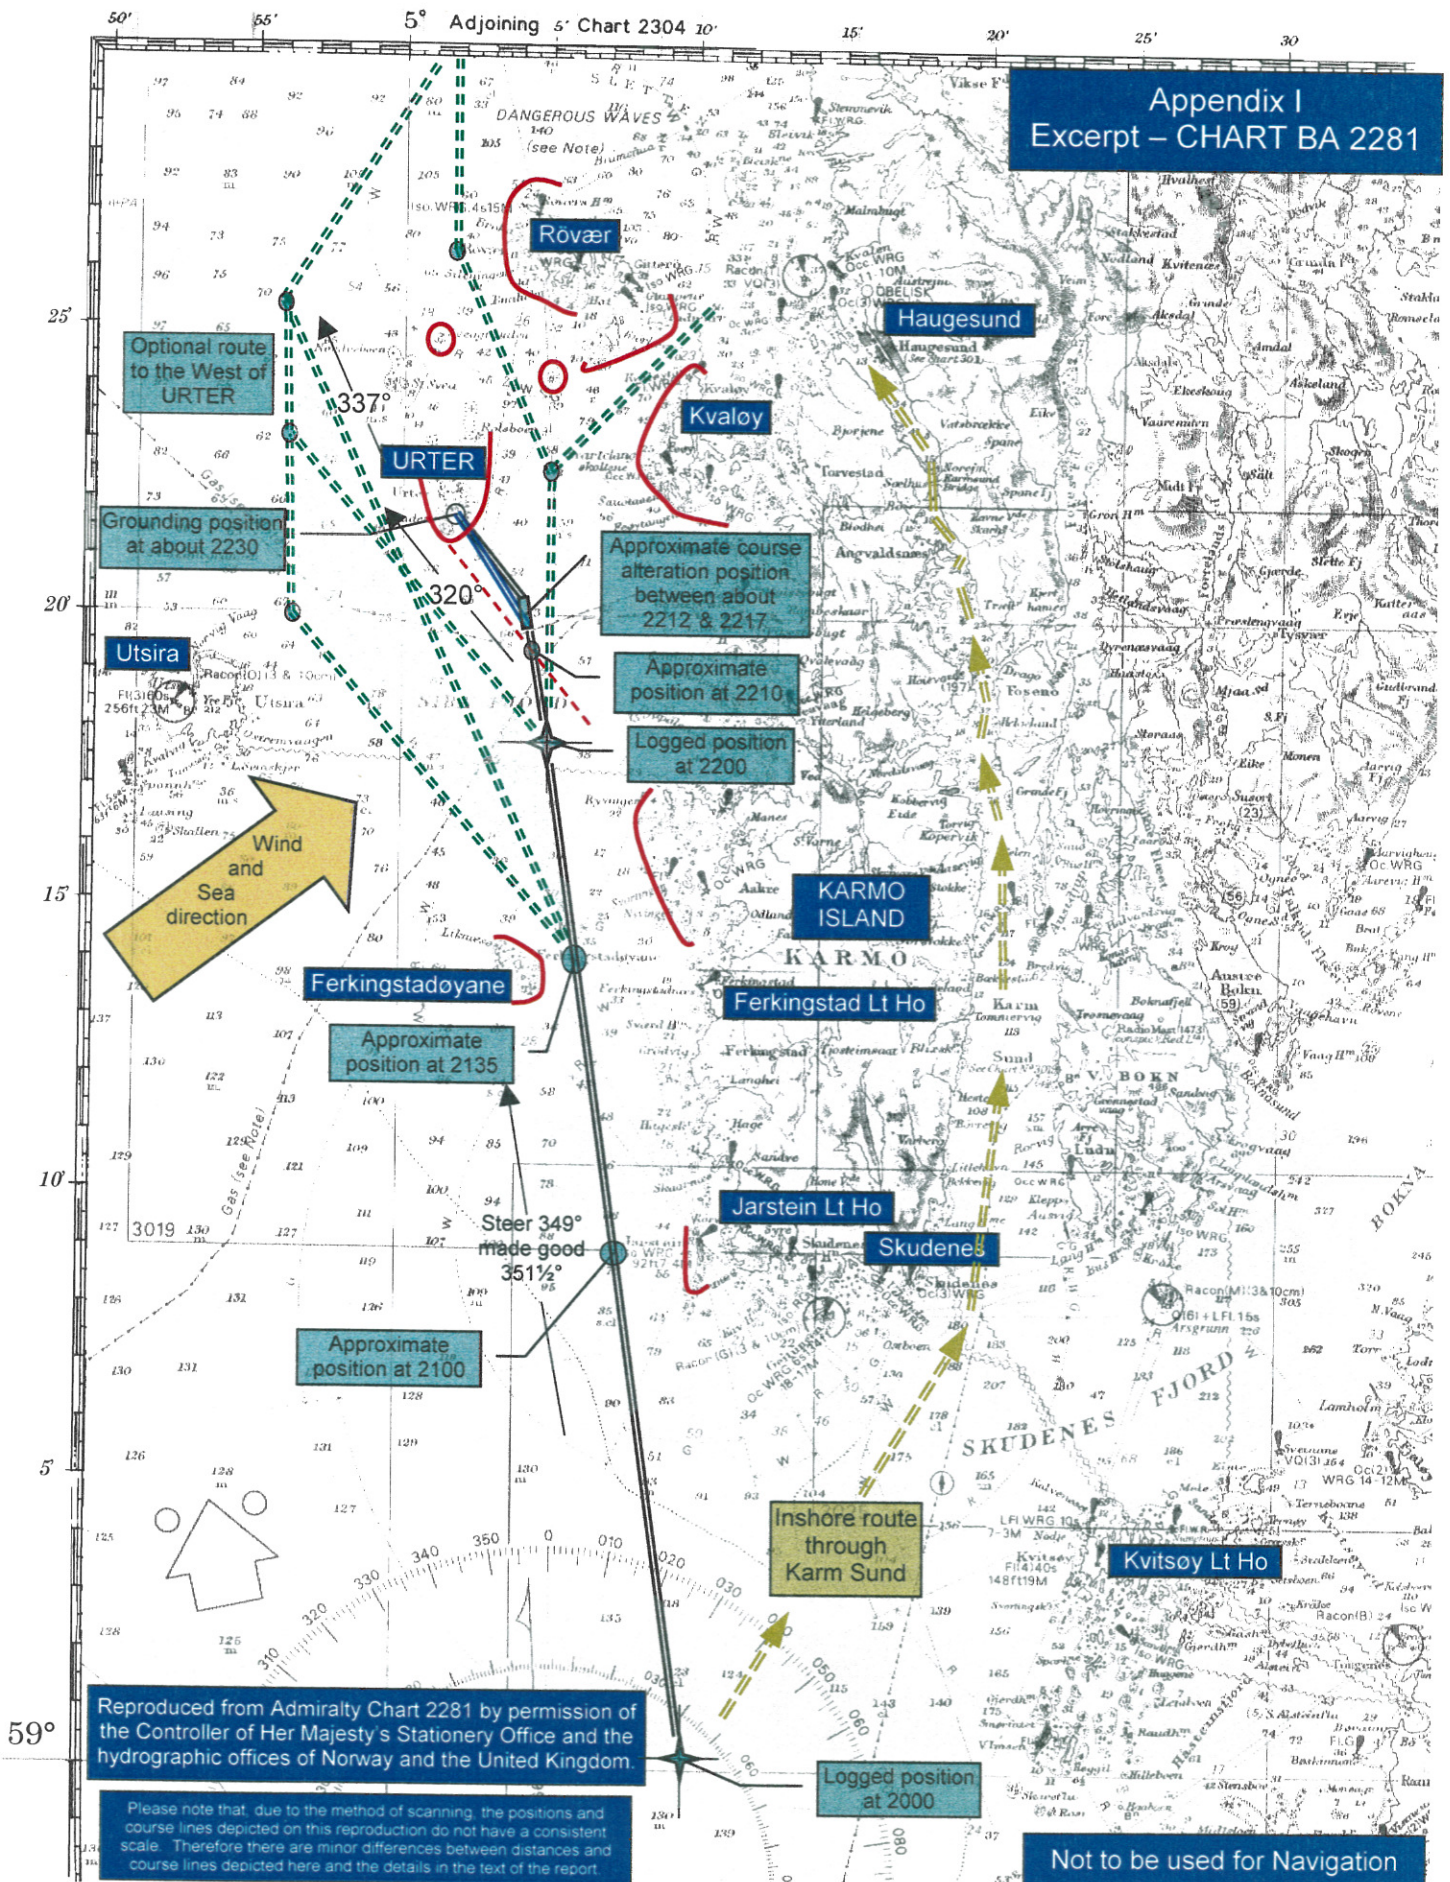
• A **solid double black line** to indicate the route followed by the vessel between the logged positions of 2000, 2200 and where the vessel grounded. This is supplemented by a similar short **solid double blue line** to indicate the route had the vessel been subjected to the set and leeway discussed in paragraph 4.3.2.
-

• The **solid red lines** mark approximate zones of rocks and dangers adjacent to the course that was followed.
-

• The **olive green double dashed line** approximately indicates the inshore route to Haugesund and beyond that passes through Karmo Sund.
-

• The **dashed double green lines** indicate possible courses that could have been followed by the vessel to avoid the dangers of the area. (These are discussed in section 4.7 of this report.)

- 4.4.2 When a 320° line is plotted back from the danger area to the South West of Urter Island (shown as a red pecked line on the charts of Appendix I) it can be seen to intersect the projected 2000 to 2200 course line at a time of about 2210. The vessel would have then been about three nautical miles from the Island. It is therefore evident that had the vessel made good a course of 320°, after that time, without any set or leeway having effect, it would still have run aground on some part of the island.

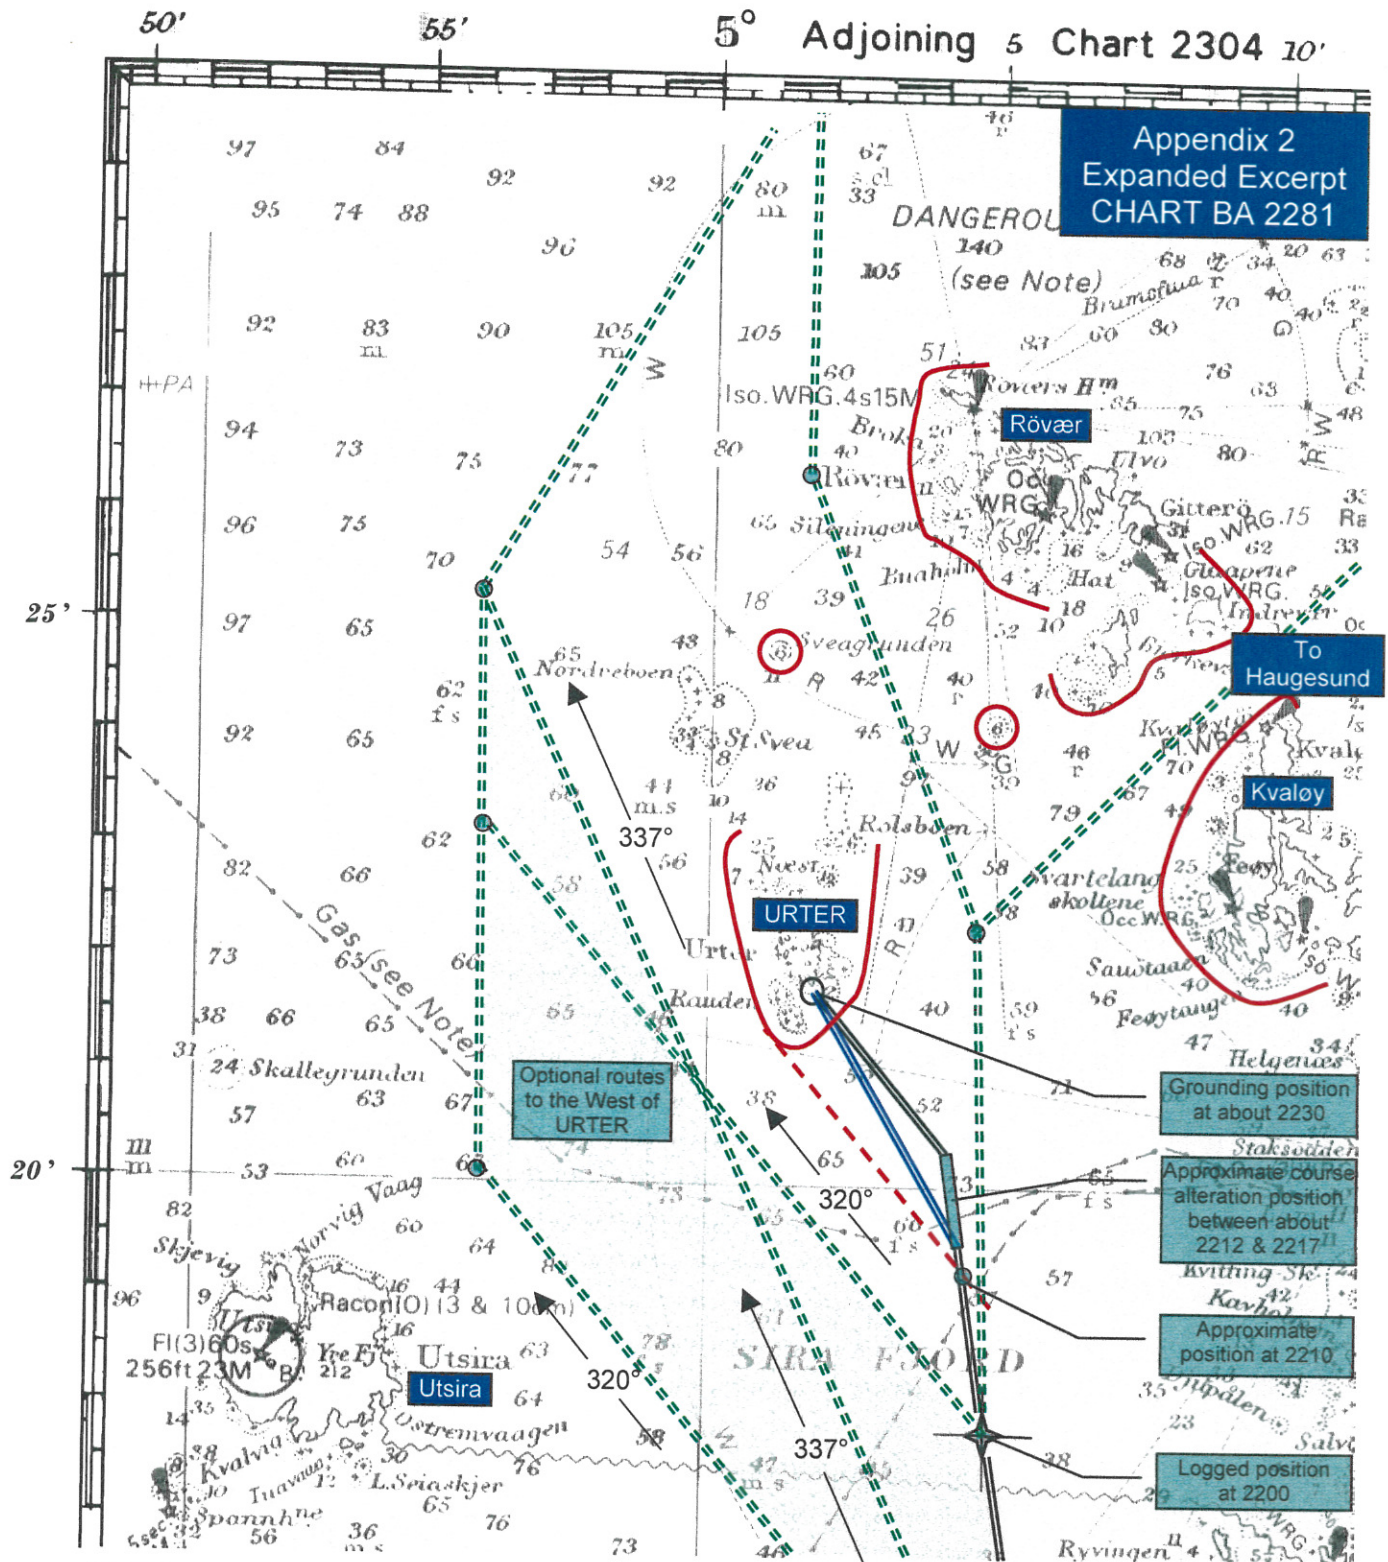
The dashed double green lines indicate possible courses that could have been followed by the vessel to avoid the dangers of the area. (These are discussed in section 4.7 of this report.)

- Alter course to port, in order to pass to the West of Urter Island, then proceed to the North before altering to starboard to approach Bergen. Had such an alteration been made soon after passing Ferkingstadøyane, a course of about 337° would have been sufficient to pass at least one nautical mile to seaward of Urter. Alternatively, to achieve the same effect, a course alteration to 320° (the same course that was eventually adopted prior to the grounding) taken any time up to 2200, would have taken the vessel within the shaded area on the charts in the Appendices.

- From the 2200 position, steam towards Rövær Island light, heading approximately North within the white sector of the Island light, and to the East of Urter, after which altering course to port to pass to the West of Rövær Island, taking care to avoid the two six fathom (11 metres) patches.
- From the 2200 position, steam towards Rövær Island light, heading approximately North within the white sector of the Island light, and to the East of Urter after which altering course to starboard to pass close to the North West of Kvaløy Island, joining the inshore route towards Bergen that passes close to Haugesund.
