**The Bahamas
Maritime Authority**

**Report of the investigation into
the grounding of
*M/V Mona Lisa***

at the Irbe Strait, Latvia

**on
04th May 2008**

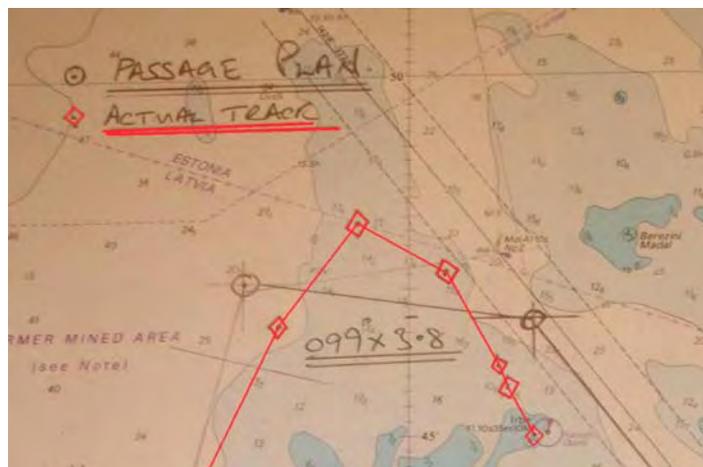
- 3.5.7** According to the statement from the Quartermaster, an alteration of course to 150° was ordered by the Chief Officer, a review of the AIS data indicated that the alteration was made at about 0709 hours. In his statement, the Chief Officer said he had intended to alter course to 130°, but instead ordered a course alteration to 150°.

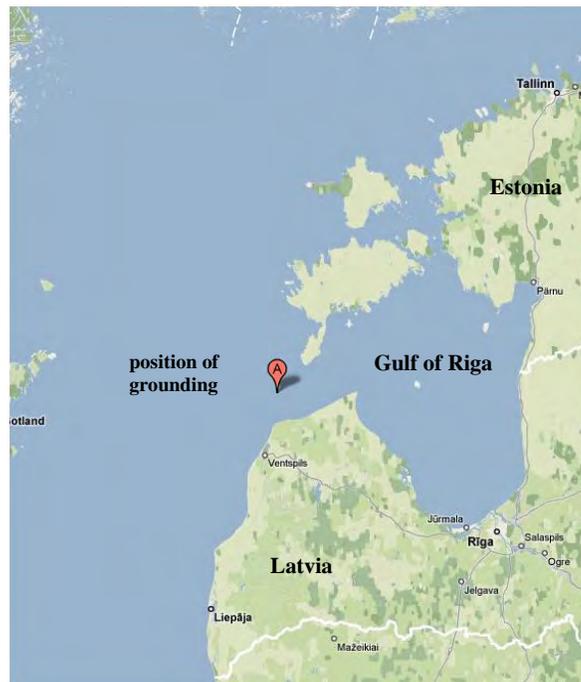
- 3.6.1** On 04th May at 0725 hours the vessel ran aground in position LAT 57°45.0 N and LONG 021°43.0 E; at the distance of 0.24 miles, bearing 061° to Irbe Lighthouse, at the charted depth of 5 m

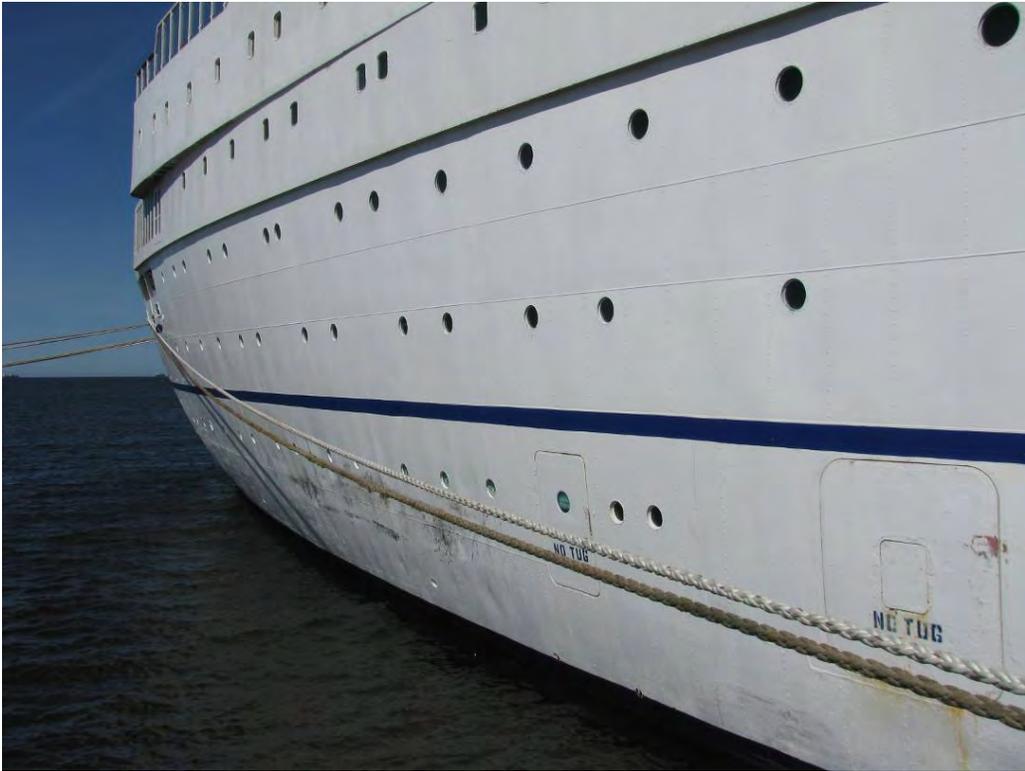
3.8.3 It was noted the shell plating locally rubbed and set in above waterline in the starboard quarter probably due to the tugs pushing during refloating operations.

Outer shell plating in starboard quarter

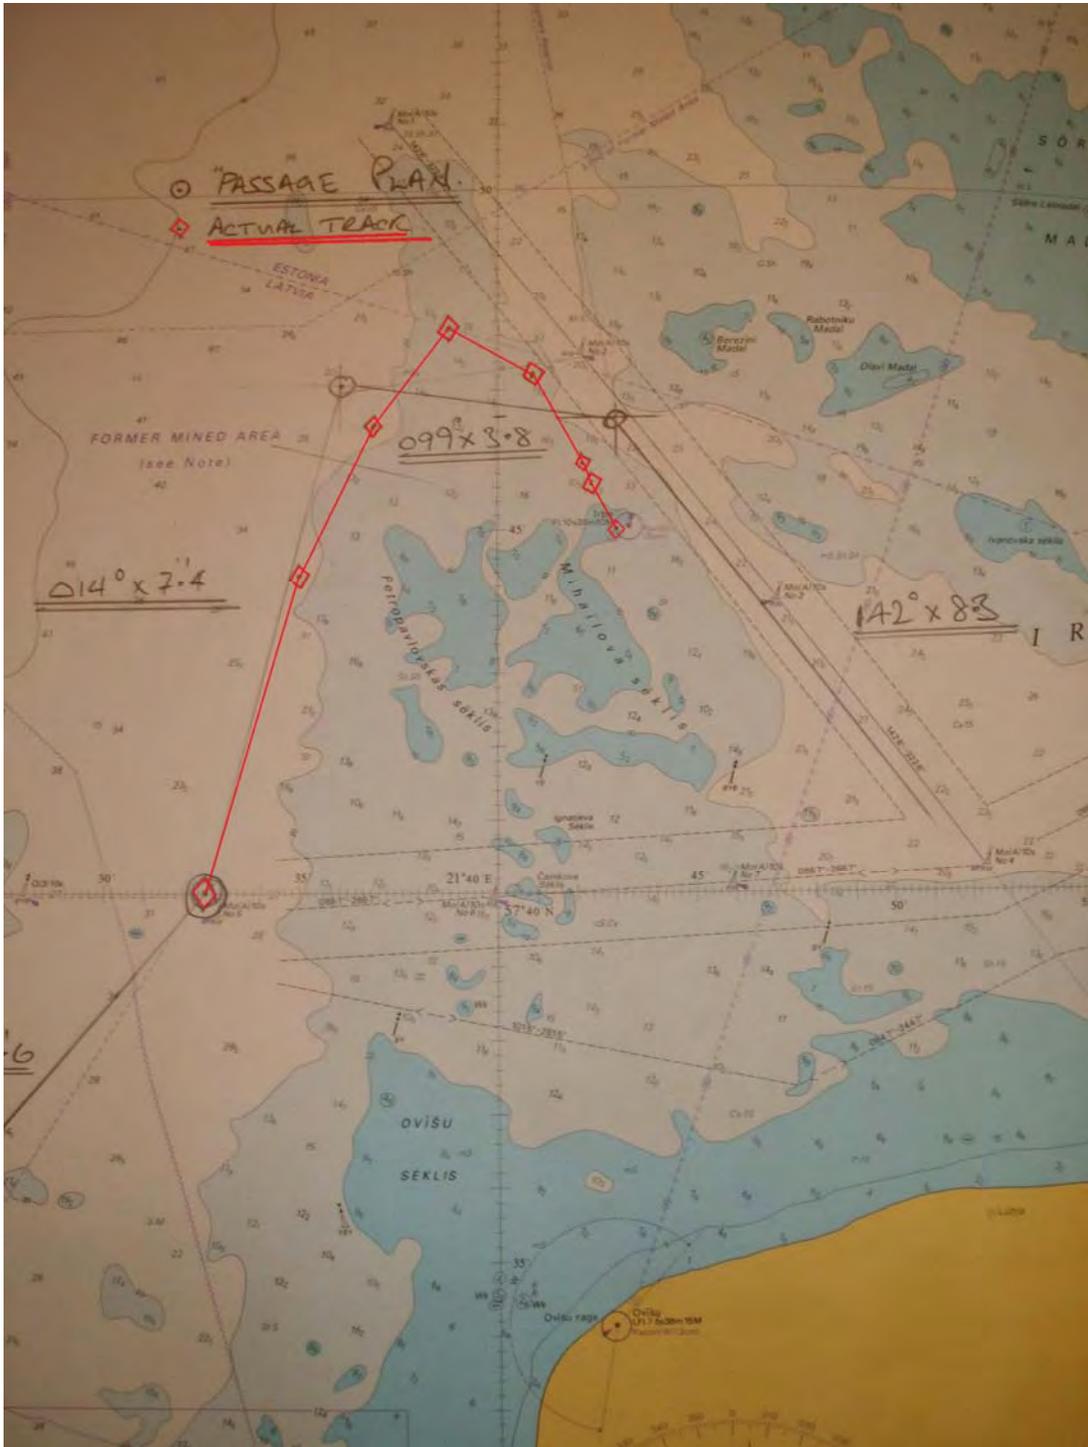
Appendix VI

Passage Plan overlaid with AIS Track

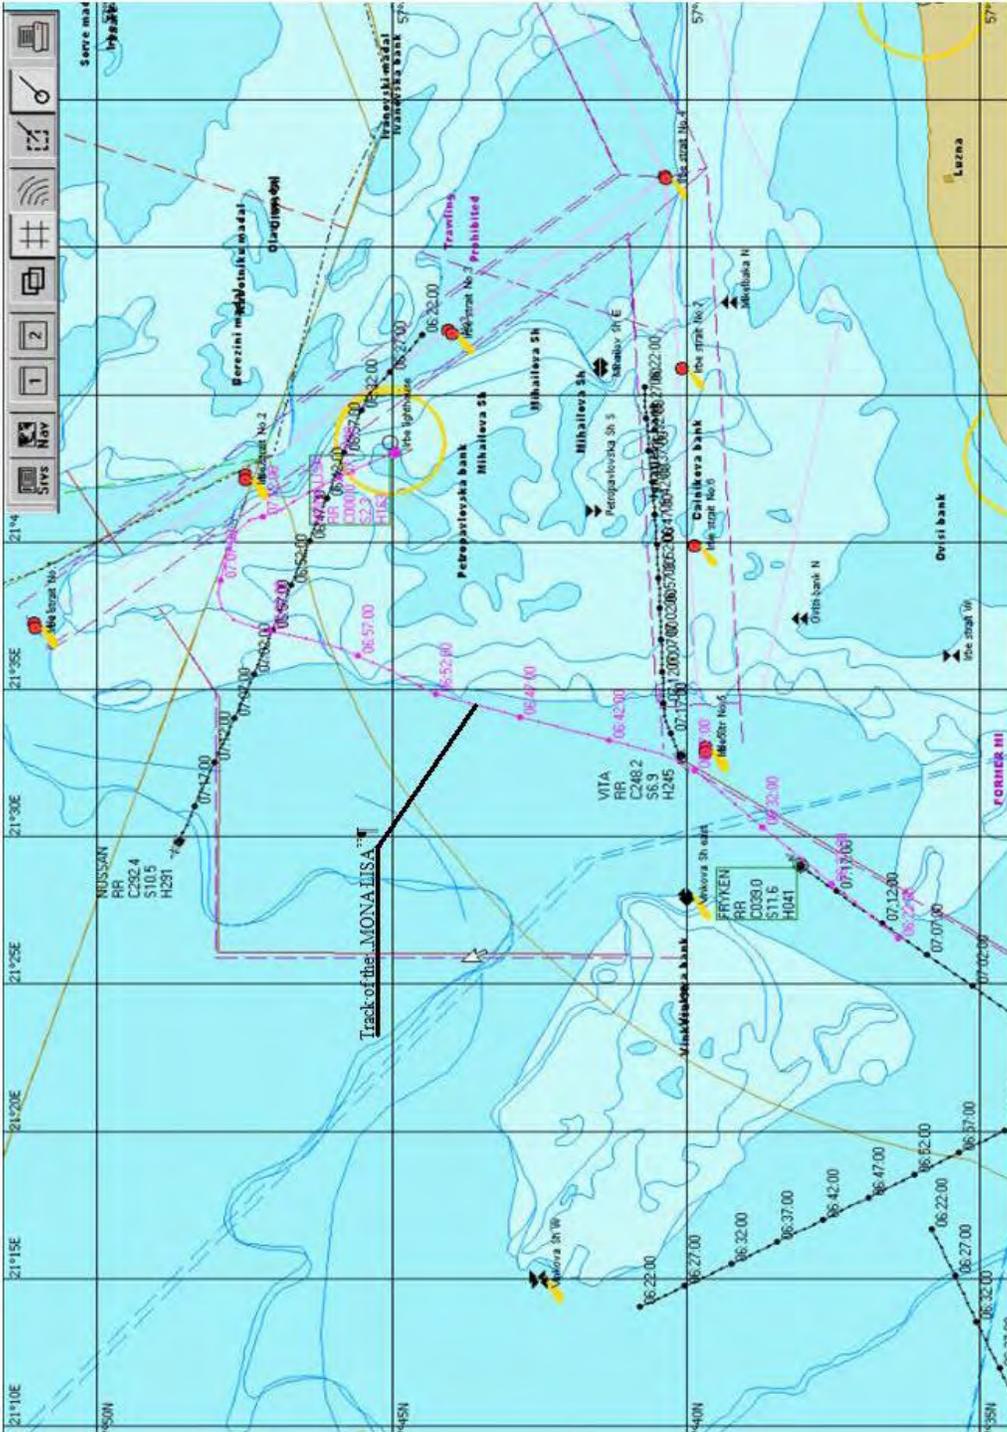
Appendix VII

AIS Track of Mona Lisa
