**THE JOINT DIVISION FOR INVESTIGATION OF MARITIME
ACCIDENTS & BAHAMAS MARITIME AUTHORITY REPORT**

QUEST
Grounding on 27 June 2007

The casualty report has been issued on 4 August 2008

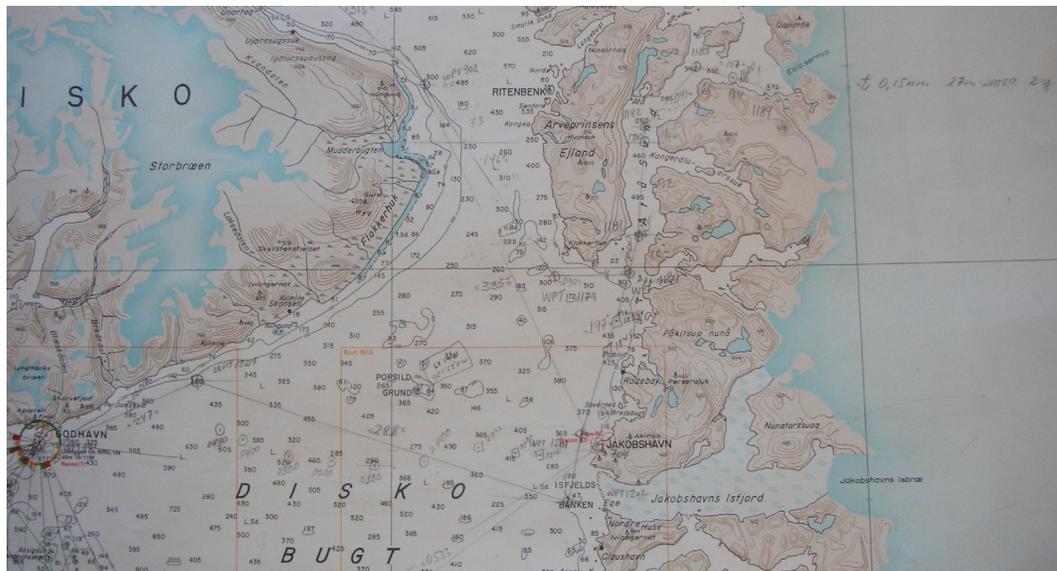
QUEST's Danish chart no. 1500. Photo by the Investigation Division

When the 2nd Officer took over as OOW at 0000 hours on 27 June the speed was reduced to about 4 knots and he was told by the CO to remain on this speed and to call the Master at 0430. The course according to the voyage plan was 288° but due to icebergs the vessel was deviating from the plan.

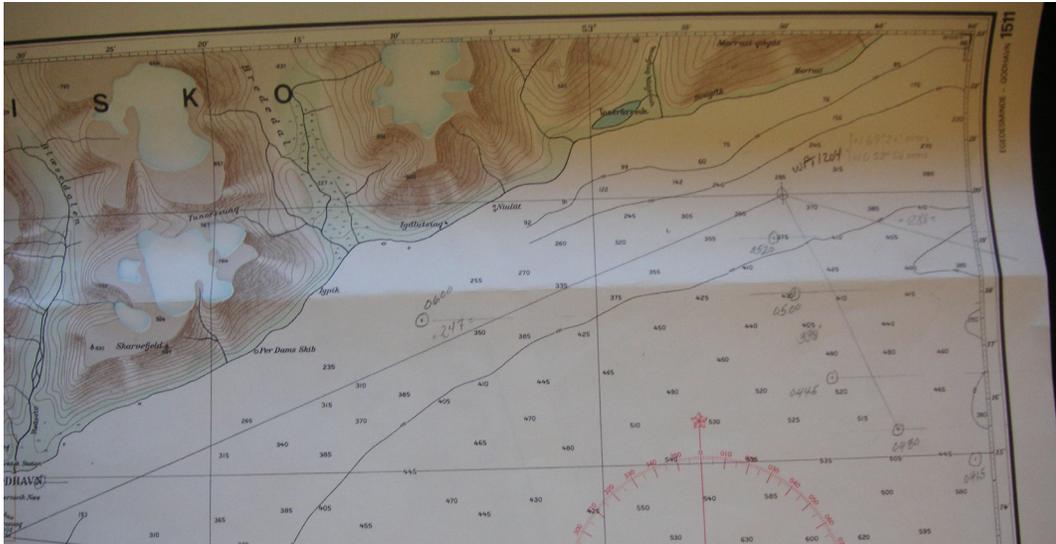
QUEST's Danish chart no. 1511. Photo by the Investigation Division

It was the decision of the Master to go closer to the coast than original planned in the Voyage Plan. He did so for the benefit of the passengers, who could watch the icebergs and whales at close hand.

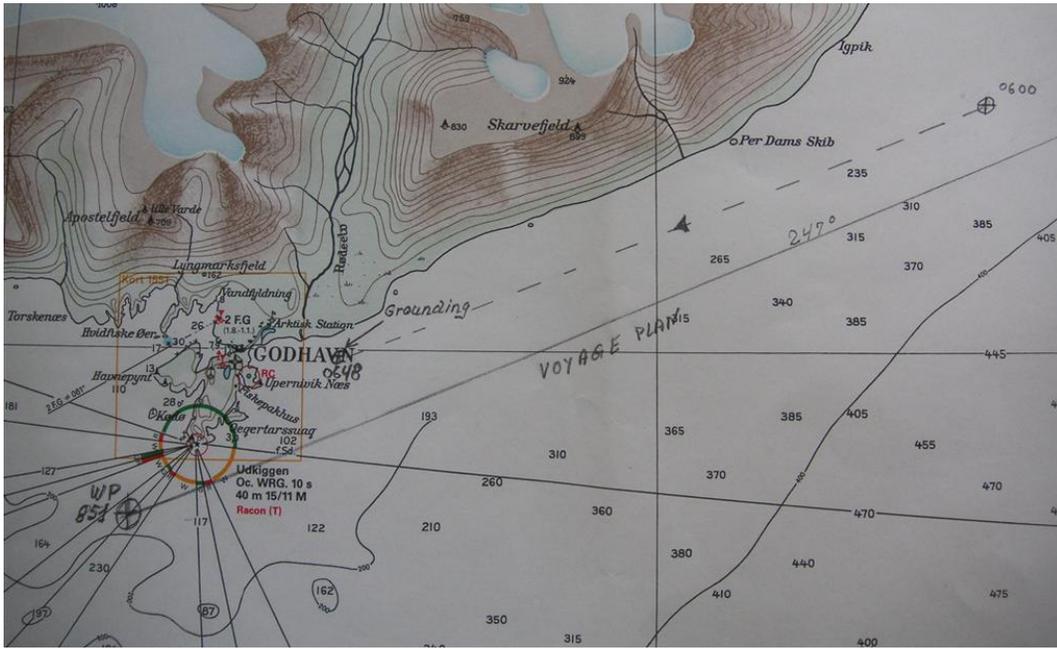
For the voyage across the Disko Bay the course according to the Voyage Plan was 288° towards WP 1204 in position 69°20' N - 52°50' W. From WP 1204 the track inserted in chart No. 1511 went along the coastline on course 247° to WP No. 851 in position 69°13,25' N - 53°35,80' W, just outside Qeqertarsuaq.

The actual route sailed across the bay was about 3 miles south of the route of the Voyage Plan. According to the 2nd Officer, this was because of the many ice bergs.

At 0520 the Master altered the course to 270° and continued on this course past the Voyage Plan track on course 247° along the coastline. At 0600 the position according to the Deck Log Book was 69°17,8' N - 53°09,6' W. The Master has explained that he decided to sail closer to the coast than originally planned, so they could manoeuvre between the ice bergs and the passengers could watch the whales between the ice bergs.

Photo by the Investigation Division. Chart no. 1511

From about 0600 and until the grounding at 0648 the vessel passed an area for which the chart did not contain any depth curves and with only very few soundings marked in the chart.

It is recommended that the managers update QUEST's ISM procedures concerning Voyage Planning to reflect the importance of carefully routeing in Greenland waters, where surveys may be sparse, to reflect the importance of following the Voyage Plan,

and finally to reflect the importance of updating the Voyage Plan, when circumstances have necessitated a deviation from the plan.
