“RAVEN ARROW”

**IMO Number 8011328
Official Number 399426**

**Report of the Investigation into
the Grounding of
“RAVEN ARROW”
at Boat Bay, Johnstone Strait, British Columbia
on
24 September 1997**

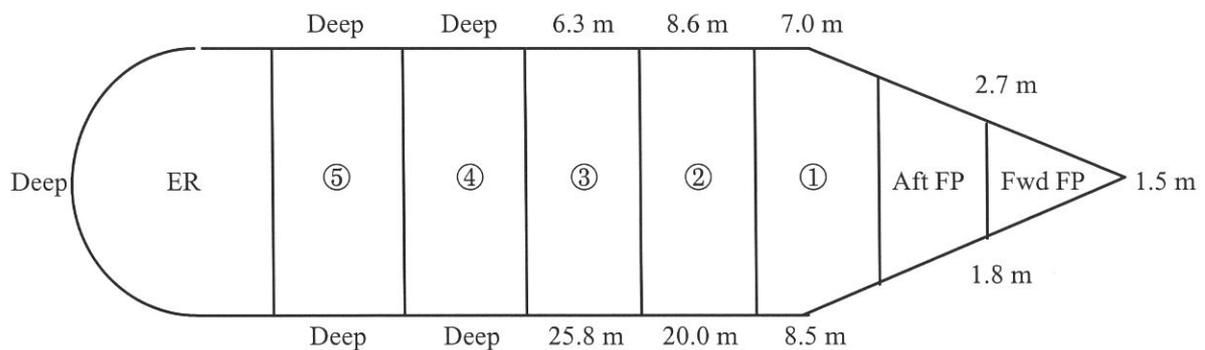
3.4.4 The following overside hand lead soundings were taken at 0300 hours, at low water. The term “Deep” refers to a depth beyond the range of the lead line.

3.4.8 By 0615 hours soundings within the vessel had established that the Forward and Aft Fore Peak tanks (Fwd FP and Aft FP above), Nos. 1, 2 and 3 port double bottom tanks and No. 1/2 wing tank (port) had all been breached.

- 3.4.13 The damage extended forward of frame No. 125 up to the bulbous bow, to the port side of the centre line. A diver’s survey at Johnstone Strait revealed that plating was set in and breached revealing a total of 38 holes and fractures of various sizes way of the tanks referred to in **paragraph 3.4.8** above.
