M.v STAR PRIDE

IMO NUMBER: 8707343

**Report of the marine safety investigation into a grounding
at Isla de Coiba on 22nd December 2015**

Date of Issue: 17th August 2017

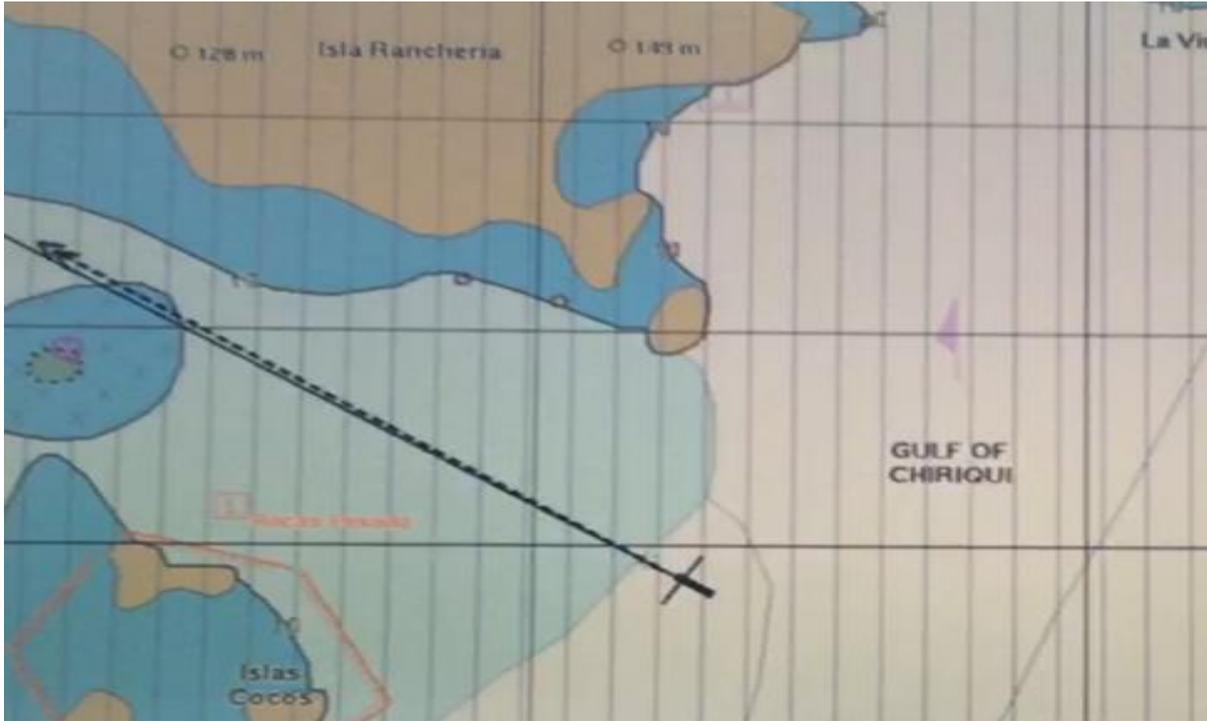
Figure 7: Ecdis screenshot showing vessel's approach to Canal (channel) de Rancheria (ENC No. 1401). Vertical lines indicate incorrect scale in use.

- 4.16 This extract is timed at 0611:22 on 22nd December, the Master had been at the Conn for approximately six (6) minutes, the engines had been on stand-by for one (1) minute and the vessel was heading 305° at a speed of 13.9 knots over the ground.

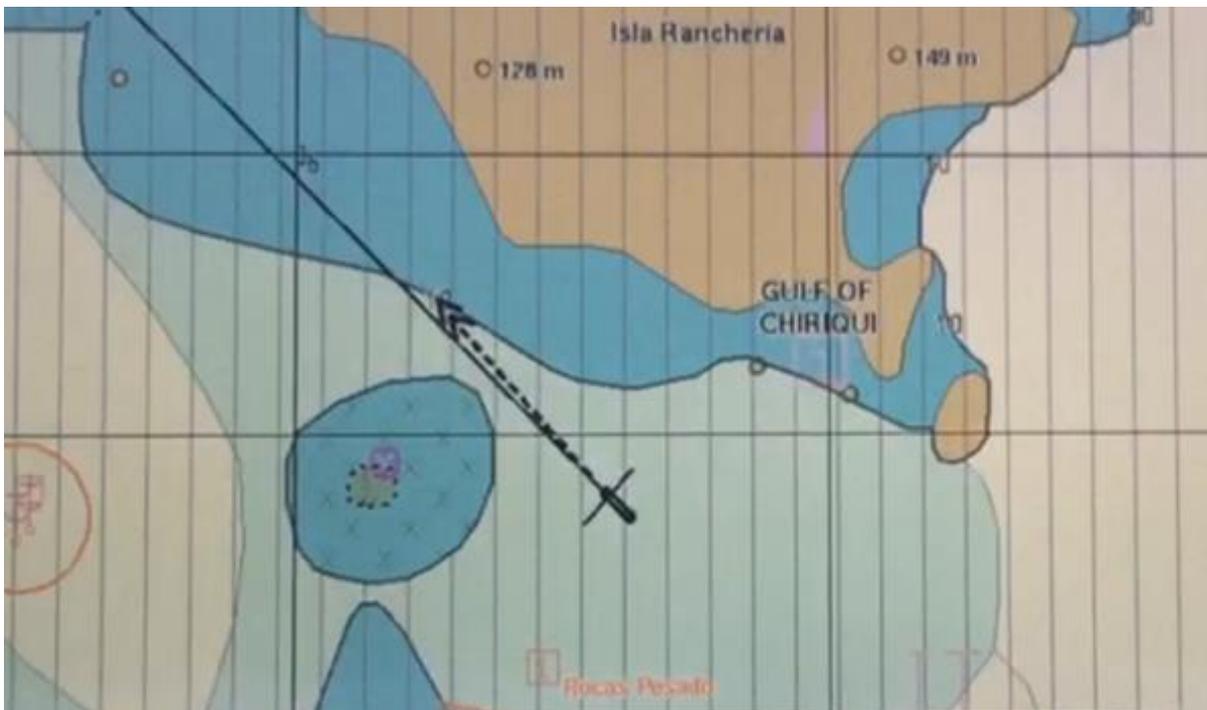
Figure 8: Ecdis screenshot showing vessel's grounding position at 1615:21. Vertical lines indicate incorrect scale in use.

- 4.17 The vessel grounded at 0615:21 on 22nd December (as seen in figure 8) at which point the speed over the ground reduced to 4.0 knots almost immediately.

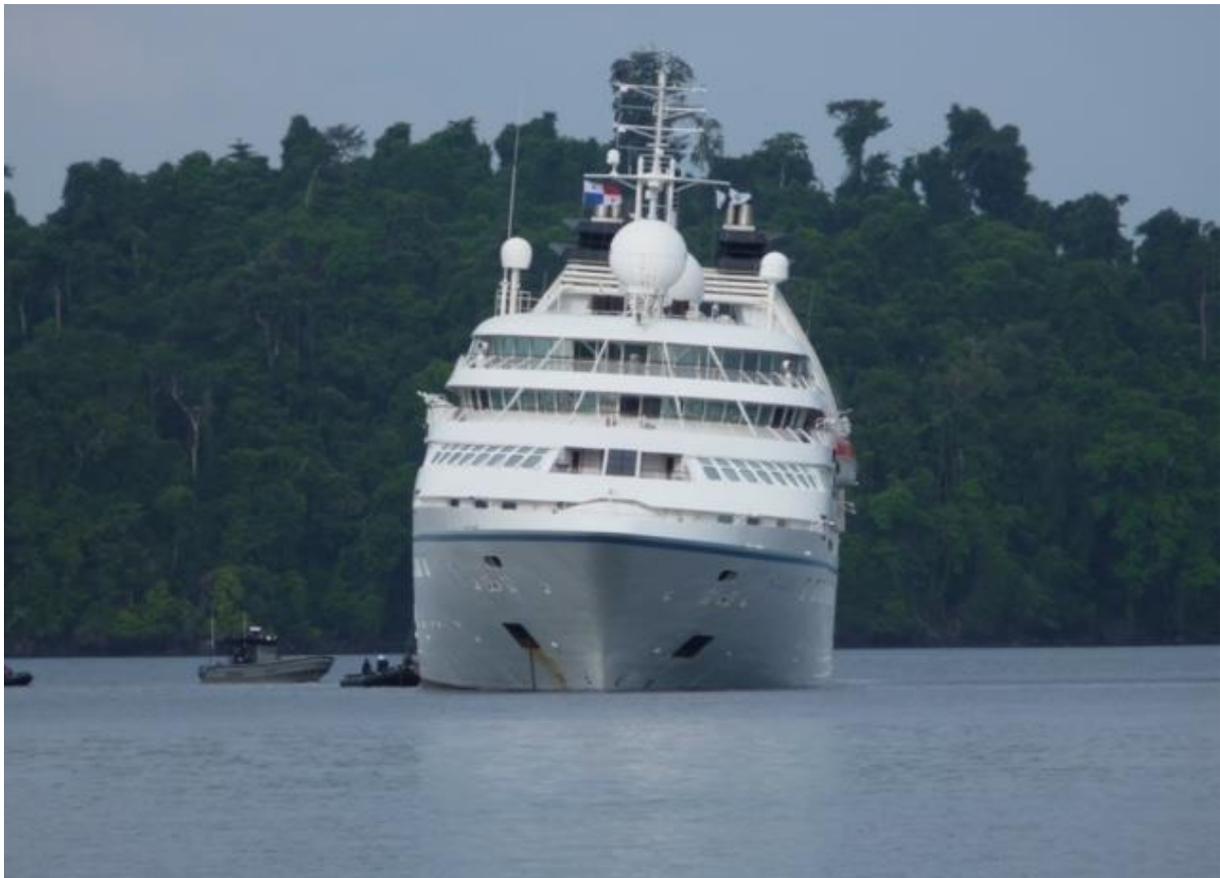
Figure 9: Vessel pictured on the 22nd December at 1712 at 4.1° list, viewed from ashore

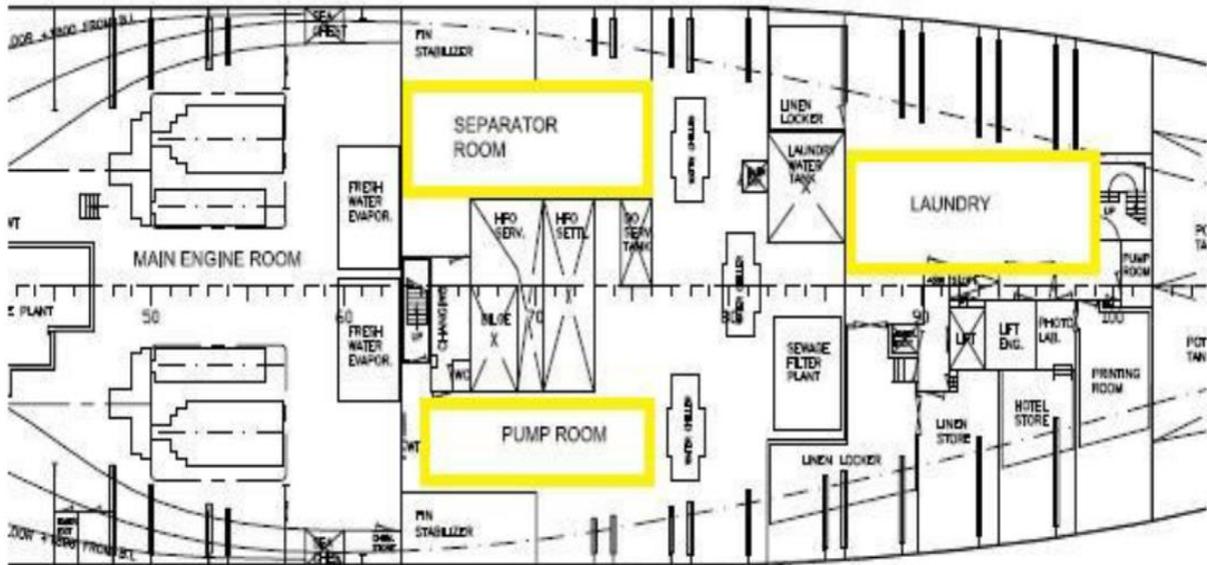
- 4.39 Seven crew members remained with the vessel until the arrival of teams from Resolve Salvage on the 25th December.
- 4.40 The vessel's engine spaces were flooded in two principle areas. These were the forward machinery room which includes the pump room and purifier room and the laundry space.

Figure 10: Flooded spaces as of the 27th December highlighted above and as follows: Separator Room, Pump Room and Laundry

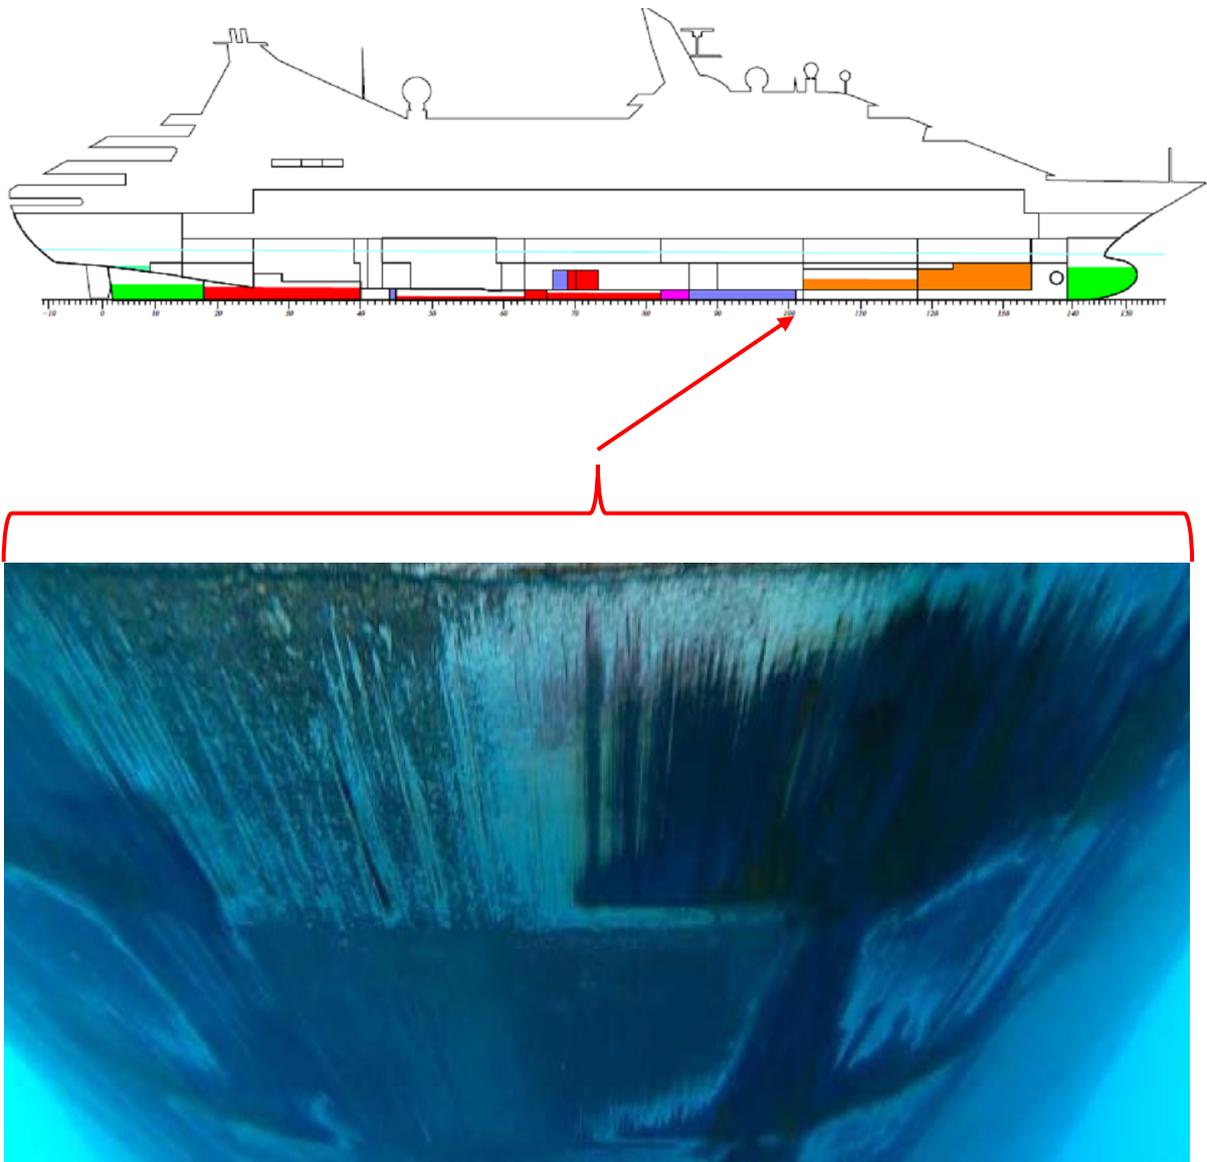
Figure 11: Frame 101 – 102 bottom impact and scrape, no cracks or penetrations

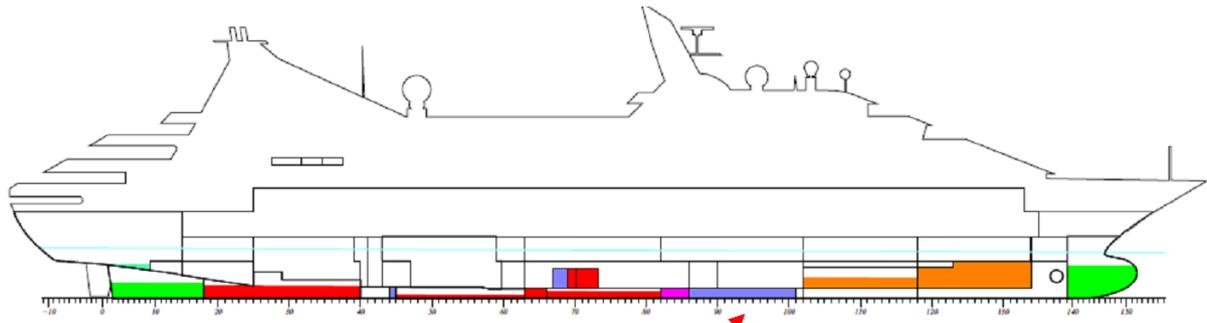
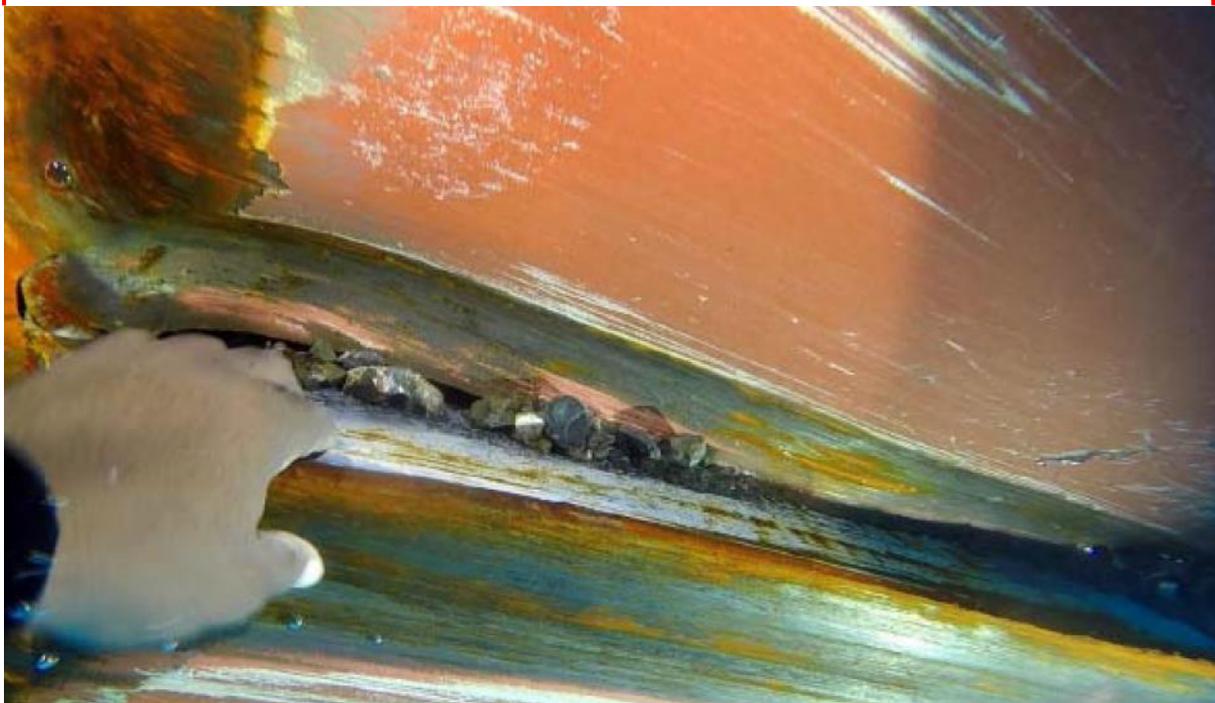
Figure 12: Frame 92 – 95 port centre, longitudinal crack 1800mm x 80-120mm in way of #3 port grey water tank

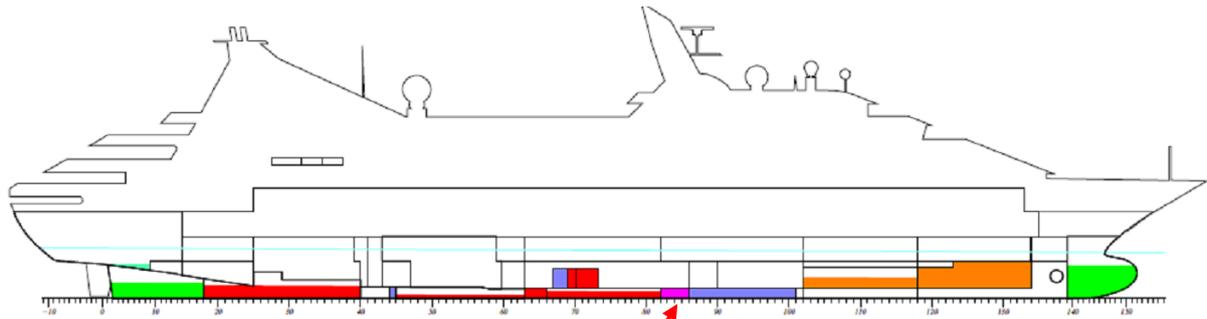
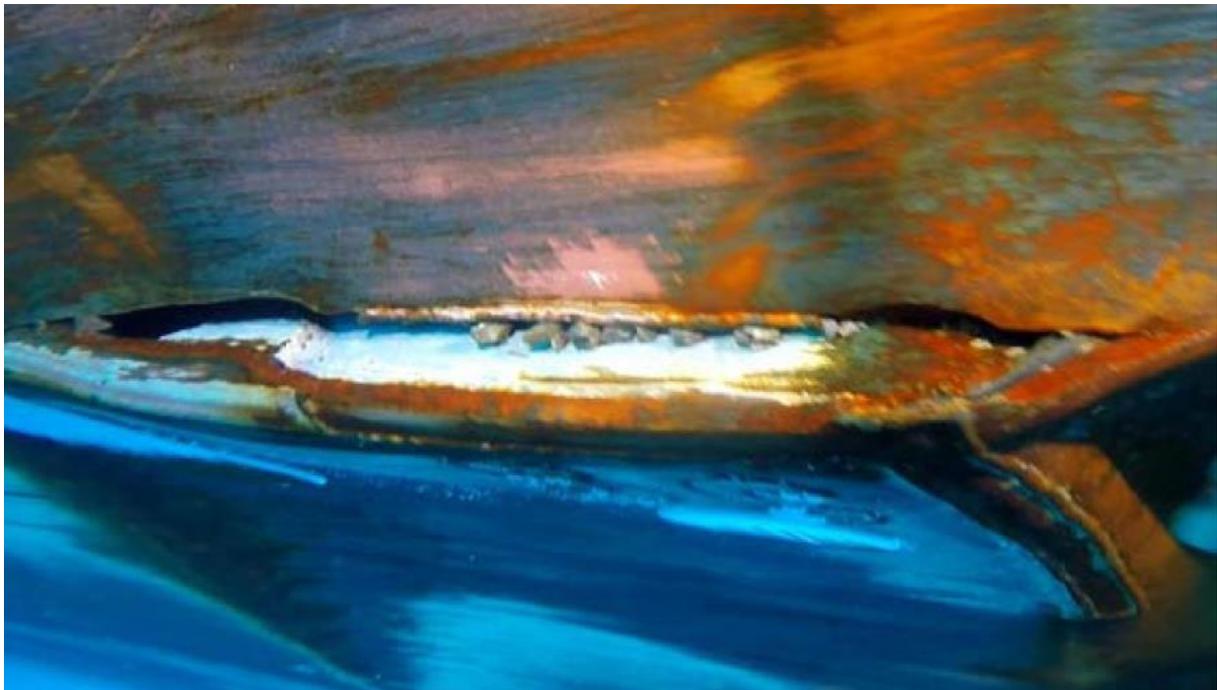
Figure 13: Frame 82 – 86 starboard side, longitudinal crack 400 x 60-80mm in way of #3 starboard grey water tank and #5 centre MGO tank. 2nd crack 105mm x 30-40mm in way of #3 starboard grey water tank and #5 centre fuel oil tank

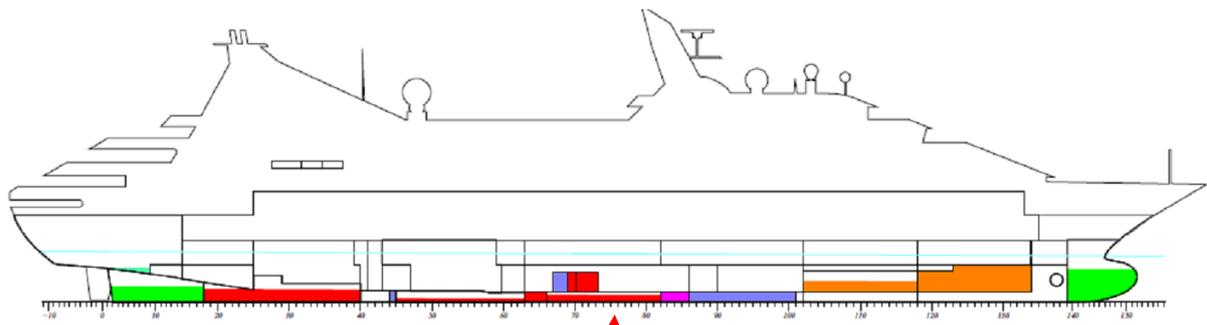
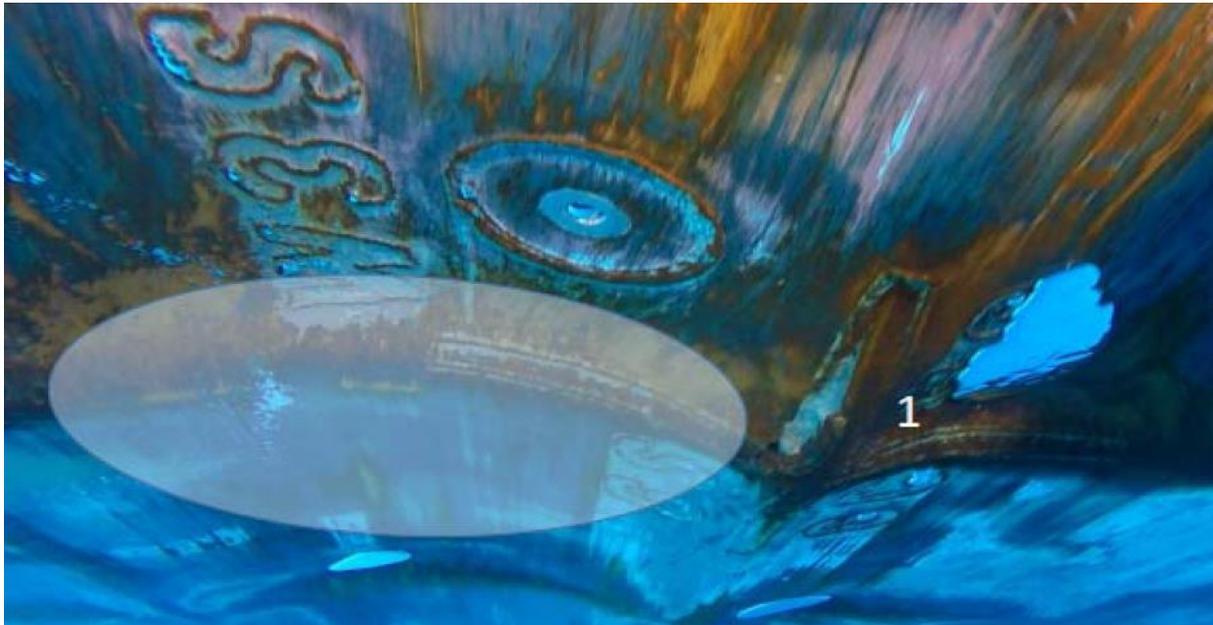
Figure 14: Frame 75 port side, 50-100mm plate indentation/deflection under tank 6 port and 7 port HFO/sludge storage tanks. No cracks. Frame 84 (image not shown) minor indents.

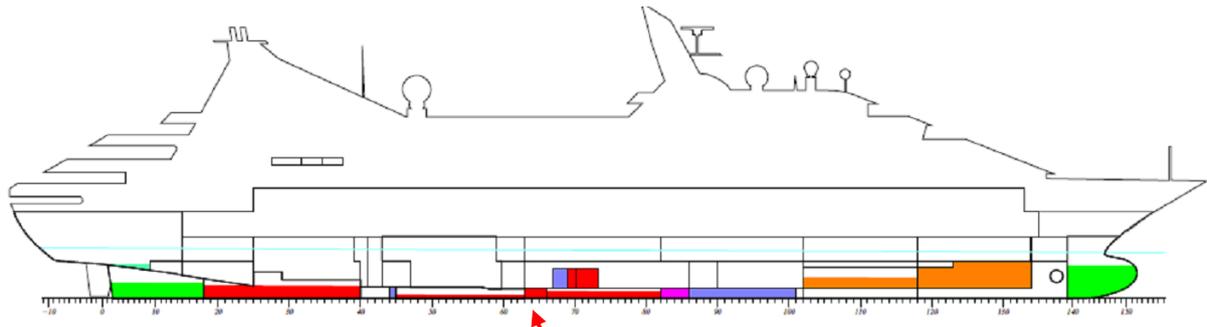
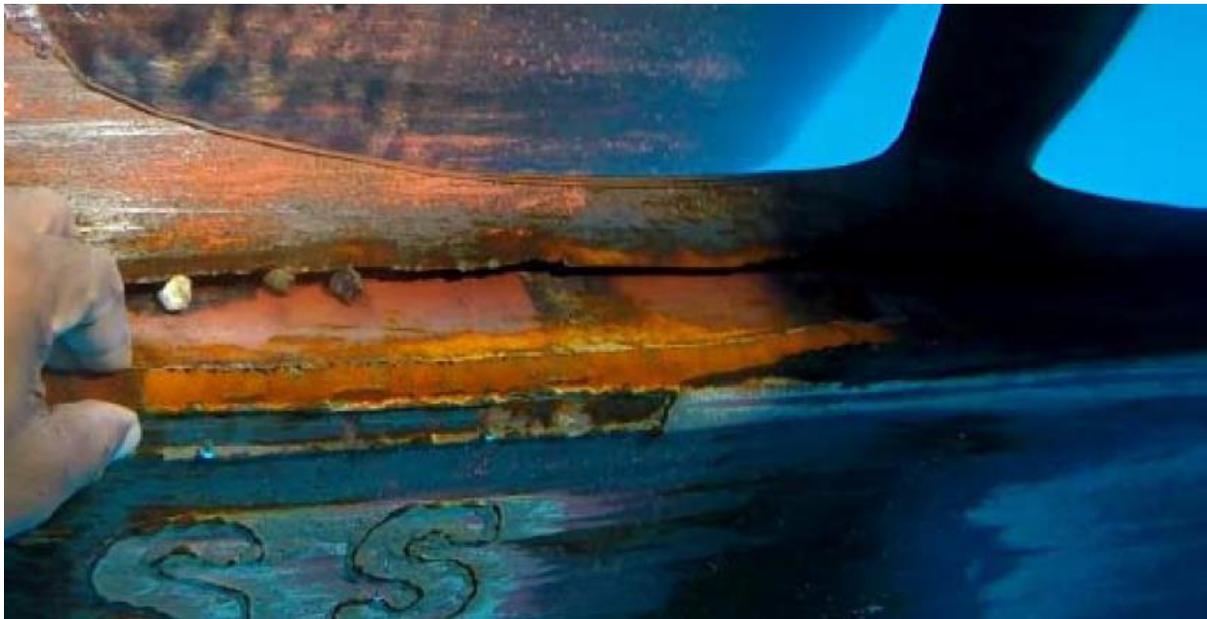
Figure 15: Frame 63-66 starboard, 100-150mm indentations below starboard stabilizer. Crack 1500mm x 60-80mm into #6 HFO tank. Crack 100mm x 10mm into #15 starboard FO overflow tank.

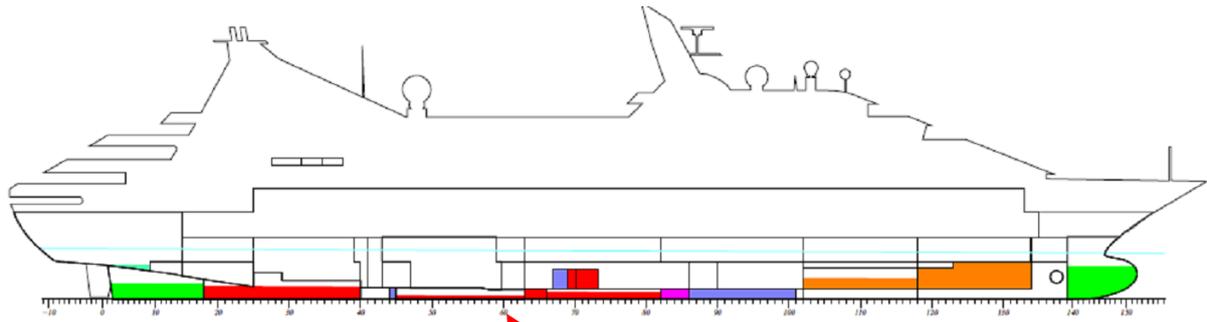
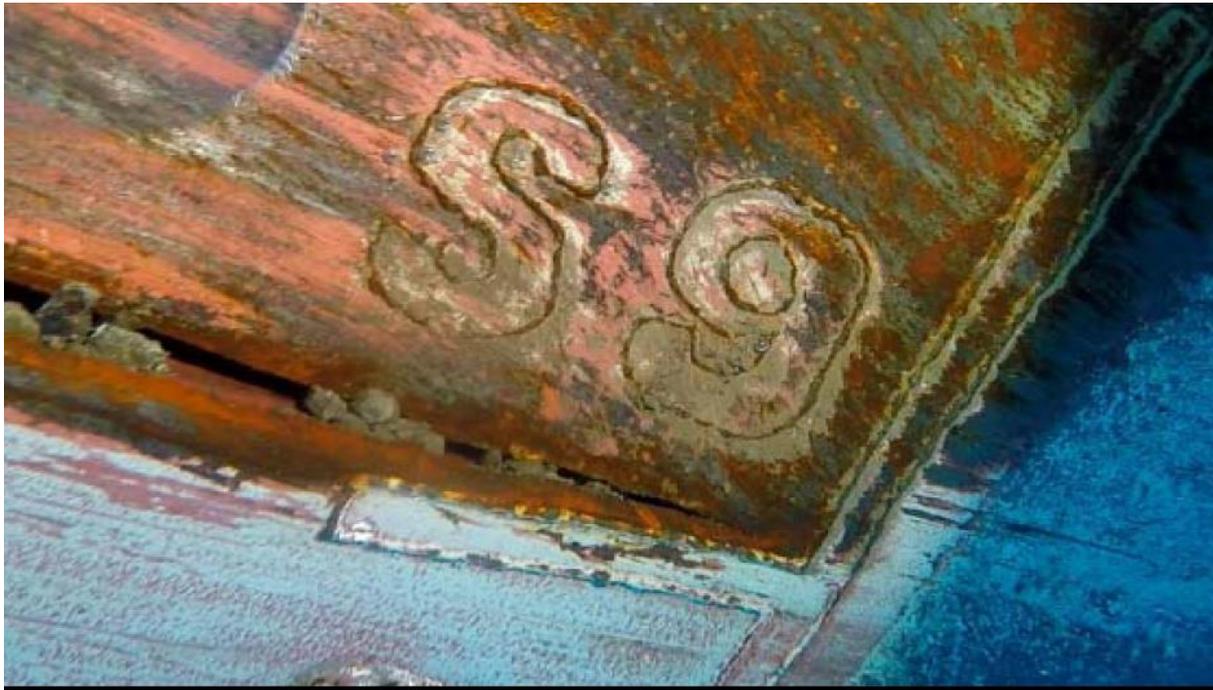
Figure 16: Frame 61-63 port side, minor indentations. Crack 100mm x 20-40mm in way of #17 port grey water tank and cooling water drain tank #2.

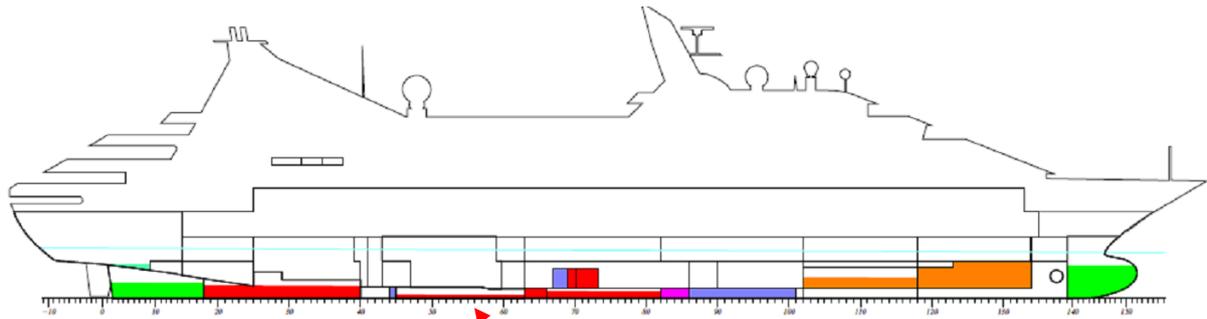
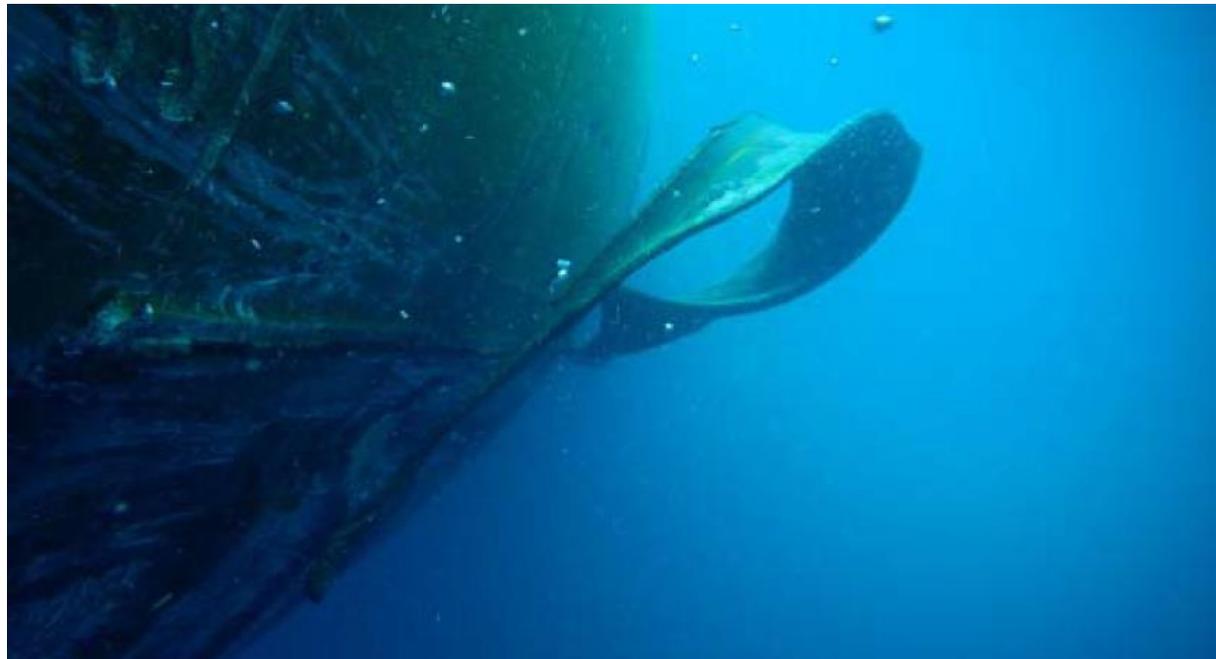
Figure 17: Bilge keep port side partially detached from vessel

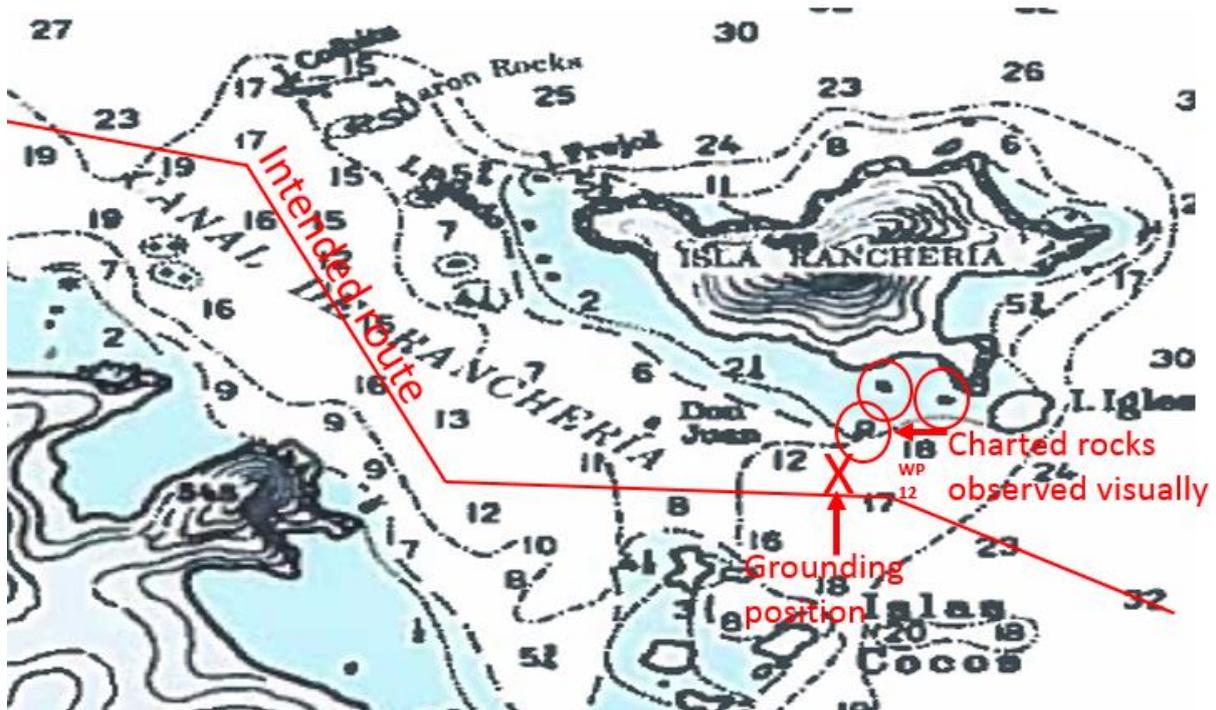
Figure 18: Intended route for passage 164 between Isla Rancheria and Isla de Coiba overlaid onto US Defence Mapping chart 21583 (depth in fathoms)

- 5.1.10 The Master who at the time of the grounding had the Conn, manoeuvred the vessel to port in order to provide more safe water between the vessel and the chartered rocks seen both visually and by radar (circled within figure 18). In doing so the Master deviated from the intended route by altering course to port, before regaining once he deemed sufficient safe water had been achieved between the rocks and the vessel. Moments after regaining the intended route, in proximity of way point 12, the vessel ran aground in an area with a charted depth of approximately 12 fathoms (21.9m) of water.

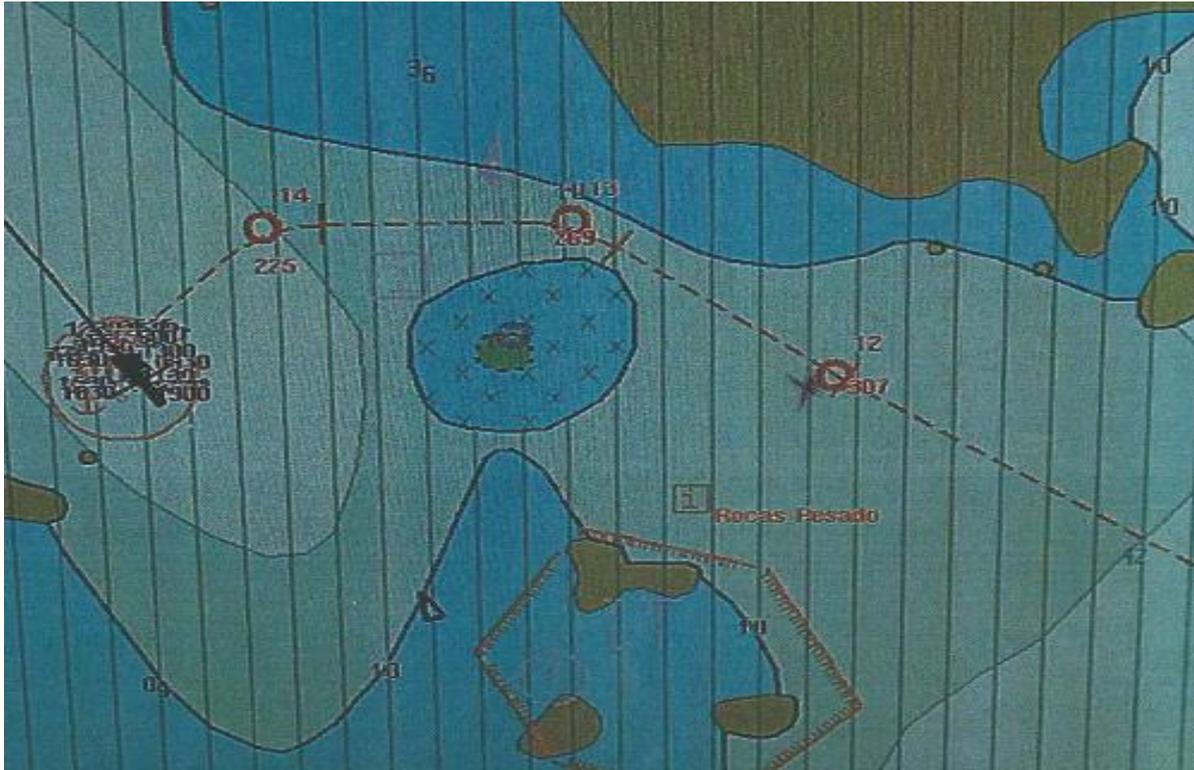
- 5.1.12 The Chief Officer marked a paper copy of the vessel's ECDIS screen with the location of the bumping experienced on the 16th December, reproduced in figure 19 below (as indicated by the 'x'). As an approximate comparison, the grounding position on the 22nd is marked on the ECDIS identified by the vessel's location within figure 20 below.

Figure 19: Reproduced ECDIS screenshot with 'x' marking the position of the unknown source of the bumping experienced on the 16th December

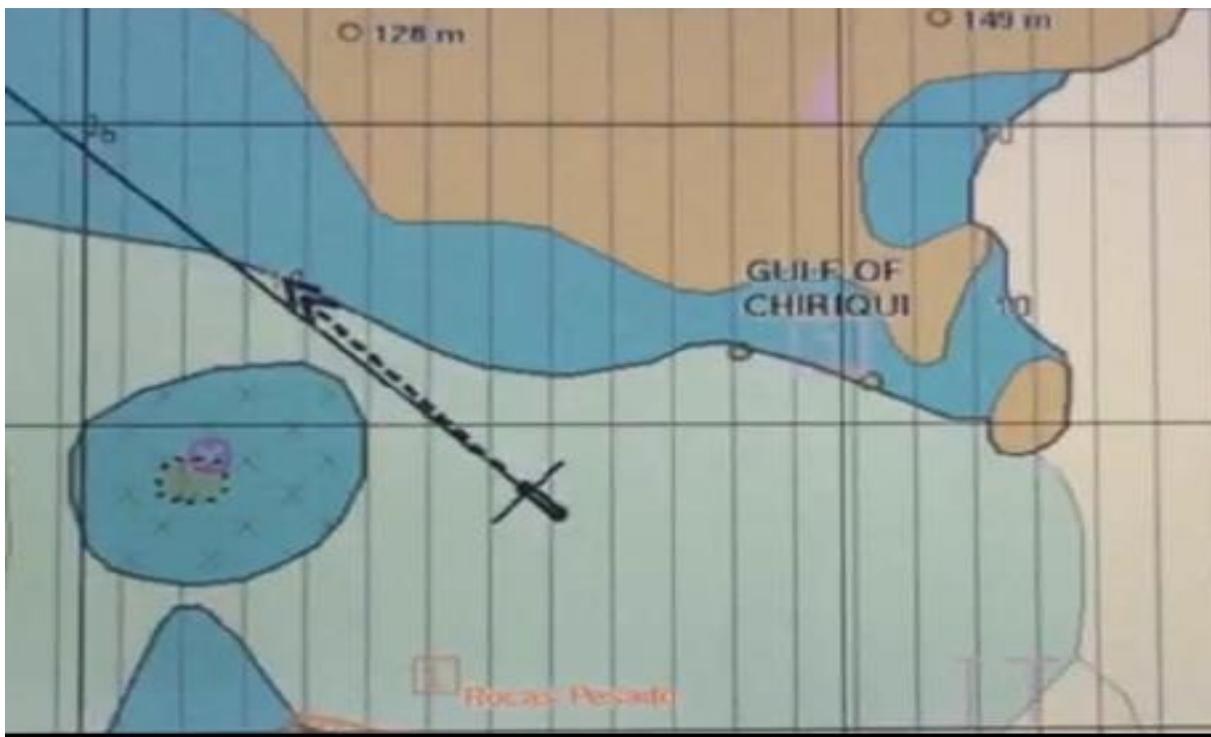
Figure 20: ECDIS display on the 22nd December indicating position of grounding

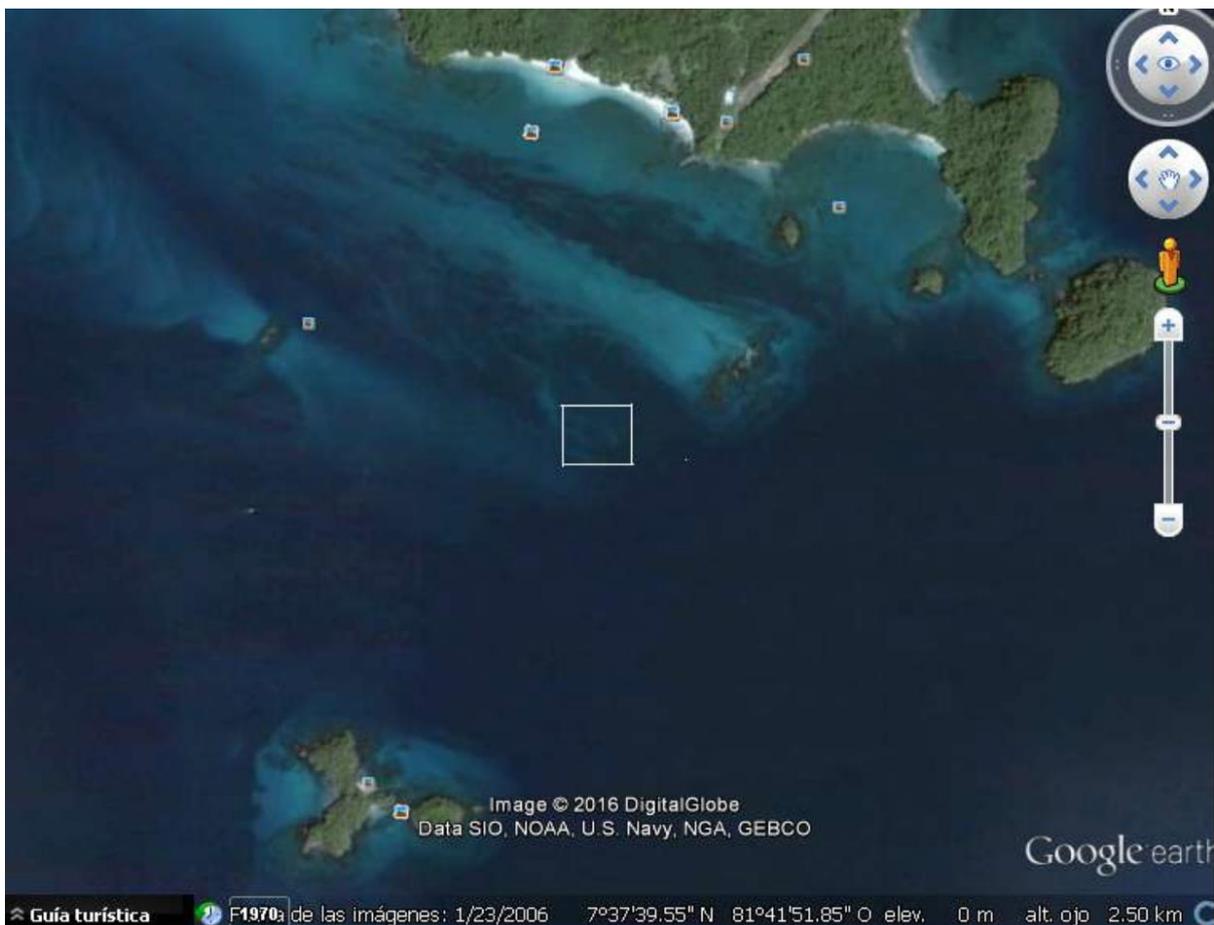
Figure 21: Google Earth image with a white box around lighter blue water at the grounding location, indicating visually an area of shallow water

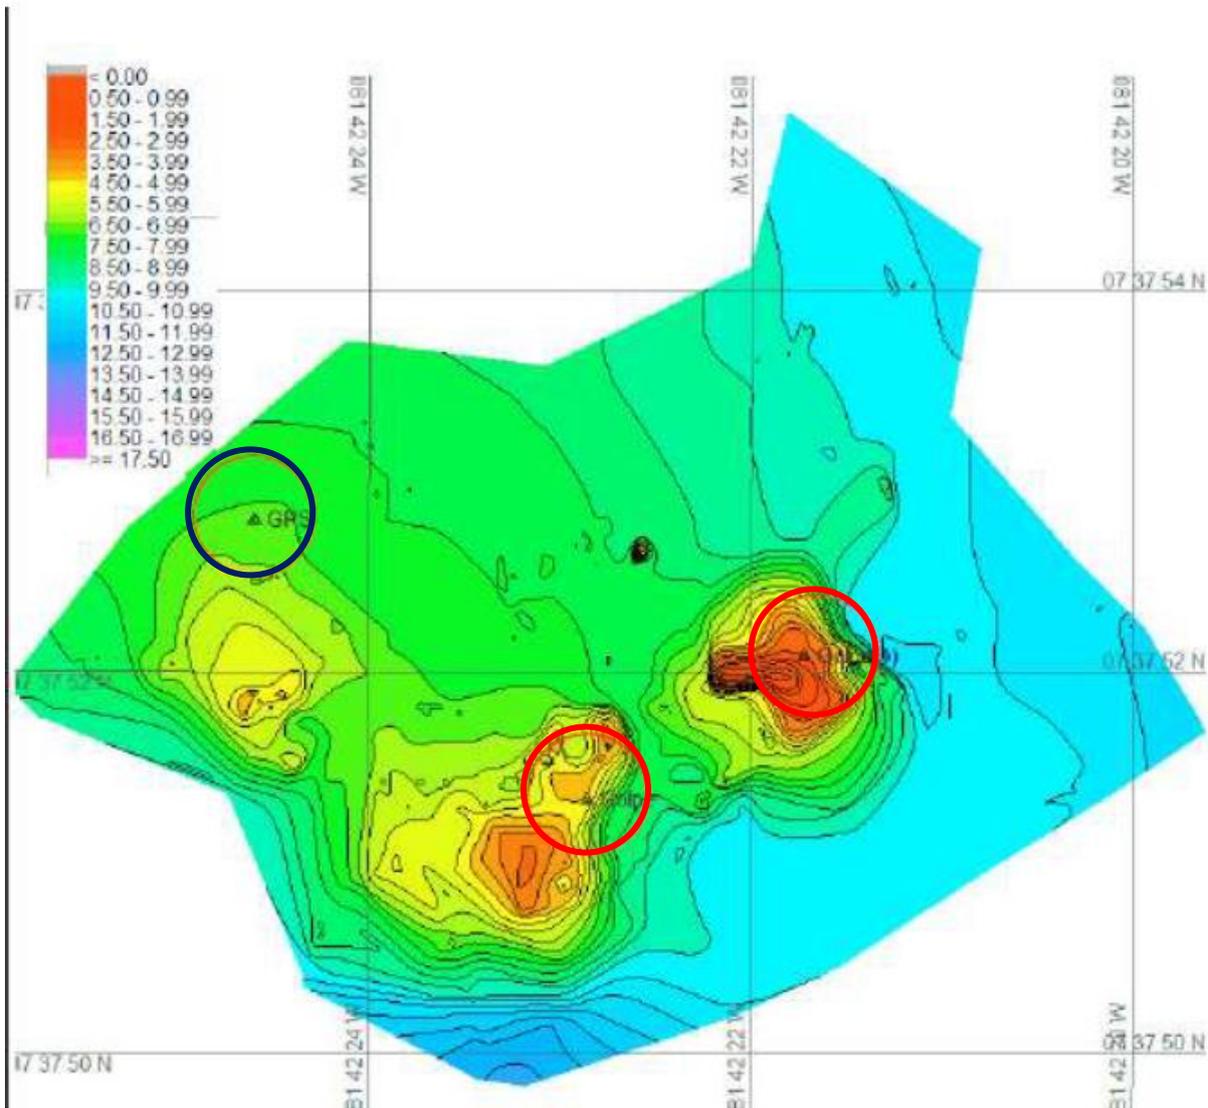
5.2.3 Bathymetry of the area was performed and the result shown within the contour chart below (figure 22 below). The GPS position to the left of the image shows the location of the grounding according to the position provided by the Owners. The two red circles to the right of the GPS position were confirmed later by divers as the exact location of the grounding. These two positions correlate with the GPS plots and google earth imagery confirming that the location of grounding was not charted. Additionally, the bathymetry was able to determine the depth of water in the surrounding area. The two locations identified within the survey of the two grounding positions determined that the actual depth of water experienced was between 0.5 – 4.99m rather than the charted depth of approximately 21 meters.

Figure 22: Bathymetry survey of area. Location of grounding circled in red and original GPS position of grounding in blue

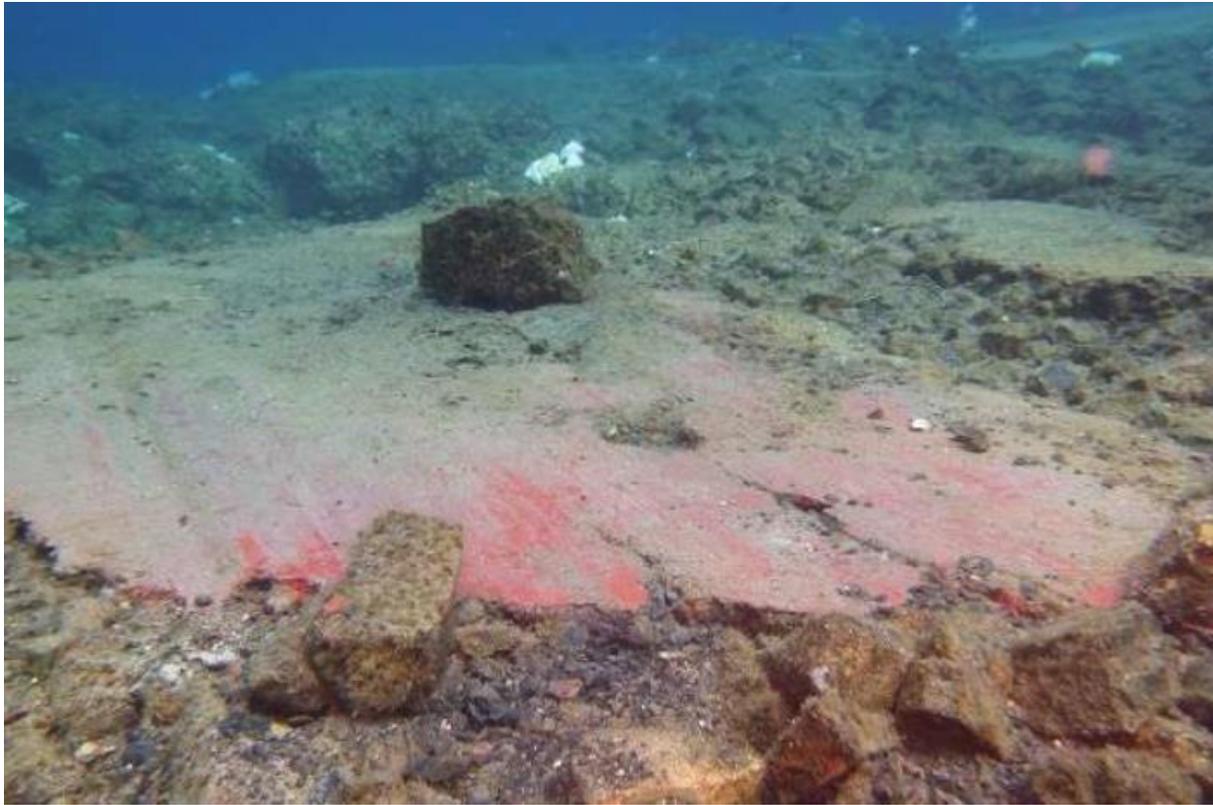
- 5.2.4 A dive survey was also conducted in the location of the grounding position. The pictures provided below confirm the vessel grounded by presence of red paint from the hull deposited on the flattened rock.

Figure 23: Picture of rock confirming vessel grounded

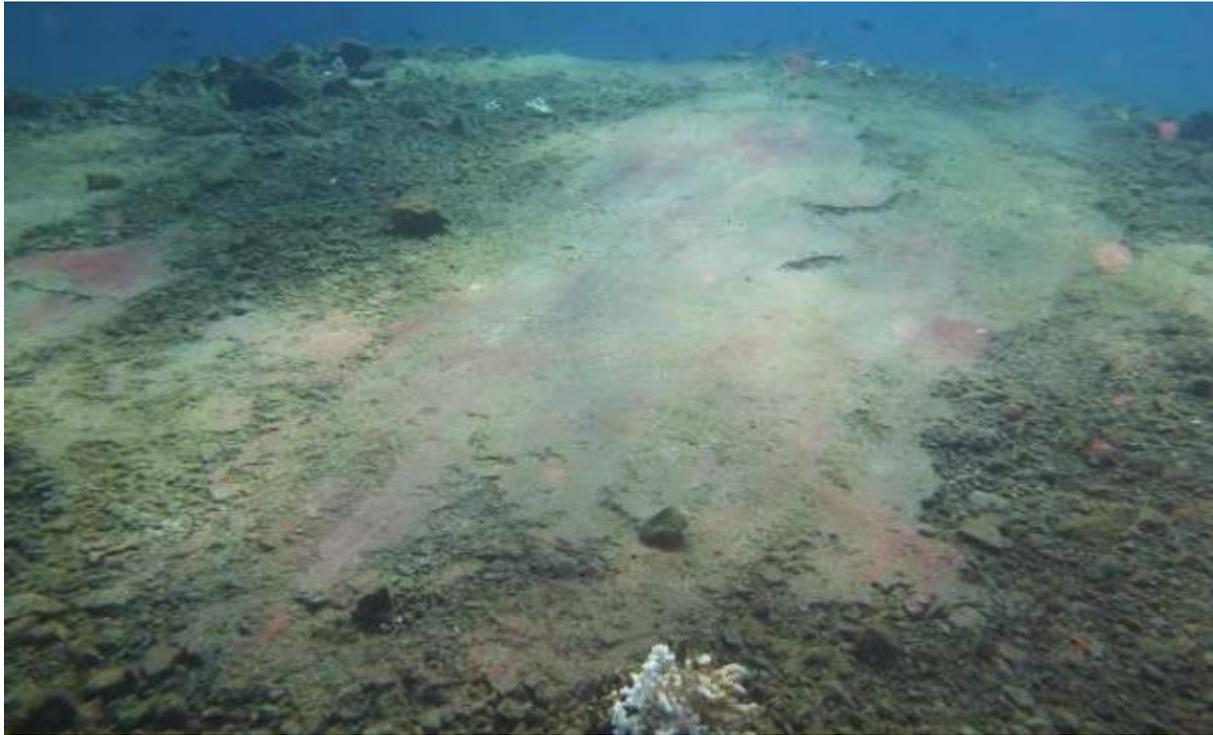
Figure 24: Picture of second rock confirming vessel grounded

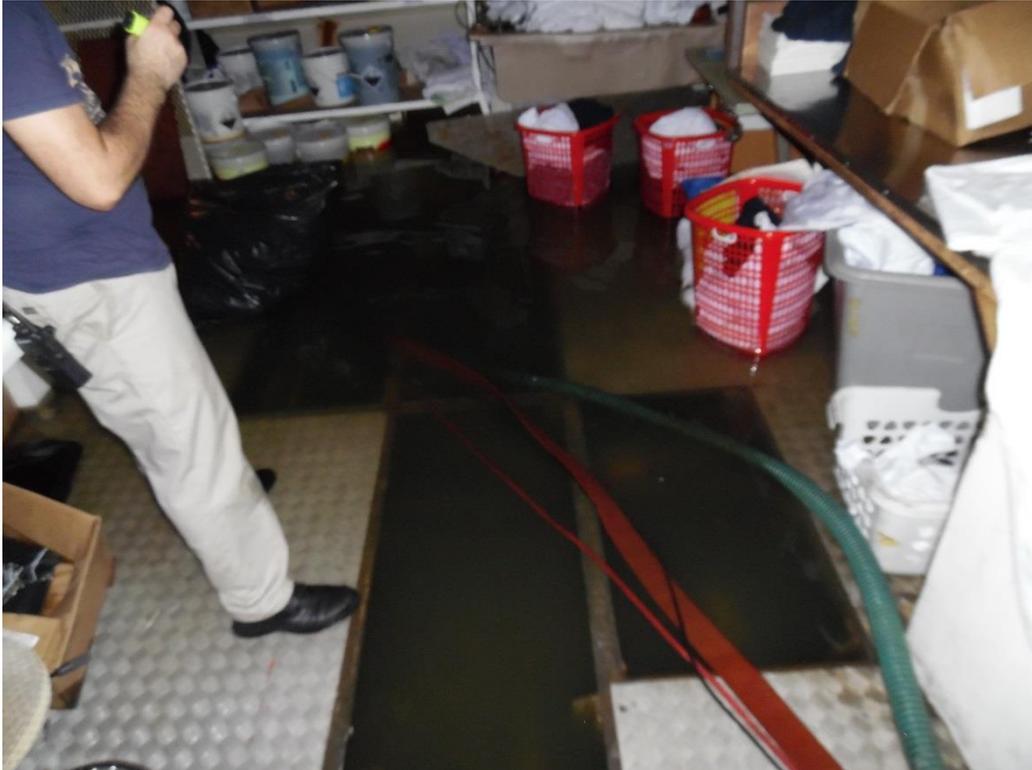
Picture 1: Flooding in the laundry Taken by Panama Authorities at Isla de Coiba

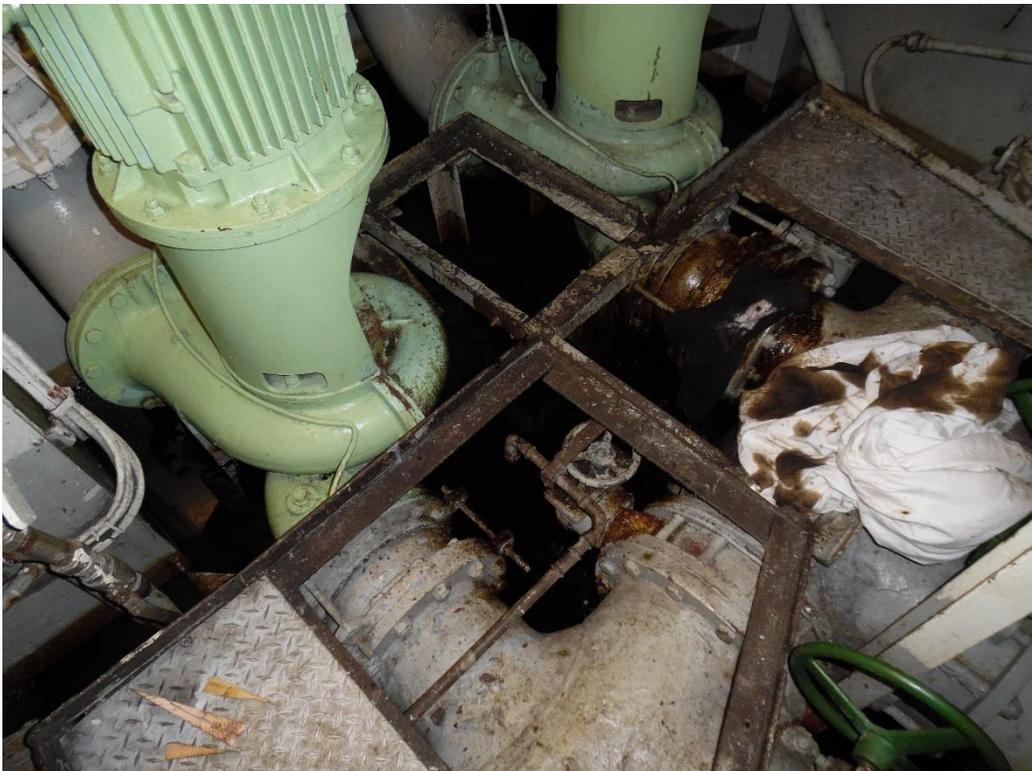
Picture 2: Flooding in Forward engine room space

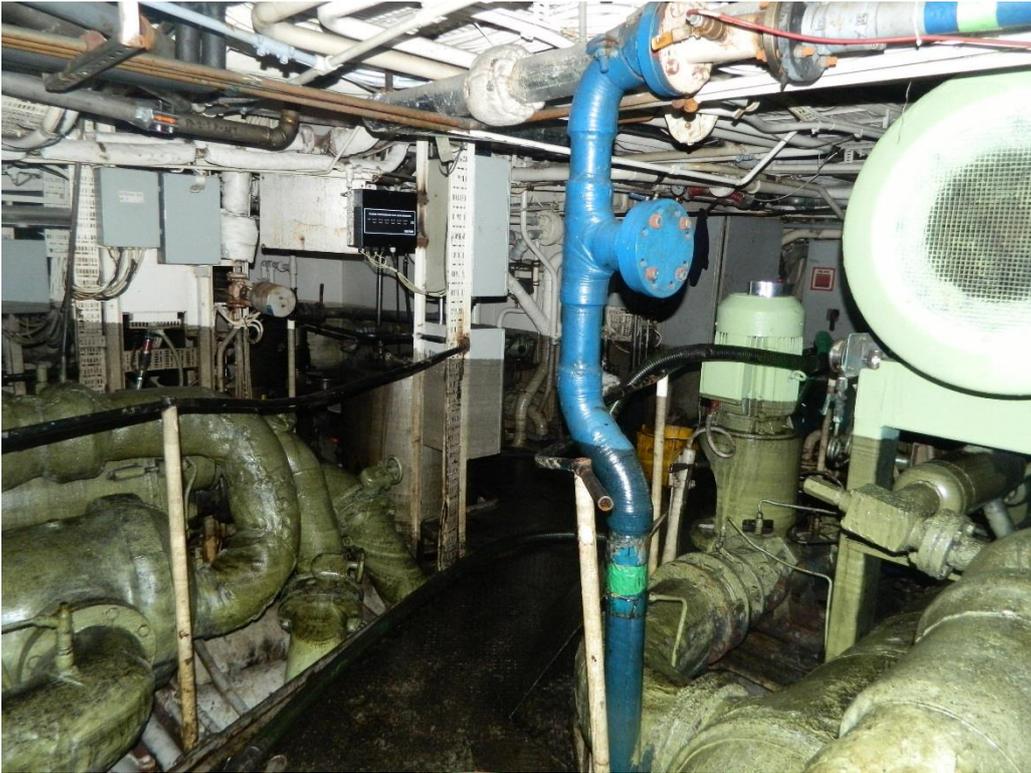
Picture 5: The forward engine space at Balboa anchorage after tow (the dark stain indicates the maximum depth of flooding)
