M.v STAR PRIDE

IMO NUMBER: 8707343

**Report of the marine safety investigation into a grounding
at Isla de Coiba on 22nd December 2015**

Date of Issue: 17th August 2017

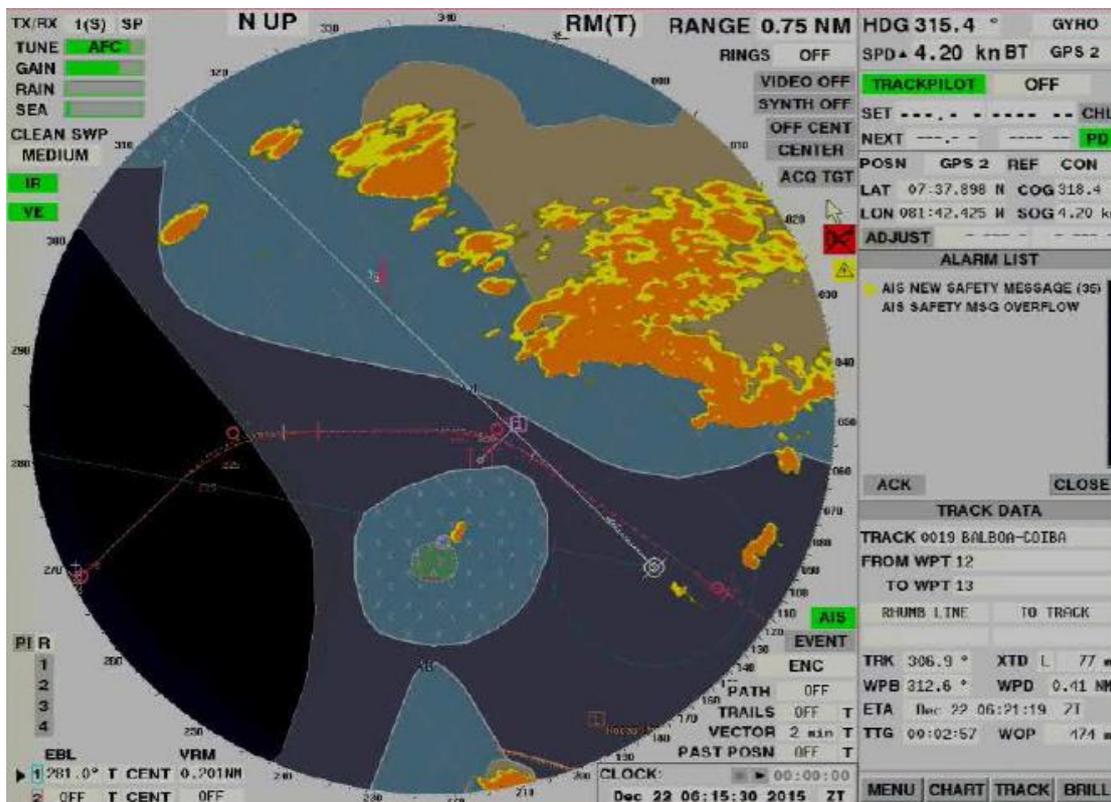
Vessel position at 0615:30 LT - Grounding
